STATE OF WASHINGTON  
DEPARTMENT OF ECOLOGY

**Re: Further Action at the following Site:**

- **Site Name:** Alfys Pizza Container
- **Site Address:** 2317 Broadway, Everett, WA 98201
- **Facility/Site No.:** 75334599
- **Cleanup Site ID:** 16656
- **VCP Project No.:** NW3347

**Description and Diagrams of the Site**

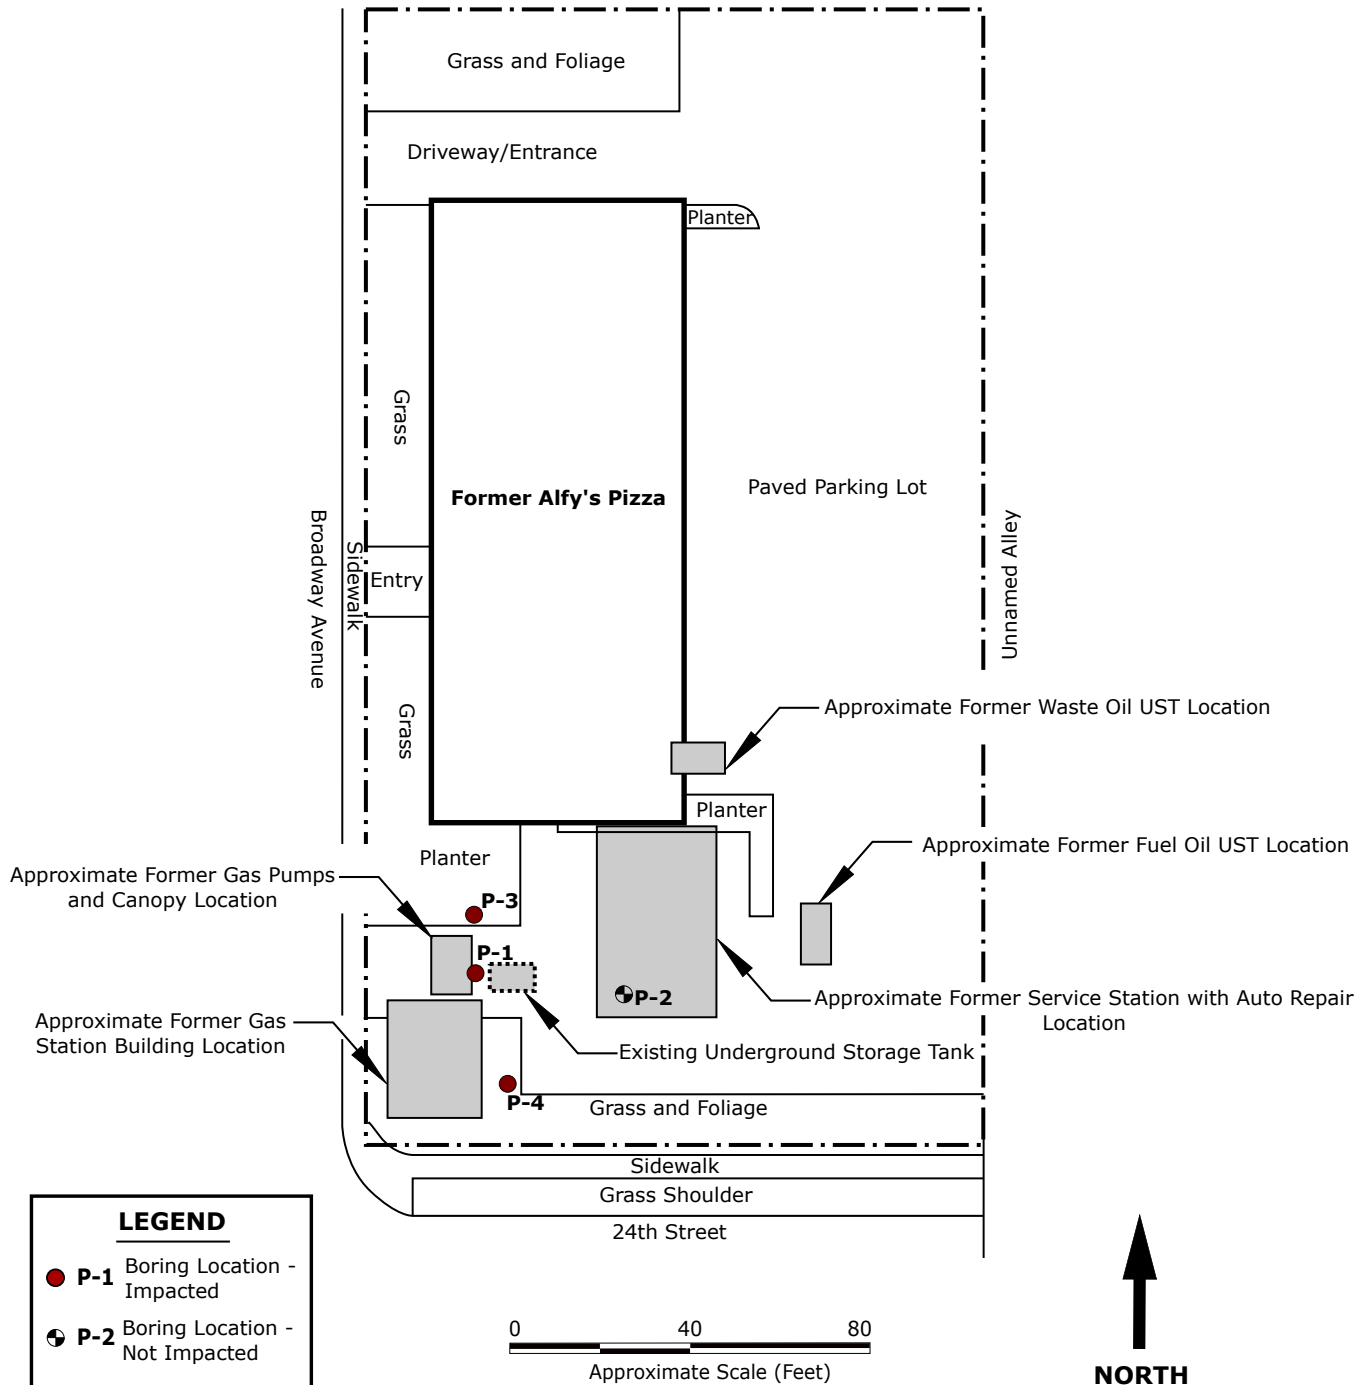
**FIGURE 3**  
DIRECT-PUSH BORING  
LOCATIONS

Site soil is contaminated with TPH-G, TPH-D, and TPH-O, benzene, total xylenes, and cPAHs above the MTCA Method A cleanup levels. The source of the contamination is from past operations of the former gasoline service station (**Enclosure A, Figure 2**). One

Former service station locations are taken from prior consultant's reports. Dimensions and locations are approximate.

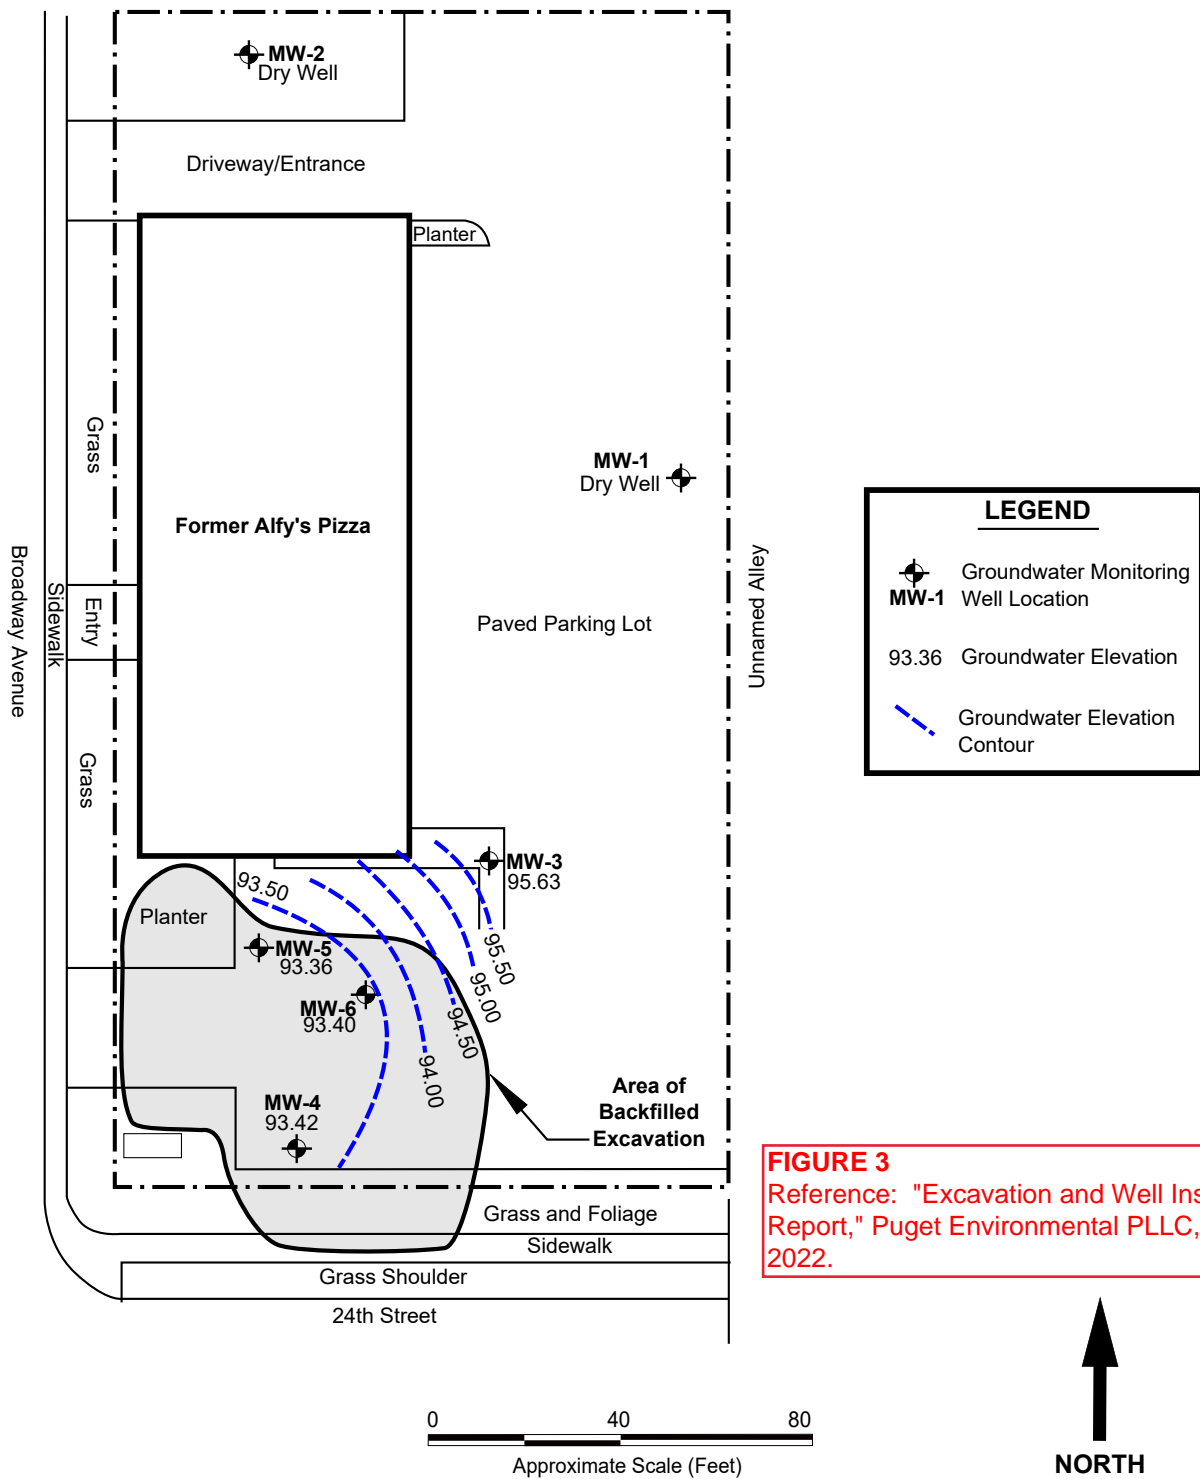
**FIGURE 3**  
Reference: "Excavation and Well Installation Report," Puget Environmental PLLC, April 8, 2022.

Contaminated soil was confirmed in the southwest corner of the Property prior to and after UST removal activities in 2021. Soil samples collected at the lateral and vertical (18 feet below the ground surface [bgs]) limits of the UST removal excavation exceed MTCA Method A cleanup levels. The excavation extended to the west Property boundary and across the south Property boundary (**Enclosure A, Figure 3**).

**FIGURE 7**  
GROUNDWATER ELEVATION  
CONTOUR MAP

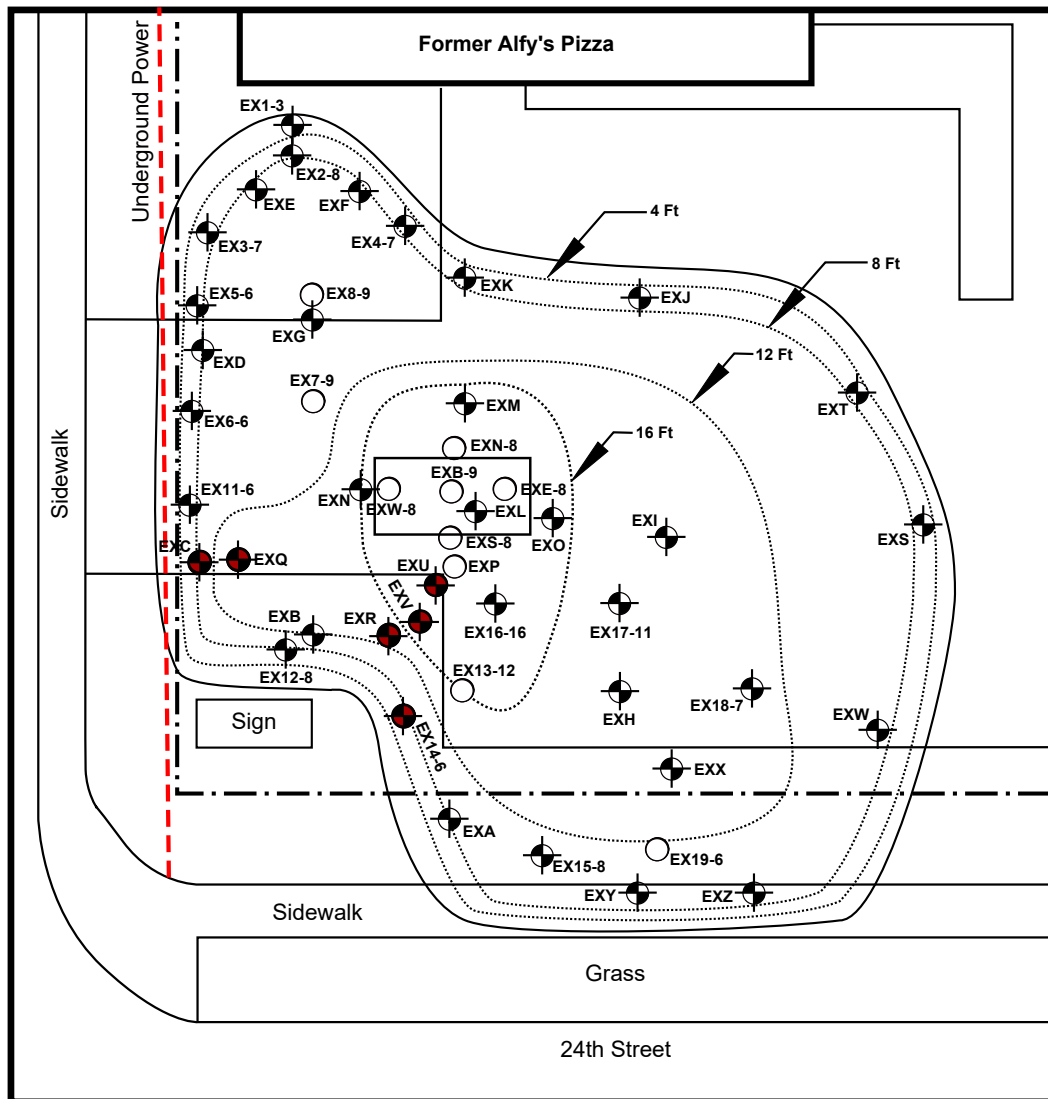
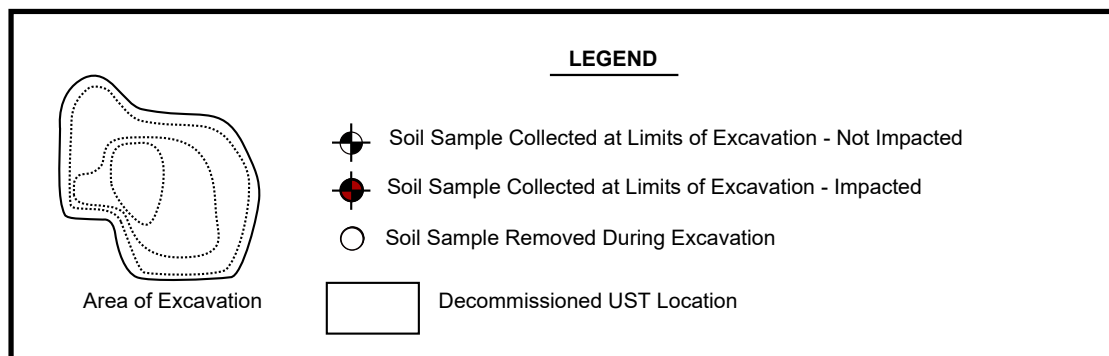
**FIGURE 4**

The lateral extent of the soil contamination has not been defined in the southwest corner of the Property (downgradient direction) and it has not been determined whether soil contamination extends off the Property at that location. The vertical extent of soil contamination has also not been delineated (**Enclosure A, Figures 2, 4, and 5**).

**FIGURE 3**  
EXCAVATION SOIL  
SAMPLE LOCATIONS

Additional soil sampling is needed to define the lateral and vertical extents of the soil contamination.

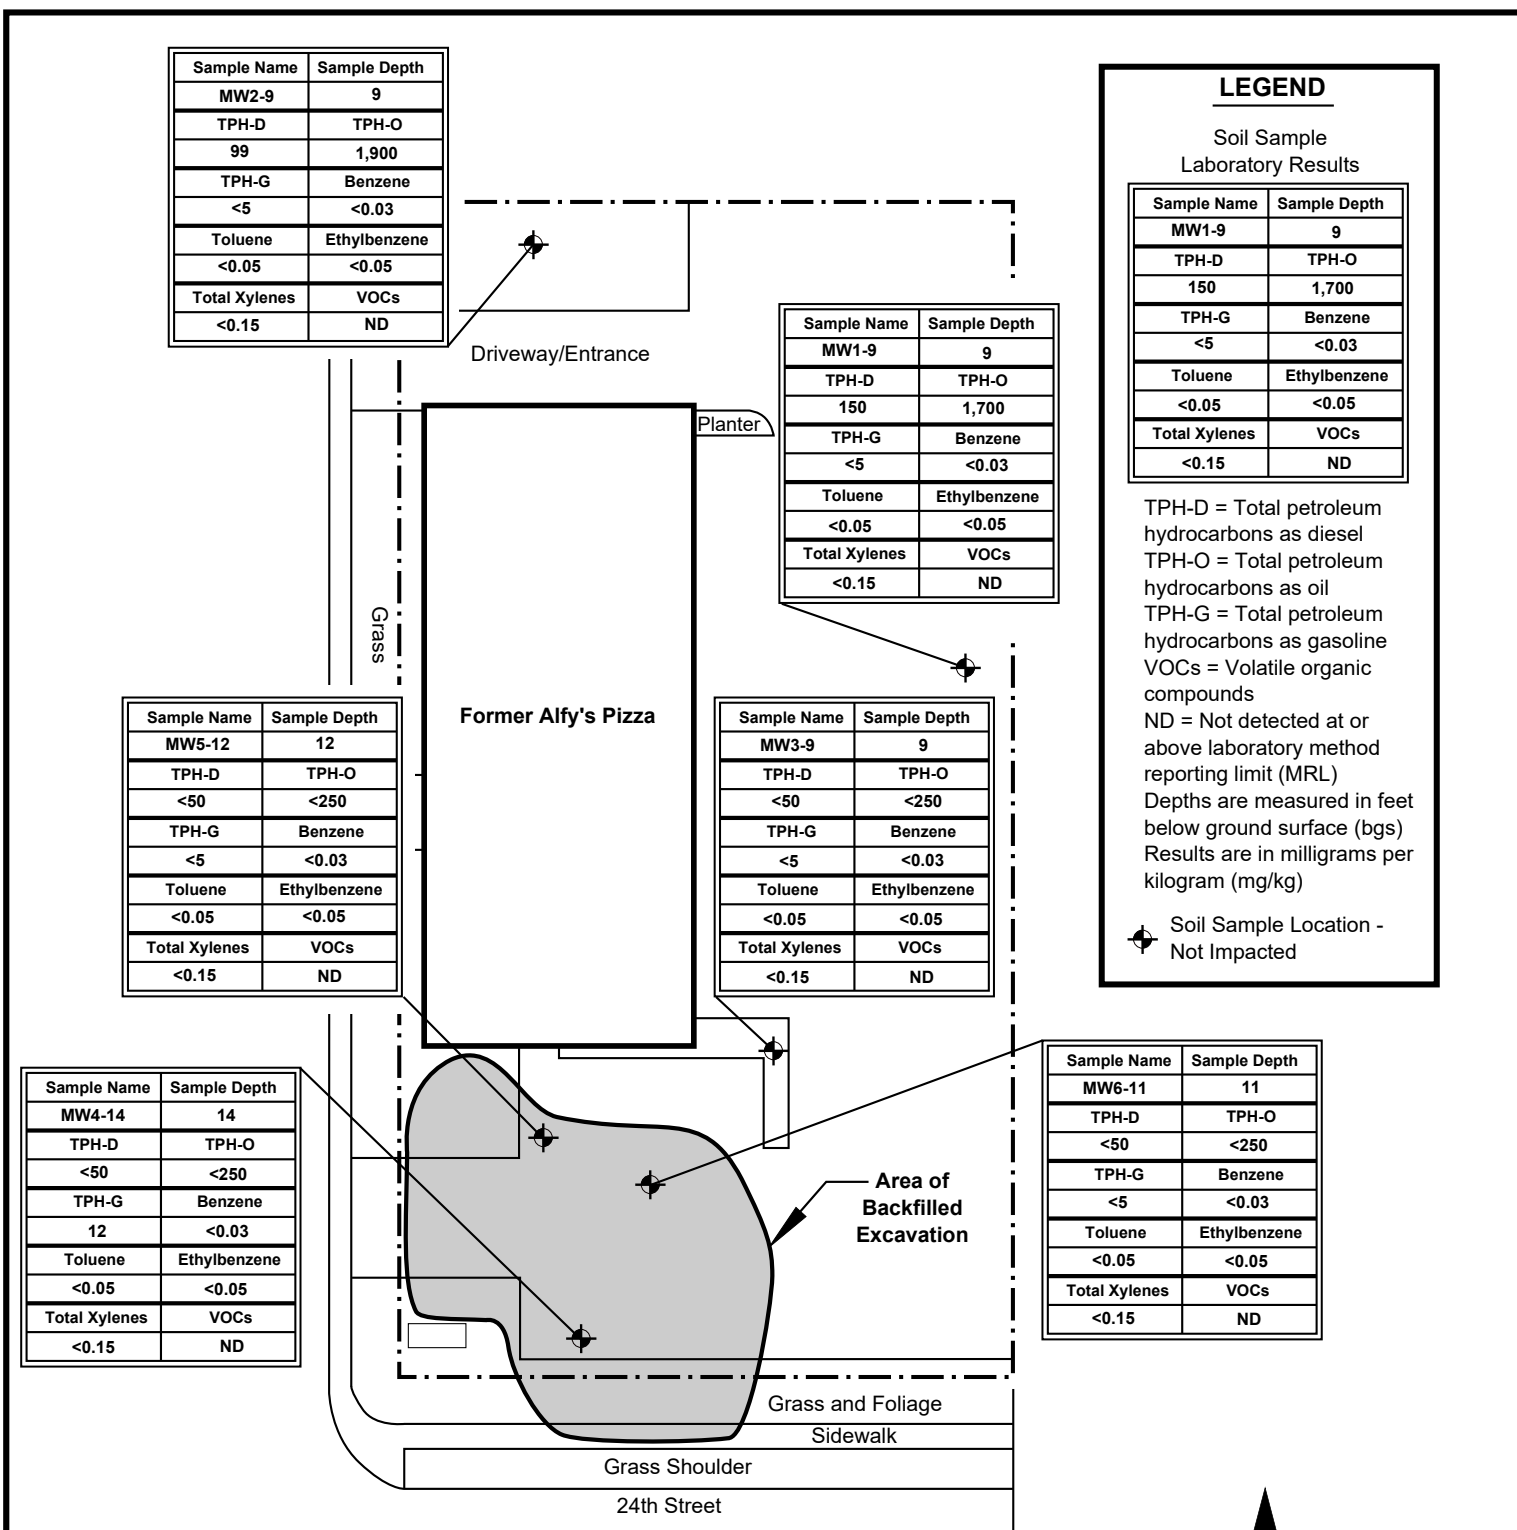
**FIGURE 5**  
 Reference: "Excavation and Well Installation Report," Puget Environmental PLLC, April 8, 2022.

**FIGURE 5**  
 MONITORING WELL  
 LOCATIONS AND SOIL SAMPLE  
 LABORATORY RESULTS

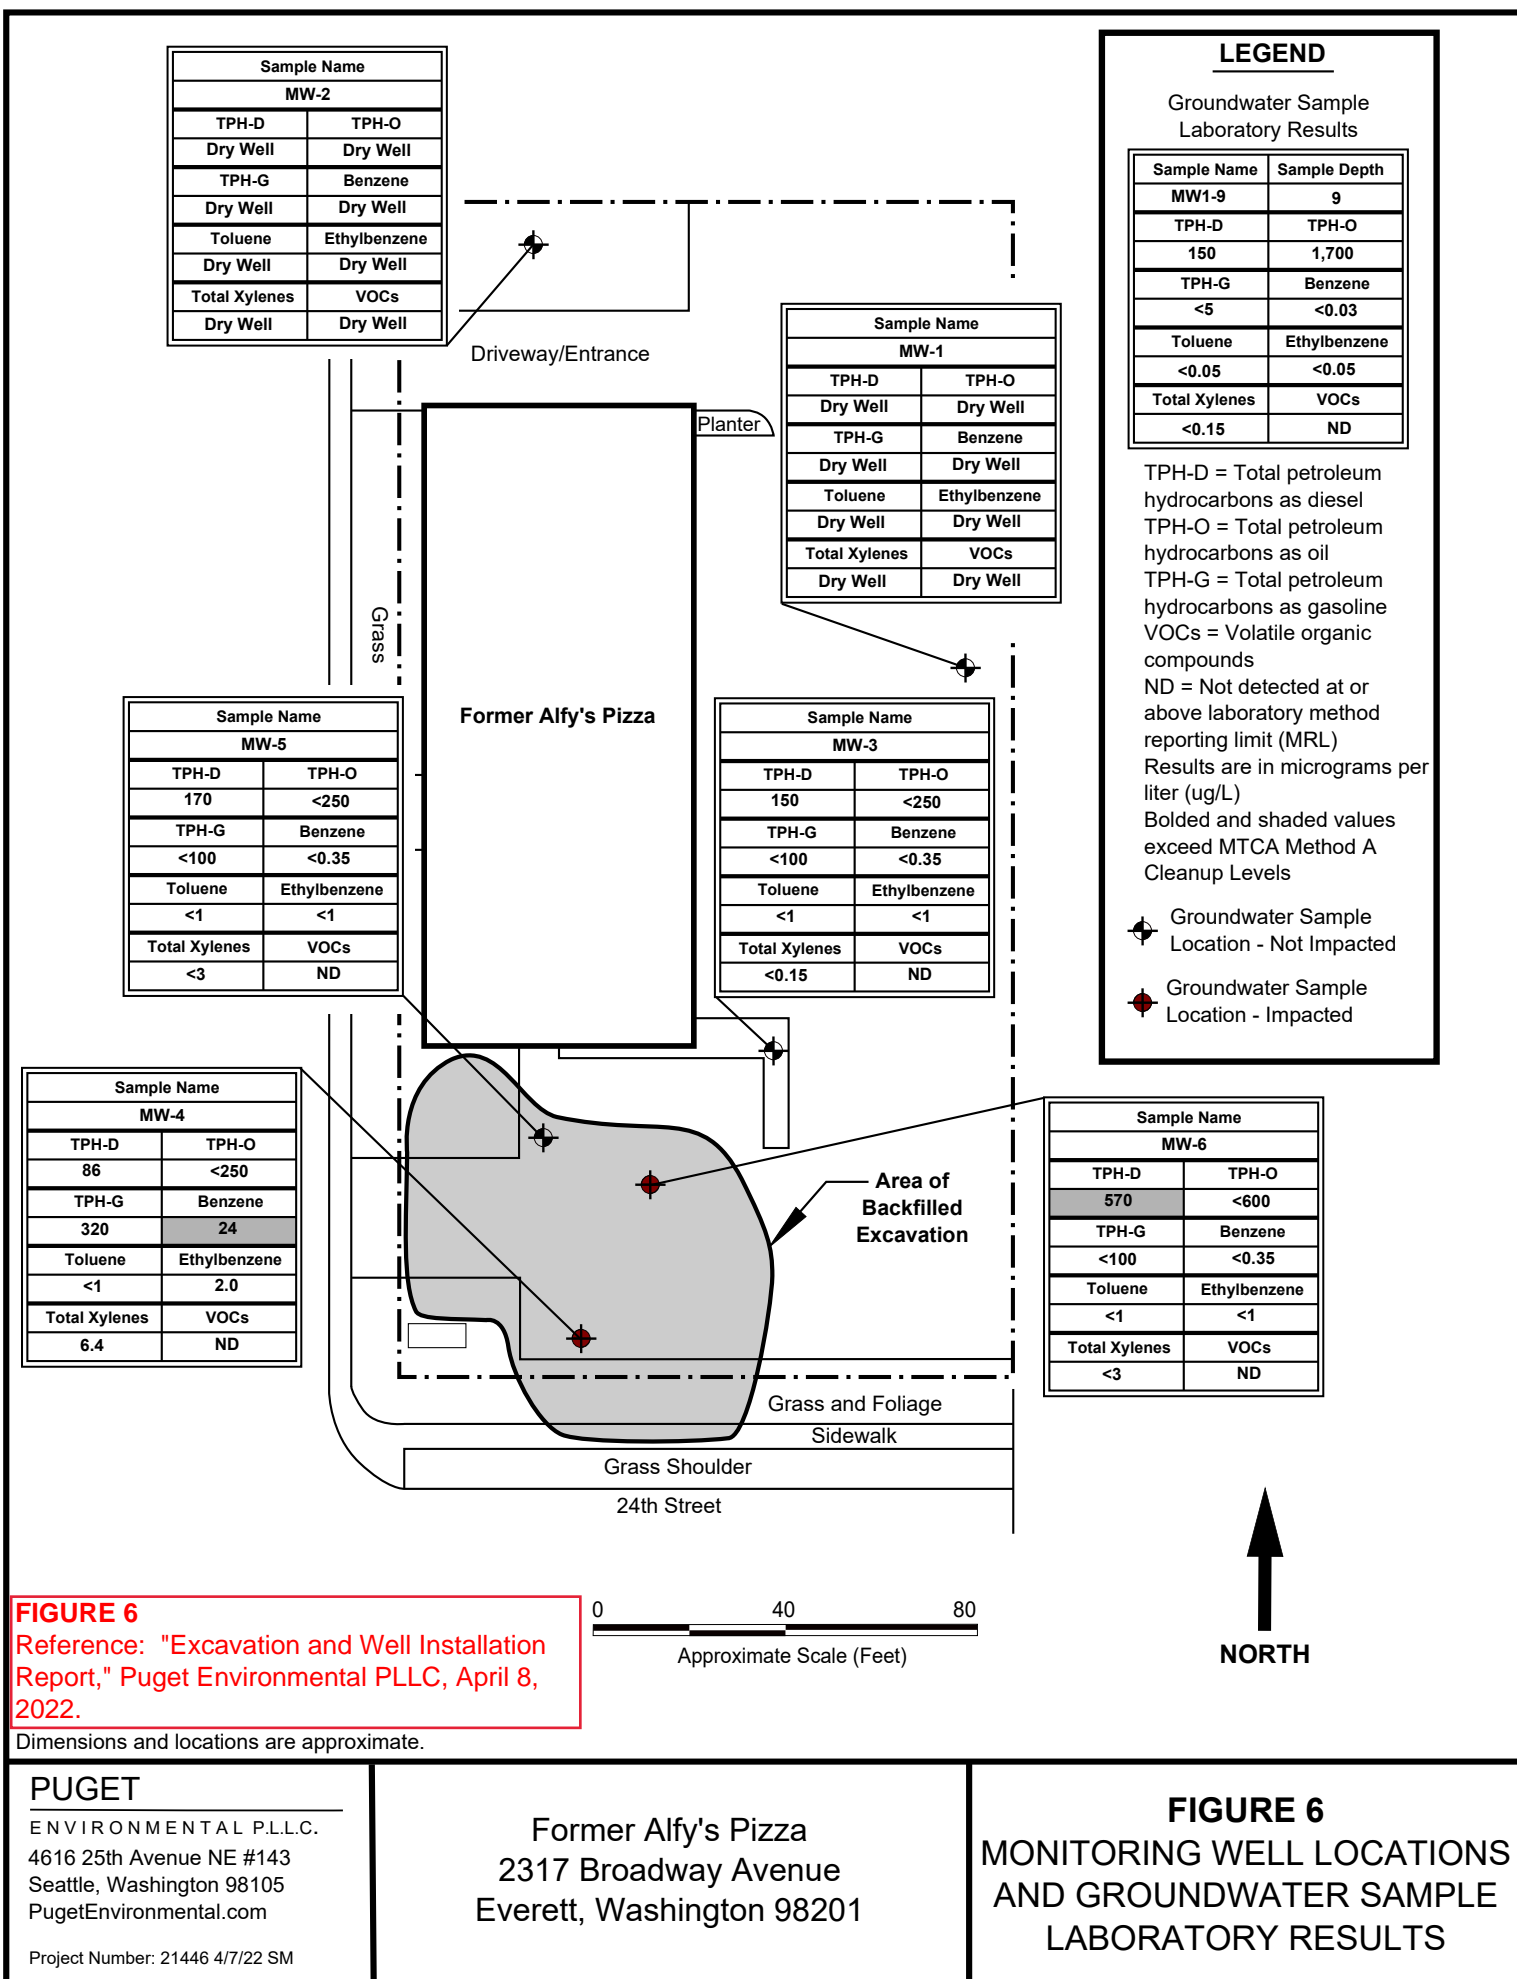
Site groundwater is contaminated with TPH-G, TPH-D, and TPH-O, benzene, and cPAHs above the MTCA Method A cleanup levels. Six groundwater monitoring wells (MW-1 through MW-6) were installed on the Site. Groundwater from monitoring wells MW-4 and MW-6 (downgradient wells) and from boring P-1 contained contaminants exceeding the MTCA Method A cleanup levels. The groundwater plume has not been delineated to the south or southwest. It is unknown whether groundwater contamination has migrated off the Property toward the southwest (downgradient direction). Refer to **Enclosure A, Figures 3, 4, and 6**.

Two wells located in the southwest portion of the Property (MW-4 and MW-6) contained contaminants in groundwater above the MTCA Method A cleanup levels. MW-4 contained benzene at 24 µg/L and MW-6 contained TPH-D at 570 µg/L (**Figure 6**). It should be noted that the MRL for TPH-O (sample from MW-6) was 600 µg/L, which is above the Method A cleanup level of 500 µg/L for TPH-D+TPH-O. None of the groundwater samples were analyzed for cPAHs.

Additional groundwater monitoring wells are needed to delineate the extent of the contaminated groundwater plume and to determine whether groundwater contamination has migrated off the Property.
