**2022 ANNUAL PROGRESS REPORT  
SWMU 1 – OILY WATER SEWER  
HF SINCLAIR PUGET SOUND REFINING LLC**

HF Sinclair Puget Sound Refining LLC  
8505 South Texas Road  
Anacortes, WA 98221

February 27, 2023

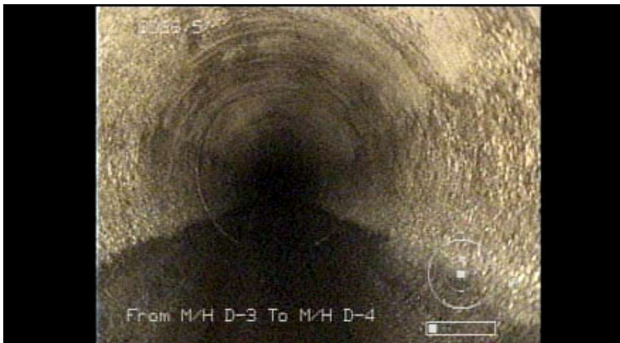
21.0\_SRI\_From-07\_To-09.jpg

**Date:** 6/21/2017  
**Distance:** 21 ft  
**Obs:**  
SRI - Surface Damage  
Roughness Increased  
**Comments:**  
EER: 1

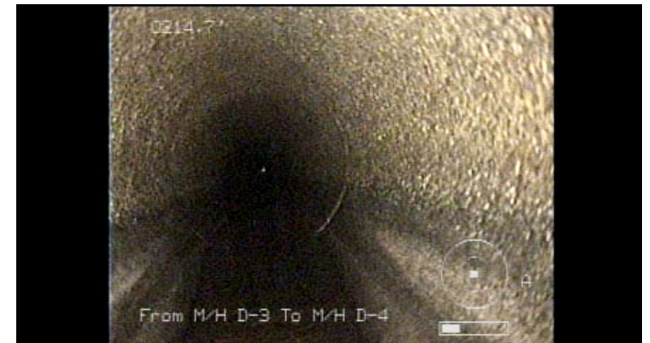
201.0\_SRI\_From-07\_To-05.jpg

**Date:** 6/21/2017  
**Distance:** 201 ft  
**Obs:**  
SRI - Surface Damage  
Roughness Increased  
**Comments:**  
EER: 1

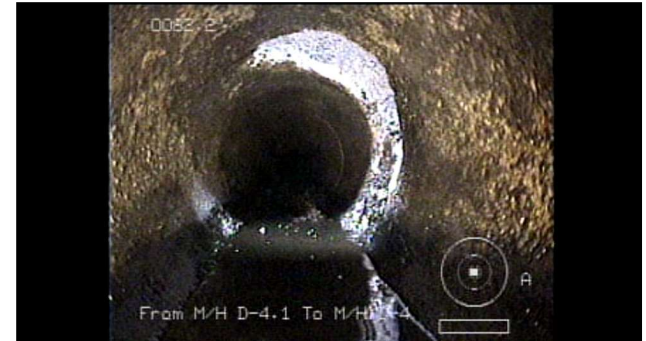
85.5\_HSV\_From-12\_To-05.jpg

Sewer Trunk Segment (MH to MH)	NASSCO Code	EER	Location (Length (ft.)/Clock position)	Comments
MH D-4 to MH D-20 & MH D-6.1 to MH D-20	Hole Soil Visible	4	85.5' / 12 to 5 o'clock & 233.8' / 7 to 12 o'clock	Hole created to access Manhole D-20. Infiltration Runner Connection (IRC) from hole. The same code is in both sewer segments because both inspections end at MH D-20.
MH D-6.1 to MH D-20	Broken Void Visible	3	172.6' / 11 o'clock	Noticeably displaced pieces moved from their original position above the flow line.
MH D-6 to MH D-19	Broken Void Visible	3	69.0' / 12 o'clock	Noticeably displaced pieced moved from their original position above the flow line.
MH D-6 to MH D-19	Hole Soil Visible	3	74.0' / 12 o'clock	4 inch hole above flow line.

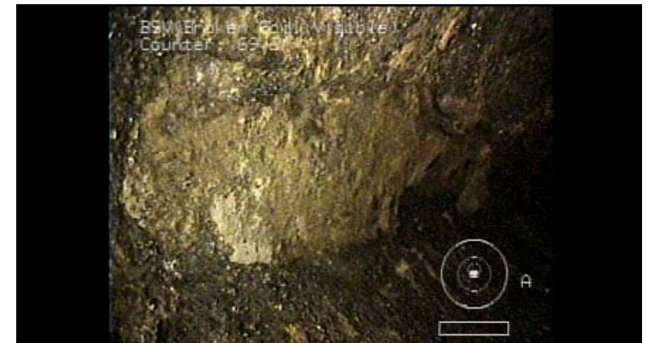
69.0\_BSV\_From-12\_To-.jpg

**Date:** 7/10/2017  
**Distance:** 69 ft  
**Obs:**  
 BSV - Broken Soil  
 Visible  
**Comments:**  
 EER: 3

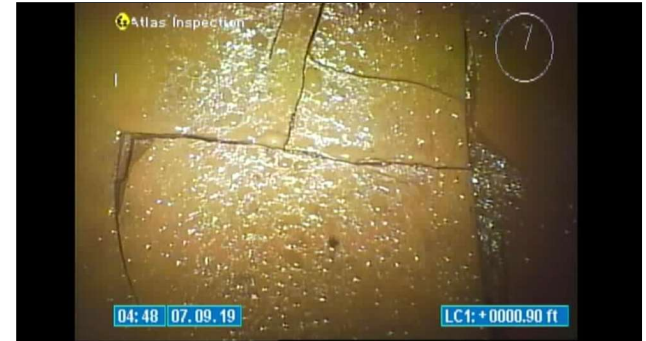
0.8\_FM\_From-11\_To-01.jpg

0.8		FM - Fracture Multiple					11	01	EER: 2
0.9		FC - Fracture Circumferential					06	06	EER: 2
4.2		CS - Crack Spiral				X	08	10	EER: 1
4.2		OBJ - Obstruction Wedged In The Joint			005	X	03	06	EER: 1. Zip ties and possibly a dead vermin. Unclear.

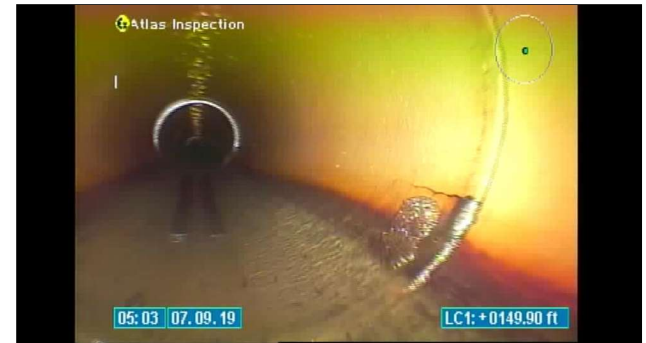
150.5\_FM\_From-02\_To-04.jpg

146.3		CM - Crack Multiple		X	11 03 EER: 1
150.5		DAE - Deposits Attached Encrustation	005	X	04 05 EER: 1
150.5		FM - Fracture Multiple		X	02 04 EER: 2
150.5		IWB - Infiltration Weeper Barrel		X	04 EER: 1. Related to FM at 150.5'.

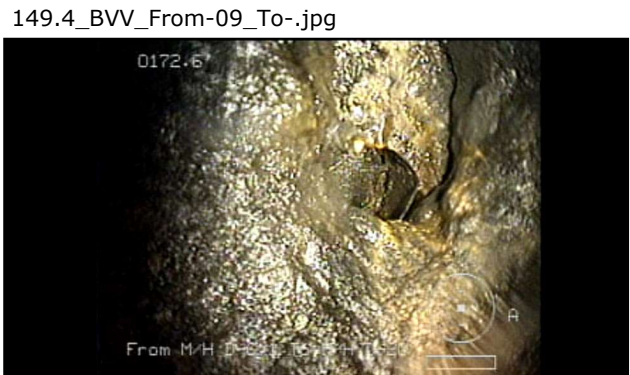
**Date:** 6/29/2017  
**Distance:** 172.6 ft  
**Obs:**  
 TBI - Tap Break-in  
 Intruding  
**Comments:**  
 EER: 1
