STATE OF WASHINGTON DEPARTMENT OF ECOLOGY

Re: Opinion pursuant to WAC 173-340-515(5) on Remedial Action for the following Hazardous Waste Site:

- Site Name: Morningside Acres
- Site Address: 5021 Rainier Avenue S, Seattle, WA 98118
- Facility/Site No.: 4321
- Cleanup Site ID No.: 12408
- VCP Project No.: NW3345

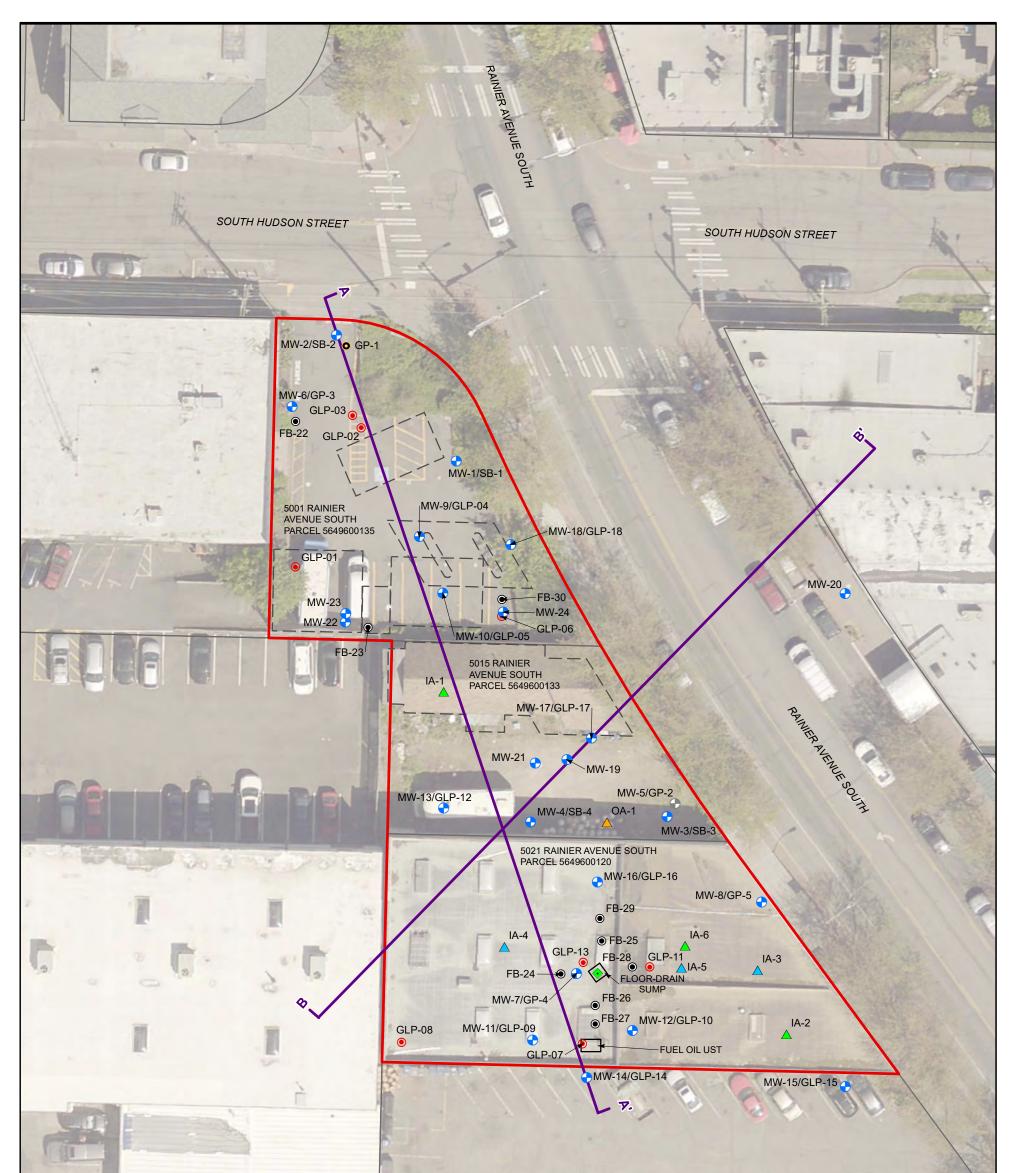
Groundwater: From 2006 to 2023, 24 wells were installed on the Property (MW-1 to MW-24; **Figure 3**, **Figure 8**). Wells were equipped with 4 to 10-foot screens installed between depths of 3 and 48 feet bgs.

Air: Based on the analytical results of groundwater sampling, groundwater under the Property contained TCE and vinyl chloride above the Method B screening level for vapor intrusion. Air sampling was conducted on the Property in July 2019 to address the potential for CVOCs to be present in indoor air in buildings. One indoor air sample was collected from the 5015 Building on and five from the 5021 Building. One ambient air sample was collected from the open space between the two buildings (OA-1; **Figure 3**).

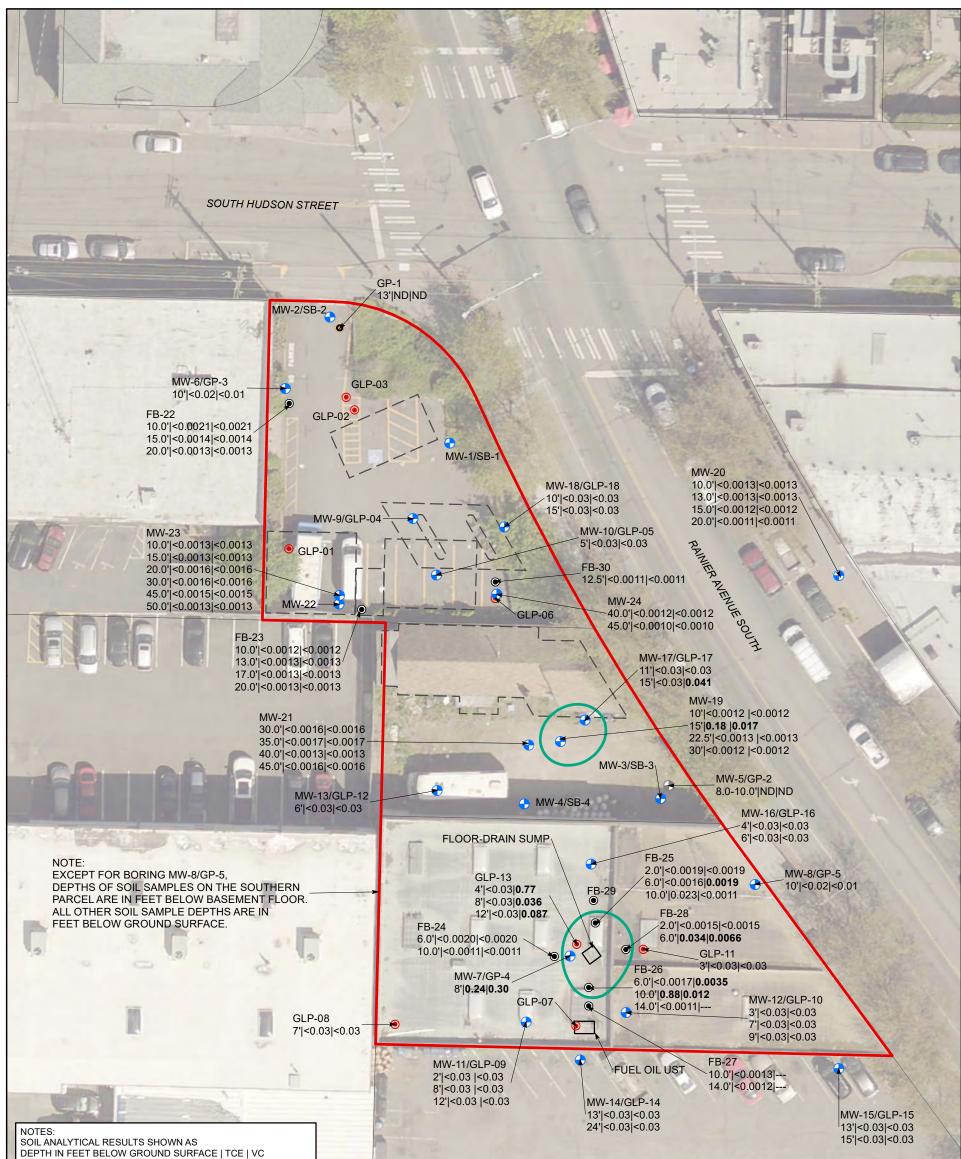
Releases of chlorinated solvents to soil are confined to the 5015 and 5021 Parcels. Soil at a depth of approximately 15 feet bgs in the vicinity of MW-17 and MW-19 in the 5015 parcel contains TCE and vinyl chloride above their respective Method A and Method B cleanup levels (see **Enclosure A, Figure 4**). This area of contamination is defined vertically and laterally, to the south by MW-5, to the west by MW-21, and to the north by FB-30. Ecology recommends collecting additional soil samples to the east of MW-17 to define the eastern extent of TCE and vinyl chloride contamination in soil.

drain in the basement of the building on that property. Soil from depths of 6 to greater than 12 feet bgs contains TCE and vinyl chloride above the applicable cleanup levels. This area of contamination is bounded horizontally, but not vertically as all borings in this area were installed using a limited-access drill rig. In an email communication on 1/26/2023, Ecology concurred that assessment of the vertical extent of chlorinated solvents in soils in this area could be assessed after the building has been demolished. Ecology recommends collecting soil samples from this area prior to remedial excavation to ensure that sufficient data are collected to effectively design the remedial excavation such that all soil containing vinyl chloride above the cleanup level can be removed.

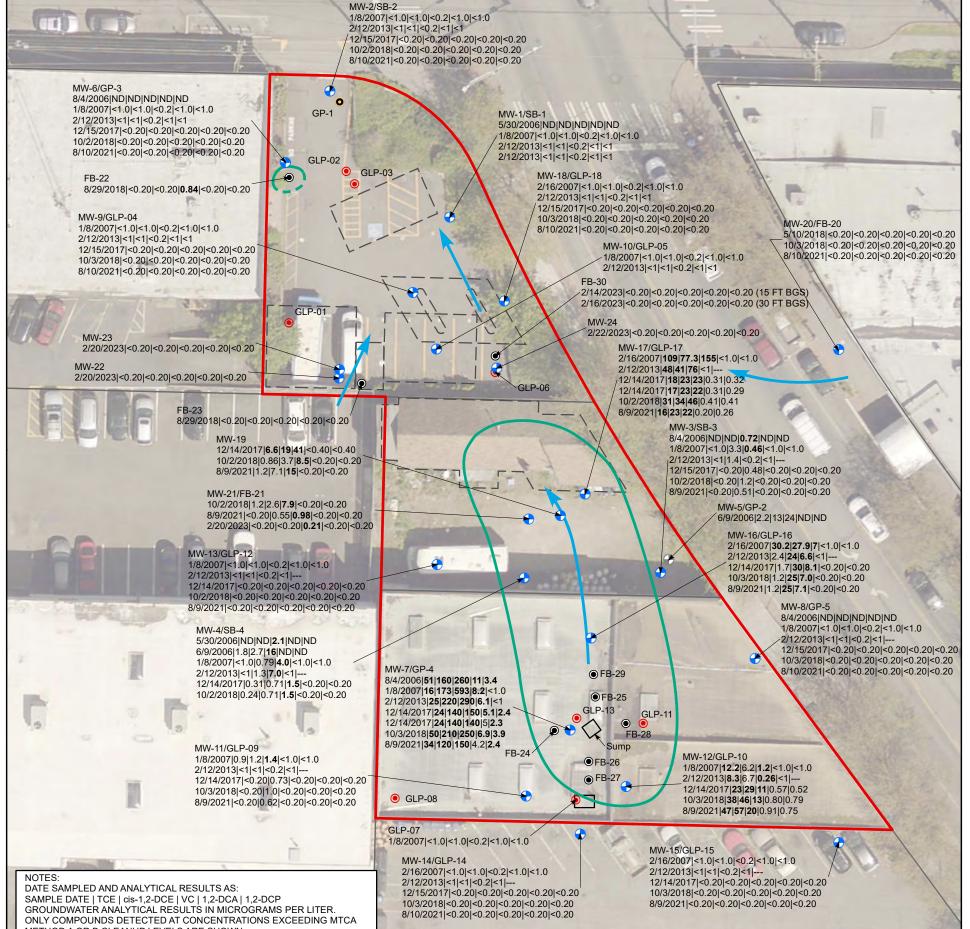
The vertical extent of CVOCs exceeding cleanup levels in groundwater has also not been defined. The most recent groundwater samples collected from MW-21, screened at a depth of 35 to 45 feet bgs, contained vinyl chloride above the Method A cleanup level. As discussed above, Ecology recommends installing an additional monitoring well in the source area of the CVOC plume to define the vertical extent of vinyl chloride in groundwater.

Current groundwater analytical data indicate that vinyl chloride was above the Method A cleanup level in MW-4, MW-7, MW-12, MW-16, MW-17, MW-19, and MW-21 (**Figure 5**, **Figure 9**). Vinyl chloride was also detected above the Method A cleanup level in a groundwater sample collected from a temporary well installed in FB-22 in August 2018. Groundwater samples collected from MW-7, MW-12, MW-17, and MW-19 also contained TCE and cis-1,2-DCE above their Method A and Method B cleanup levels (**Figure 5**). 1,2-DCP was also detected above the Method B cleanup levels (Figure 5). 1,2-DCP was also detected above the Method B cleanup levels (Figure 5). 1,2-DCP was also detected above the Method B cleanup level in groundwater samples collected from MW-7. Groundwater samples collected from the remaining wells at the Site did not contain CVOCs above Method A or Method B cleanup levels (**Figure 5**).

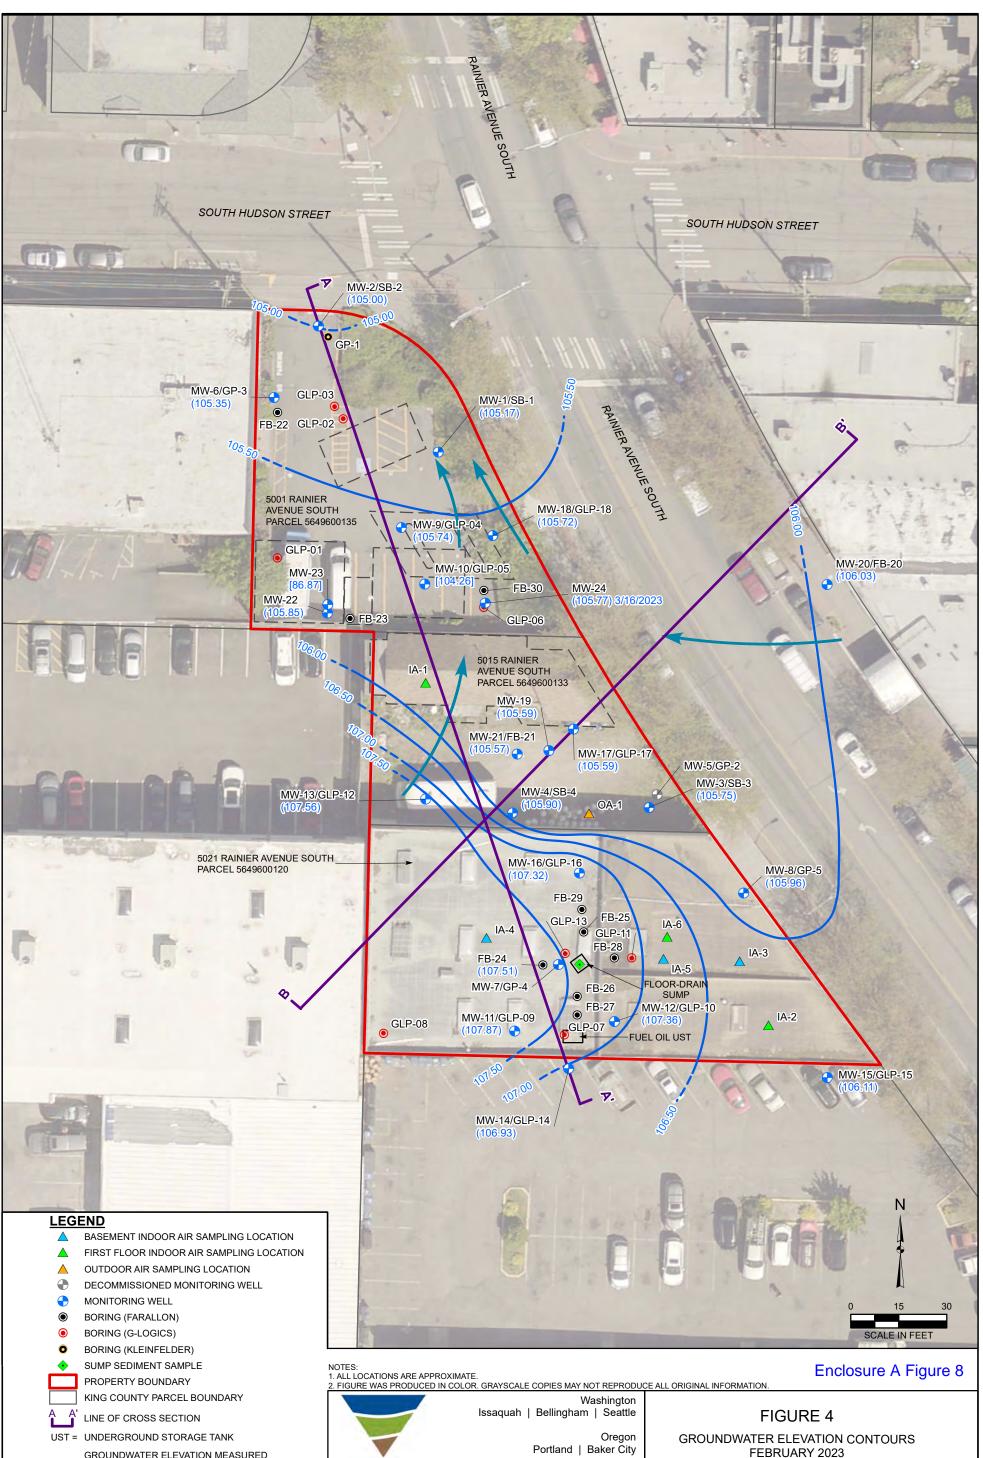
Groundwater is present at the Site at depths ranging from 0.48 to 13.37 feet bgs with the exception of MW-23. MW-23 is screened from 38 to 48 feet bgs and, since its installation in February 2023, depth to water measurements have ranged from 30 to 42 feet bgs. Groundwater flow at the Site is generally oriented northwest. Due to the location of the Site in a valley, groundwater flow is oriented to the northeast on the west side of the Site, and to the west on the east side of the Site (**Figure 8**).

As discussed in **Enclosure A**, depth to groundwater in MW-23 has been measured more than 15 feet deeper than other Site monitoring wells. Additional discussion of this discrepancy, potentially including an additional cross section through this area, is recommended.

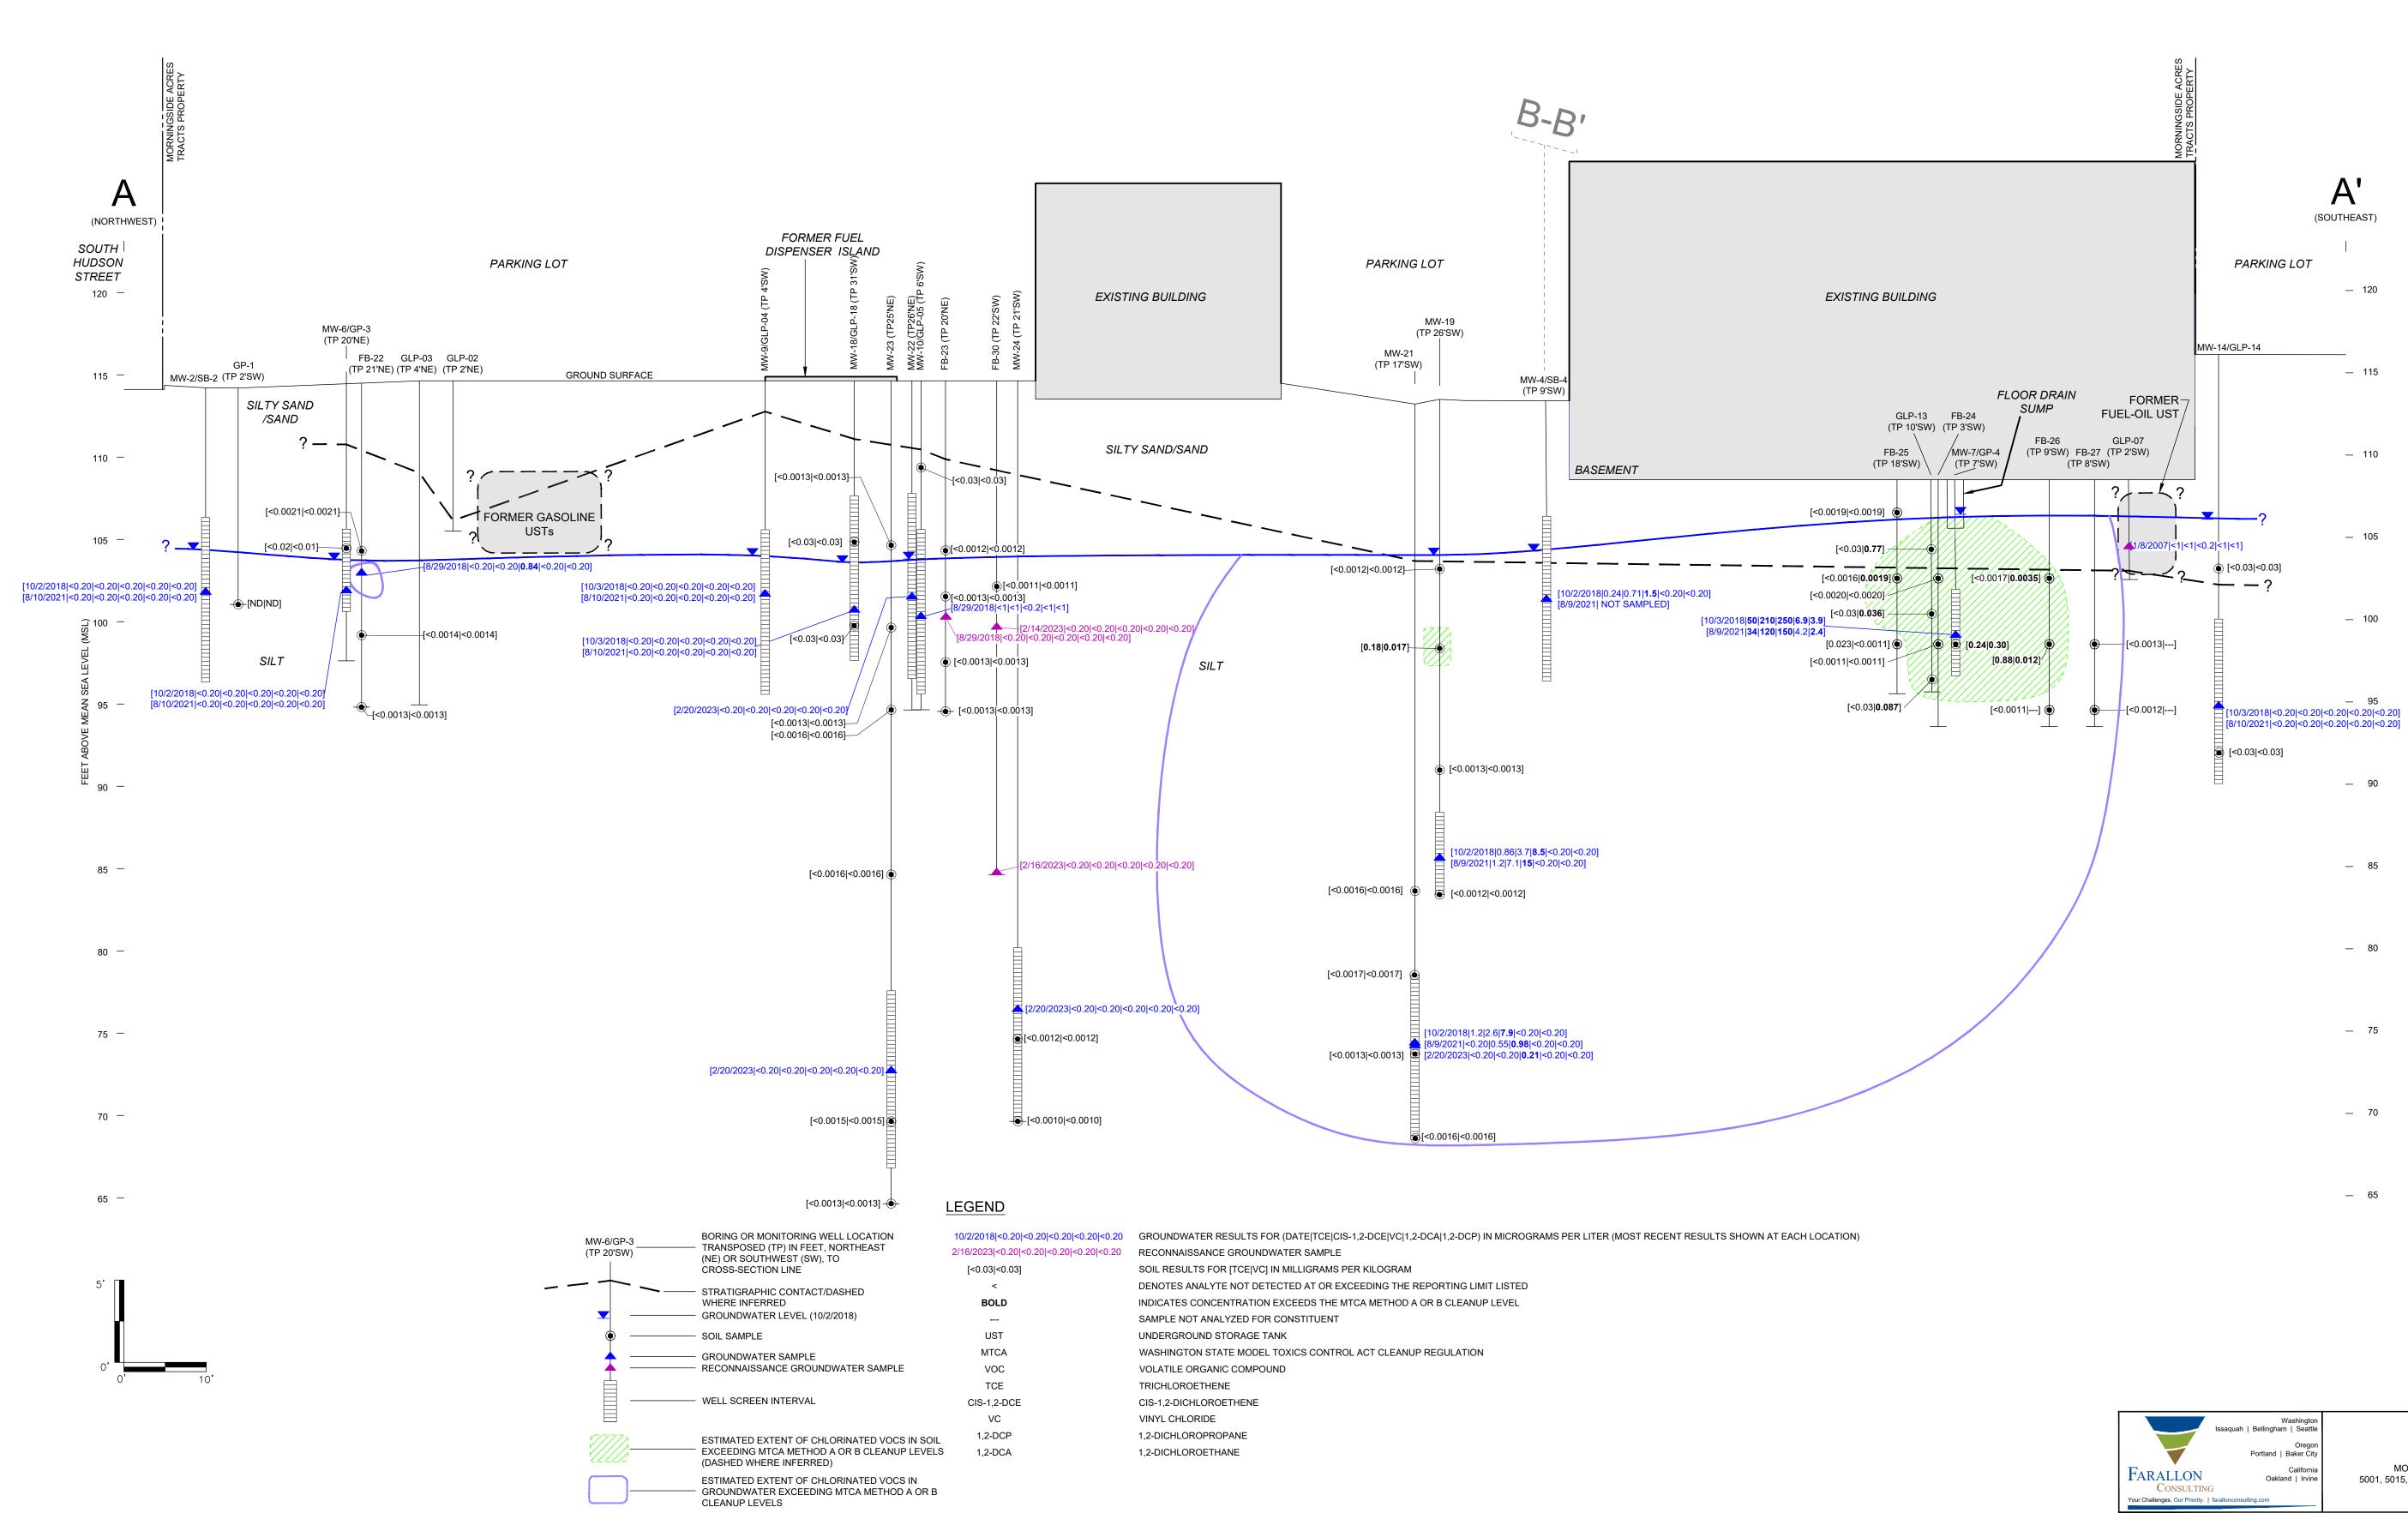
Supplemental soil sampling was conducted in 2017 through 2023 to further delineate the extent of TPH and CVOCs in soil at the Site. Eleven borings were advanced on the Property (MW-19, MW-21 to MW-24; FB-22 through FB-30) and one boring was completed on the east side of Rainier Ave S to the east of the Site (MW-20, **Figure 3**). Soil samples collected from MW-19, FB-25, FB-26, and FB-28 contained TCE and/or vinyl chloride above the applicable Method A and B cleanup levels at depths ranging from 6 to 15 feet bgs (**Figure 4**, **Figure 9**). Soil samples collected from FB-23 and FB-30 contained TPH-G and/or TPH-D above the Method A cleanup level at depths ranging from 5 to 13 feet bgs (**Figure 6**).
