Memorandum

Date: August 22, 2011

Subject: South Tacoma Channel Well 12A Groundwater Extraction and Treatment System (GETS) Inspection

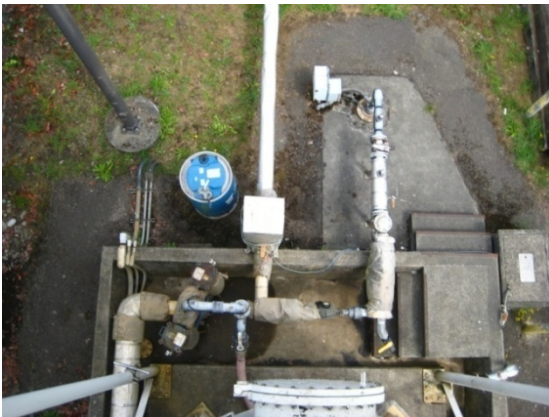
- The well efficiency has declined significantly since the initial pump test, but has not changed significantly since 2004.
- Production is limited by the well, not the pump or discharge pipe.
- The low level sensor is not functioning and will not protect the pump from running dry.
- Rehabilitation is recommended if additional production is desired from this well.

Figure 3. Extraction well 1 (EW-1).

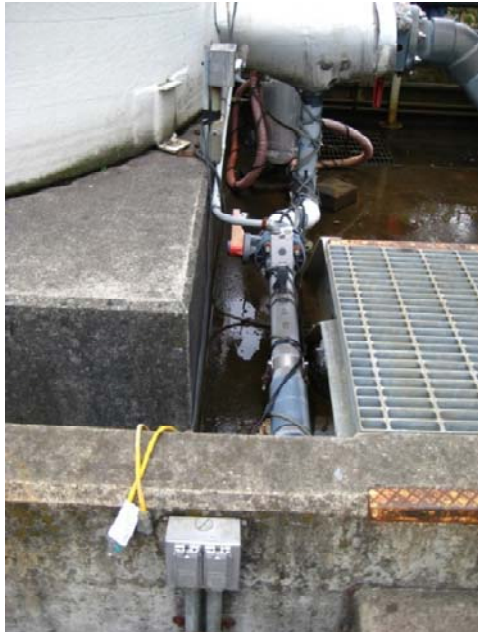
Figure 5. Heat tracing (black) placed throughout lines near effluent storage tank.

- Broken parts and non-functioning equipment in and beneath the GETS trailer that should be disposed of.
- Damaged electrical wiring should be repaired and heat tracing should be reapplied in accordance with the manufacturer recommendations.
- A new pump will be needed for transfer of water from the sump to the effluent storage tank during media change out activities.

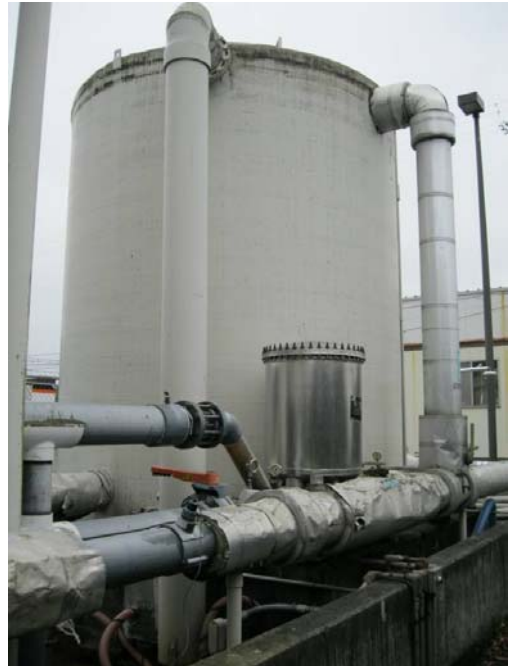
Items such as broken pressure gauges, damaged system components, and other unnecessary equipment and supplies should be removed from within and beneath the GETS trailer. Buckets of GAC stored beneath the trailer should be disposed of during the next GAC change out. Pipe insulation is in poor condition. Over the years, several sections of pipe insulation have been removed to access the piping and in those areas the piping is no longer protected from the elements. However, the insulation is in a similar condition to when the City of Tacoma assumed responsibility for system O&M. Much of the piping is also heat traced (Figure 6). The heat tracing is activated by a thermostat and given the ambient temperature was significantly above freezing during the inspection, it was not possible to test the heat tracing to verify that is functioning properly. Where possible, the heat tracing was inspected visually. The heat tracing between the sump pump and the effluent storage tank is disorganized and not installed in accordance with manufacturer recommendations and should be reinstalled. Additionally, several sections of wiring associated with heat tracing on the east side of the site are damaged and may be an electrical hazard (Figure 8). The damaged wiring should be repaired or replaced.

Figure 6. Effluent storage tank and piping. Several stretches of piping without insulation.

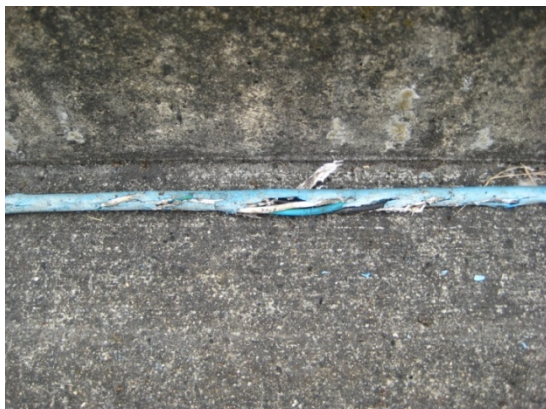
Figure 7. Frayed wiring present in several locations at the GETS.

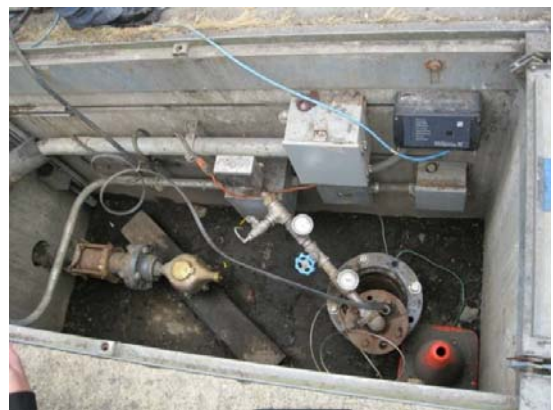
Figure 8. EW-3 during pump pull. Piping was dismantled to remove the pump.

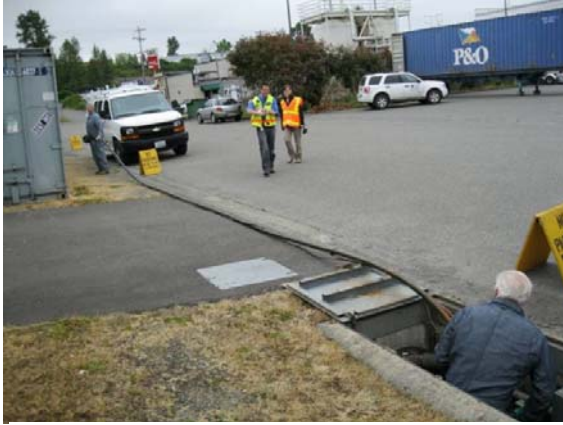
The pump and down-hole discharge pipe for EW-3 was replaced on July 20, 2011. The old pump and piping were replaced because flow rates had decreased from approximately 9 gallons per minute (gpm) to 3 gpm. The old pump and HDPE pipe were pulled and found to be impacted with what appeared to be a soft iron precipitate. Significant fouling was identified in the piping - when connected to a fire hydrant at full capacity, there was a small steady flow exiting the pipe. This fouling was the primary cause for reduced flow capacity at EW-3. The original pump was kept on site as a spare since it appeared to be functioning, and the primary cause of the reduction in flow rate was determined to be an obstruction in the down-hole discharge piping.

Figure 9. EW-3 during pump pull. Black HDPE tubing was replaced due to fouling.

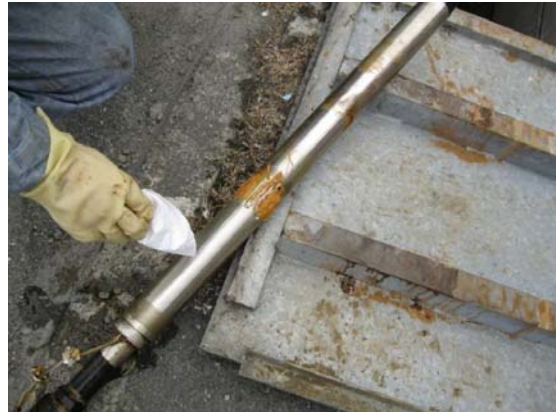
Figure 10. EW-3 pump showing iron precipitate that accumulated on pump intake.
