State of Washington
POLLUTION LIABILITY INSURANCE AGENCY
PO Box 40930 • Olympia, Washington 98504-0930
(360) 407-0520 • (800) 822-3905
www.plia.wa.gov

Re: No Further Action at the Following Site:

- **Facility/Site Name:** Longview Auto and Tire
- **Facility/Site Address:** 655 Commerce Avenue, Longview, WA 98632
- **Facility/Site ID:** 69286382
- **Technical Assistance Program No.:** P-SW2094

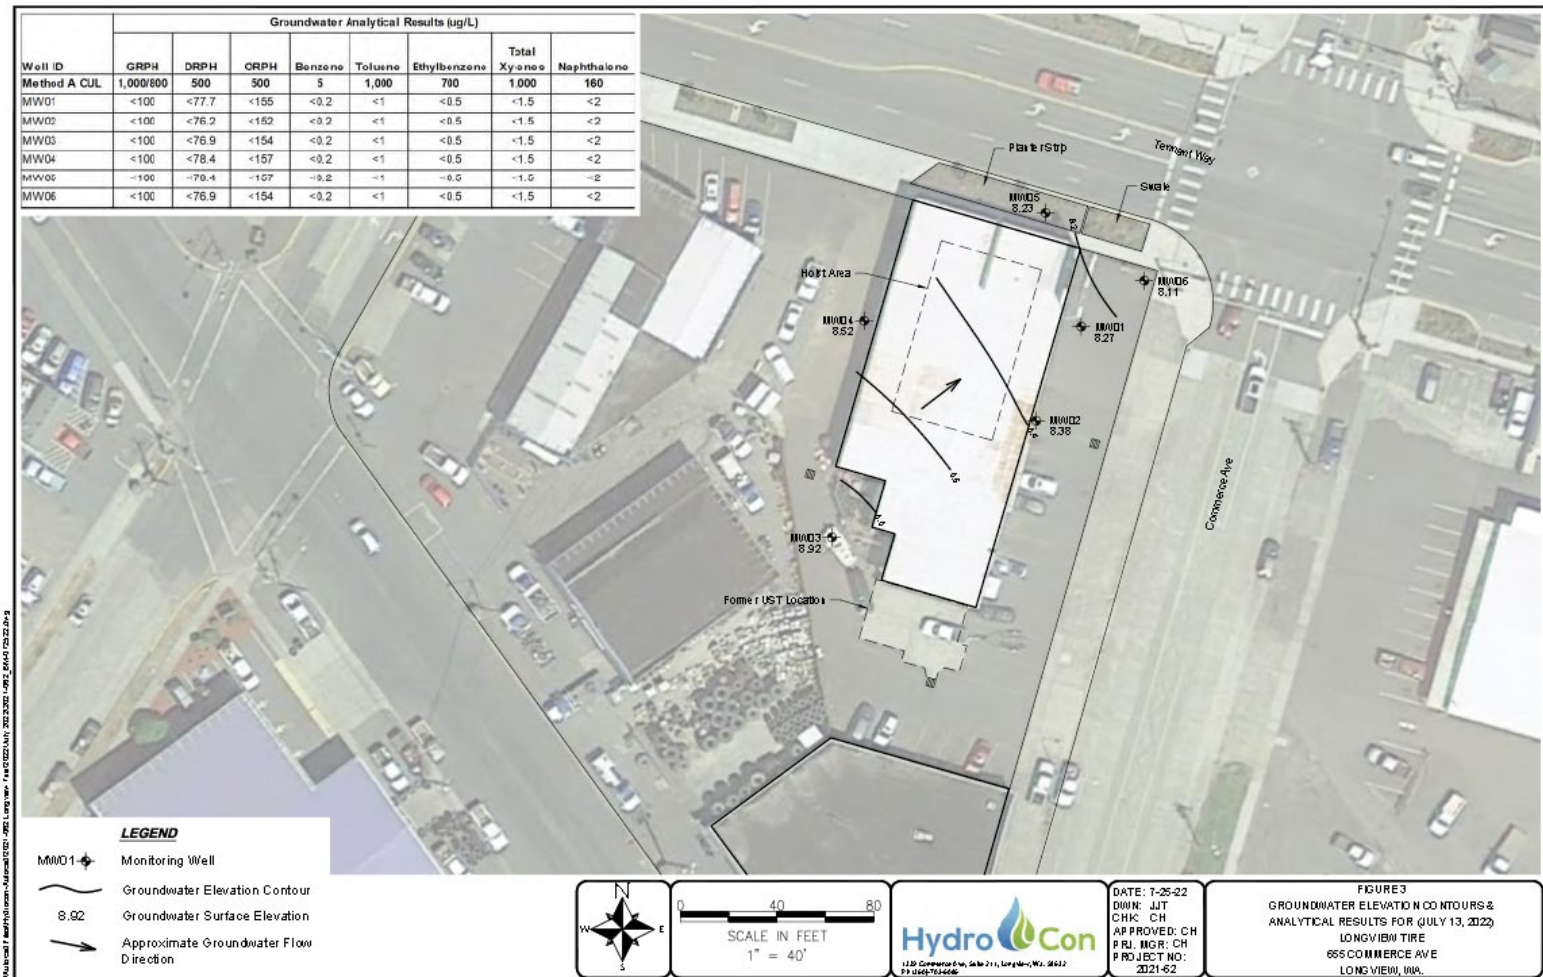
Figure 3: Groundwater Elevation Contour Plot – July 13, 2022

- On July 13, 2022, HydroCon performed the fourth groundwater monitoring event at the Site (see *Groundwater Monitoring – July 2022*, HydroCon, July 25, 2022). Depth to groundwater recorded at the Site ranged from 7.65' to 8.75' bgs in the monitoring wells. The groundwater elevations ranged from 8.11' to 8.92' above mean sea level. A groundwater elevation contour plot for the July 13, 2022 dataset (Figure 3) indicated groundwater flows towards the northeast at an

approximate gradient of 0.0026 feet/foot between MW01 and MW03.
