STATE OF WASHINGTON  
**DEPARTMENT OF ECOLOGY**

June 13, 2023

**Re: Opinion pursuant to WAC 173-340-515(5) on Remedial Action for the following  
Hazardous Waste Site:**

- **Site Name:** Firestone 31A3
- **Site Address:** 351 Rainier Avenue South, Renton, WA 98057
- **Facility/Site No.:** 62398766
- **Cleanup Site ID No.:** 16657
- **VCP Project No.:** NW3354

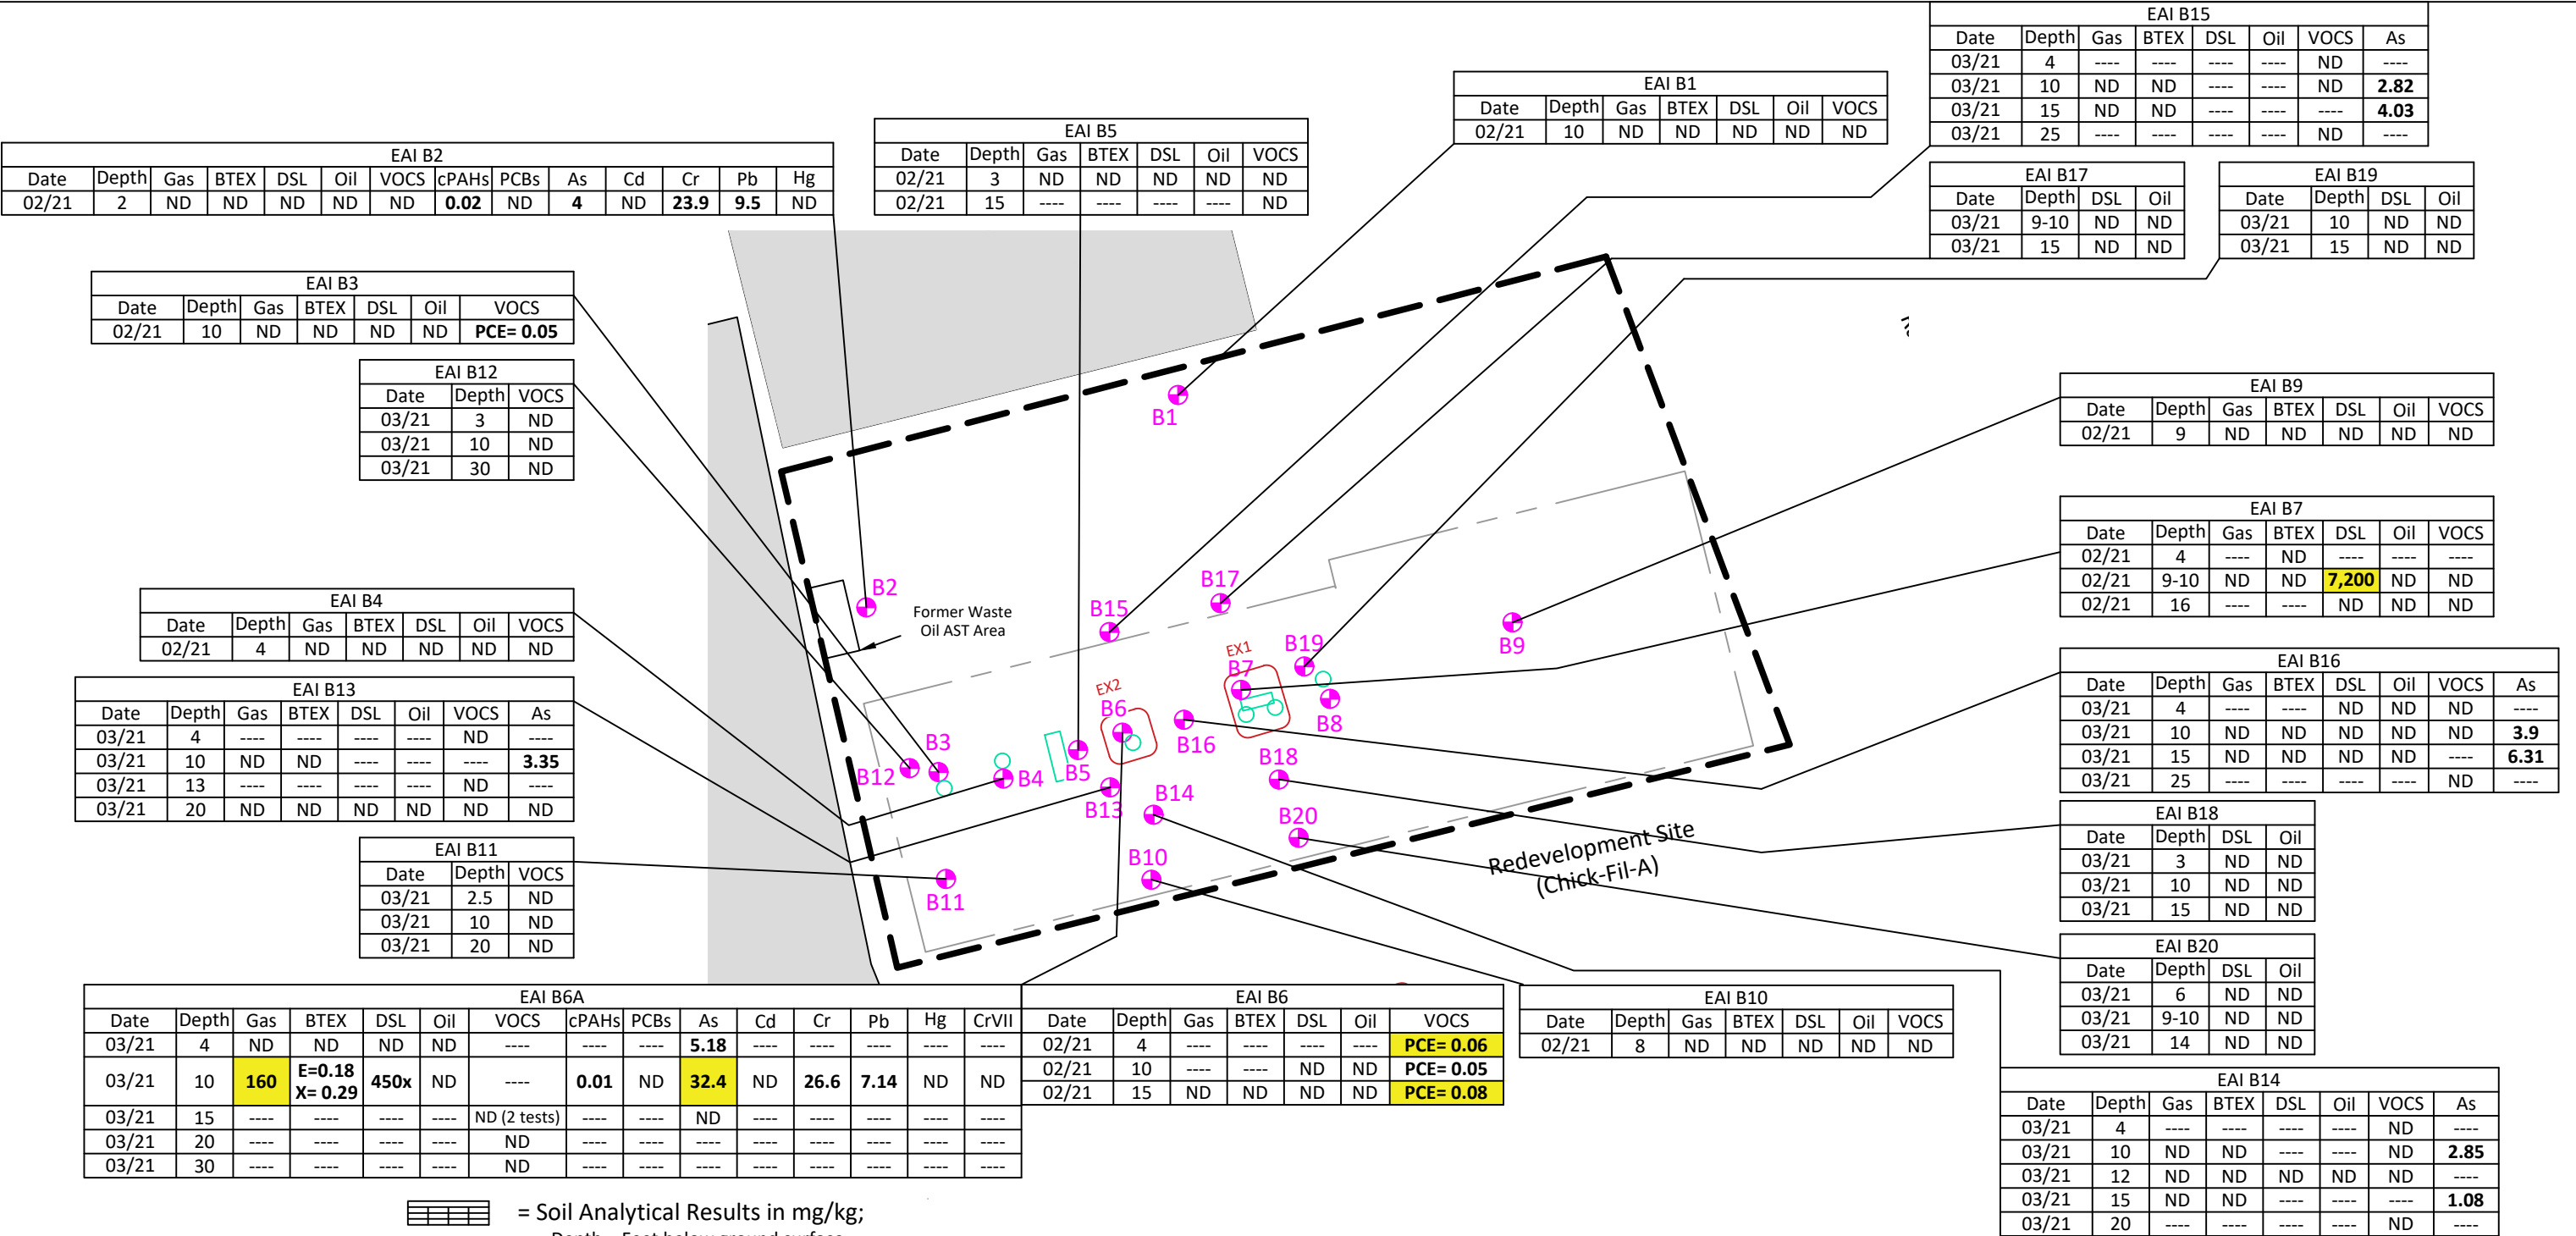
Enclosure A Figure 2

Soil at the Site was contaminated with TPH-G, TPH-D, PCE, and arsenic, sourced from historic operations of a former automobile service station located at 351 Rainier Avenue S in Renton, Washington (the Property). Contaminated soil was discovered in 2021 during due diligence investigations at the site. The source for contamination at the Site appears to be two in-ground hydraulic hoists, located in the proximity of explorations B6 and B7 (See **Enclosure A, Figure 2**).

Soil samples collected from B6 contained PCE above the Method A cleanup level at 4 and 15 feet bgs. Boring B6A was advanced in the immediate vicinity of B6 to confirm the release of PCE to soil. PCE was below the Method A cleanup level and laboratory reporting limit in soil samples collected from 15 to 30 feet bgs in B6A, indicating that the PCE contamination in this area does not appear to extend beyond 15 feet bgs. In addition, a soil sample collected from 10 feet bgs in B6A contained TPH-G and arsenic above the Method A cleanup levels. A soil sample collected from 9 feet bgs in B7 contained TPH-D above the Method A cleanup level.

**Sources of Contamination:** Contamination was discovered at the Site in 2021 in borings B-6 and B-7 (**Figure 2**). Soil samples collected from these borings contained TPH-G, TPH-D, PCE, and arsenic above the Method A cleanup levels. Releases appear to be sourced from historic vehicle servicing operations, most notably related to the auto hoists that were in the central

Three soil-vapor samples were collected from borings during Site characterization activities in 2021 B5, B9, and B10; **Figure 2**). Naphthalene was detected above the MTCA Method B screening level for unrestricted use in all three samples. Soil gas sample B5 also contained PCE above applicable MTCA Method B screening level for unrestricted use.

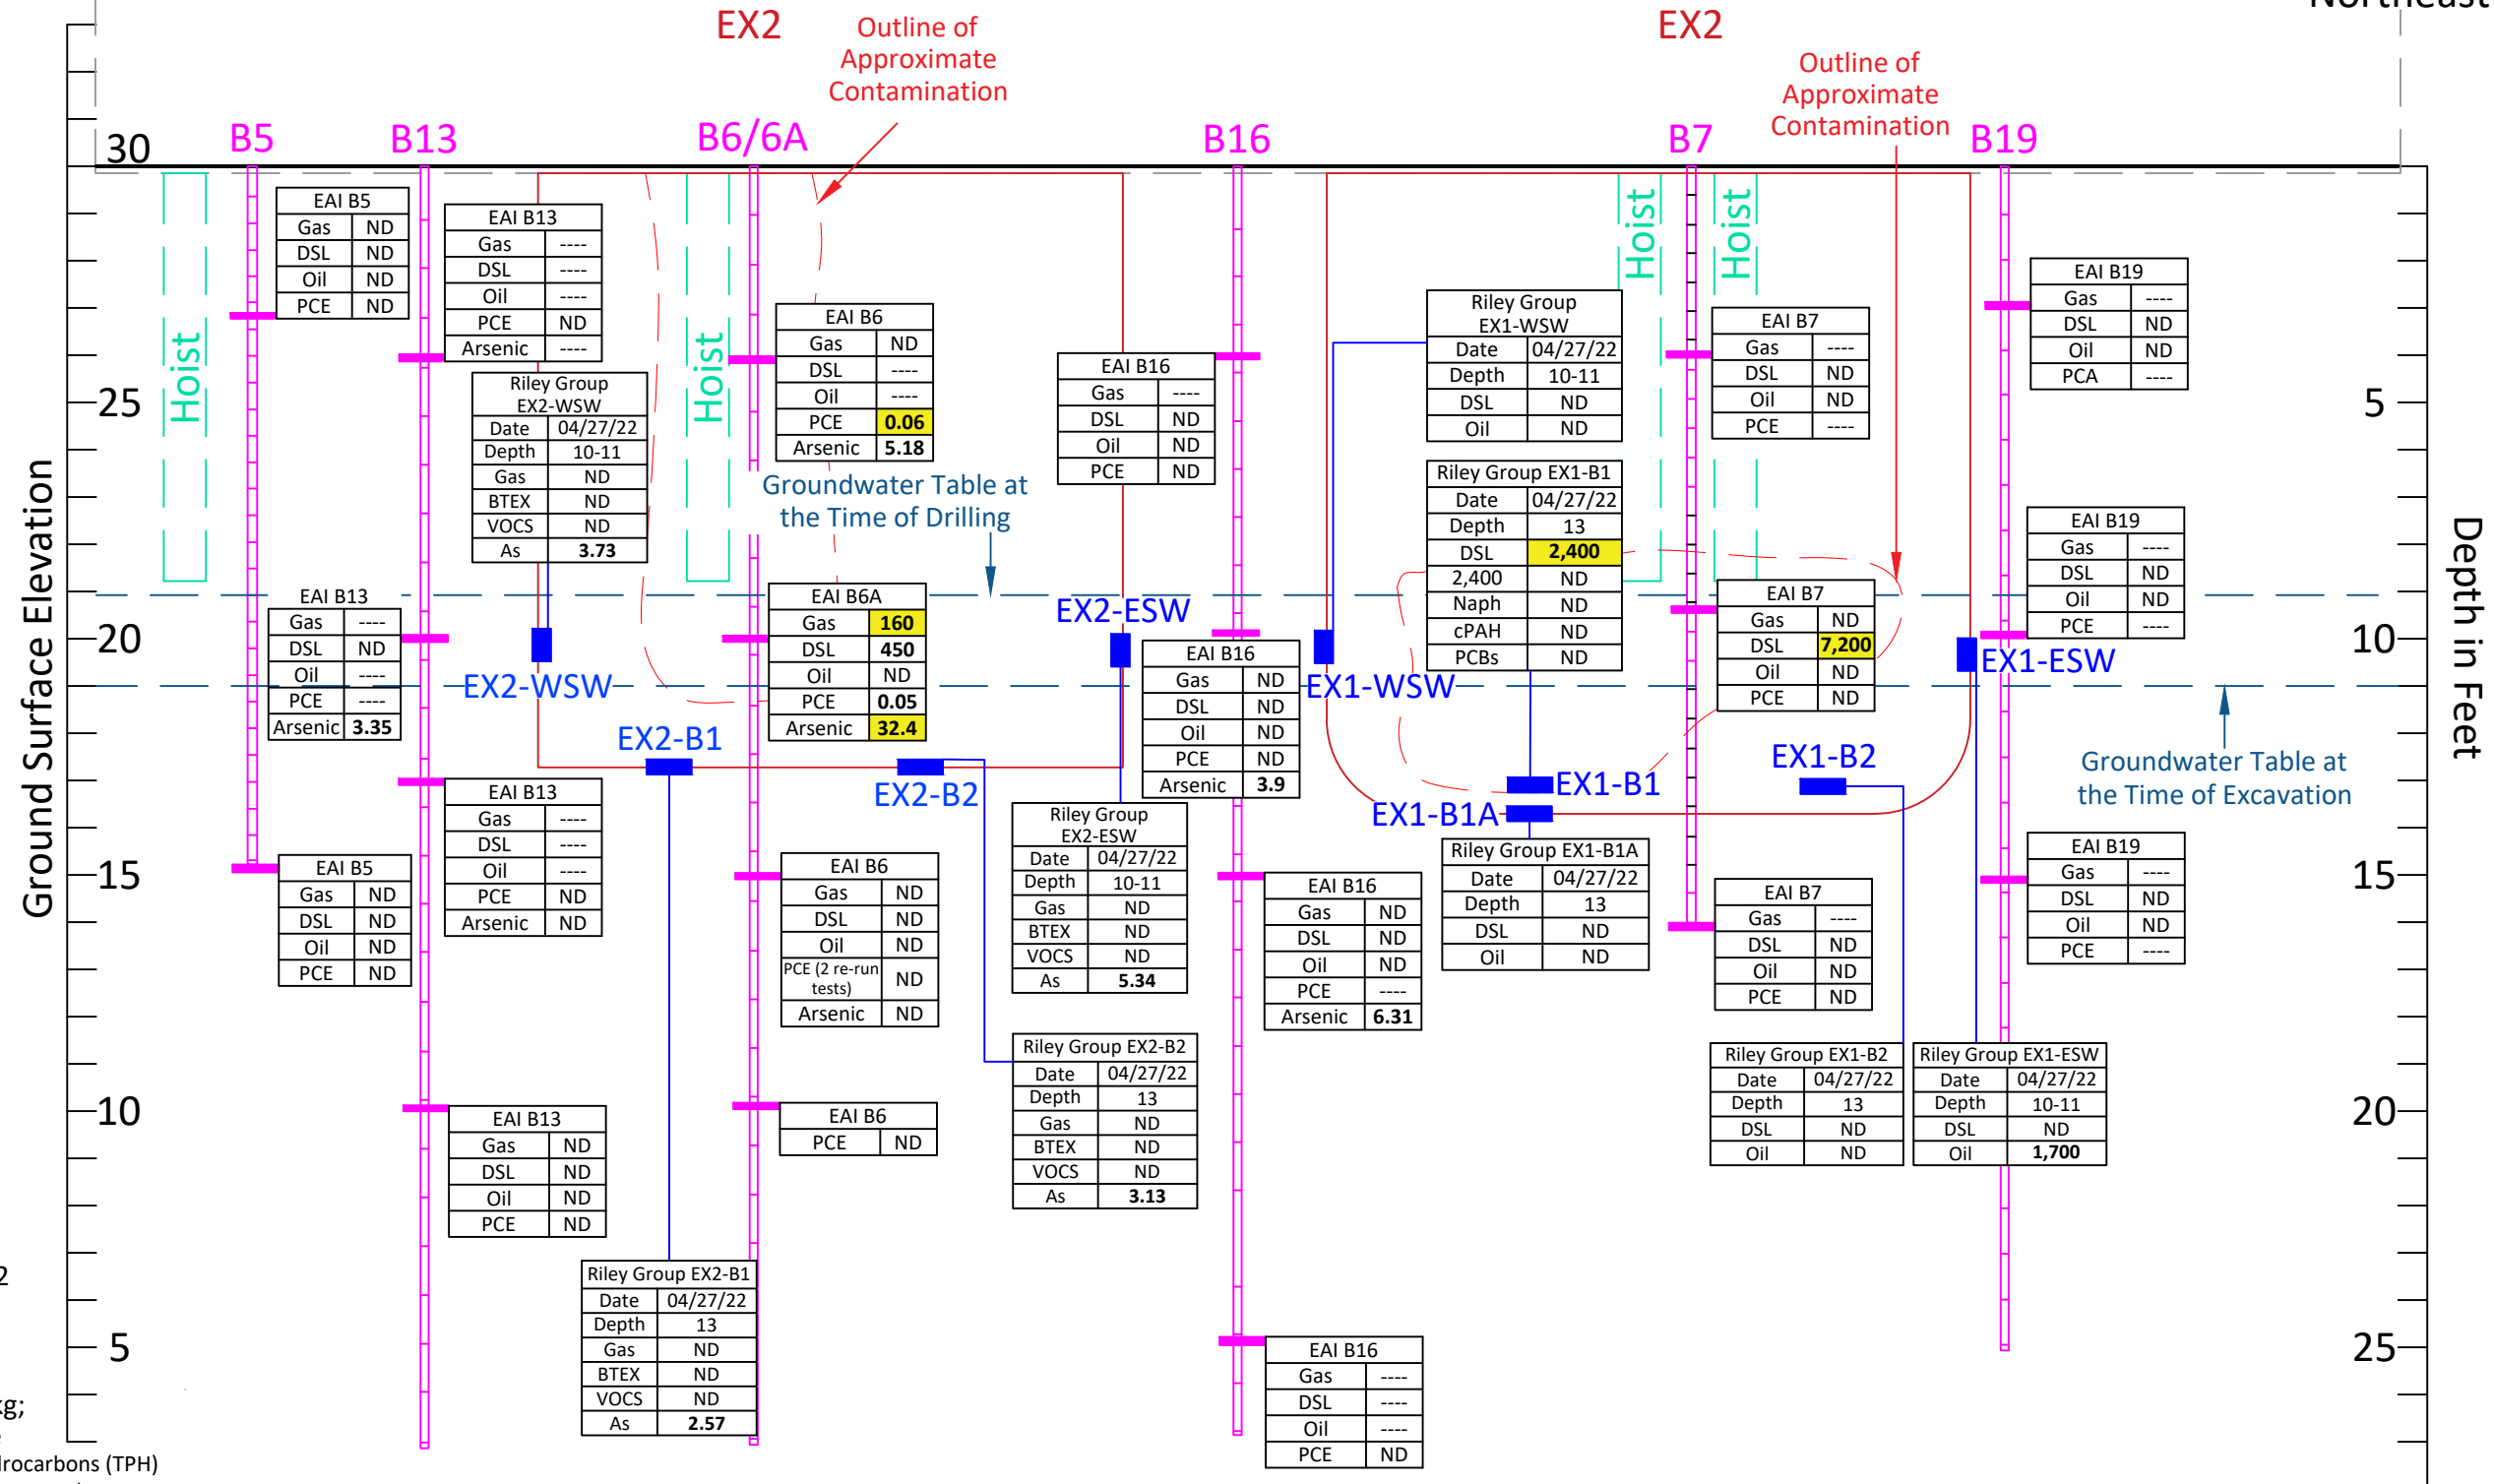
Enclosure A Figure 3

**Ground Water:** No permanent monitoring wells are currently located at the Site. Depth to groundwater has been observed at 9 to 11 feet bgs in borings and excavations at the Site in 2021 to 2022 (**Figure 3**).

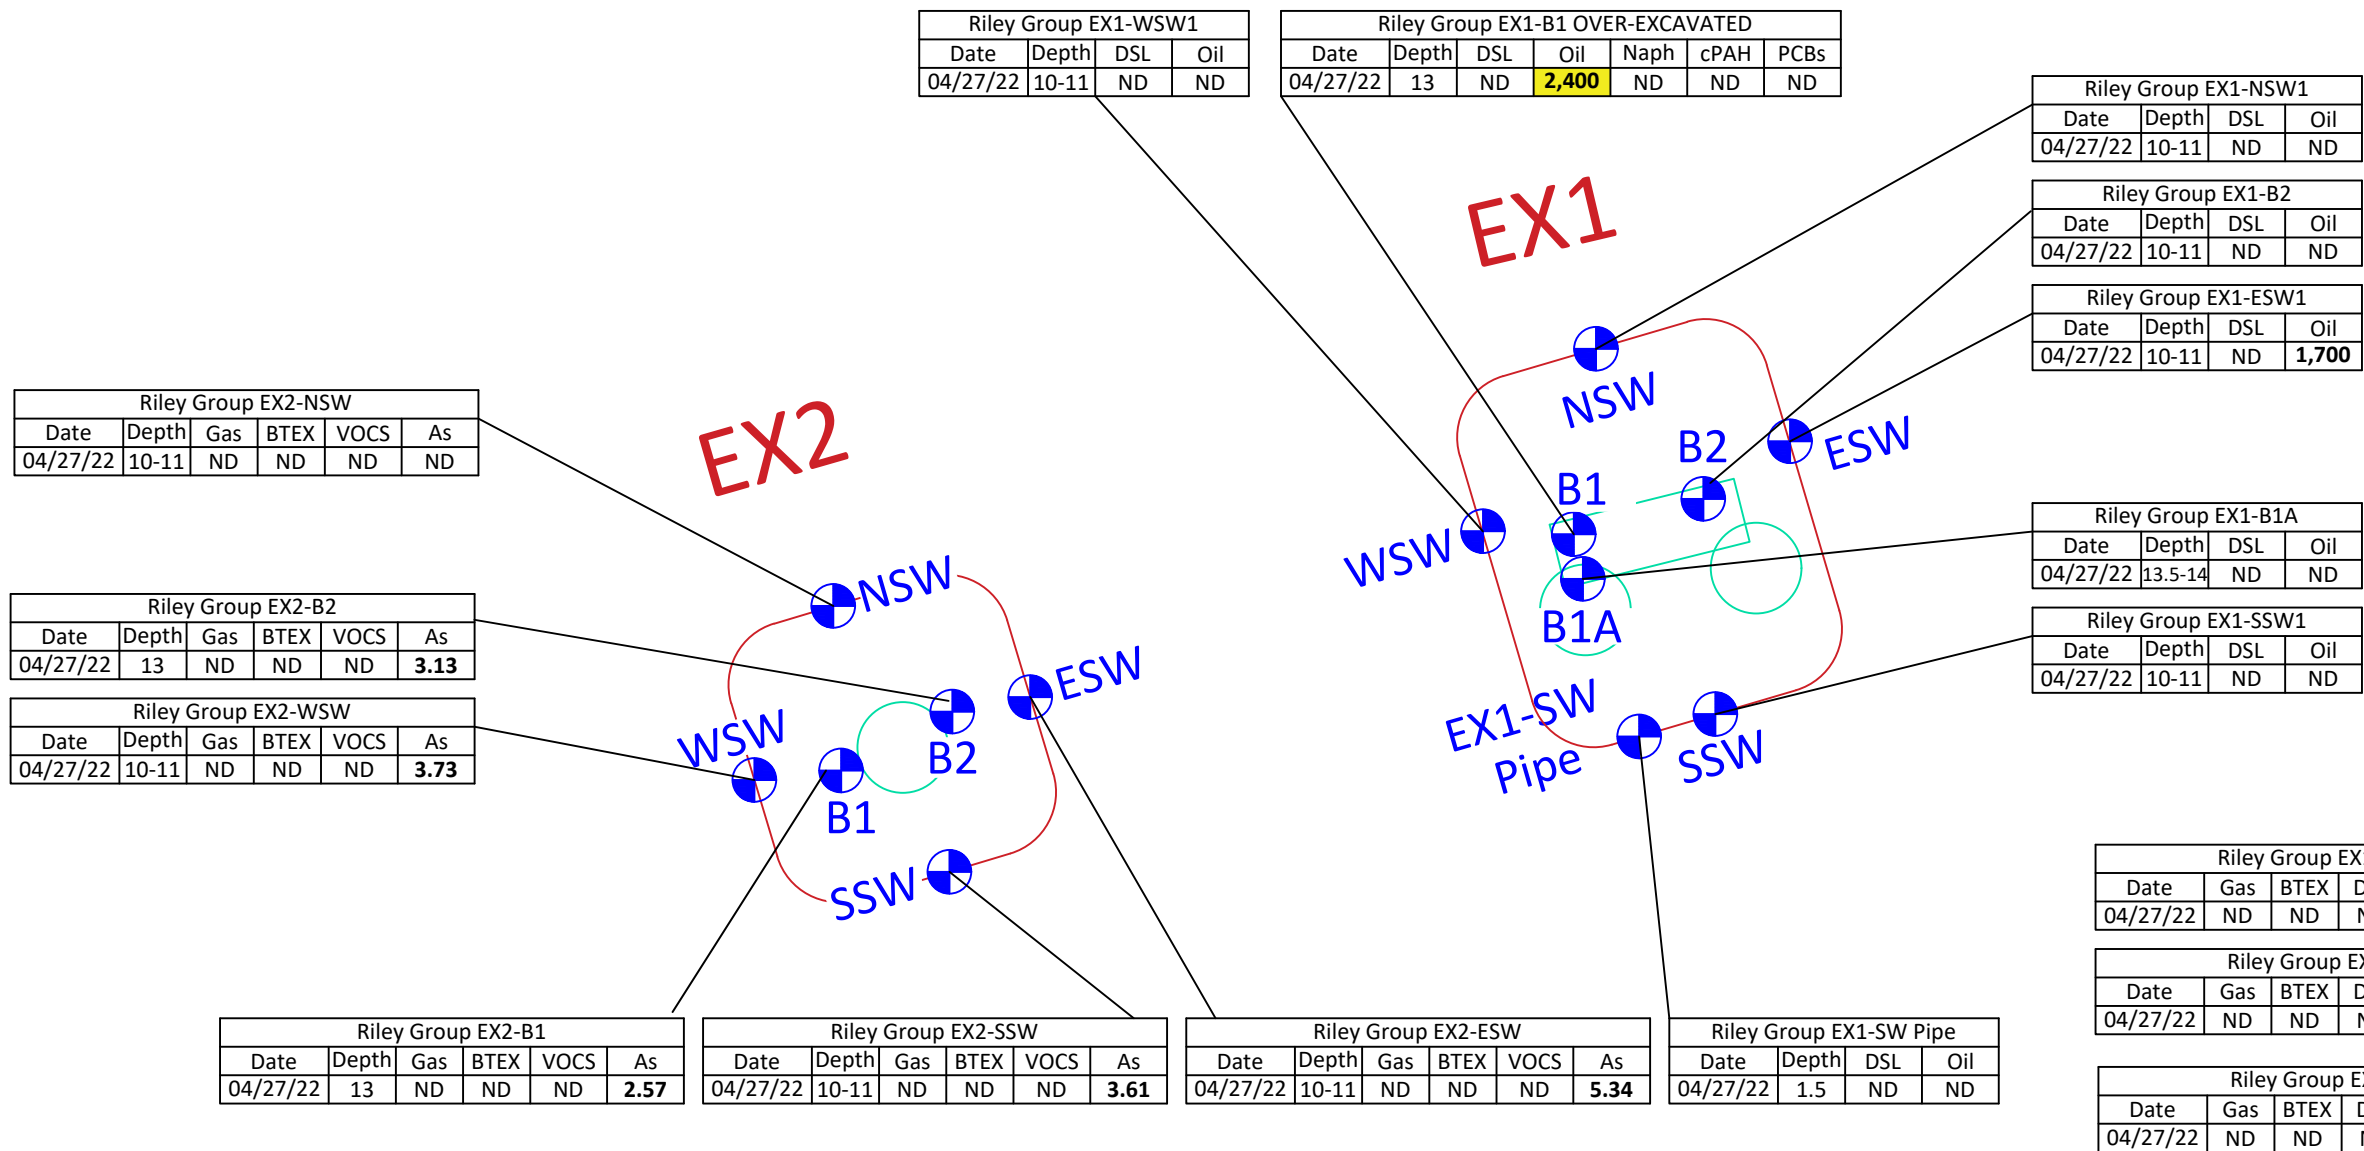
**Interim Remedial Actions:** The building demolition of the former Firestone building occurred in April 2022. Two remedial excavations were advanced in the vicinity of B6 and B7 to remove the contaminated soil (**Figure 2, Figure 3, Figure 4**).

Performance soil samples were collected from the bottom and sidewalls of the excavations. A soil sample collected from the bottom of EX-1 at a depth of 13 feet bgs contained TPH-O at a concentration of 2400 mg/kg, above the Method A cleanup level (EX1-B1; **Figure 4**). The excavation was extended vertically by another 6 inches, and another confirmation sample collected, which did not contain TPH-D or TPH-O above the Method A cleanup level.

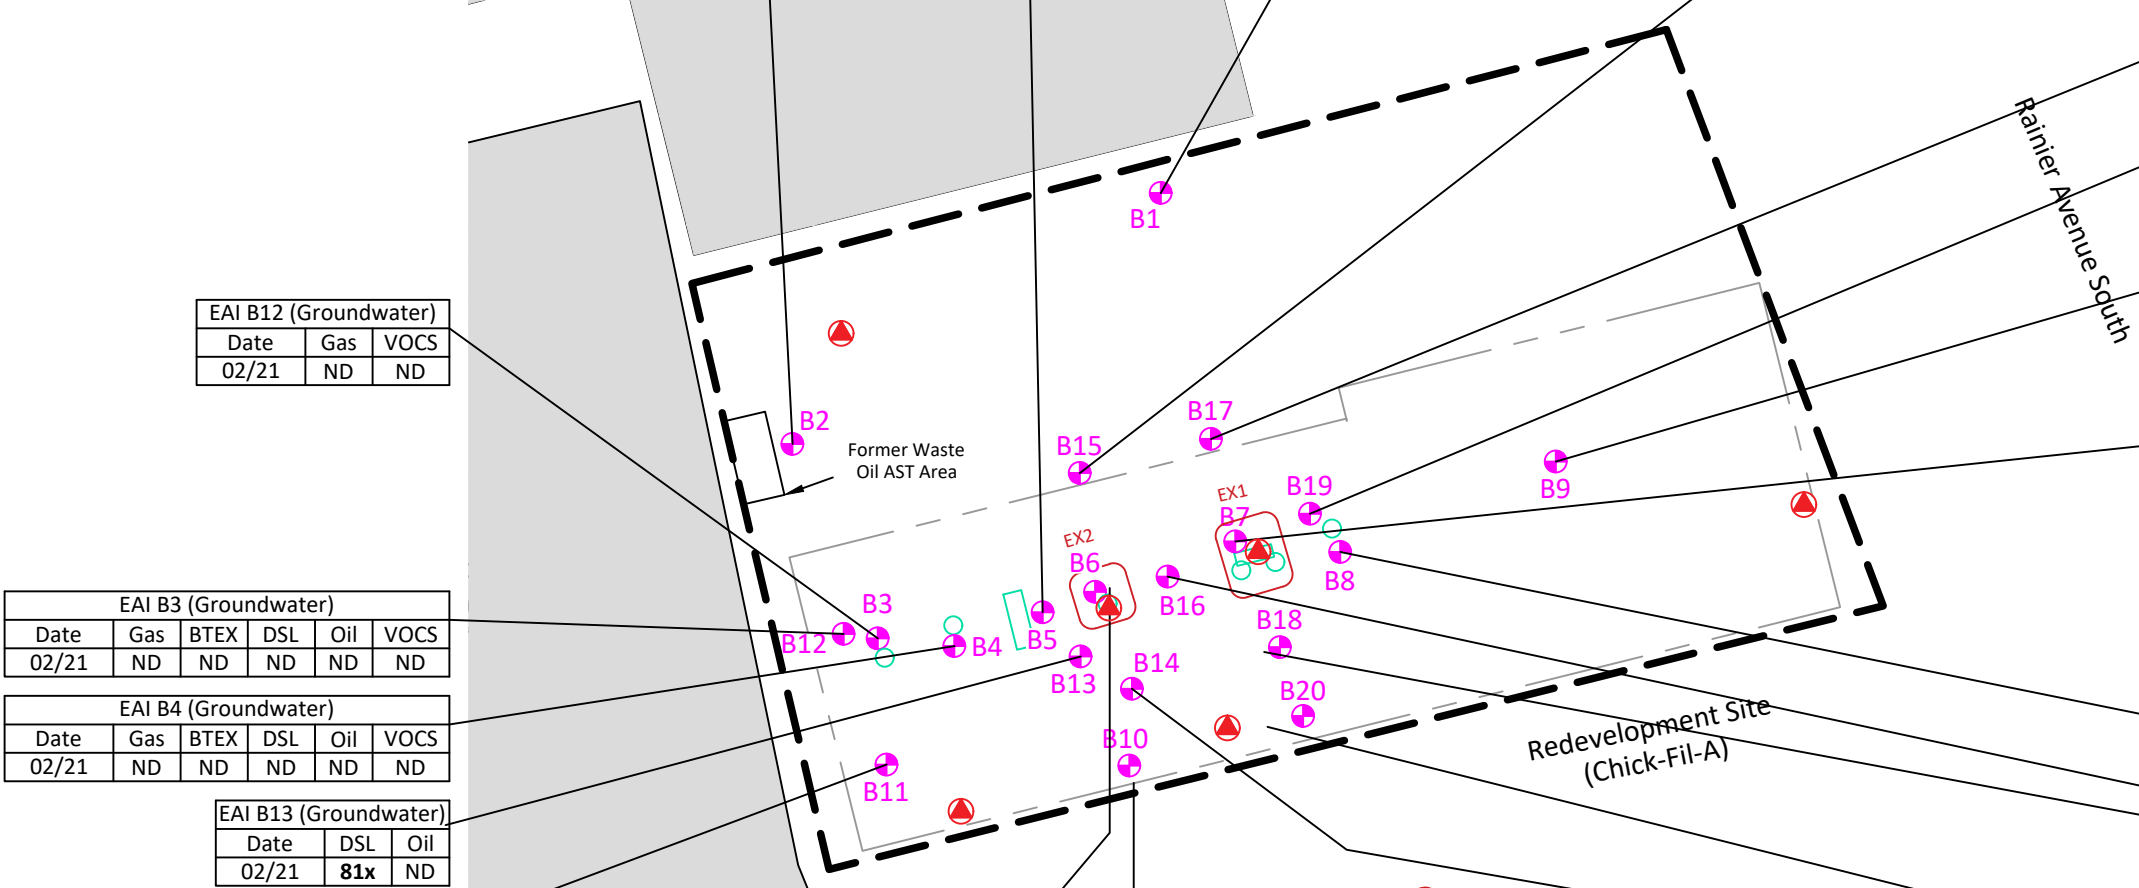
Enslosure A Figure 5

Groundwater samples were collected from temporary wells installed in borings B1 to B20 from February to March 2021. With the exception of B6 and B7, contamination was not detected above MTCA cleanup levels in groundwater samples collected at the Site. Groundwater samples collected from B6 and B7 contained TPH-D at concentrations of 2,400 and 16,000 micrograms per liter ( $\mu\text{g/L}$ ), respectively. These concentrations are above the MTCA Method A cleanup level. Groundwater samples collected from B2 and B7 were analyzed for the recommended waste oil analytes in MTCA [Table 830-1](#)<sup>3</sup>. With the exception of TPH-D in B7, none of these analytes were detected above the laboratory reporting limit.

Ecology concurs with the proposed monitoring well network discussed in the *August 2022 CAP* (see **Enclosure A, Figure 5**). This monitoring well network is well situated to characterize any remaining impacts to groundwater. Further characterization of contamination is necessary to demonstrate that the interim action, discussed below, is protective of groundwater. Due to the presence of TPH-G, PCE, and arsenic in soil and PCE and naphthalene in soil vapor at the Site, Ecology recommends analyzing groundwater samples for these compounds in addition to TPH-D and TPH-O for a minimum of four quarters to evaluate whether they are present in groundwater at the Site. Depending on the groundwater monitoring results, additional groundwater monitoring may be needed.

Ecology appreciates your efforts characterizing and cleaning up the Site to date. Additional characterization and confirmation sampling is needed to demonstrate the efficacy of the interim actions conducted at the Site. Ecology concurs with the proposed location of groundwater monitoring wells at the Site and the planned initial sampling schedule. As discussed above, Ecology recommends that groundwater samples collected from proposed Site monitoring wells should be analyzed for all Site contaminants.
