## **Second Periodic Review Corner Express (Texaco)**

**1131 Morgan Street, Davenport, Lincoln County  
Facility Site ID: 85214652, Cleanup Site ID: 7310**

**Toxics Cleanup Program, Eastern Region**

June 2023

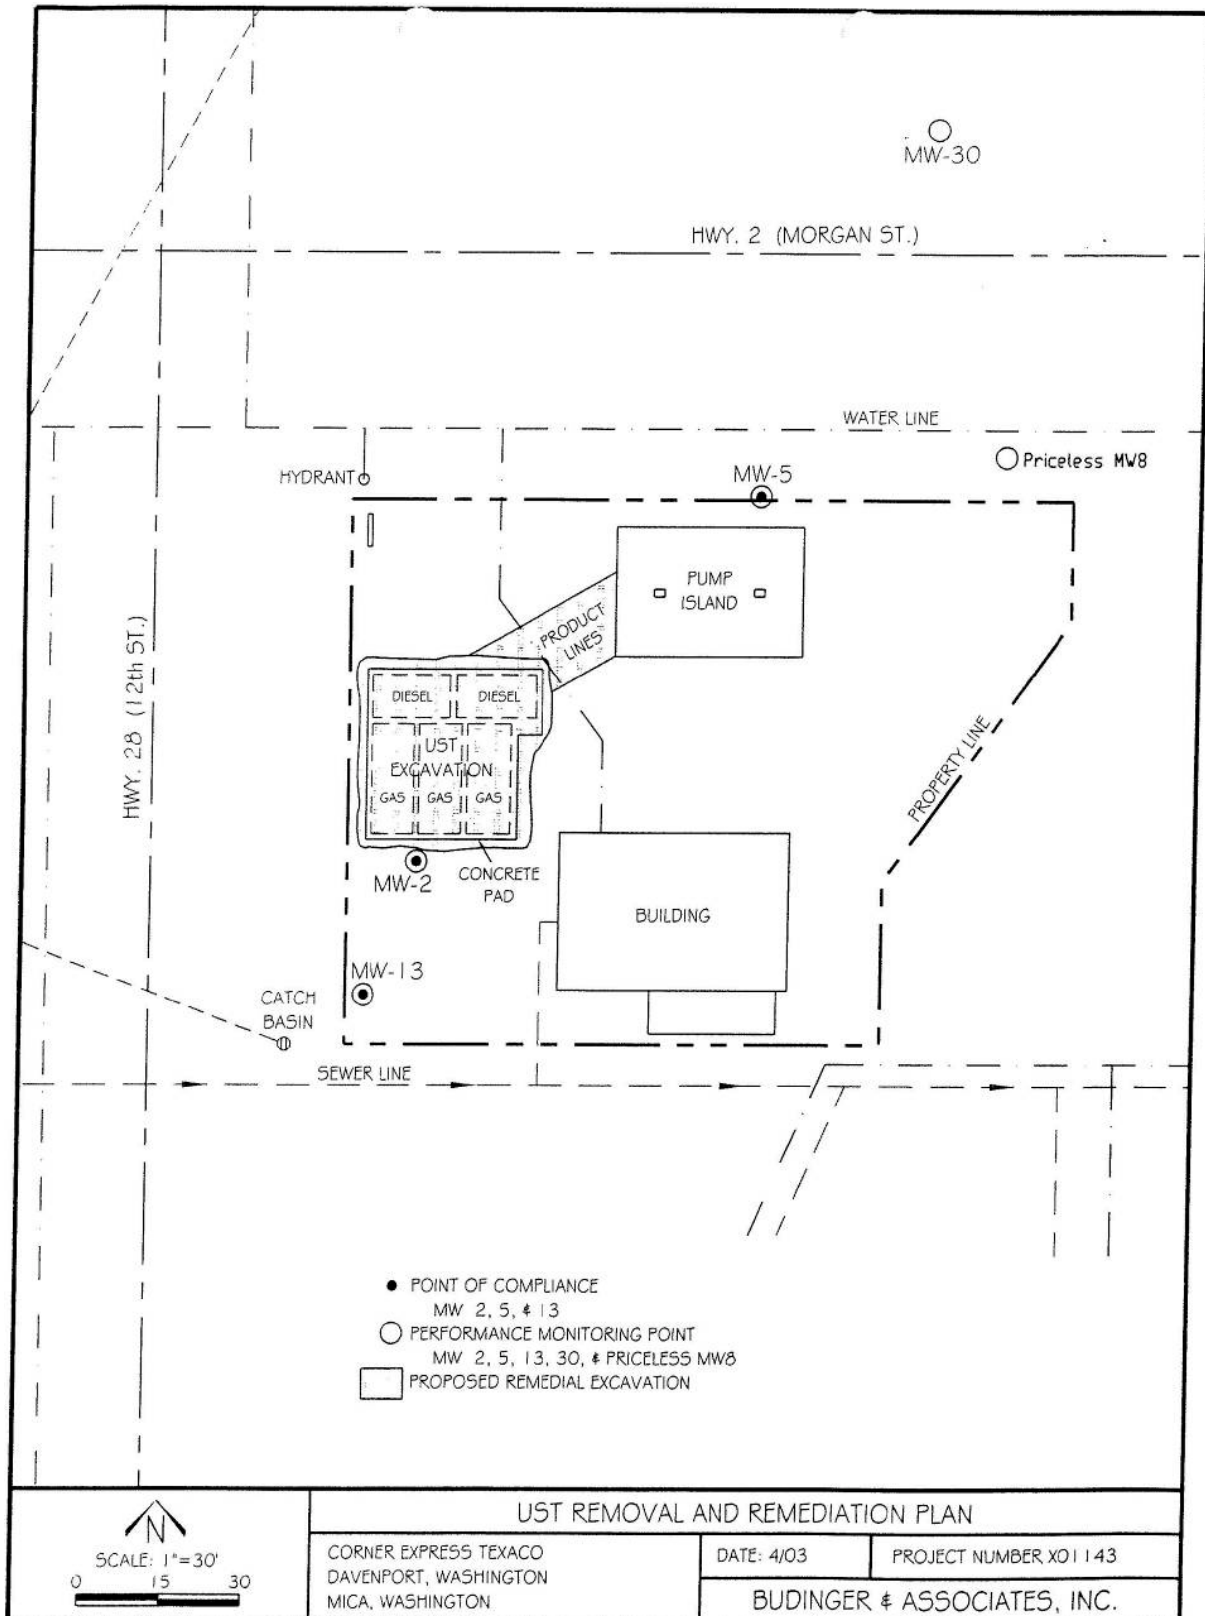
## Appendix B. Site Plan

Groundwater monitoring has been conducted semi-annually, at a minimum, since monitoring wells were installed at the Site in 2001. Monitoring wells MW-2, MW-5, MW-8, and MW-13 are used to evaluate Site cleanup performance. MW-30 serves as a perimeter well to verify that contamination is not leaving the Site. Groundwater monitoring wells are shown on the site plan in Appendix B.

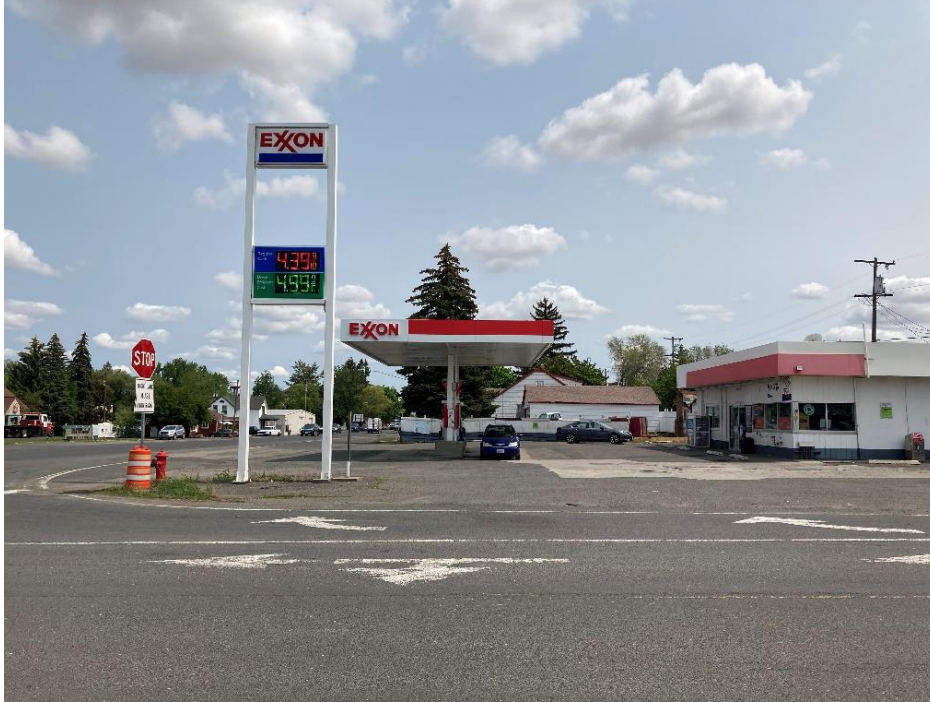
**Photo 1: Corner Express Site – from the west**

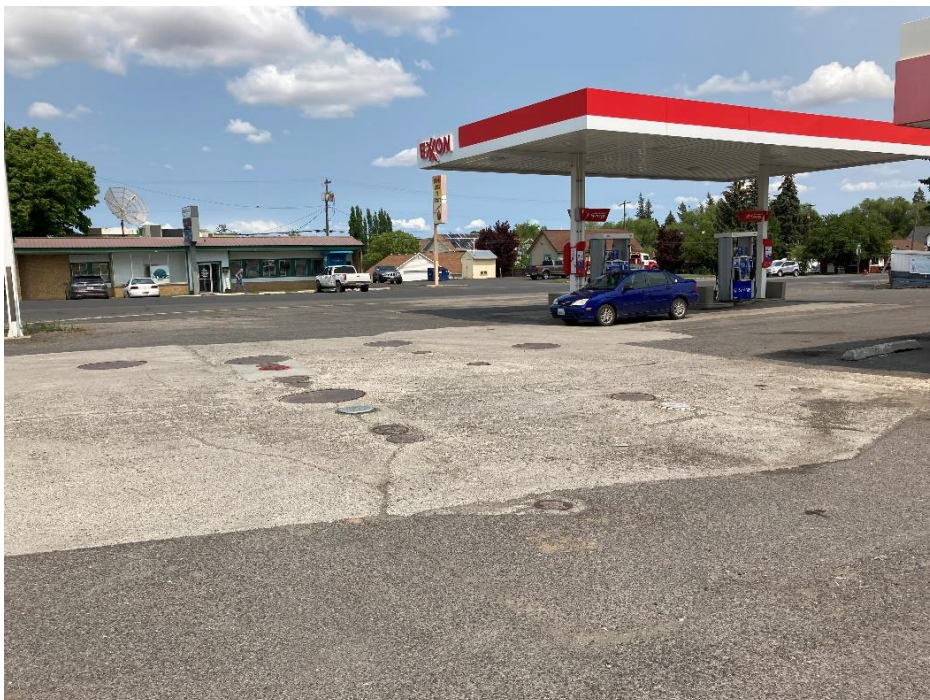
**Photo 2: Tank pit and pump island with MW-2 in foreground – from the southwest**

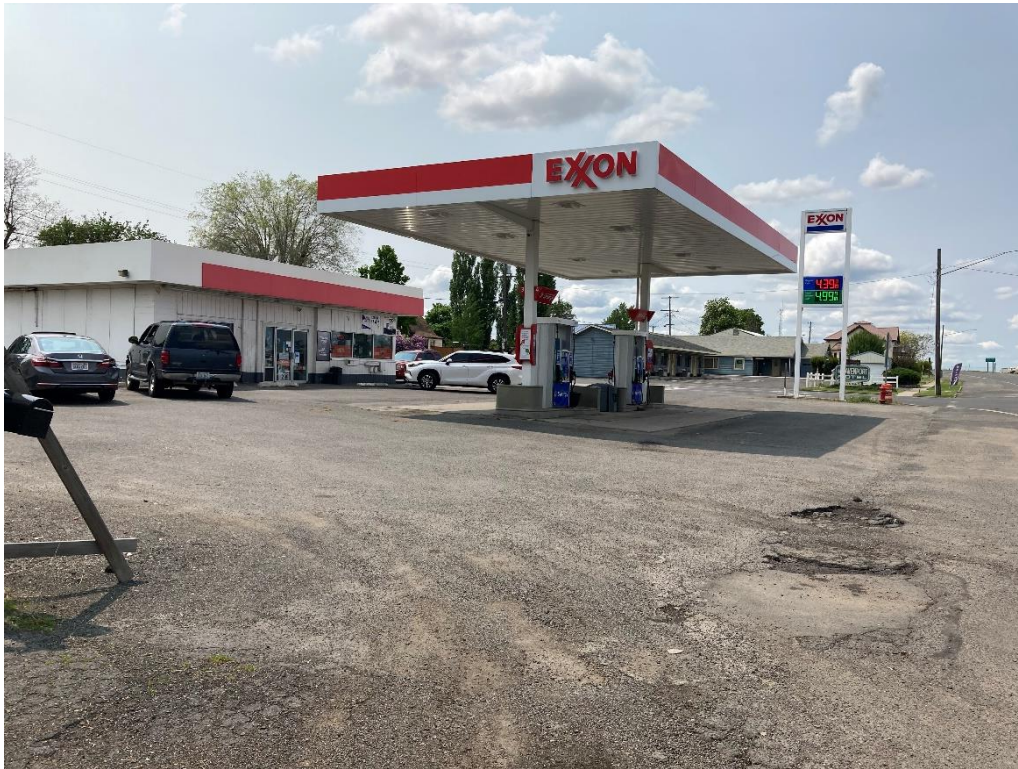
**Photo 3: MW-8, storefront, and pump island – from the northeast**

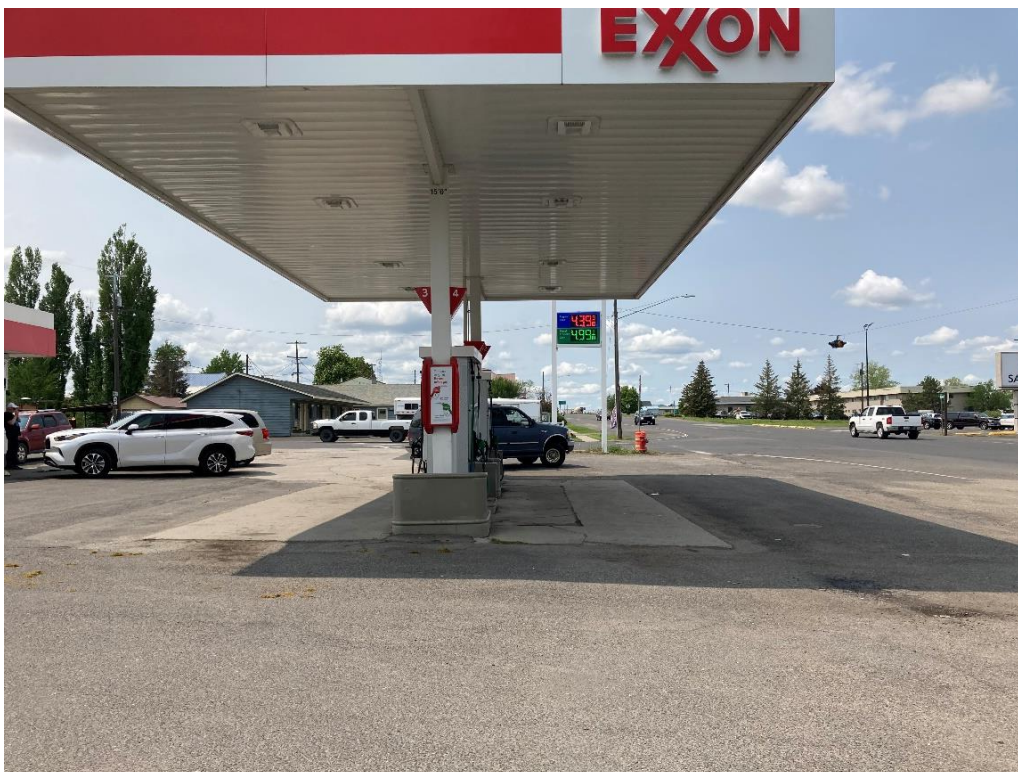
**Photo 4: Pump island – from the east**
