State of Washington
POLLUTION LIABILITY INSURANCE AGENCY
PO Box 40930 • Olympia, Washington 98504-0930
(360) 407-0520 • (800) 822-3905
www.plia.wa.gov

Re: No Further Action for the Following Site:

- **Facility/Site Name:** Wondrack Distributing, Inc.
- **Facility/Site Address:** 1602 Rudkin Road, Yakima, WA 98901
- **Facility/Site ID:** 57713524
- **TAP Project Number:** PC032

PLIA has determined that **no further action is necessary** to clean up petroleum contamination at the Site.

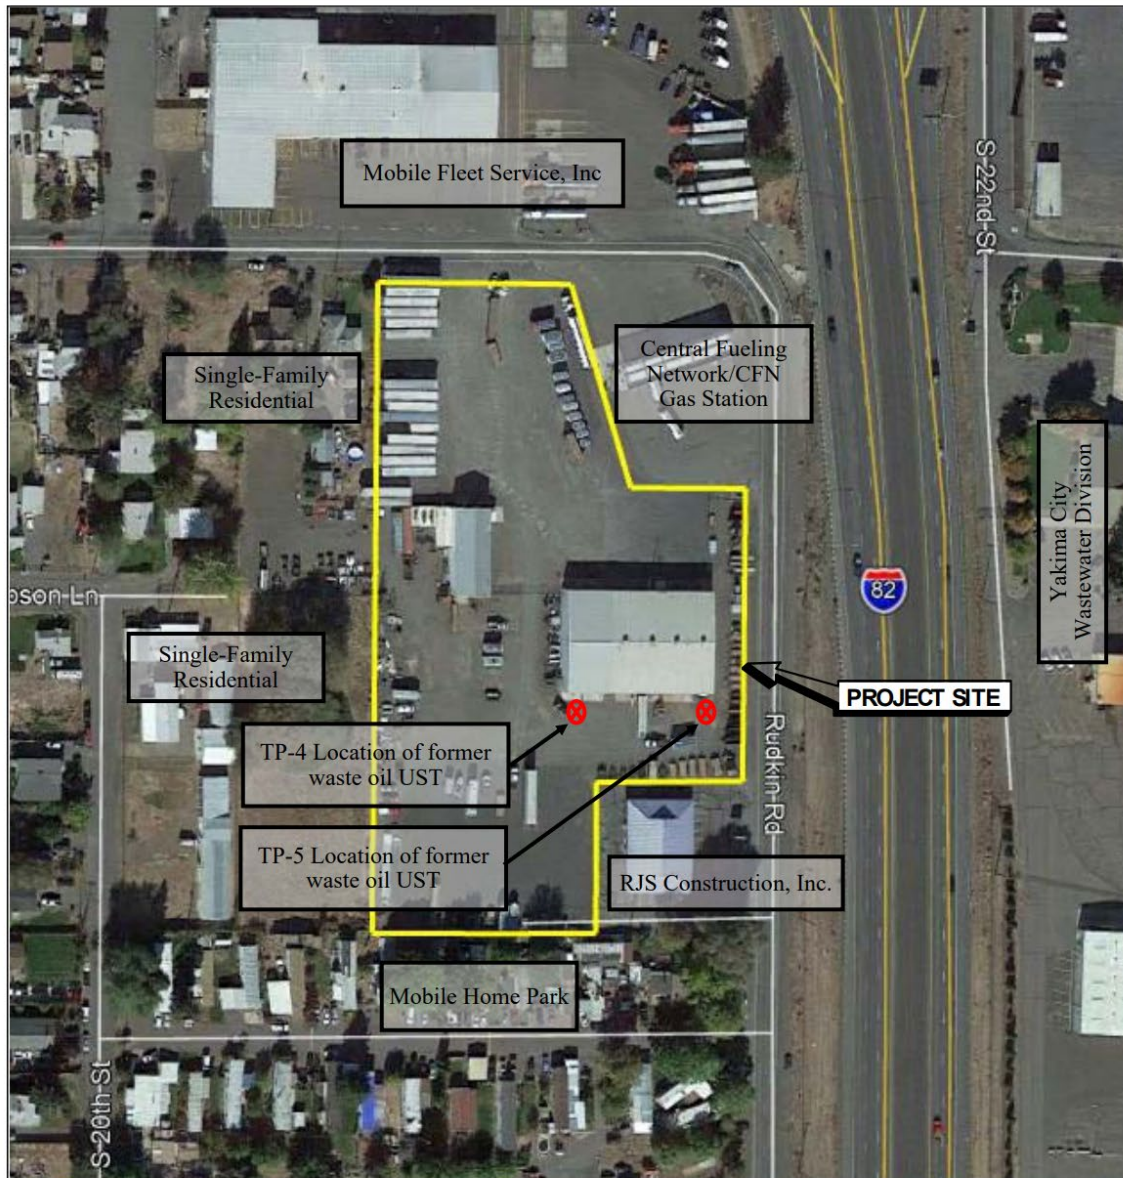
Figure 2: Site Plan Map

- A Table showing Analytical results from *Phase II Environmental Site Assessment*, NetCompliance, February, 2000.
- An investigation was performed for the UST that was situated on the north side of the former truck wash facility (Figure 2). The second UST system investigated contained two 500-gallon waste oil tanks located at the southeast and the southwest corners of the shop building.

Site Assessment Report summarizing UST removal activities associated with removal of two approximately 500-gallon waste oil tanks from separate excavations. The oil USTs were located adjacent to the southwest (excavation #1) and southeast (excavation #2) foundation of the current Shop Building (Figure 2). According to the report, each excavation was approximately 10' by 10' and extended to a depth of 7'. White Shield's UST Site assessor determined that additional excavation at these locations "would jeopardize the structural integrity of the building foundation" (Figure 2).

Historic documentation submitted with White Shield's site check summary indicated that **both diesel USTs had passed leak detection integrity assessment conducted in 1992.** During White Shield's investigation, **two test pits** were excavated to determine if petroleum contamination related to UST existence or usage was present. **The two test pits were located adjacent to the USTs: one on the east side of the east tank, the second on the west side of the west tank. Both test pits were excavated to an approximate depth of 6' (Figure 2).**

In January of 2000, NetCompliance conducted a Phase II Environmental Site Assessment (ESA) of the Site. The Phase II ESA focused on the two locations of former USTs. NetCompliance excavated five test pits (TPs): three in the approximate location of the former diesel USTs (TP1, TP2, and TP3), and two in the approximate location of the former waste oil USTs (TP4 and TP5). Soil samples were collected from excavation depth (8' to 12' below ground surface [bgs]). Two samples were collected from each of the three TPs located in the former diesel UST area. One sample was collected from each of the two TPs in the former waste oil UST locations (Figure 2).

Specifically, concentrations in the two identified **waste oil TPs (TP4 and TP5), with heavy oil range hydrocarbons ranging from less than 53 ppm to 79 ppm, are sufficiently low enough that no additional waste oil constituent analysis is required.** The MTCA Method A CUL (residential levels) for TPH-o is **2,000 ppm.** Additionally, the Site is zoned as light industrial/commercial. No sensitive human or ecological potential receptors are present on the Site (Figure 2).
