STATE OF WASHINGTON  
DEPARTMENT OF ECOLOGY

**Re: Opinion pursuant to WAC 173-340-515(5) on Remedial Action for the following  
Hazardous Waste Site:**

- **Site Name:** Midas Muffler Ballard
- **Site Address:** 7055 15th Avenue NW, Seattle, WA 98117
- **Facility/Site No.:** 19188572
- **Cleanup Site ID No.:** 16663
- **VCP Project No.:** NW3350

## **Enclosure A**

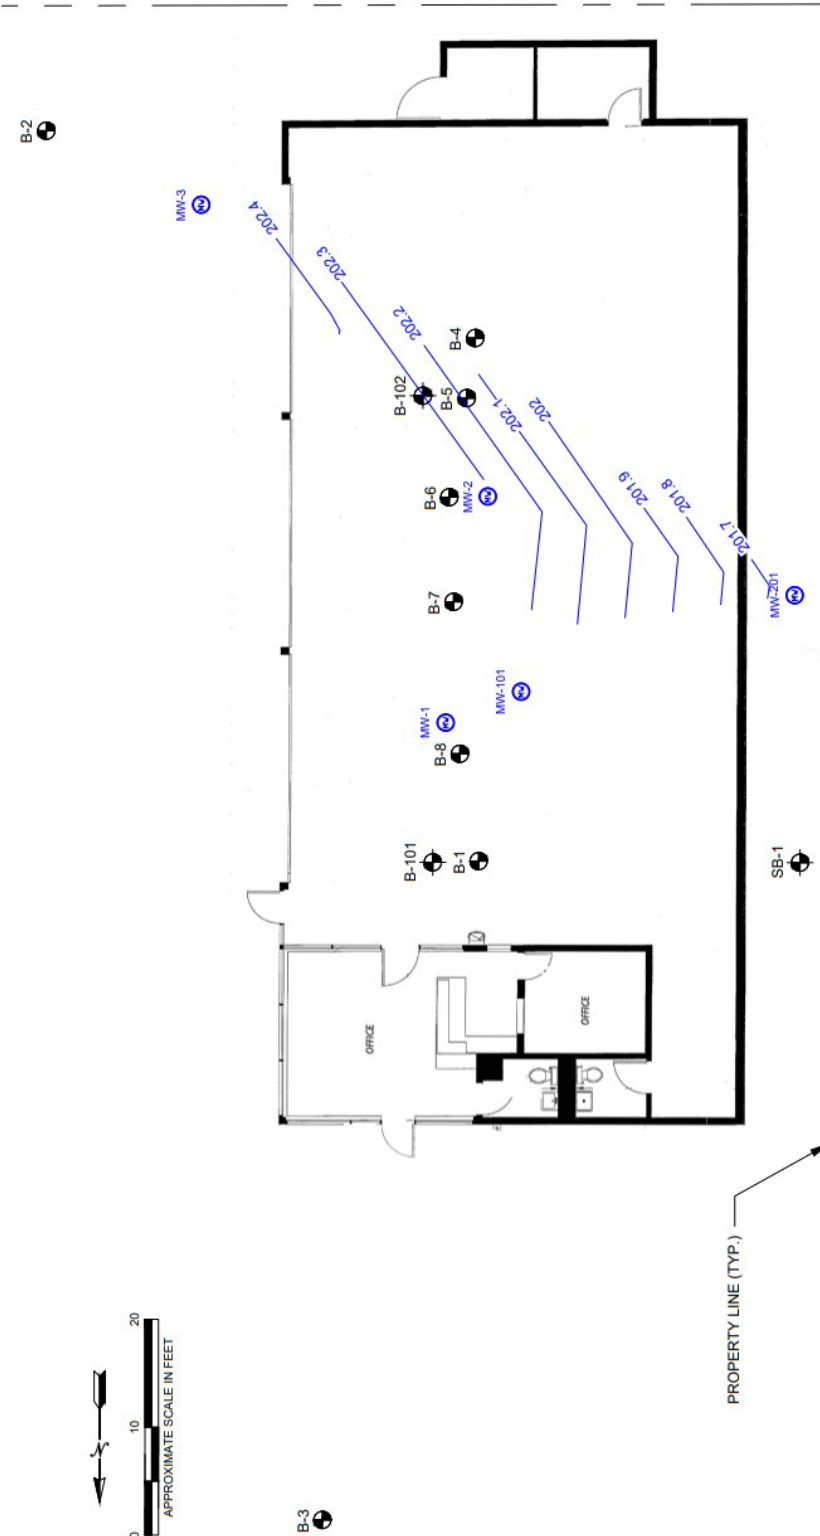
Enclosure A, Figure 2

Groundwater has been consistently encountered at approximately 45 to 49 ft bgs. Horizontal gradient and flow direction varies seasonally, but generally flows toward the southwest (**Figure 2**).

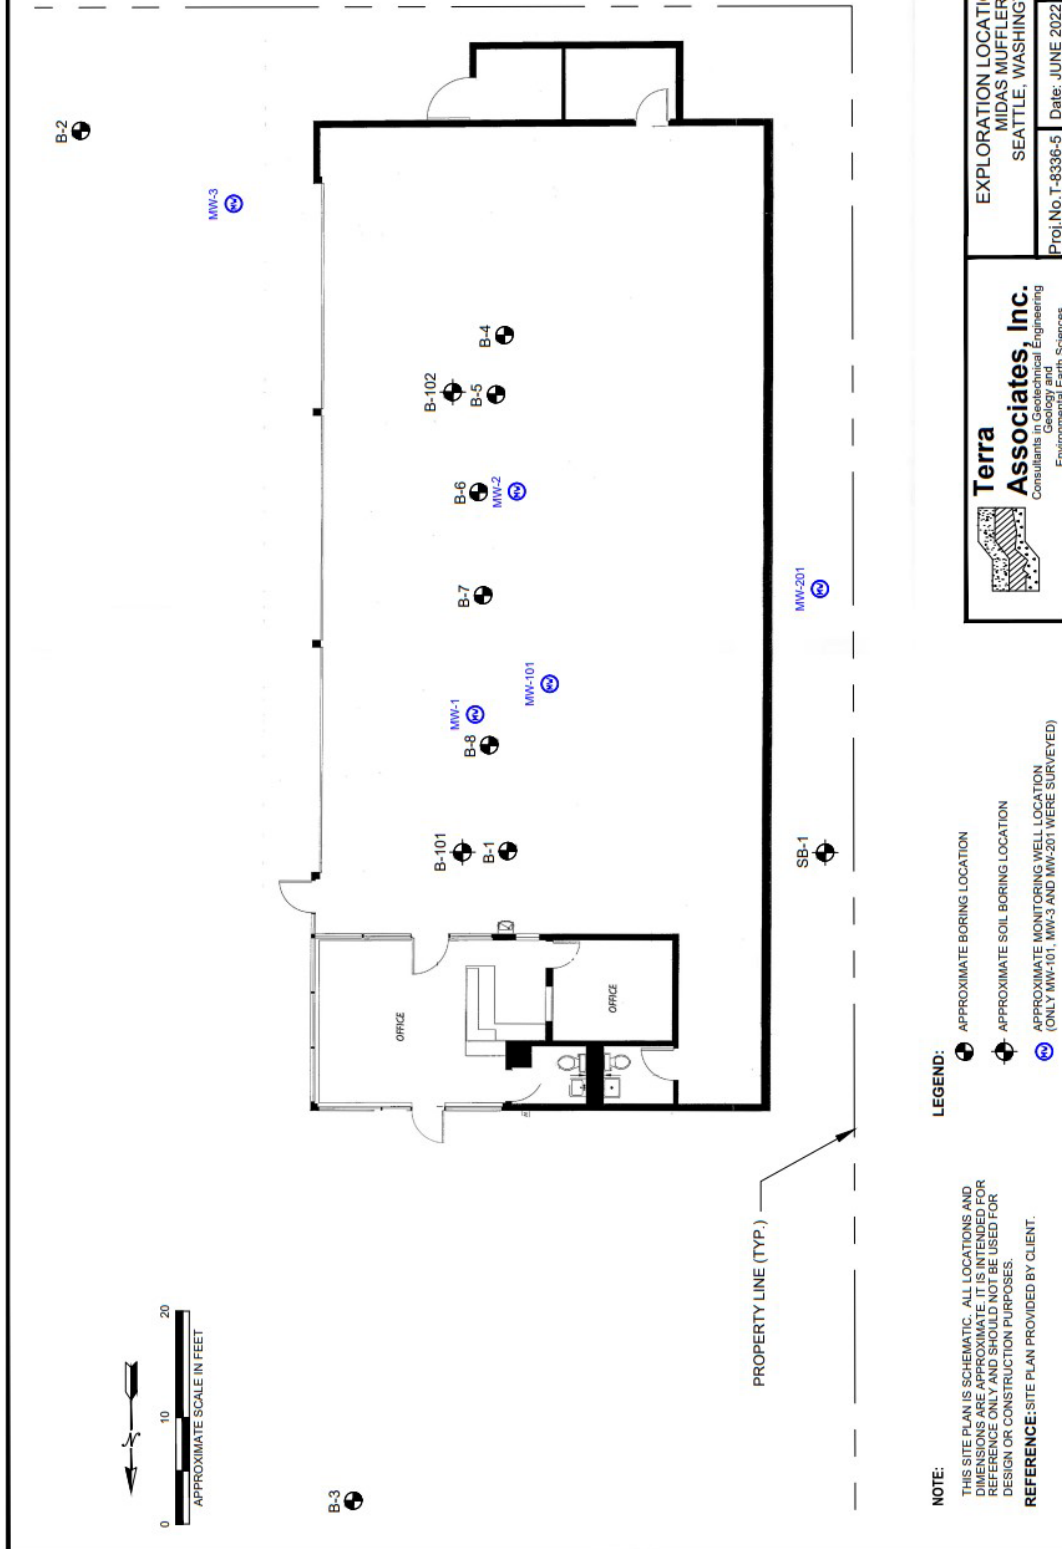
Enclosure A, Figure 3

During characterization of the site, a total of 11 soil borings (B-1 through B-8, B-101, B-102, and SB-1) and five monitoring wells (see above) were installed at the Site (**Figure 3**). The table below summarizes soil samples that exceeded the MTCA Method A cleanup level for TPH-D +TPH-O.

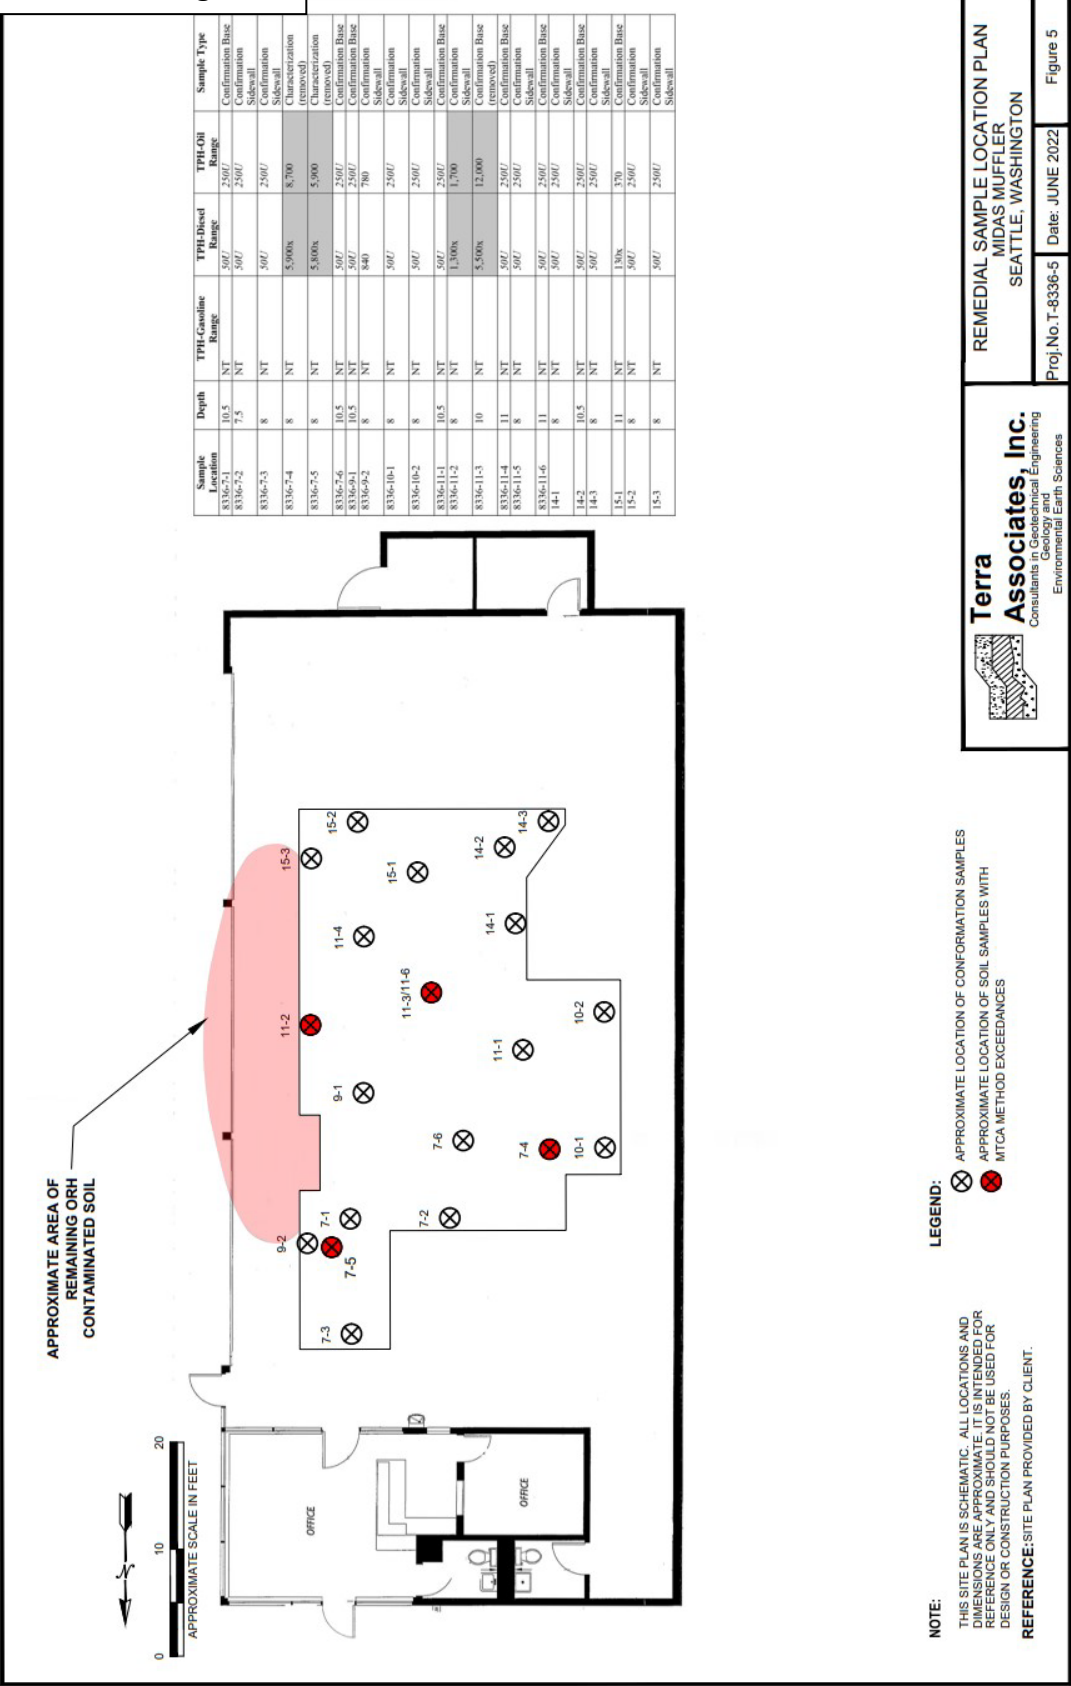
Enclosure A, Figure 4

A remedial excavation was conducted in February 2022 within the footprint of the existing building (**Figure 4**). This excavation removed a significant volume of petroleum-source material. Petroleum-contaminated soil was left in place near/beneath the building's eastern foundation wall due to structural concerns. Contamination was confirmed by soil sample 11-2 (**Figure 4**). The lateral and vertical extent of contamination remaining in this area is unbounded to the east, beyond the building's footprint.

Performance soil samples collected from the bottom of the excavation contained total petroleum hydrocarbons at concentrations of 14,600 mg/kg and 11,700 mg/kg in two locations (samples 7-4 and 7-5, respectively, **Figure 4**). The soil in the vicinity of these samples was over-excavated, but confirmation samples were not collected to document remaining concentrations in these areas. The remaining soils in these areas reportedly did not exhibit indications of petroleum contamination, such as visible discoloration, odor, sheen development, and/or elevated photoionization detector (PID) readings.

- To address this data gap, additional soil characterization is recommended to the east of the building's foundation. Please note that samples should be collected from an appropriate depth that is representative of the likely elevation of contamination at the Site.
- PCE has not been ruled out as a COC and should be considered in future site assessment work.
- Soil samples should be collected for PCE analysis from the vicinity of the former waste-oil AST and diagnostic pit.
- Please submit a work plan before performing the additional characterization efforts.

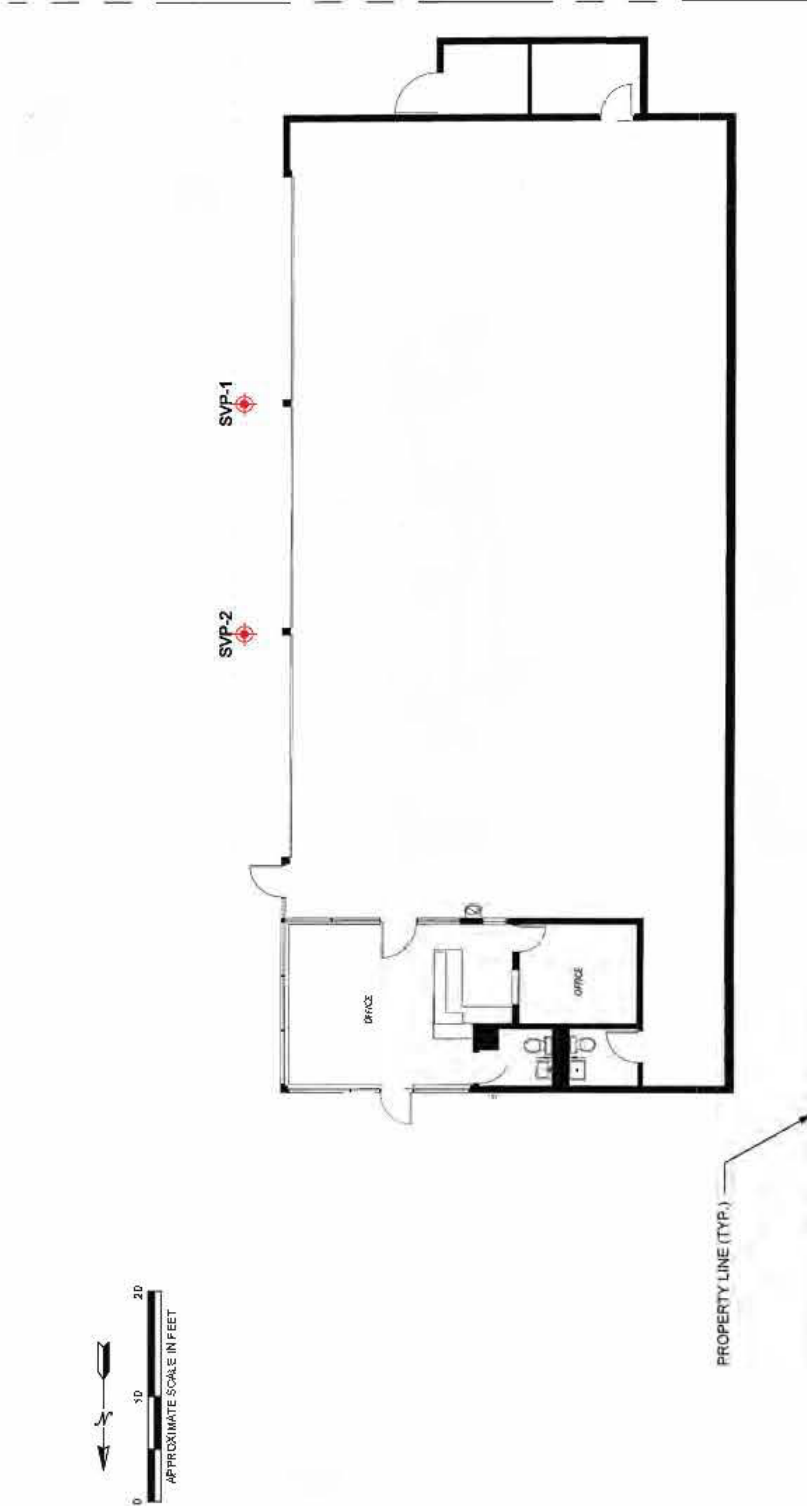
Enclosure A, Figure 5

- TPH concentrations exceeded the Generic Method B soil gas screening level of 1,500 micrograms per cubic meter ( $\mu\text{g}/\text{m}^3$ ) in both samples. Additional sampling events are needed before determining VI risk to nearby occupied buildings, per Ecology's [2022 Guidance for Evaluating Vapor Intrusion in Washington State<sup>4</sup>](#).

Soil vapor samples were collected in April of 2022 from two soil vapor probes (SVP-1 and SVP-2, **Figure 5**) and submitted to an analytical laboratory for naphthalene and air-phase petroleum hydrocarbon (APH) analysis. The samples exceeded the generic Method B soil gas screening level for TPH. The collected soil gas samples were not analyzed for PCE or other VOCs.

- Because the soil sample dataset for PCE is insufficient to discount it as a COC, Ecology recommends that subsequent soil gas samples be analyzed for chlorinated solvents.

- Ecology also recommends comparing the soil gas analytical results for TPH to a site-specific screening level, rather than the generic screening level.
