HARTCROWSER

**Summary Report on Remediation
Activities U-1 Hot Spot in
Garden Avenue North**

**Paccar Renton Site
Renton, Washington**

**January 5, 1995
J-1639-35**

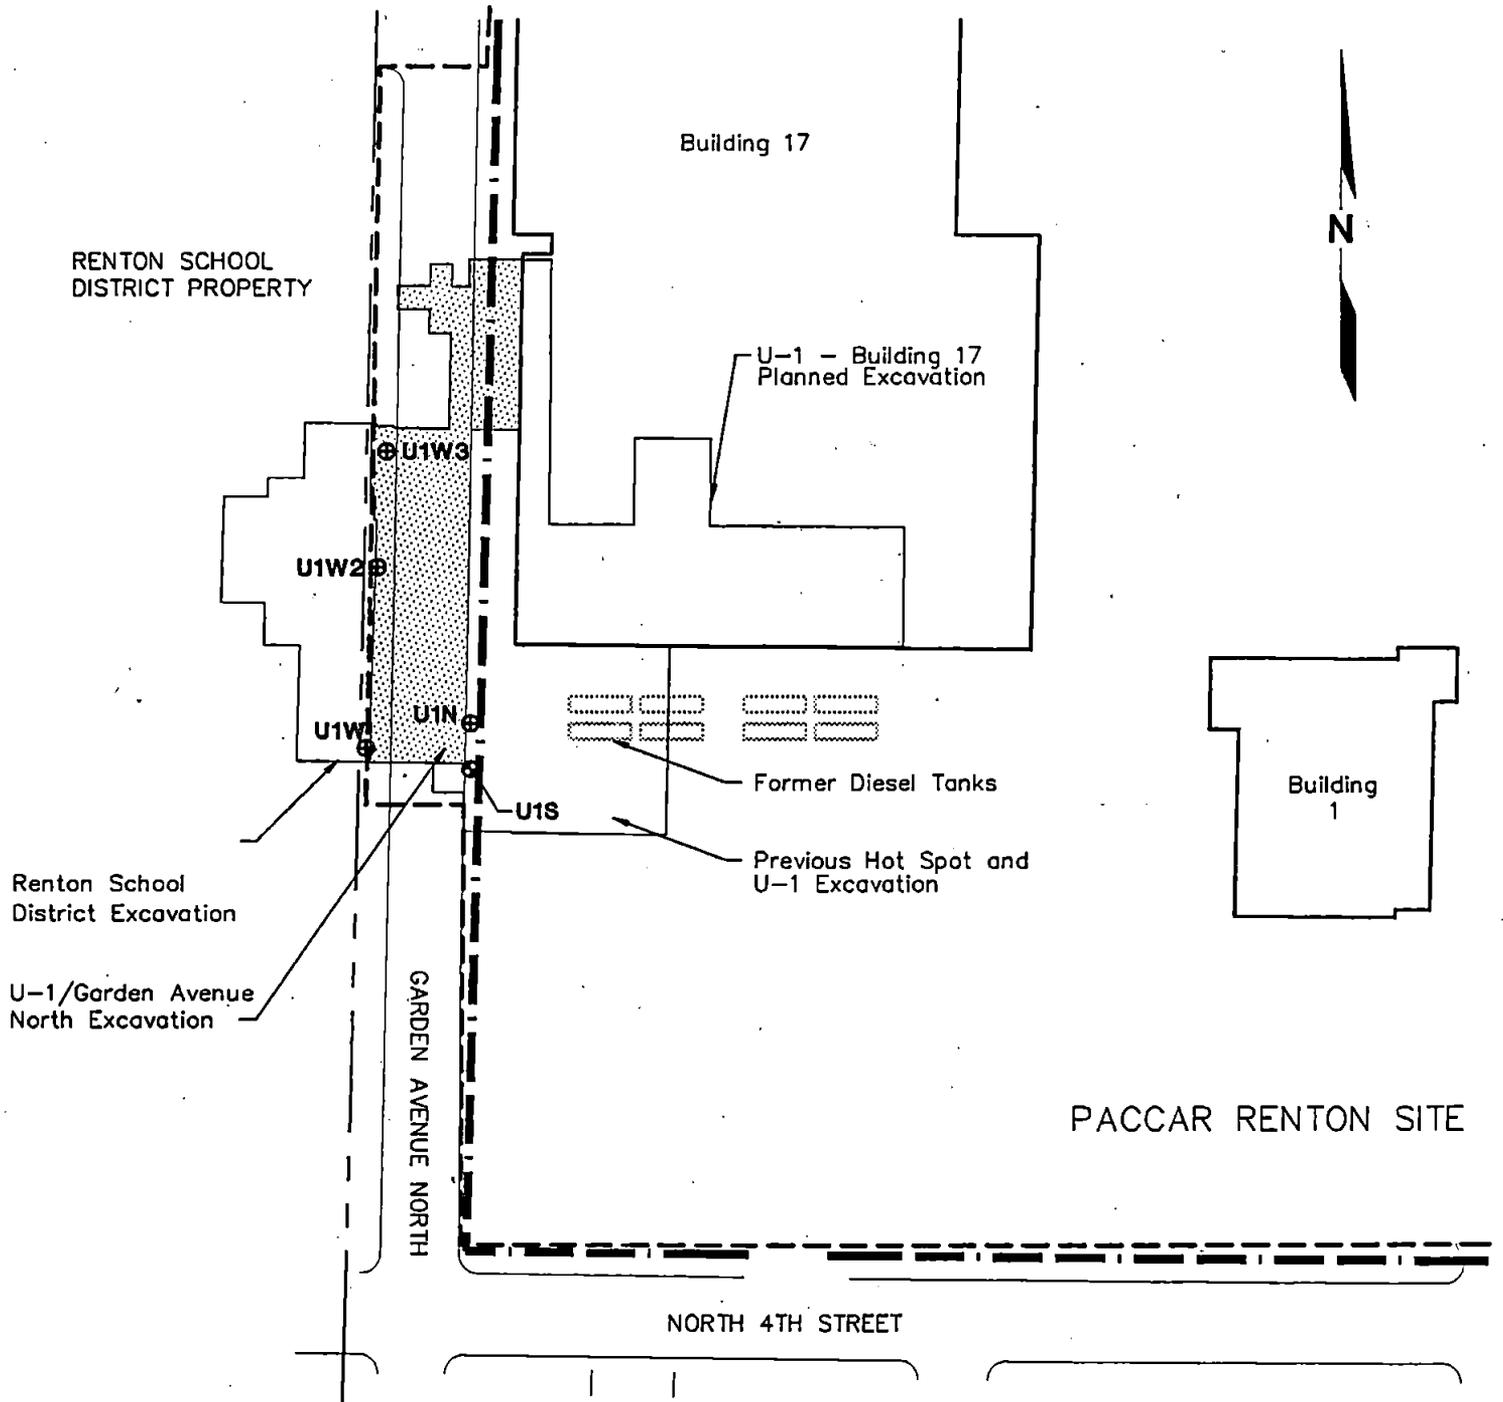
Site Plan

As a result of that work, an estimate of the extent of the diesel-affected soils was made (see Figure 2).

In general, the amendment extended the Point of Compliance for the PACCAR Renton site to include a portion of Garden Avenue as shown on Figure 2. The amendment also included other items not related to the U-1 Garden Avenue remediation, such as the incorporation of the Puget Western parcel into the site boundary.

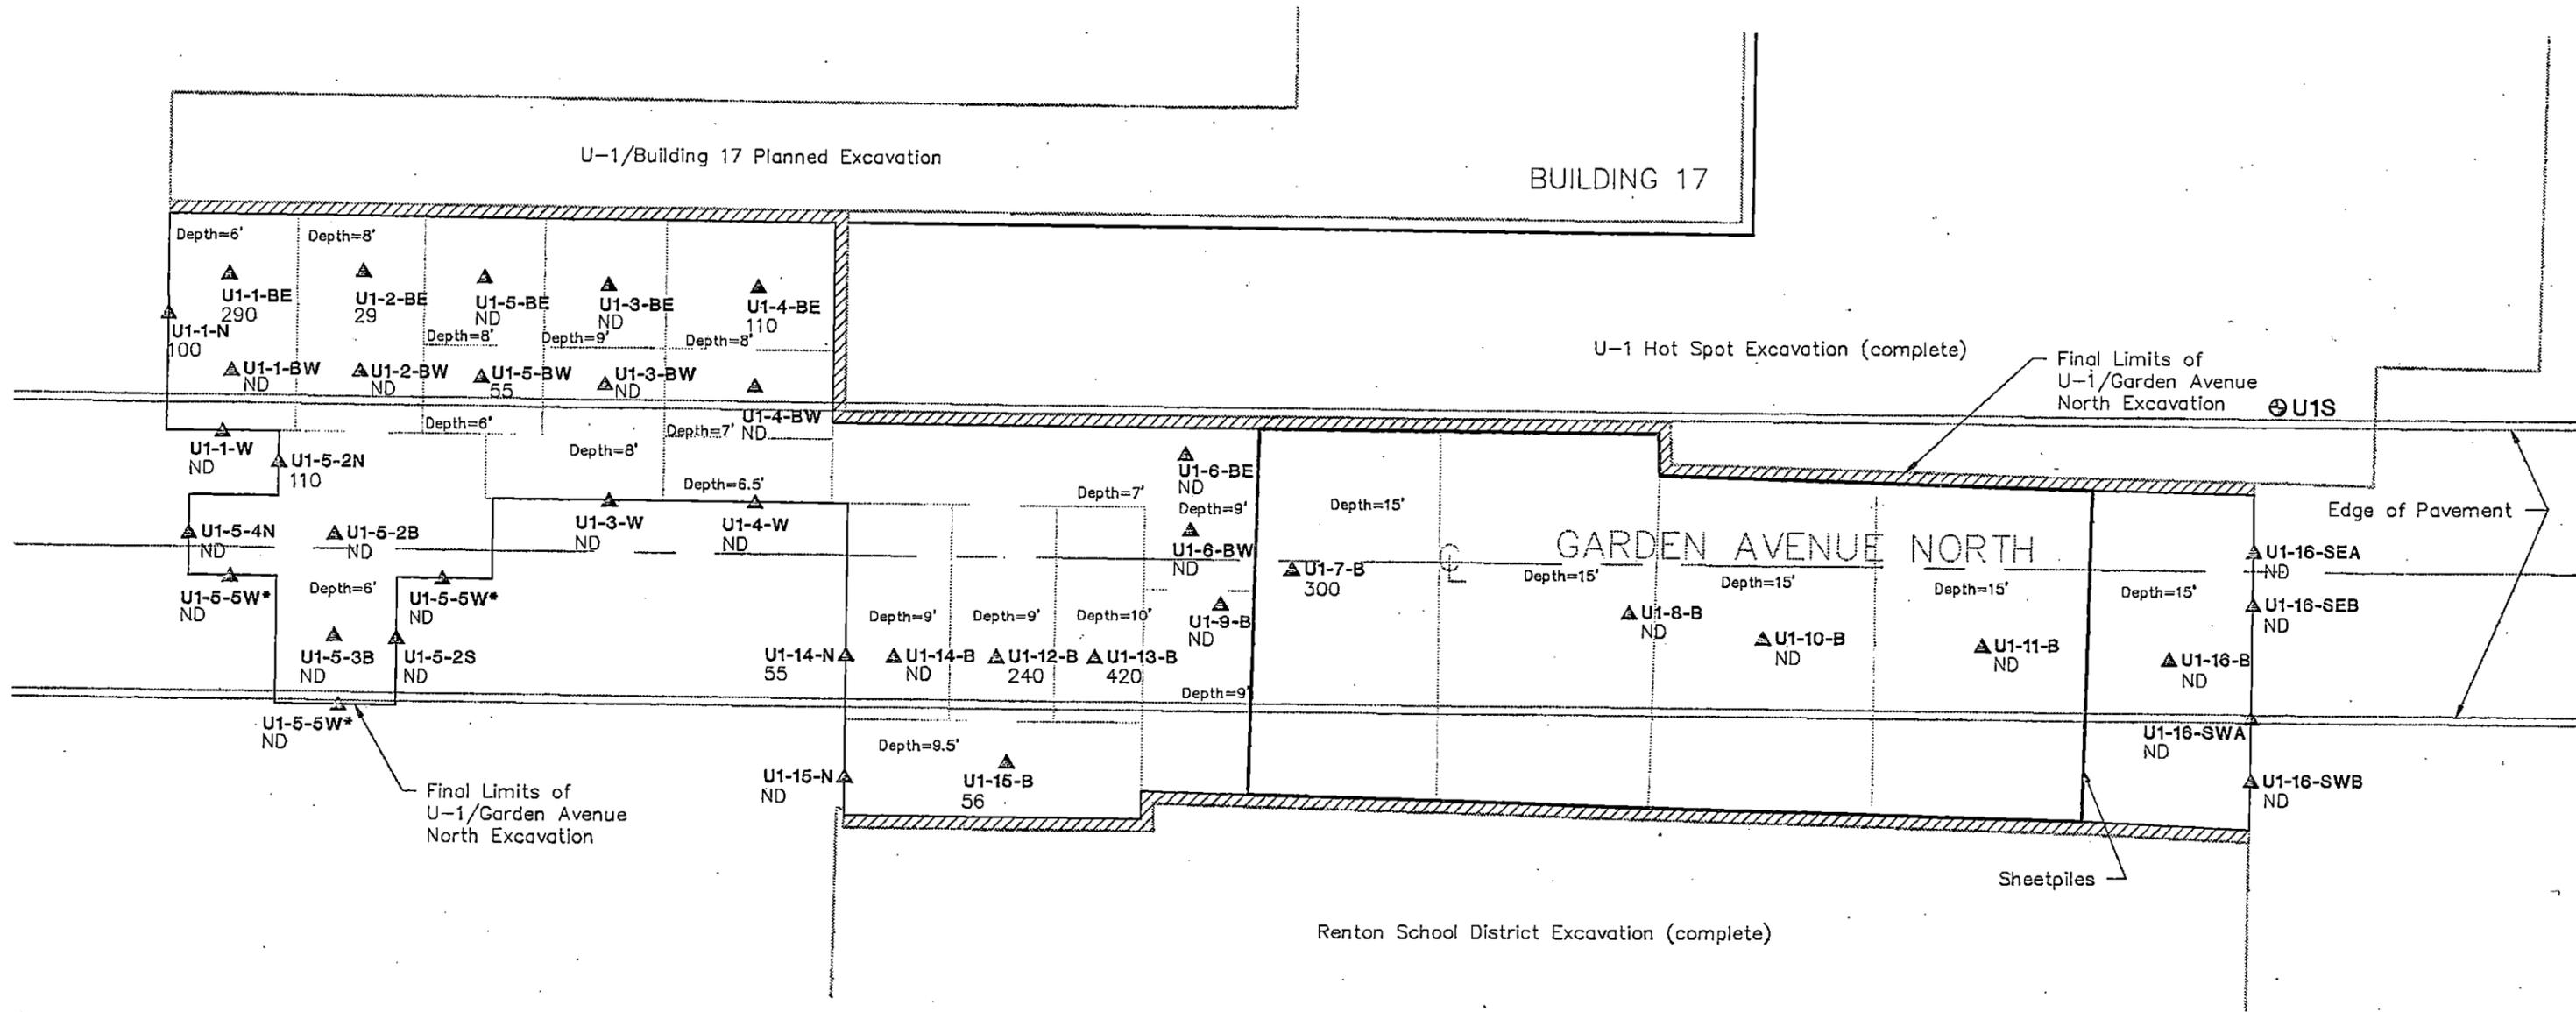
Excavation and Sampling As-Built Plan

Verification sample locations and designations for excavation side walls and bottoms which are less than the TPH HSAL for this site are shown on Figure 3 and listed in Table 1.

Note: Not shown are the side wall and bottom samples not used for final verification purposes (i.e., above the cleanup level: 200 mg/kg from 0 to 8 feet and 2,500 mg/kg from 8 to 15 feet)

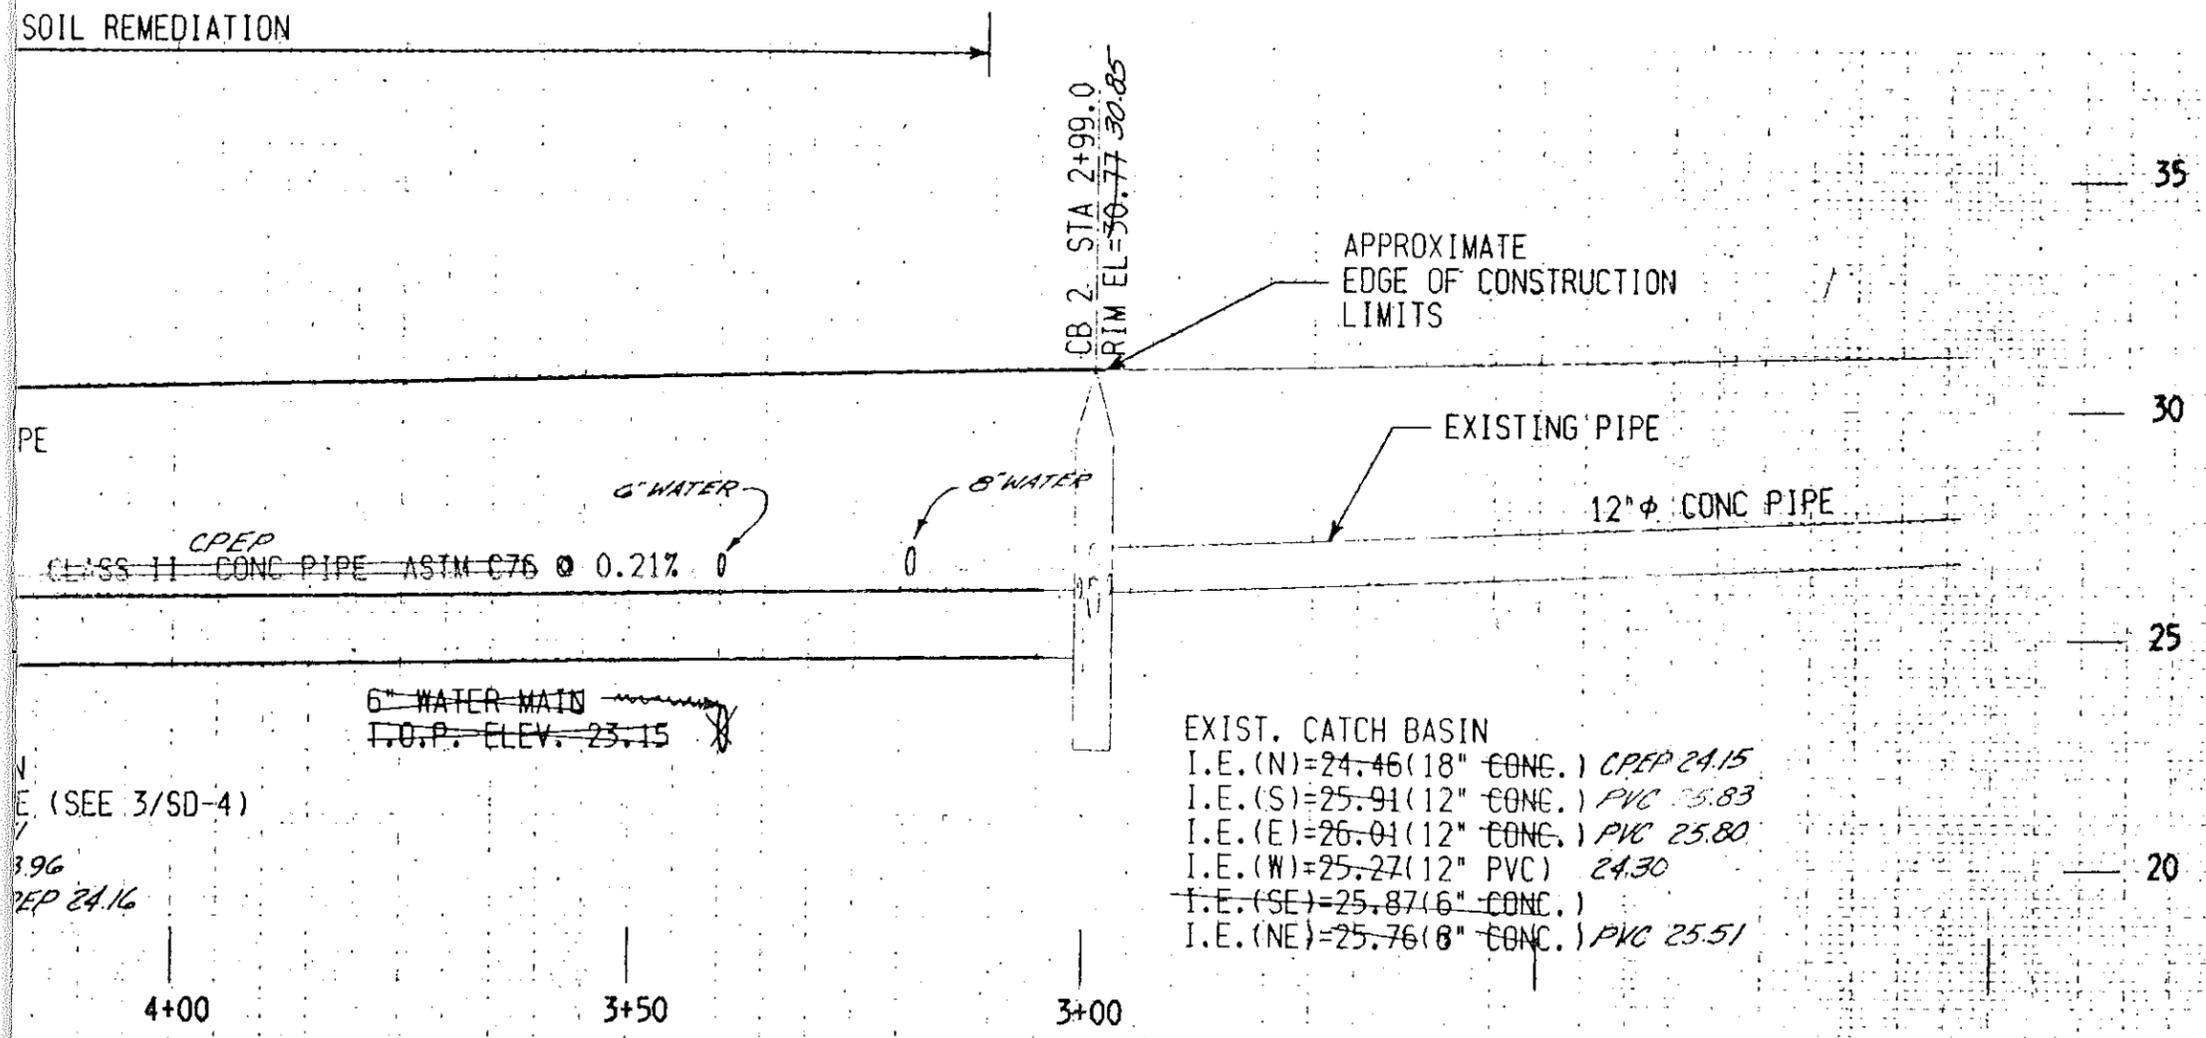
REMOVE AND REPLACE EXISTING STORM LINE WITH NEW STORM LINE AS REQUIRED FOR SOIL REMEDIATION

18-inch Storm Drain. A 170-foot-long section of an 18-inch-diameter storm drain running parallel and approximately 5 feet below Garden Avenue North were demolished and replaced. The former concrete pipe was replaced with new 18-inch-diameter double-walled corrugated polyethylene pipe (CPEP), to matching grade. The CPEP was substituted for concrete pipe by Wilder and with concurrence by Renton.

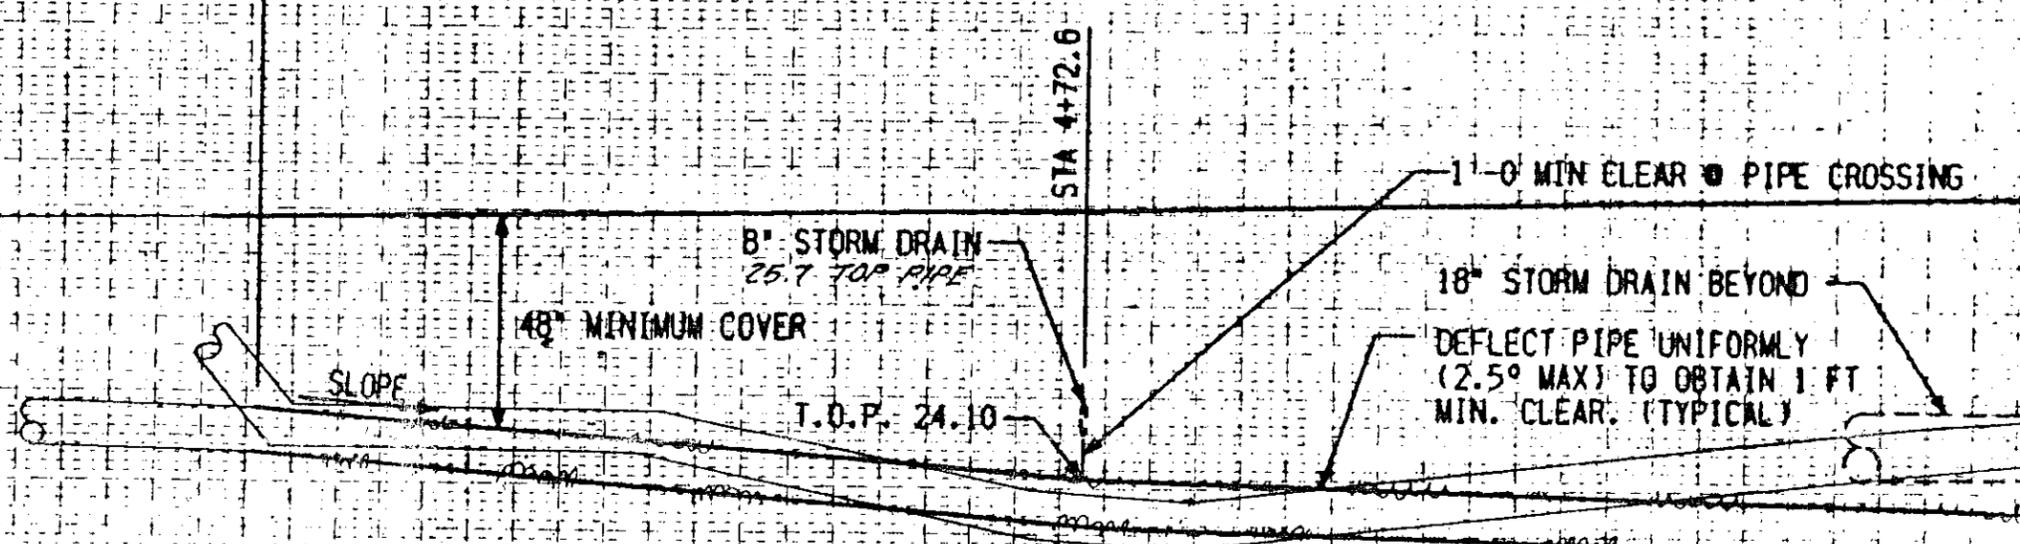
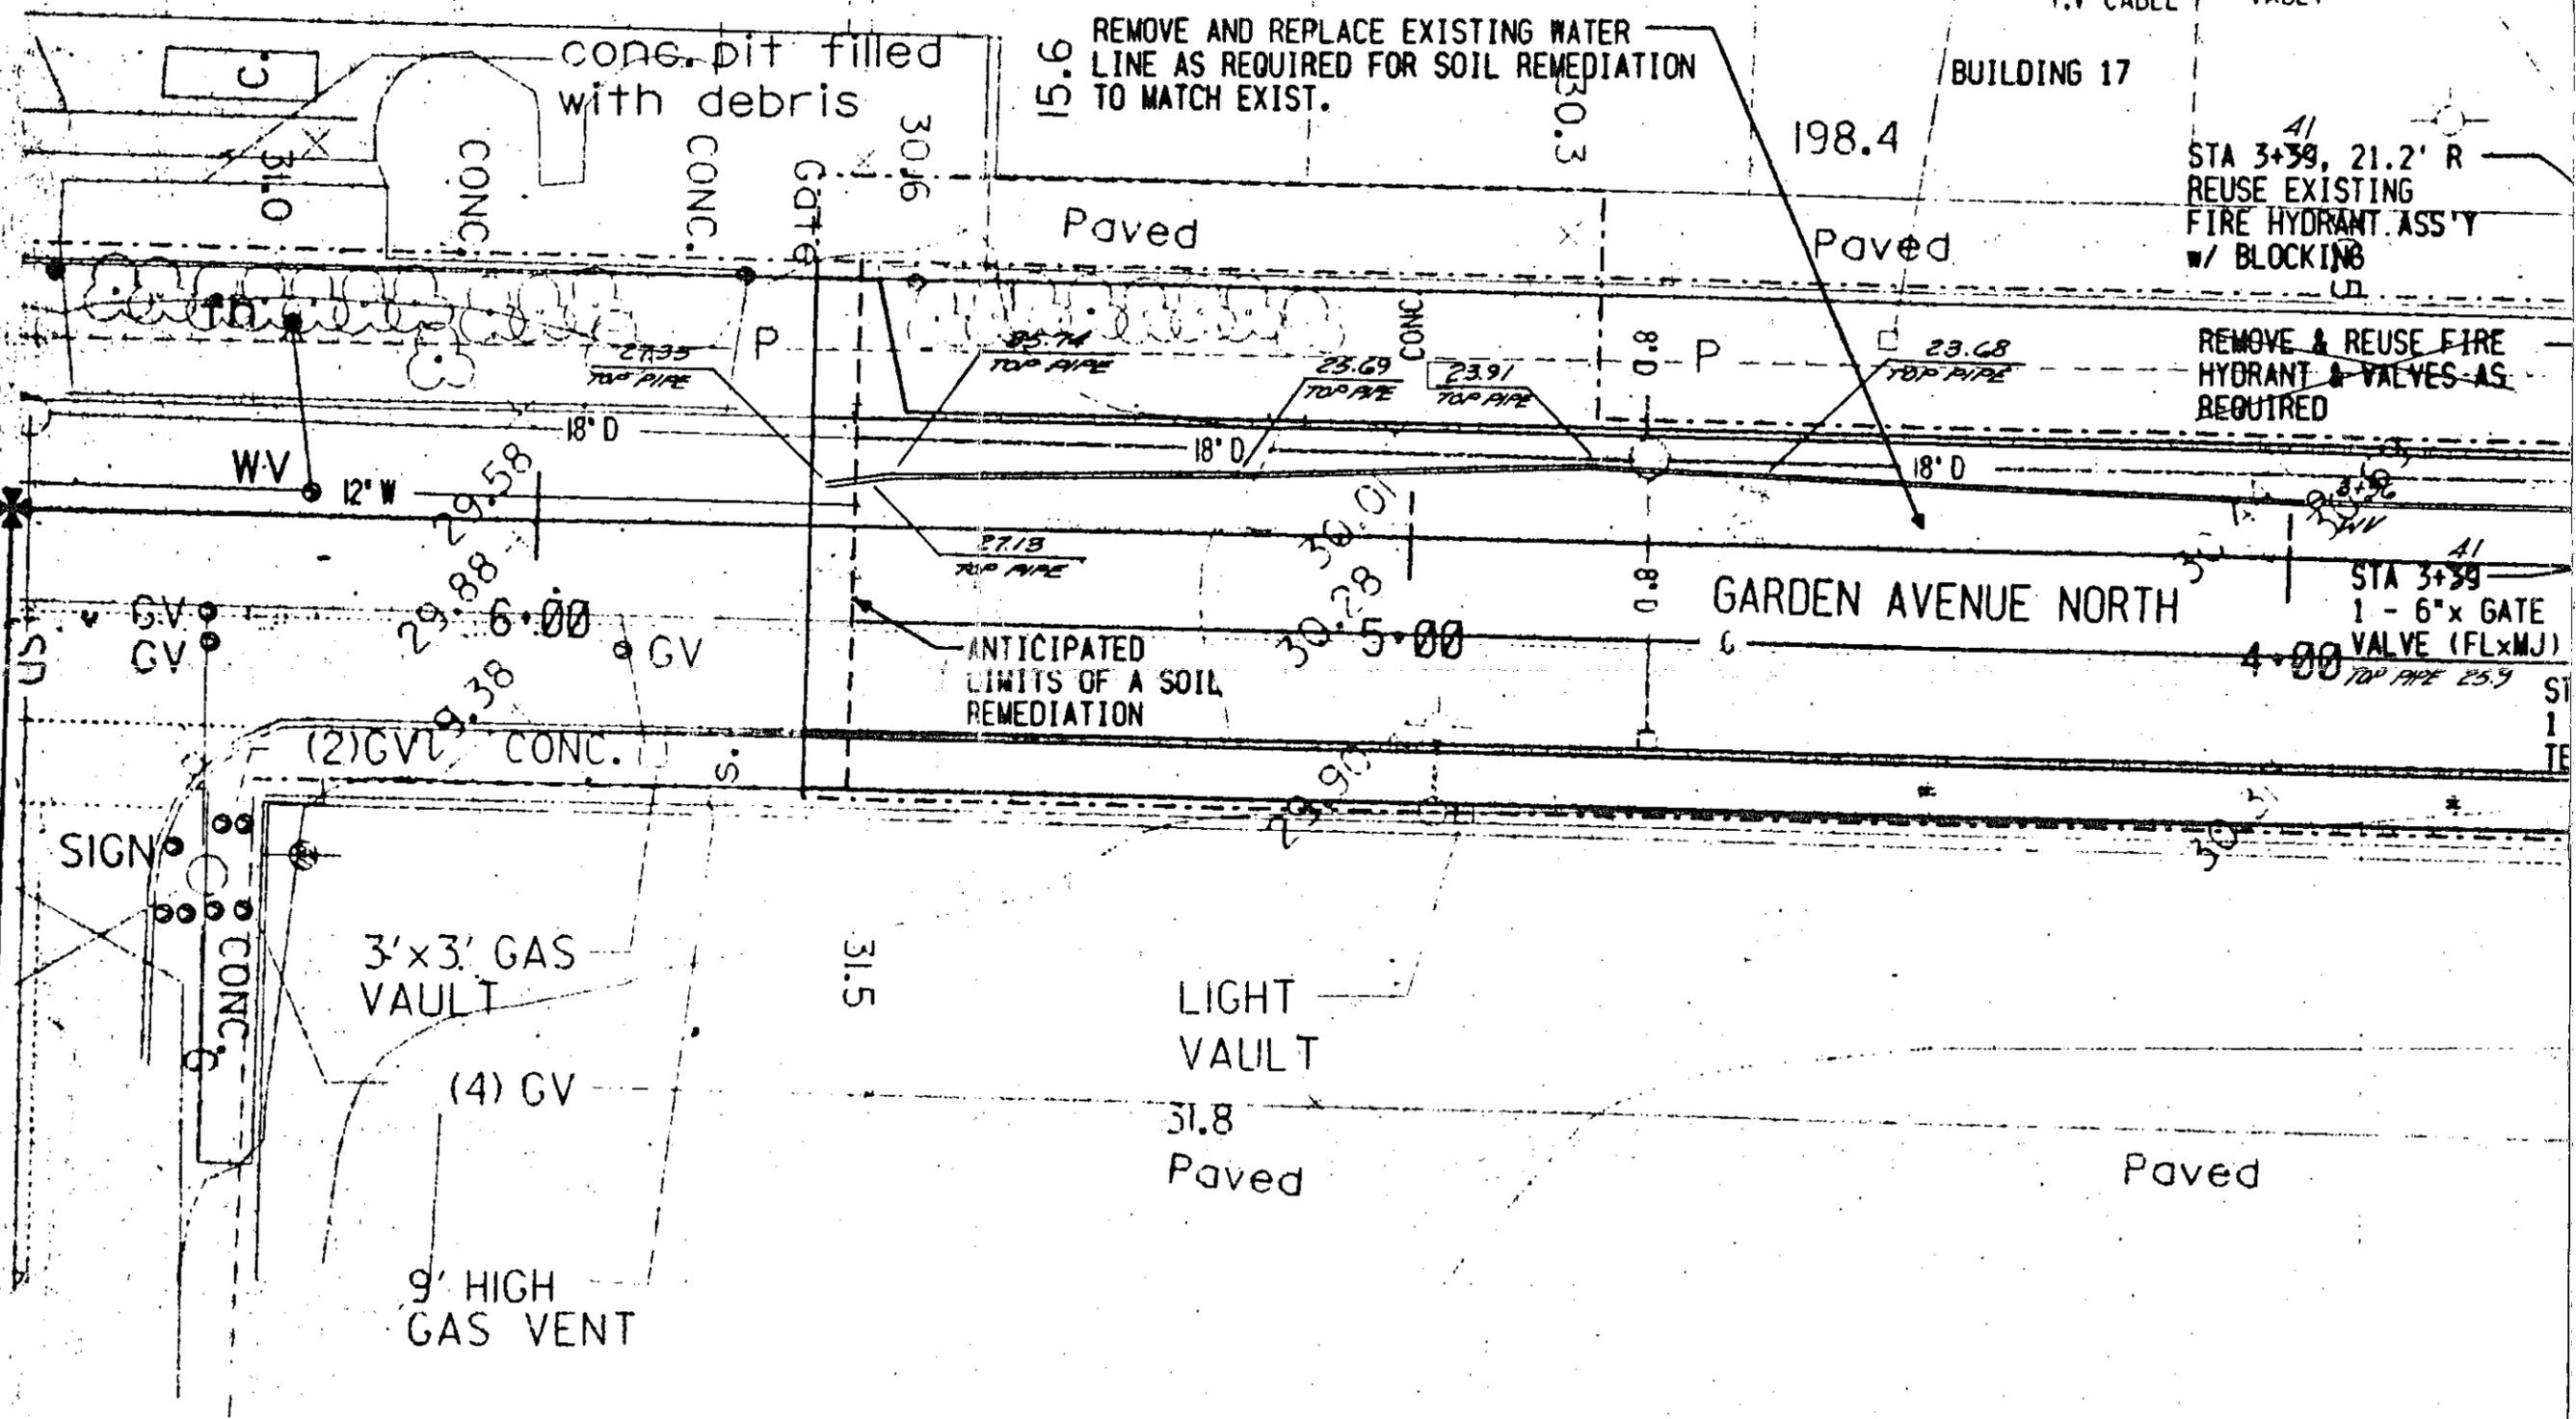
WATER LINE PROFILE

REMOVE AND REPLACE EXISTING WATER
LINE AS REQUIRED FOR SOIL REMEDIATION
TO MATCH EXIST.

12-inch Water Line. A 250-foot-long section of an 12-inch-diameter water line running parallel and approximately 2 feet below Garden Avenue North were demolished and replaced. The former transite pipe was replaced with new 12-inch-diameter ductile iron pipe, to grades as shown in the plans. In order to reach the minimum 48-inches of cover above the replacement line, 45-degree vertical bends were placed at the connection points per the direction of and with concurrence by Renton. The demolished transite pipe was saw cut and buried in place as part of the backfill of the new pipe, in accordance with PSAPCA requirements.
