STATE OF WASHINGTON  
DEPARTMENT OF ECOLOGY

**Re: No Further Action Likely opinion for the following Site:**

<b>Site Name:</b>	Markey Machinery 8th Avenue
<b>Site Address:</b>	7266 8th Ave S, Seattle, King County, WA 98108
<b>Cleanup Site ID:</b>	14476
<b>Facility/Site ID:</b>	52231
<b>VCP Project ID:</b>	NW3187

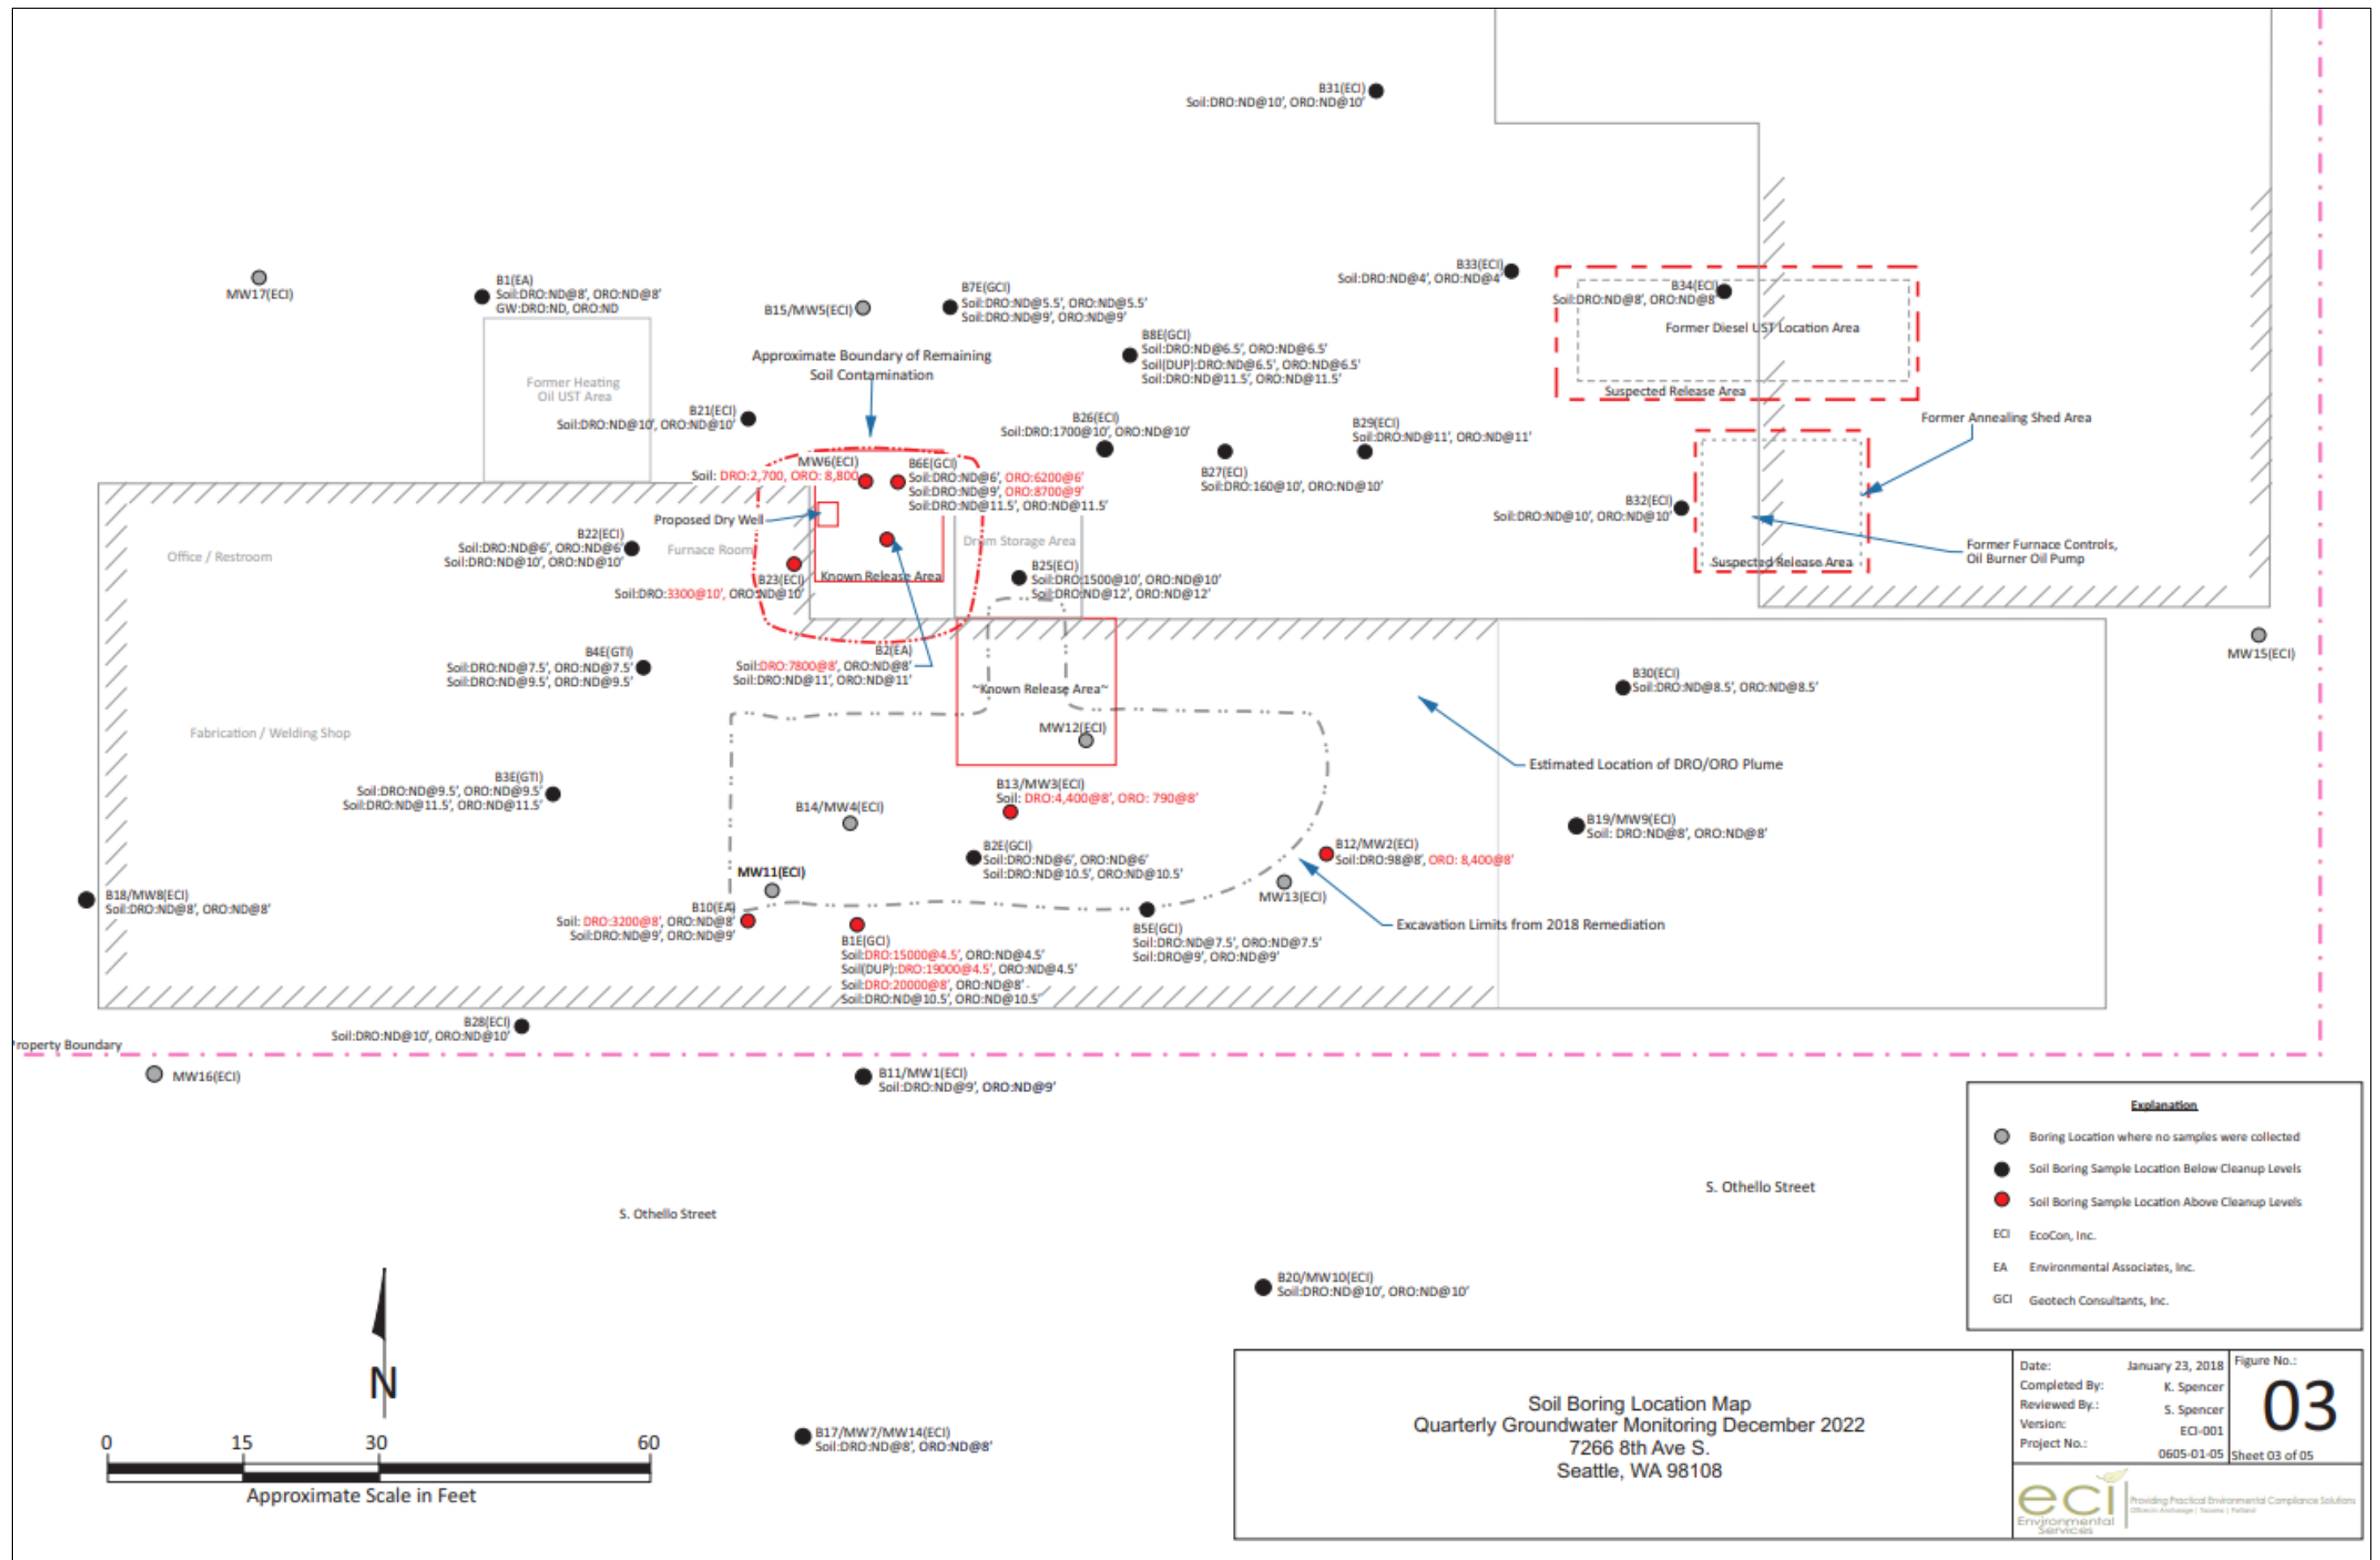
In summary, ECI determined petroleum-contaminated soils (PCS) and petroleum-impacted groundwater is present on-Site above the respective MTCA Cleanup Levels (CULs). Figures 2 and 3 illustrate the estimated extent of petroleum-contaminated soil and groundwater on-Site. A detailed rendition of the following characterization activities is presented in Enclosure A.

Ecology has concluded that the investigations of soil have sufficiently characterized the nature and extent of contamination for the Site, and no further investigation is warranted (Figure 2).

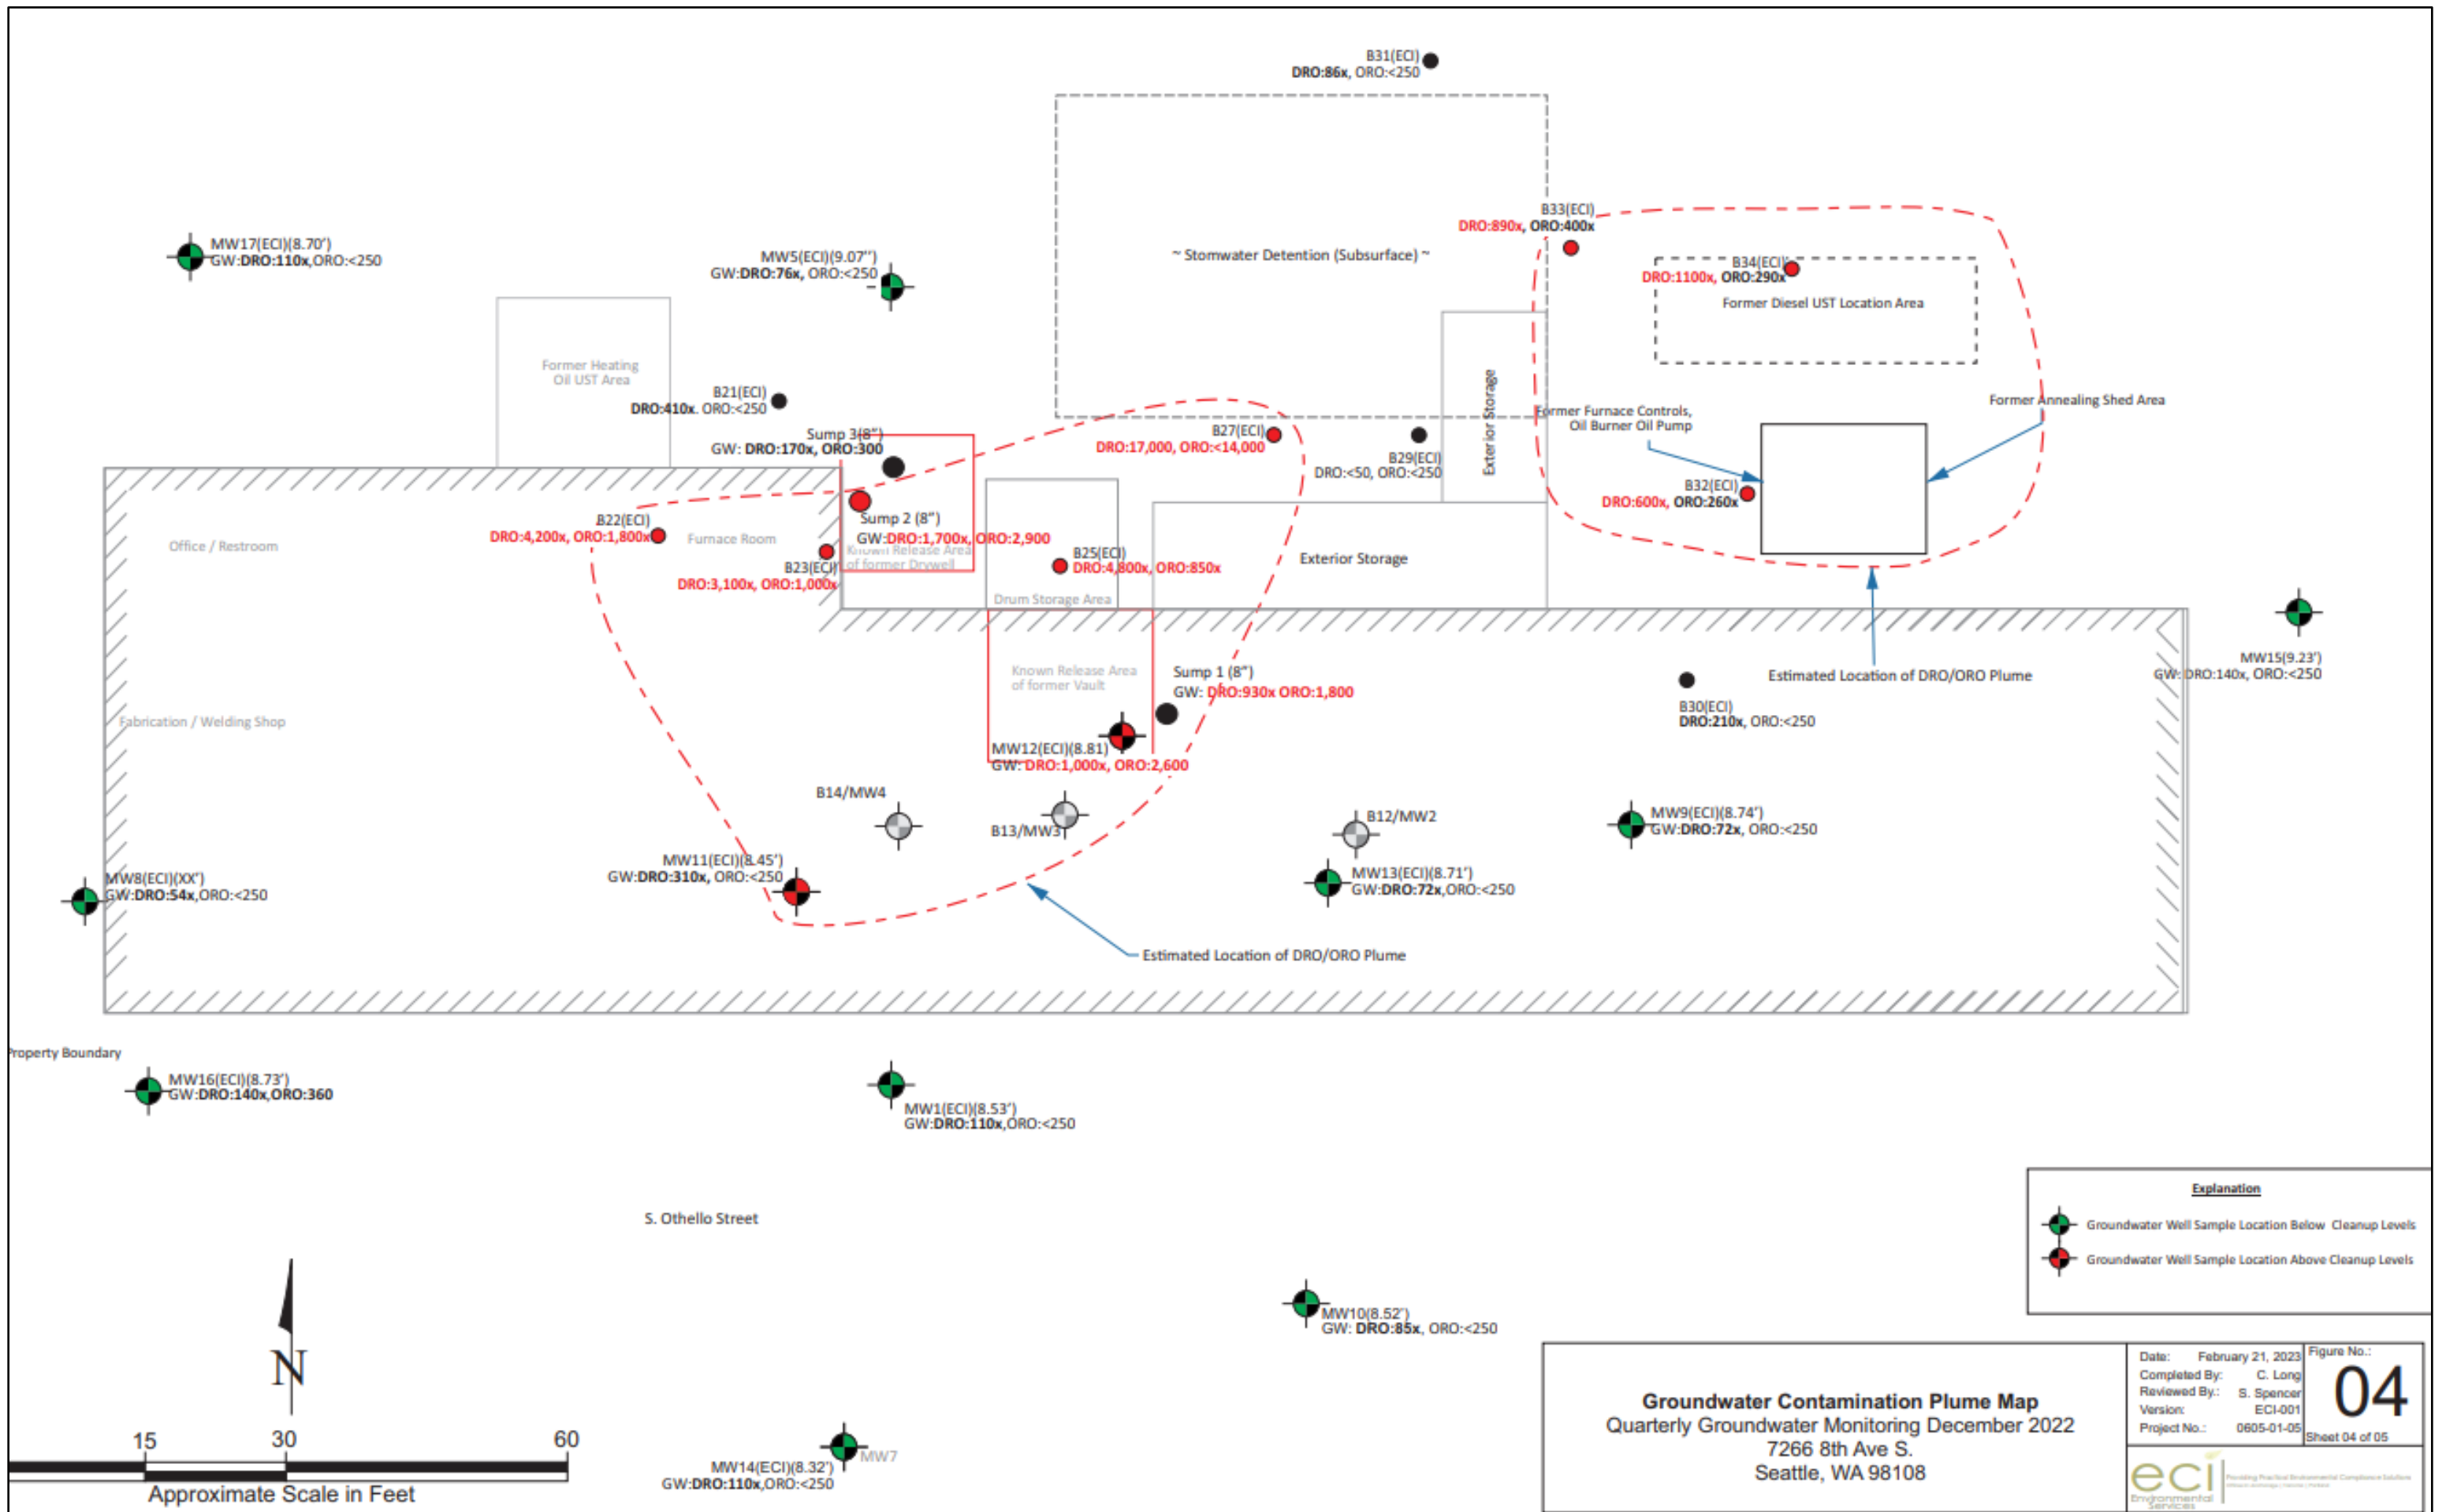
Figure 04, ECI – May 2023 ..... Groundwater Contamination Plume Map

Groundwater is impacted with TPH-Dx and -HO above cleanup standards. ECI successfully characterized the extent of groundwater contamination and is exhibited in Figure 3.

On-Site soil and groundwater are impacted with Total Petroleum Hydrocarbons-Diesel Range (TPH-Dx) and Total Petroleum Hydrocarbons Heavy Oil-Range (TPH-HO) above the respective MTCA Method A cleanup levels (CULs). Light non-aqueous phase liquids (LNAPL)/free product has historically been observed in multiple monitoring wells, specifically, MW-6, -12/Sump nos. 1 and 2.
