**First Quarter 1998  
Operation and Maintenance  
Summary and Groundwater  
Sample Results**

**Biovent System, Nikkei manor  
Seattle, Washington**

April 1998

**RE: OPERATION AND MAINTENANCE SUMMARY AND APRIL 1998  
GROUNDWATER SAMPLE RESULTS FOR BIOVENT SYSTEM, NIKKEI  
MANOR - ASSISTED LIVING FACILITY, SEATTLE, WASHINGTON**

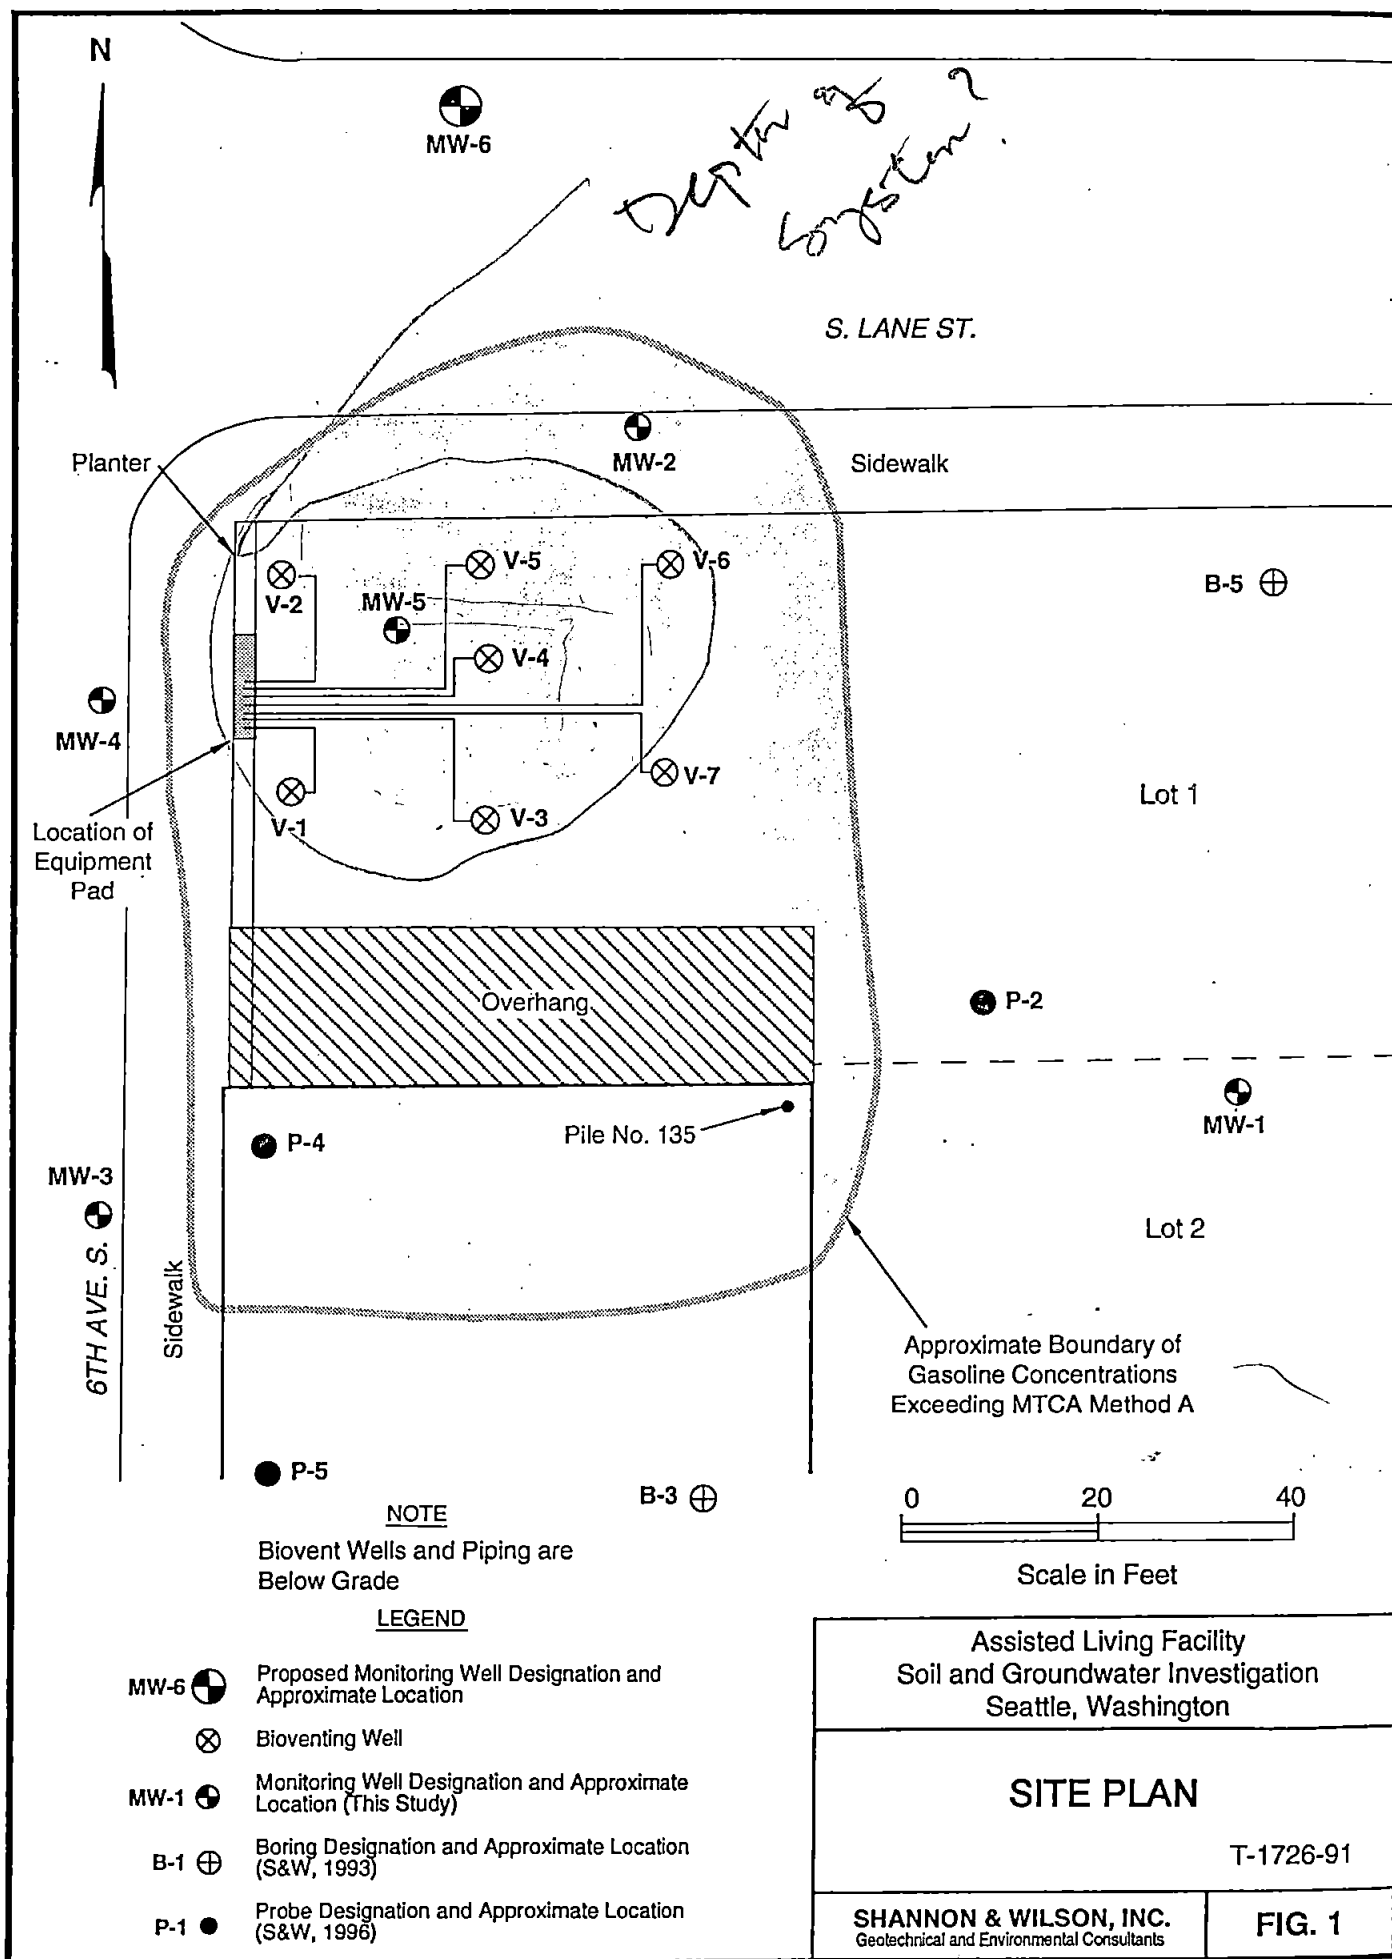
*Depth of  
contamination?*

Approximate Boundary of  
Gasoline Concentrations  
Exceeding MTCA Method A
