**Enhanced *In Situ* Bioremediation Progress Report
November 2022
402 North Meridian
Puyallup, Washington**

November 16, 2022

Date: November 16, 2022
Project No.: 1706001.010
File path: P:\1706\001\R\EISB Progress Reports\EISB Progress Report – Nov 2022
Project Coordinator: Christopher C. Young

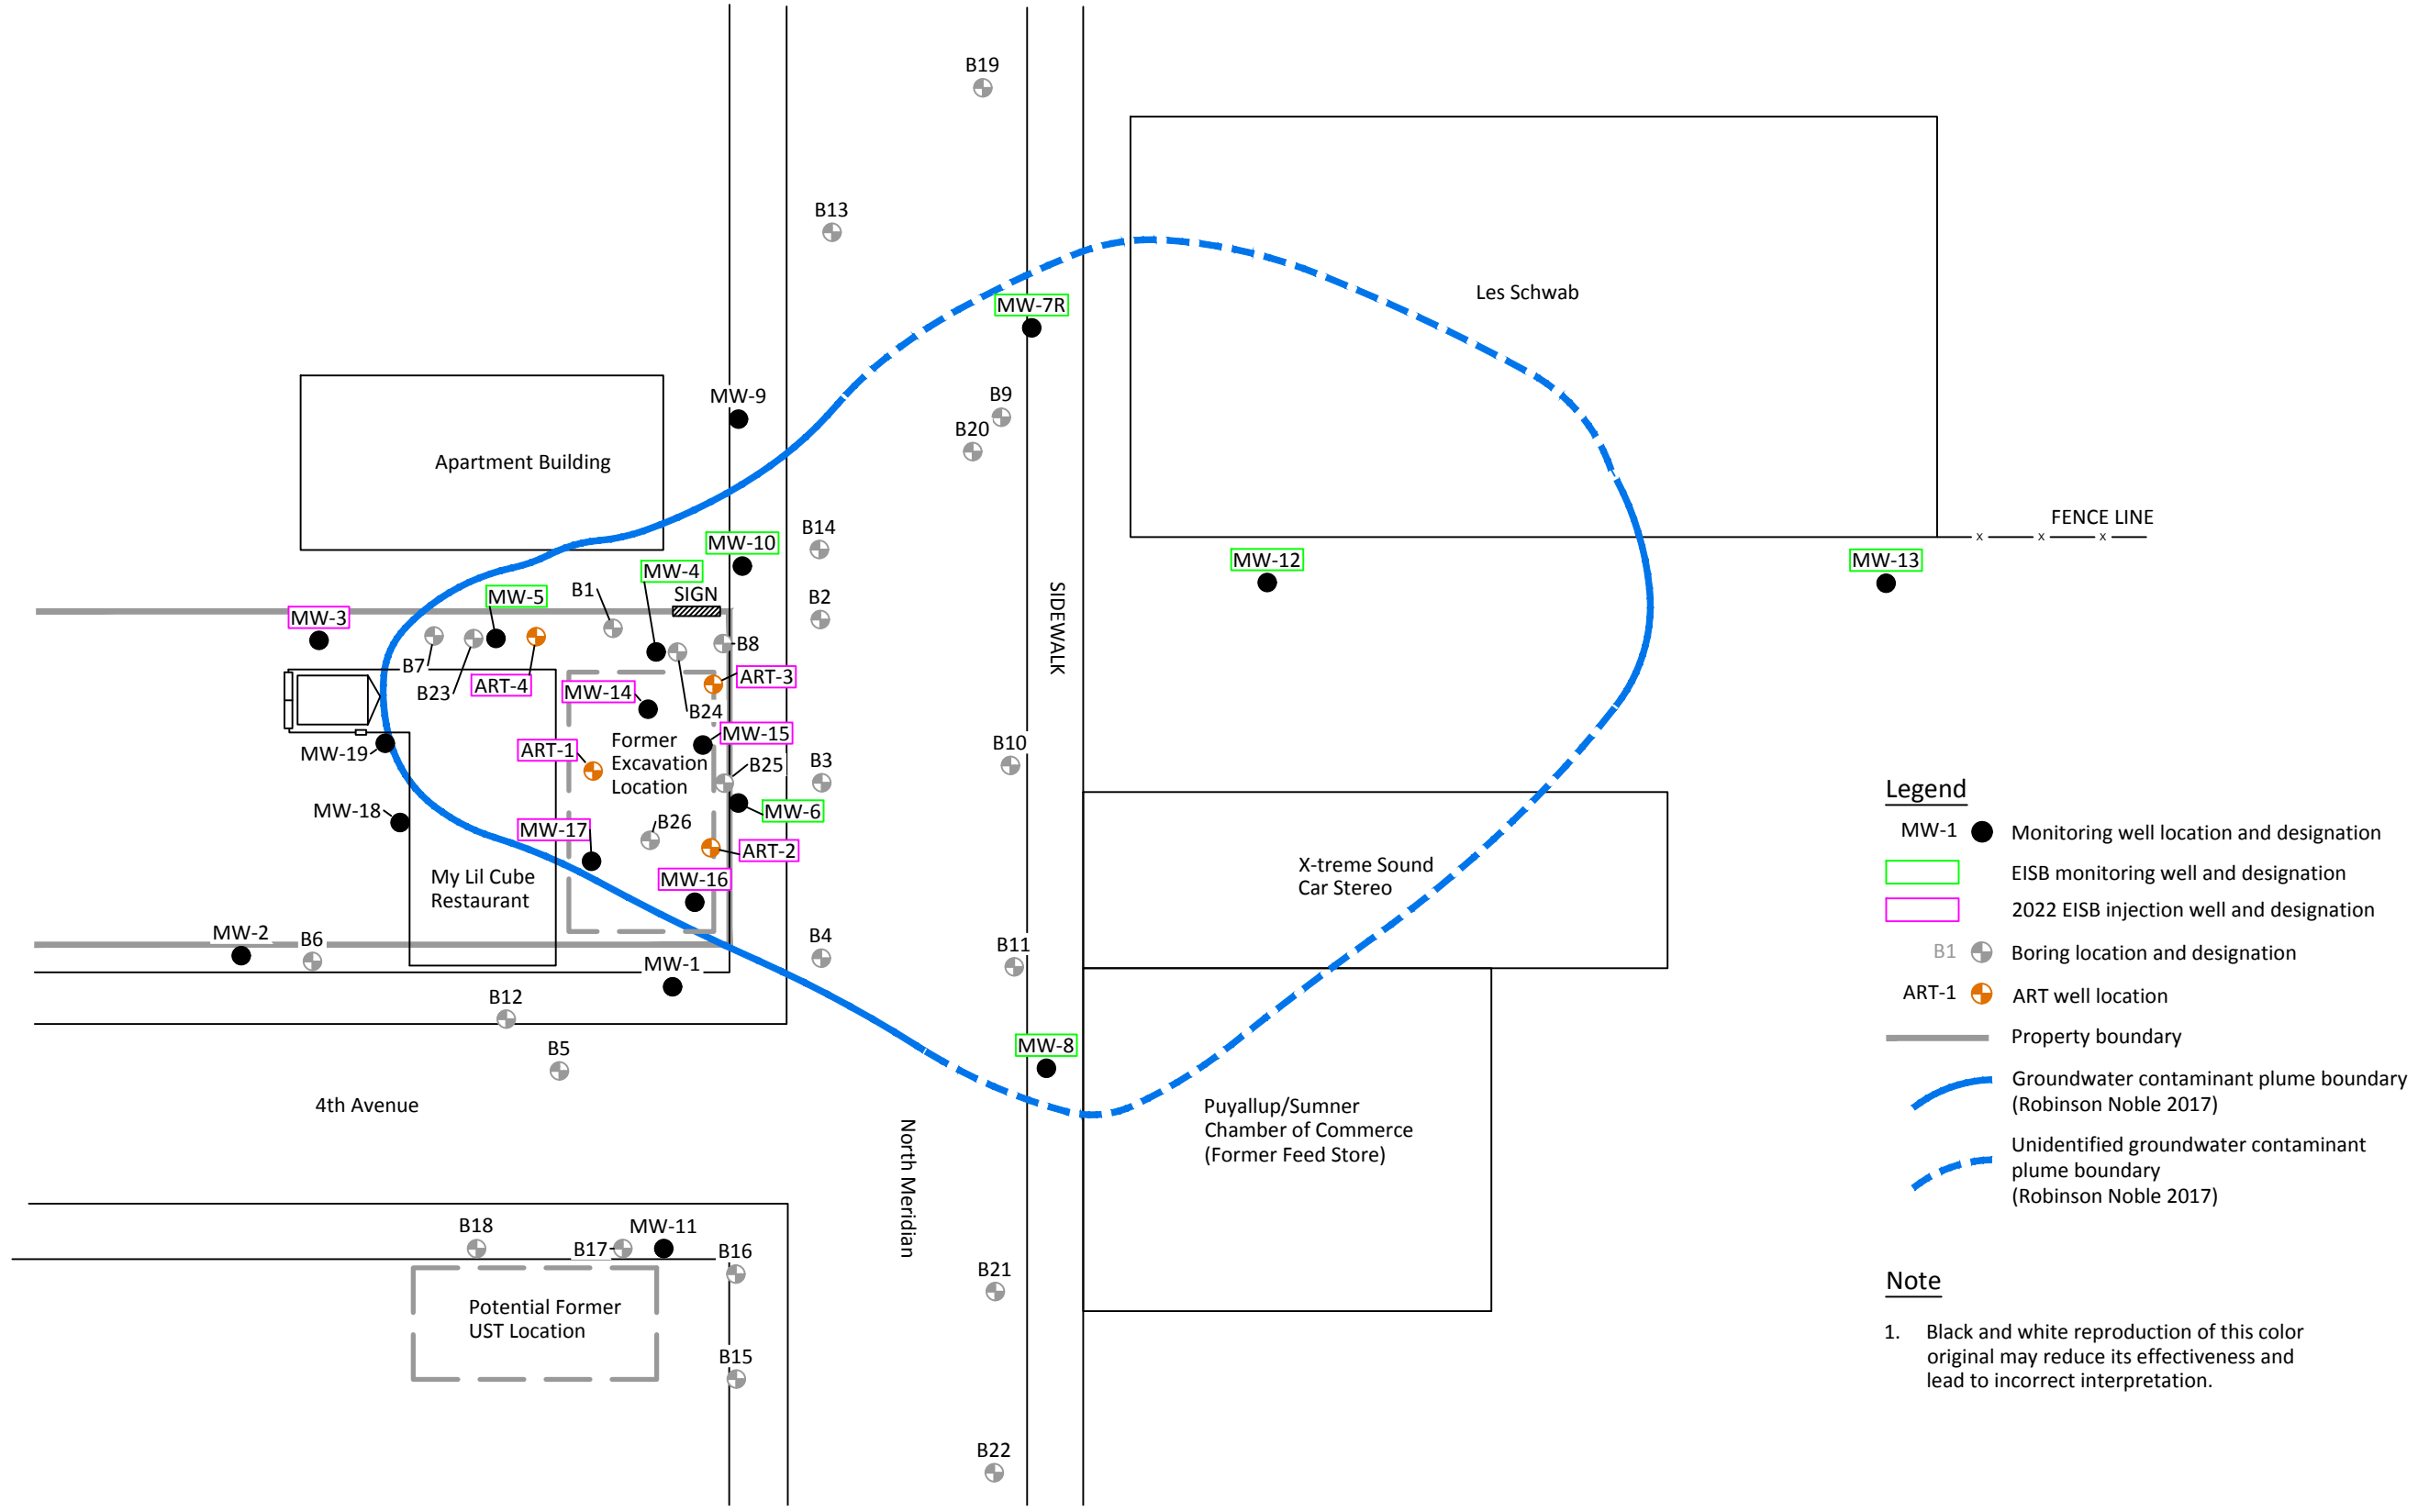
Figure
2

**EISB Injection and
Monitoring Wells**

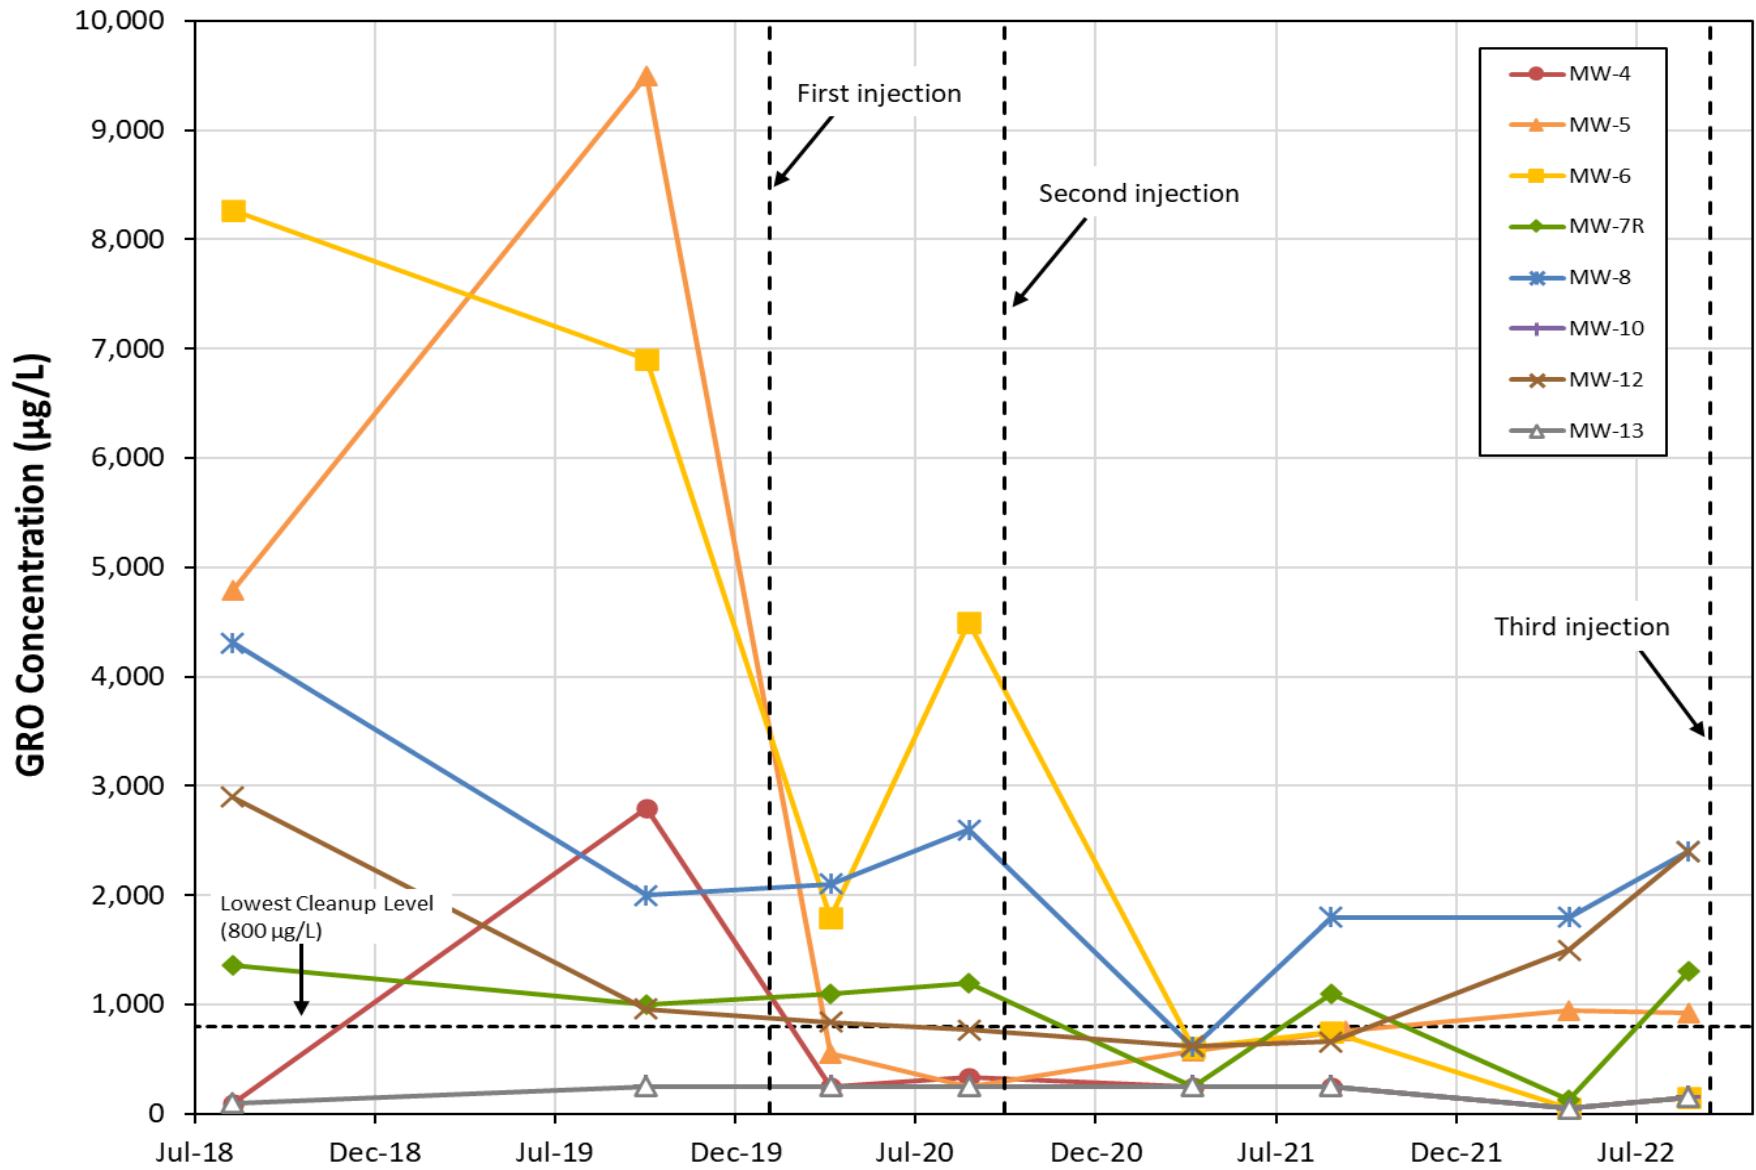
The fifth round of performance groundwater monitoring was conducted in April 2022, approximately 18 months after the second ORC injection at the site. GRO concentrations remained stable or decreased at MW-4, MW-6, MW-7R, MW-8, MW-10, and MW-13 between fourth- and fifth-round performance monitoring, and GRO concentrations increased at MW-5 and MW-12. For fifth-round performance groundwater sampling, results exceeded MTCA Method A CULs at MW-5 (on the Property), and MW-8 and MW-12 (located downgradient of the Property). DO concentrations remained high at wells located on the Property, and also remained relatively stable for wells located downgradient from the Property.

The sixth round of performance groundwater monitoring was conducted in August 2022, nearly 2 years after the second ORC injection at the site. GRO concentrations showed slight to moderate increases at most wells, including MW-4, MW-5, MW-7R, MW-8, and MW-12. The GRO concentrations at MW-6, MW-10, and MW-13 were not detected above laboratory reporting limits, which is consistent with the previous sampling results. The maximum detected GRO concentration for sixth-round sampling was 2,400 µg/L at MW-8 and MW-12. DO concentrations decreased somewhat at all site wells except for MW-13, where a significant increase in DO was observed. The third ORC injection occurred after sixth-round performance groundwater sampling.

All monitored wells have exhibited an overall decrease in GRO concentrations since baseline sampling was conducted in August 2018. Prior to the first injection, five wells (MW-4, MW-5, MW-6, MW-8, and MW-12) exceeded the MTCA Method A CUL for GRO (800 µg/L with detectable benzene present). After the first injection, concentrations of GRO remained above CULs at four wells (MW-6, MW-7R, MW-8, and MW-12). Wells MW-4, MW-5, and MW-6 near the former excavation showed the most significant decreases in GRO concentration, indicating that emplaced ORC was effective at stimulating aerobic biodegradation of the remaining GRO mass. As expected, the greatest reduction in contamination levels occurred at wells located on the Property and the least reduction occurred in the downgradient off-Property wells. The three wells that had concentrations of GRO above CULs following the first injection (MW-6, MW-8, and MW-7R) had a slight increase in GRO concentrations prior to the second ORC injection; the second injection was well-timed to prevent rebound in GRO concentrations at the other monitoring wells.

Performance groundwater monitoring in April 2021 following the second ORC injection showed that GRO concentrations at all wells had decreased to below MTCA Method A CULs. In August/September 2021, GRO concentrations at two off-Property wells (MW-7R and MW-8) re-established to a level exceeding MTCA Method A CULs. Concentrations of GRO remained relatively stable between August/September 2021 and April 2022, and then GRO concentrations increased slightly in August 2022. GRO concentrations in monitoring wells located within the limits of the Property remained below MTCA Method A CULs at all locations except for MW-5.

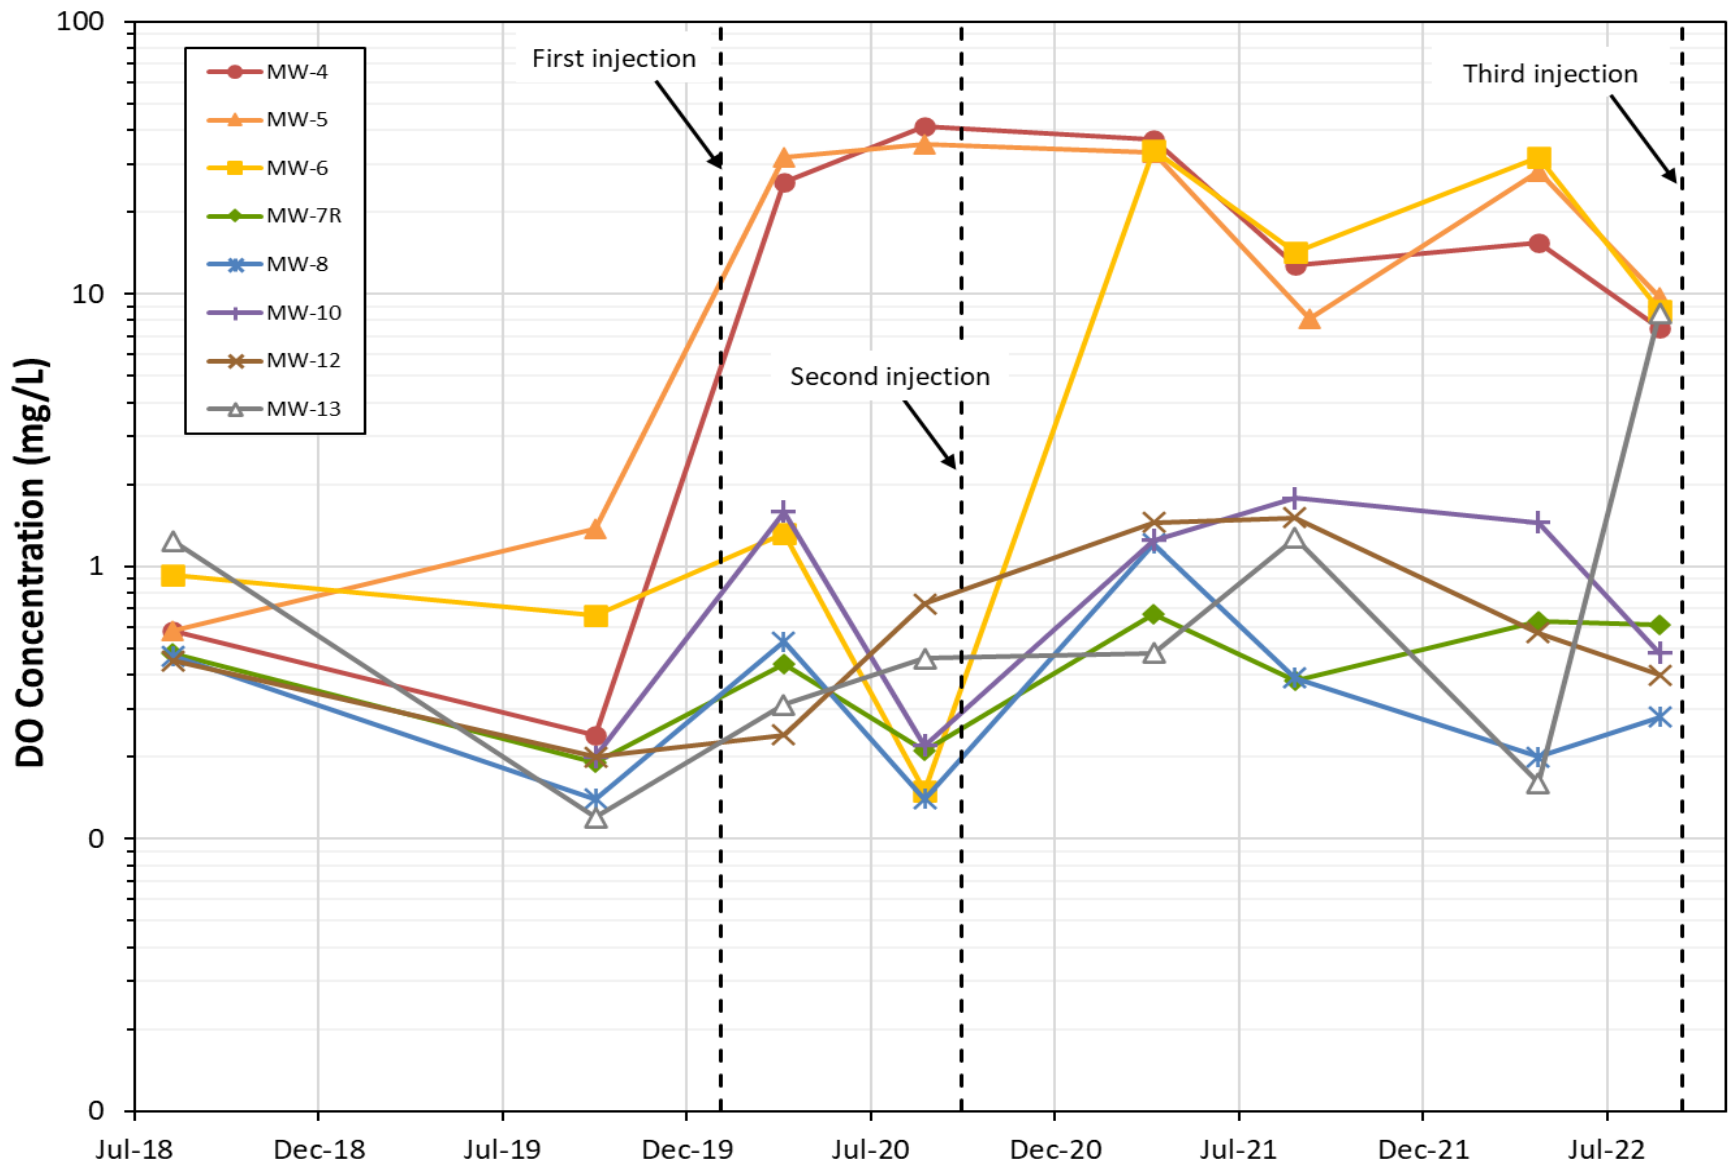
DO concentrations increased at all monitored wells following the first ORC injection. The most significant increases initially occurred at MW-4 and MW-5 near the former excavation; DO concentrations at these two wells remained high prior to and following the second ORC injection. After the second ORC injection, a significant increase in DO concentration at MW-6 was observed. All other wells showed slight increases in DO concentrations following the second ORC injection. Where DO concentrations did not show a significant increase, this may indicate that DO is being consumed by bacteria as it becomes available for biodegradation. Over the period of 2 years following the second ORC injection, DO concentrations have generally fallen somewhat, but DO concentrations in on-Property wells remain significantly higher than baseline conditions.
