# INITIAL INVESTIGATION FIELD REPORT

<u>Site Name (Name over door):</u> 503 Bella St	<u>Site Address (including City, State and Zip):</u> 503 Bella St Sedro Woolley, WA 98284	<u>Phone</u> <u>Email</u>
<u>Site Contact, Title, Business:</u> Kim Eldridge, Town Treasurer Town of Hamilton	<u>Site Contact Address (including City, State and Zip):</u> 584 Maple Street (PO Box 528) Hamilton, WA 98255	<u>Phone</u> (360) 826-2882 <u>Email</u> info@townofhamiltonwa.com
<u>Site Owner, Title, Business:</u> Umpqua Bank	<u>Site Owner Address (including City, State and Zip):</u> PO Box 230727 Tigard, OR 97281	<u>Phone</u> (866) 486-7782 <u>Email</u>
<u>Site Owner Contact, Title, Business:</u>	<u>Site Owner Contact Address (including City, State and Zip):</u>	<u>Phone</u> <u>Email</u>
<u>Previous Site Owner(s):</u> Jordan D. Mayfield, owned 2016–2022	<u>Additional Info (for any Site Information Item):</u> The property was purchased by Umpqua Bank through a foreclosure auction on 10/7/2022.

<u>Alternate Site Name(s):</u> Mayfield Property / Umpqua Bank Hamilton

Investigator: Hannah K. Hennig

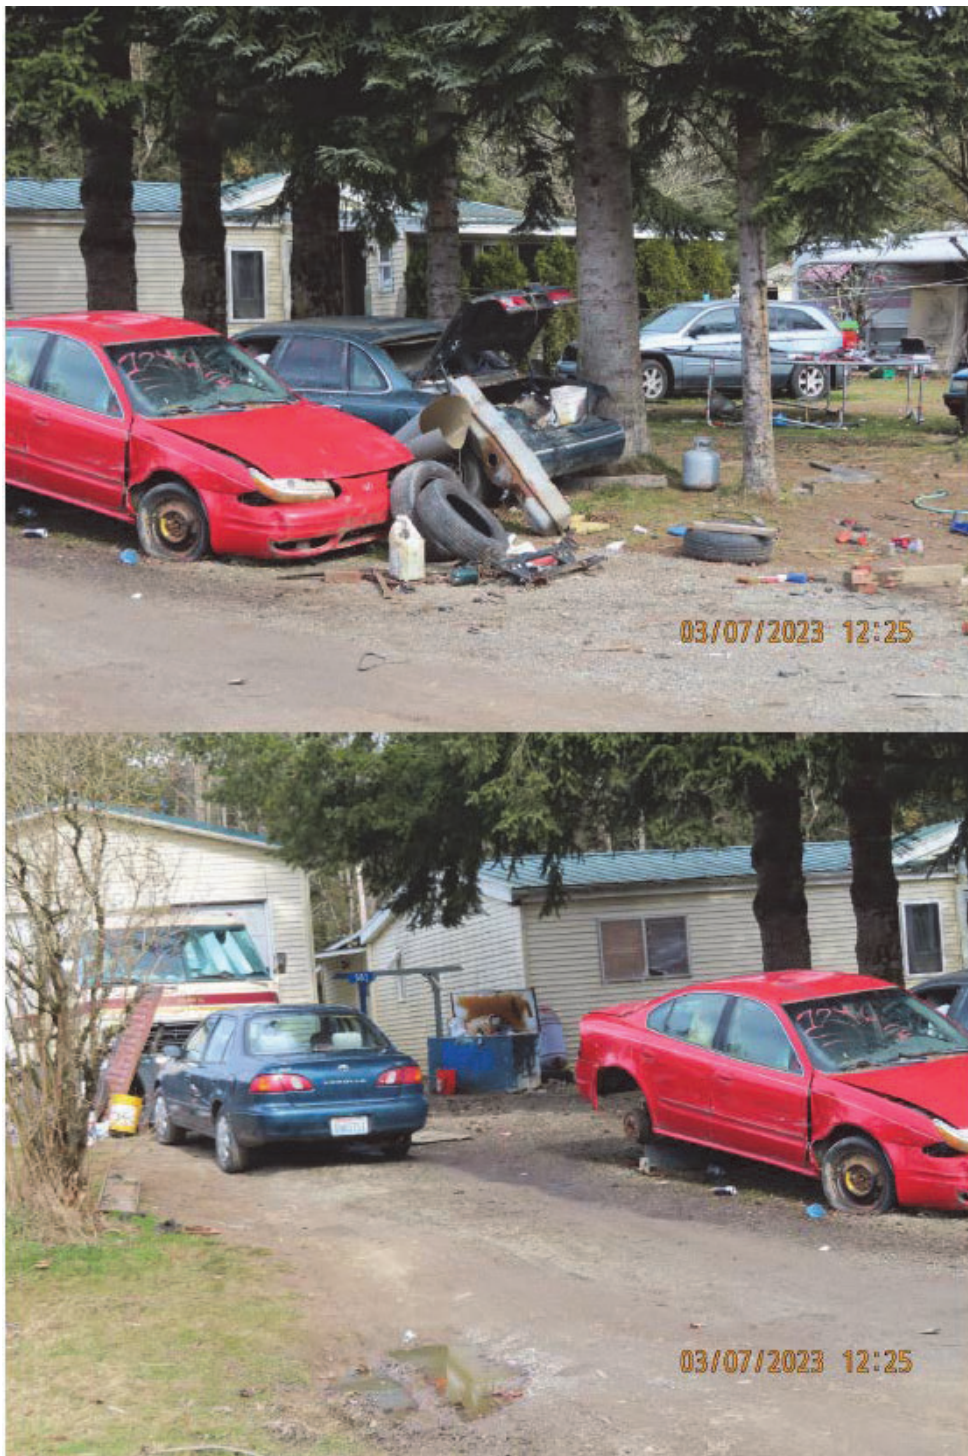
Ecology's Toxics Cleanup Program (TCP) spoke with the Town of Hamilton's Treasurer, Kim Eldridge, on March 3rd to get more information about potential soil contamination. Kim stated that she had not directly witnessed leaking vehicles, but received complaints about them from neighbors. She also shared that the current owner (Umpqua Bank) will have completed an eviction of the former tenants by March 14th. On March 28th, TCP received photos of the subject property from Skagit County's Environmental Health (Skagit EH) department, which documented the state of the property during their site visits on January 20th, February 13th and 27th, and March 7th (photos available in Skagit EH Photo Log). Skagit EH is overseeing cleanup enforcement actions related to septic and solid waste issues. In the photos from March 7th, soil appeared dry with a dark area consistent with petroleum staining near a stored car (Figure 3).

**Figure 3.** Possible soil staining near a red vehicle shown from two view points during Skagit EH's site visit on March 7th. Source: Dale Patrick, Skagit County Environmental Health.

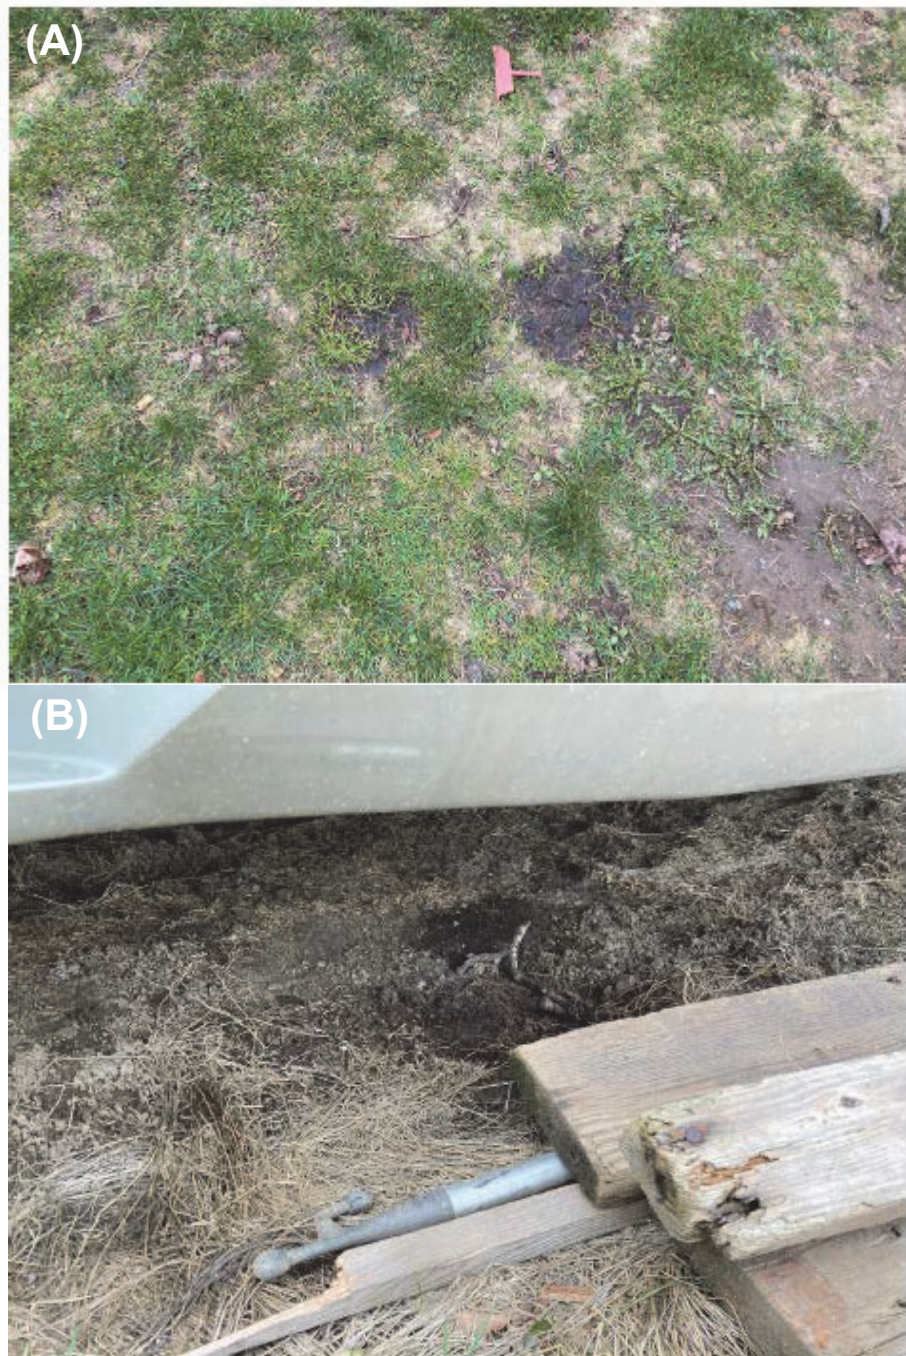
On April 5th, TCP accompanied Skagit EH on an unannounced site visit (photos available in Ecology Photo Log). Two RVs and several cars had been removed since March 7th, but otherwise the subject property appeared generally unchanged. At the time of the visit, it had not rained for approximately 48 hours; the soil and grass appeared dry with the exception of standing water in potholes along the roadway and south end of the driveway. A sheen was not observed on the standing water. Areas of stained soil were observed underneath an RV, two cars, and a riding mower; staining was also observed in open areas on the driveway and grass where vehicles may have been previously stored (Figures 4 and 5). Bottles of auto fluids were observed in multiple garbage piles, and stained gravel was observed beneath two bottles of engine oil (Figure 6).

**Figure 4.** Examples of small areas of stained soil in (A) an open grassy area and (B) underneath an RV stored on the subject property. Source: Ecology, 4/5/2023 site visit.

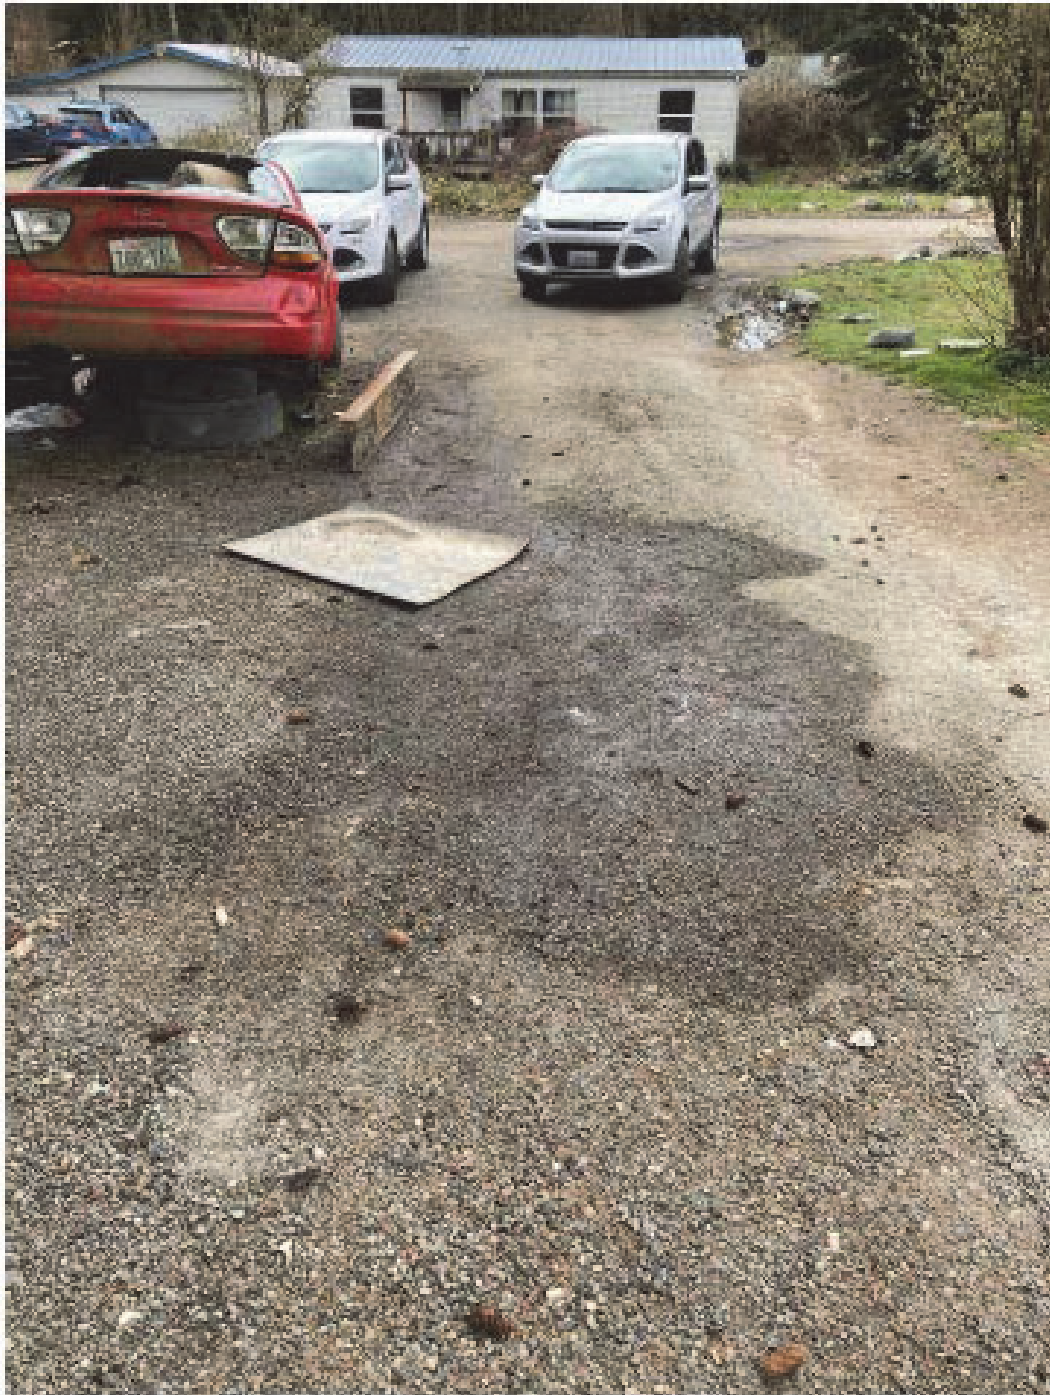
**Figure 5.** Soil/gravel staining. The area of staining near the bottom of the photo is located where a blue vehicle was observed during Skagit EH's previous visit (see Figure 3). Note: the white and silver vehicles near the top of the image are from Skagit EH and Ecology, not the property. Source: Ecology, 4/5/2023 site visit.

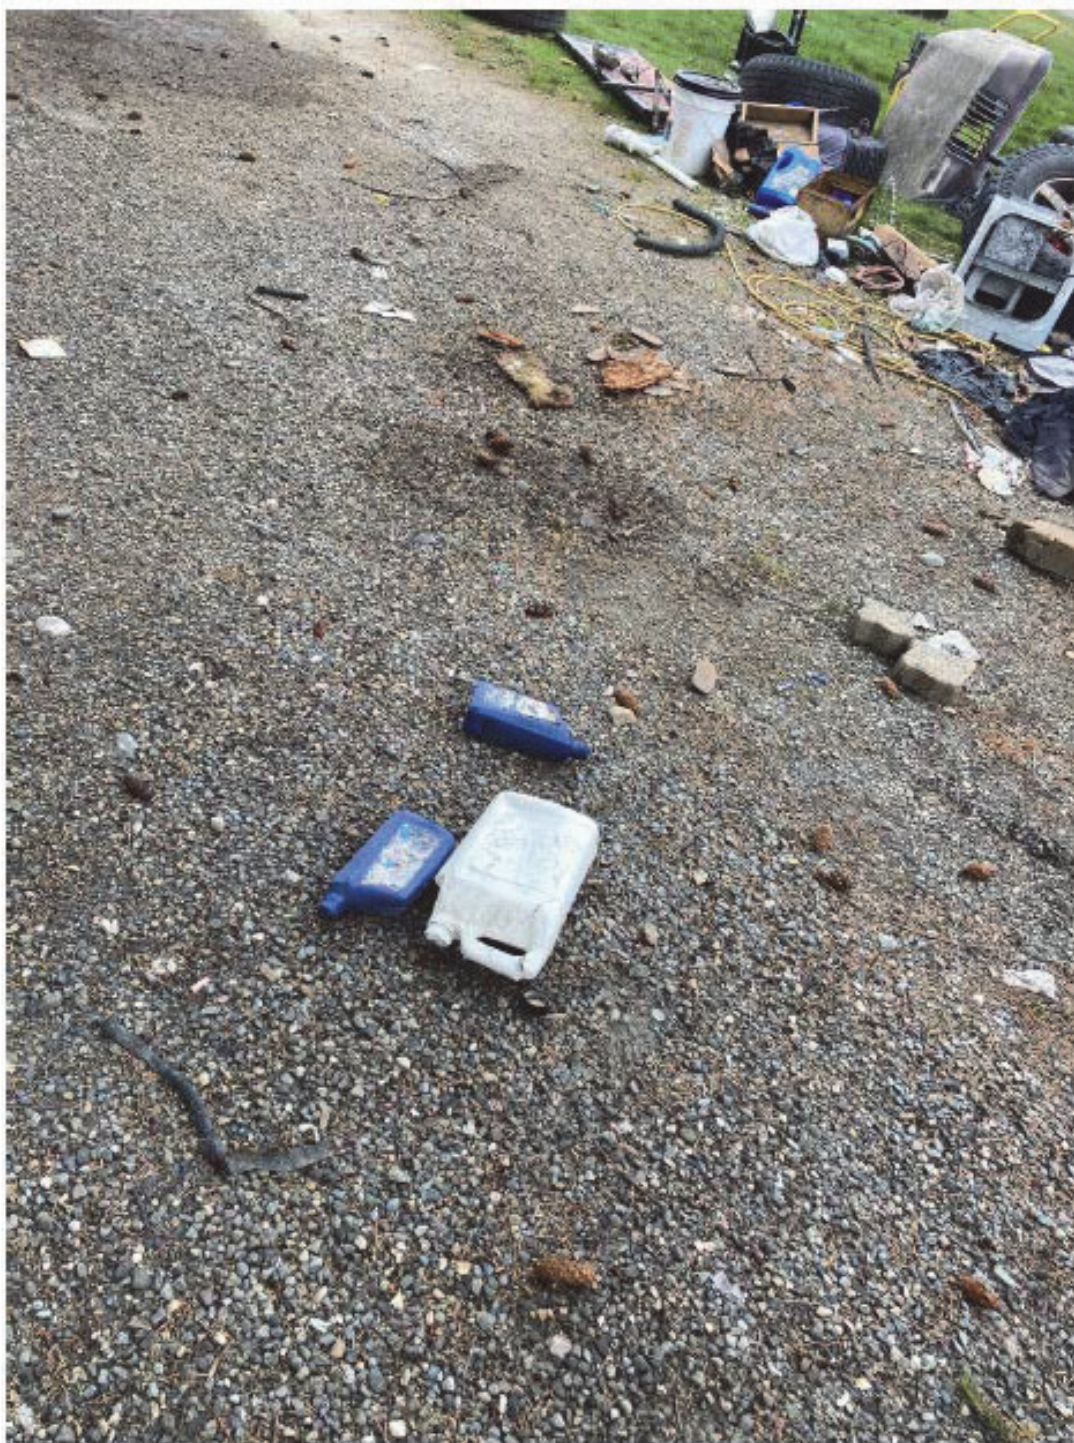
**Figure 6.** Bottles of engine oil and small areas of stained gravel. Source: Ecology, 4/5/2023 site visit.
