## TECHNICAL MEMORANDUM

**SUBJECT:** South Park Landfill 2023 Annual Landfill Cap Inspection

**PROJECT NUMBER:** 553-1550-067

**PROJECT NAME:** South Park Landfill Site Coordination

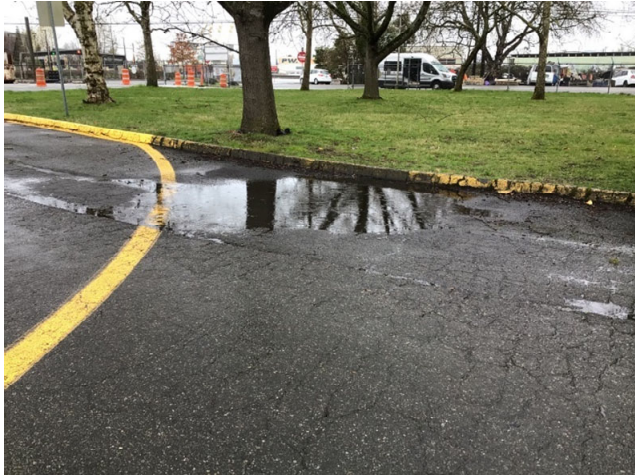
AC-3	Minor pavement cracking and ponding	Follow-up inspection	No actions taken or required	No significant changes observed	Follow-up reinspection	6 months	Site Coordinator

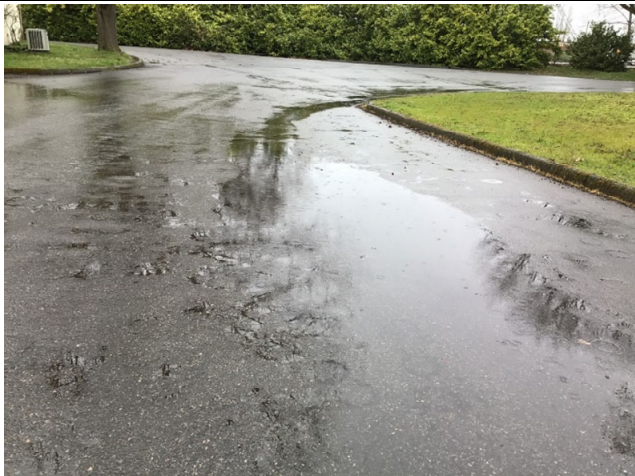
AC-4	Ponding	Follow-up inspection	No actions taken or required	No significant changes observed	Follow-up reinspection	6 months	Site Coordinator

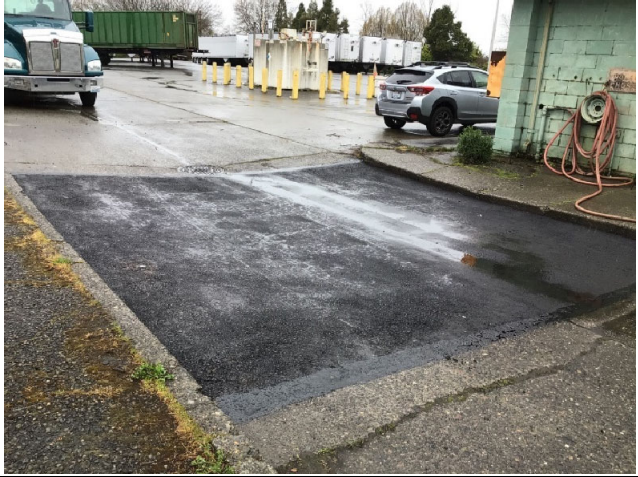
AC-7	Minor cracking and ponding in repatched area	Visible ponding near vehicle wash area appears related to wash pad. Low spot in pavement is not centered on the nearest storm drain. Ponding depth is less than a few inches. No concerns at this time. Follow-up reinspection	No actions taken or required	No significant changes observed	Follow-up reinspection	6 months	Site Coordinator

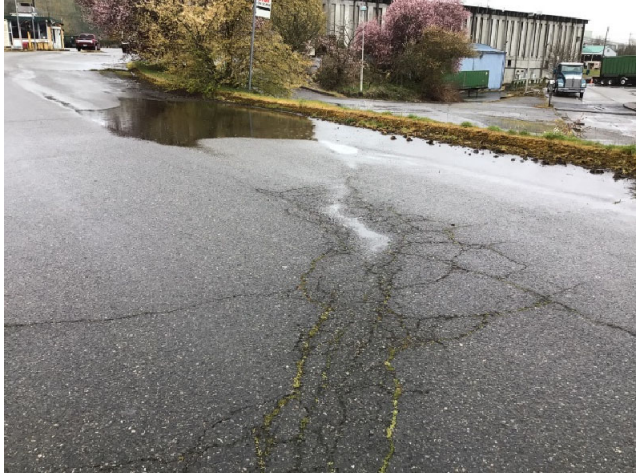
AC-9	Ponding and minor cracking	Follow-up inspection	No actions taken or required	No significant changes observed	Follow-up reinspection	6 months	Site Coordinator

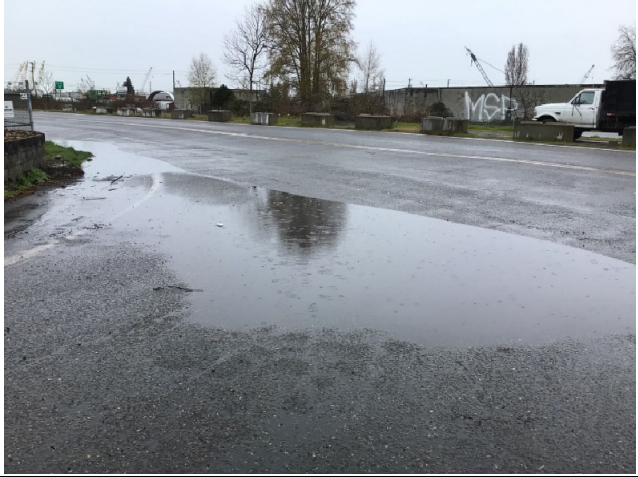
AC-11	Minor cracking with asphalt degrading and ponding	Follow-up inspection	No actions taken or required	No significant changes observed	Ponding in the area. Follow-up reinspection	6 months	Site Coordinator

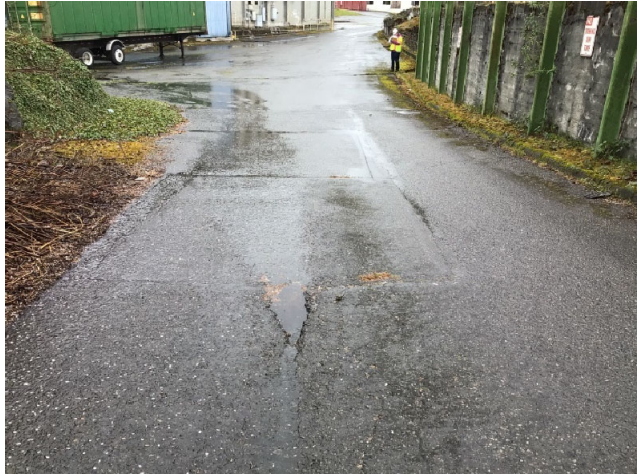
AC-13	Minor pavement cracking and deep rutting	Observed much deeper rutting, to where soil may be exposed. The open crack should be patched.	No action taken	Worse	The hole is bigger with water accumulation inside the rut. The open hole should be patched.	No later than end of calendar year	SRDS

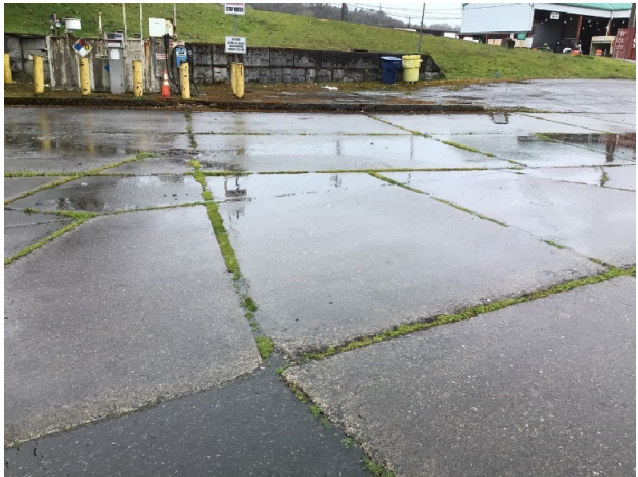
AC-15	Minor pavement cracking with moss growing in the cracks	Follow-up inspection	No actions taken or required	Worse	Observed more grass growing in the entire cracked areas. This area should be patched.	No later than end of calendar year	SRDS

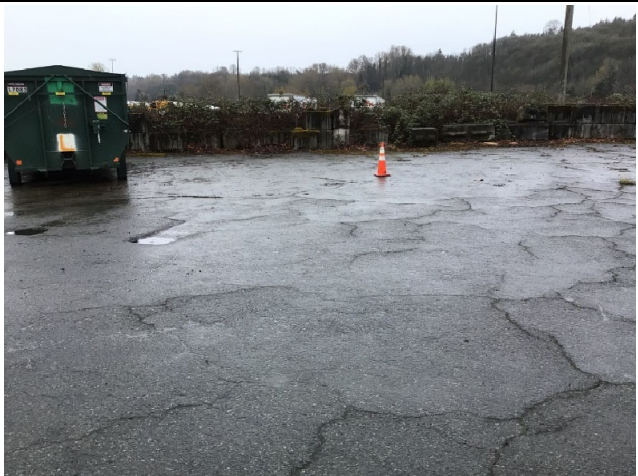
AC-16	Minor pavement cracking and ponding	Follow-up inspection	No actions taken or required	Worse	Follow-up reinspection	6 months	Site Coordinator

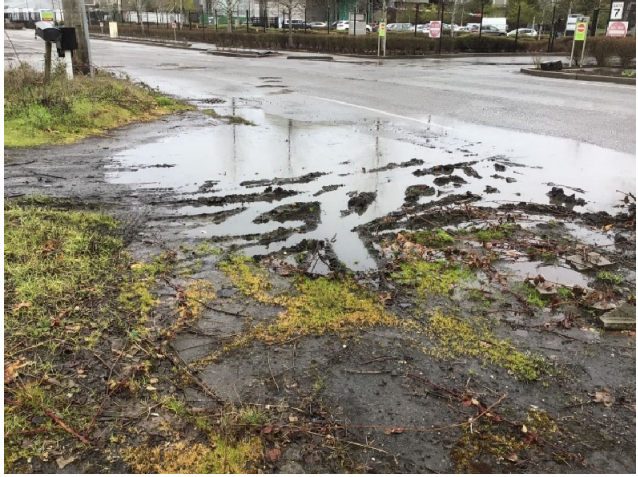
AC-18	Ponding	Follow-up inspection	No actions taken or required	No significant changes observed	Follow-up reinspection	6 months	Site Coordinator

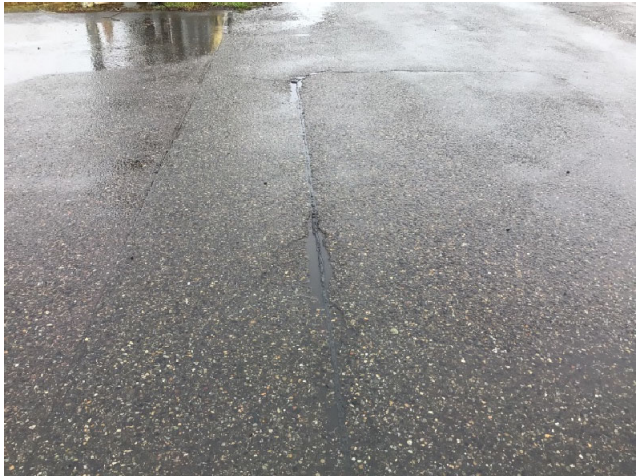
AC-19	Minor cracks in asphalt with ponding			New location	Follow up reinspection	6 months	Site Coordinator

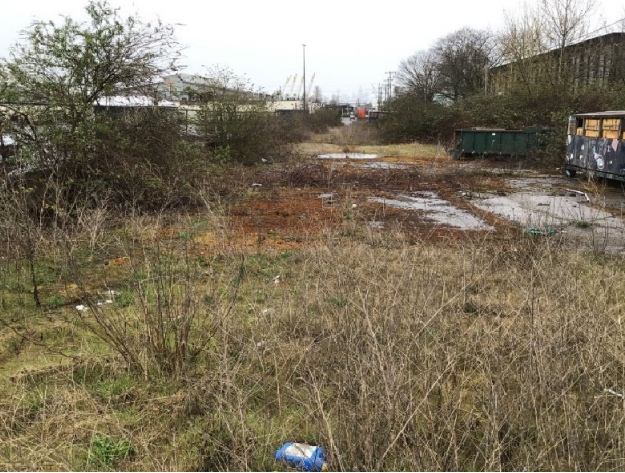
<b>Stormwater Management Facilities</b>								
SW-4	Potential run-on from SPPD	Follow-up inspection	No actions taken or required	No significant changes observed	Follow-up reinspection	6 months	Site Coordinator

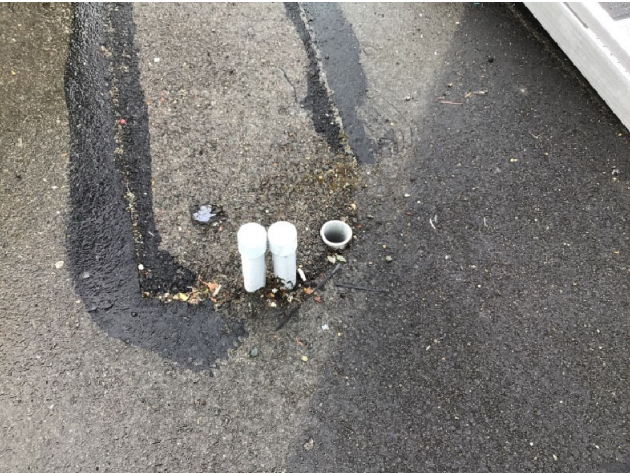
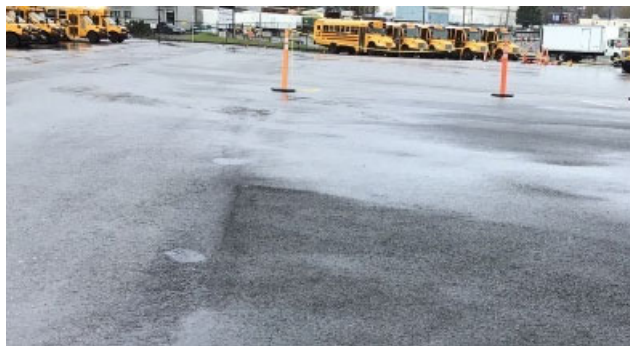
AC-3	New buildings, potential cap penetrations.	<p>There is one hole from where the previous building was that needs to have the seal fixed. An uncapped pipe protruding from the asphalt needs to be capped or filled and sealed.</p> <p>Property owner should request Occupancy Permit from tenant which would include drawings for the new buildings.</p>	Holes have been sealed. Pipe is still not capped. No maintenance form was submitted.	Some improvement	Previous recommended action regarding open pipe remains.	60 days	CenterPoint

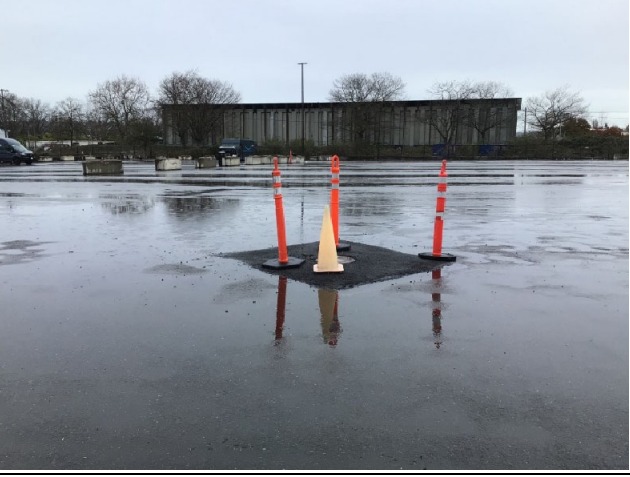
AC-5	Ponding, modification of asphalt	Follow-up inspection	No actions taken or required	No significant changes observed	Follow-up reinspection	6 months	Site Coordinator

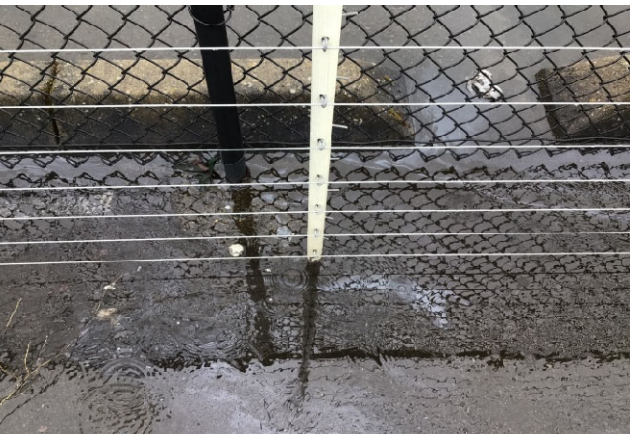
AC-6	Gaps and holes in electric fence post holes and ponding	Seal the remaining gaps in the interface between the posts of the new electric fence and the asphalt There are still some electric fence posts that have not been completely sealed, especially around the back of the pipe where it would be hard to reach. There are also some holes that were drilled next to the installed post. All posts and holes need to have complete seals.	Action Not Yet Completed	No visible improvement	Previous recommended repairs remain.	No later than end of calendar year	CenterPoint

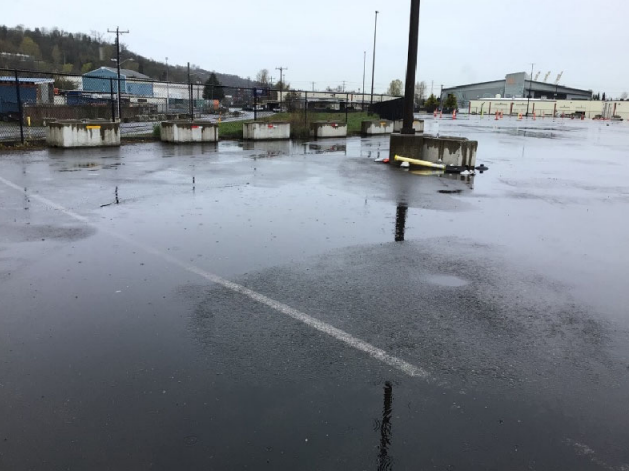
AC-8	Ponding	Follow-up inspection	No actions taken or required	No significant changes observed	Follow-up reinspection	6 months	Site Coordinator

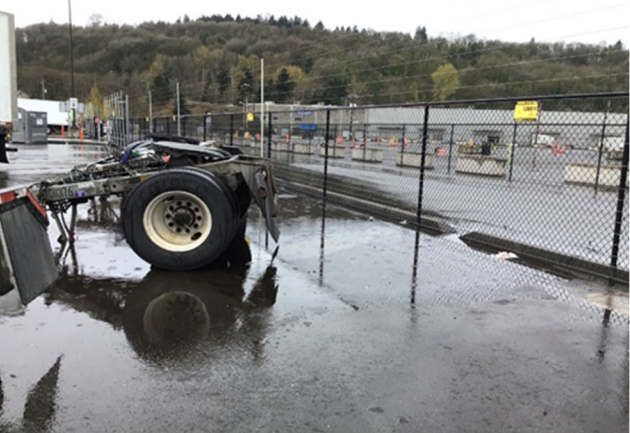
AC-10	Ponding	Follow-up inspection	No actions taken or required	No significant changes observed	Follow-up reinspection	6 months	Site Coordinator

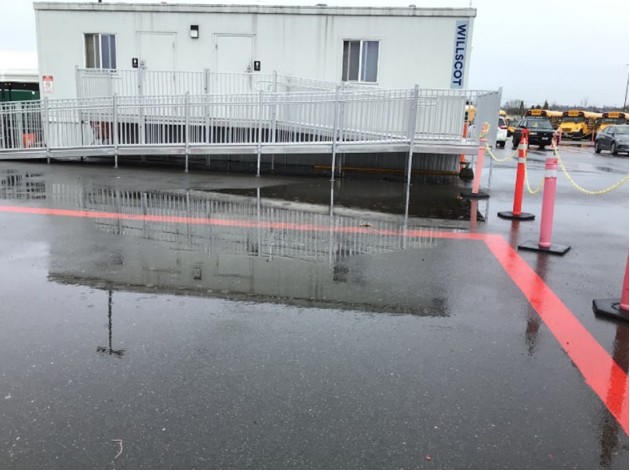
AC-12	Ponding	Follow-up inspection	No actions taken or required	No significant changes observed	Follow-up reinspection	6 months	Site Coordinator

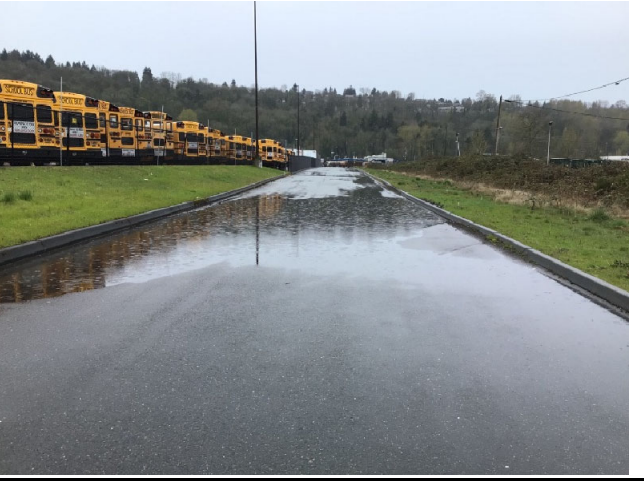
AC-17	Ponding			New location	Large area of ponding observed. Follow-up reinspection	6 months	Site Coordinator

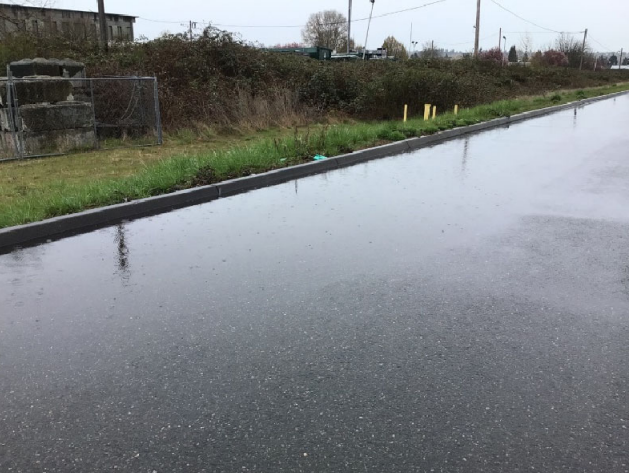
AC-18	Ponding			New location	Large area of ponding observed. Follow-up reinspection	6 months	Site Coordinator

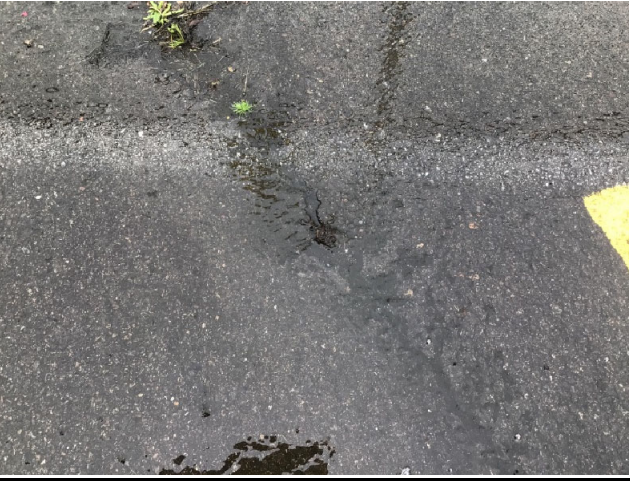
AC-20	Minor cracks and failed patch			New location	Follow-up reinspection	6 months	Site Coordinator

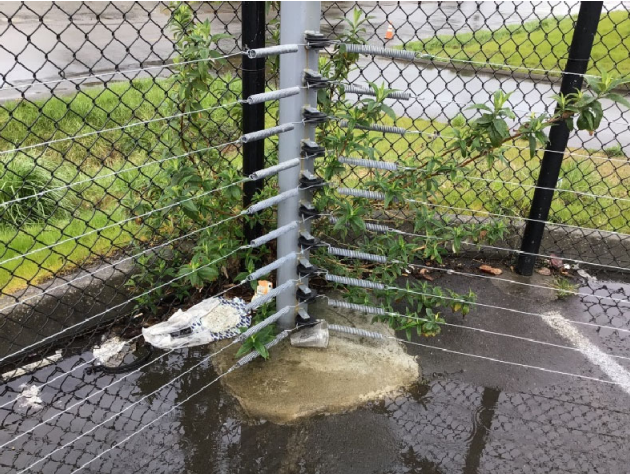
AC-21	Holes near fence allowing growth of invasive plants & ponding presence			New location	Remove plants and seal cap penetrations.	No later than end of calendar year	CenterPoint

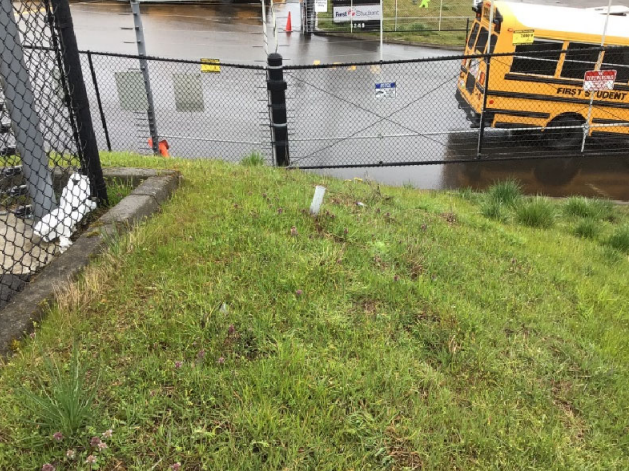
<b>Low-Permeability Geomembrane</b>								
G-1	An open pipe present	Pipes remain present. The origin and use of the pipes protruding from the ground needs to be investigated. Once the information about the pipe is known appropriate actions should be taken to ensure the integrity of the cap.	Action Not Yet Completed	No change	Need investigation of this open pipe and action should be taken to cap it, if it does not have any purpose.	No later than end of calendar year	CenterPoint

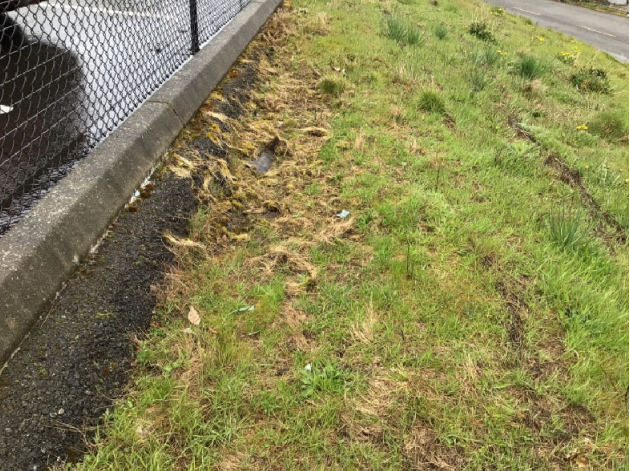
G-6	Geomembrane exposed in one area	See Location G-4 2022 recommendations.	Action Not Yet Completed	Some Improvement	Improved vegetation. Exposed geomembrane remains in one area. Add soil to exposed geomembrane and re-seed grasses	60 days	CenterPoint will work in coordination with Site Coordinator to establish a solution

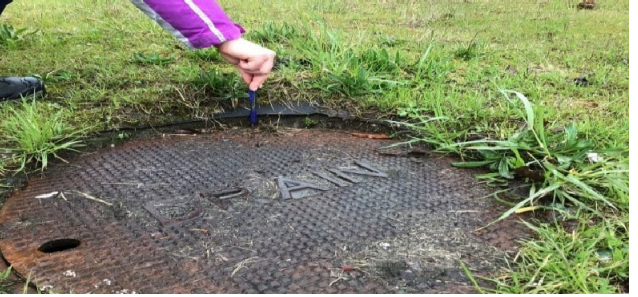
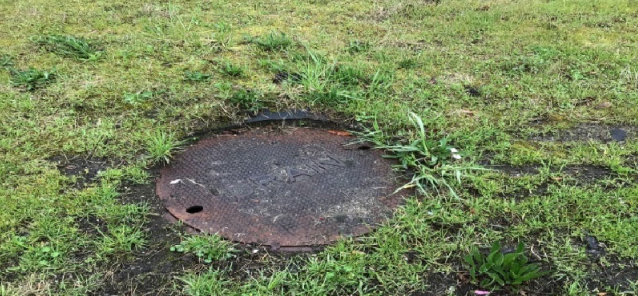
G-8	Exposed geomembrane around utility access hole	Work with Site Coordinator to prepare a plan to re-establish cover over the geomembrane. The geomembrane should be carefully exposed so as to not damage the geomembrane and inspected to determine if it is excess material or part of the cover. Make repairs as necessary and install adequate cover soil in accordance with the IAWP.	No documentation of actions taken	Improved	Improved vegetation. Previous recommendations remain	60 days	CenterPoint will work in coordination with Site Coordinator to establish a solution

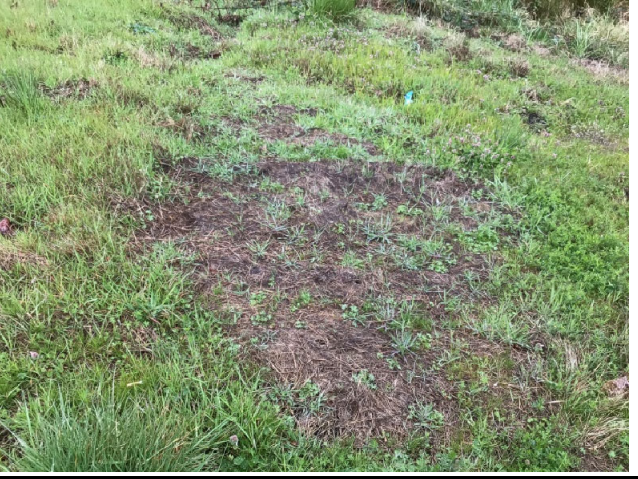
G-11	Bare Patch			New location	Re-establish vegetated cover	No later than end of calendar year	CenterPoint

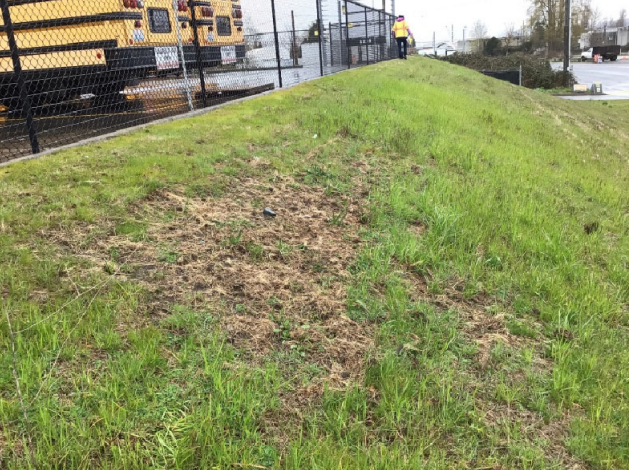
G-12	Poor vegetative cover			New location	Areas of exposed soil. Grass should be re-seeded.	No later than end of calendar year	CenterPoint

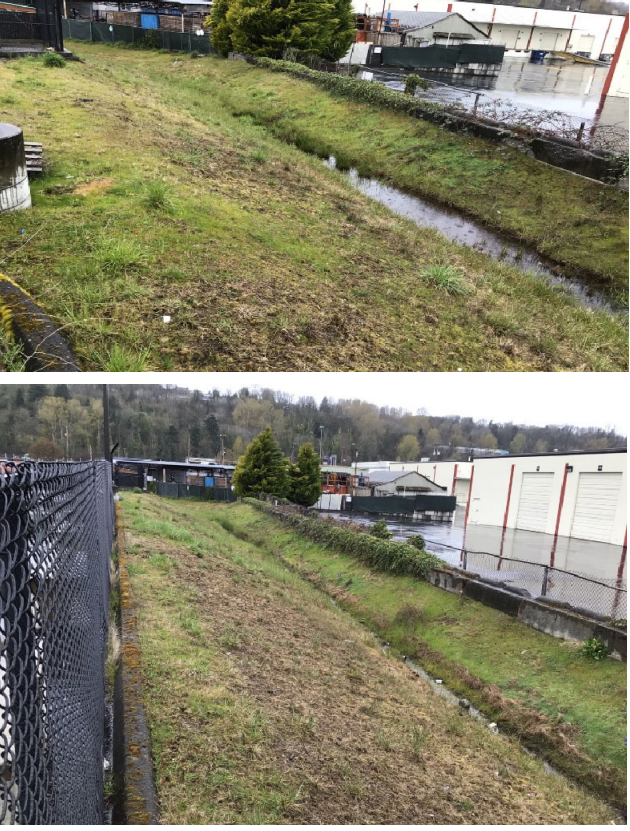
<b>Stormwater Management Facilities</b>								
SW-1	Standing water	The swale does not meet City of Seattle Stormwater Manual requirement for a biofiltration swale to have a minimum slope of 1.5%. Bottom channel should be regraded to the intended 1.5% slope. Along with Site Coordinator, prepare a plan to address this situation.	Action Not Yet Completed.	No Significant Change Observed	Previous recommended actions remain.	No later than end of calendar year	CenterPoint will work in coordination with Site Coordinator to establish a solution

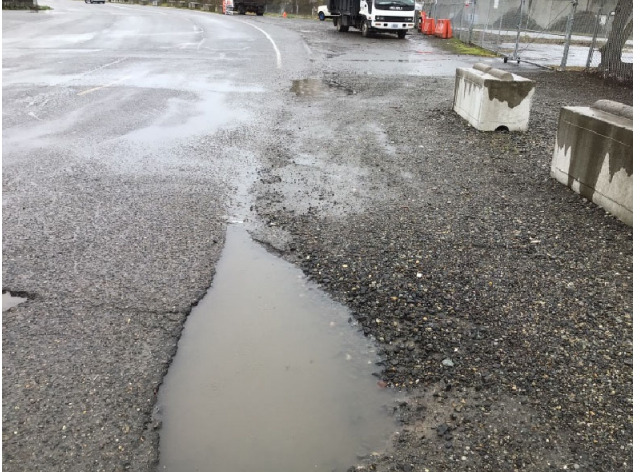
AC-3	Asphalt cracking and potholes alongside of street	Pothole appears to be getting worse and should be patched to prevent further erosion.	No action taken	No Significant Change Observed	Previous recommendations remain.	No later than end of calendar year	SPU to coordinate with SDOT
