# NE 99<sup>th</sup> Street / Leichner Landfill Liner Installation Documentation Report

Leichner Landfill  
9009 NE 94<sup>th</sup> Avenue  
Vancouver, WA 98662

04223030.10 | August 15, 2023

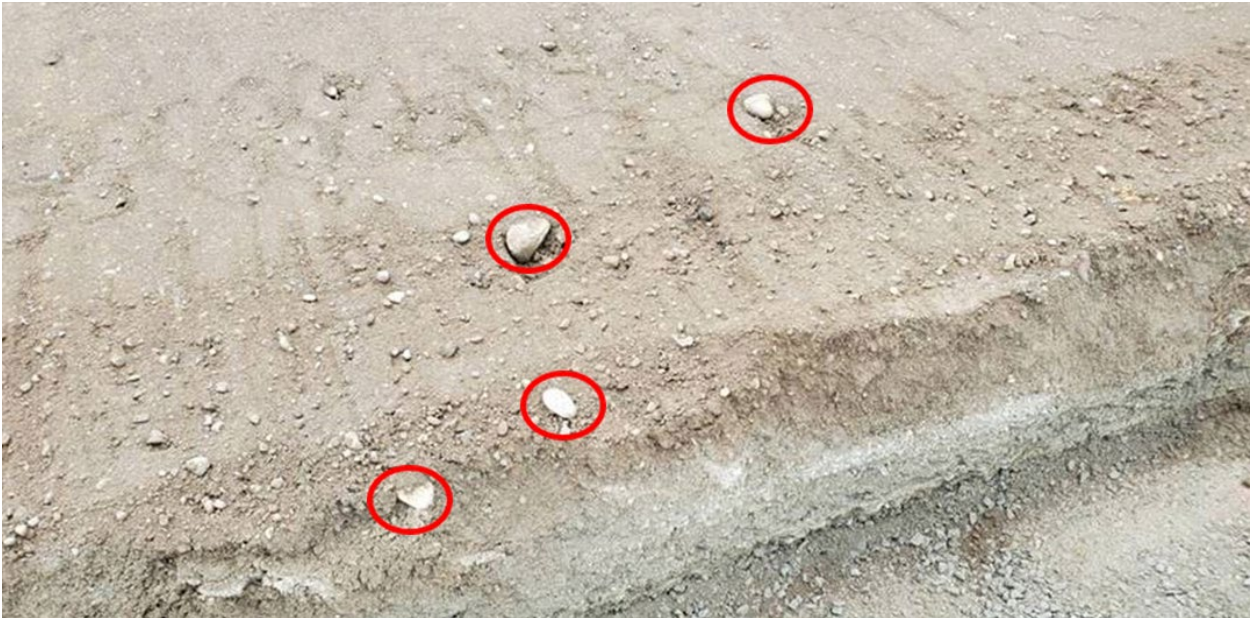
*Photo 1 - Soil with irreducible objects greater than ½ inch.*

- Fine grading and compaction are required to meet the requirements of the specification for much of the area to be covered by the geomembrane.
- Compaction, in accordance with the specifications, is required for all areas that are to be covered with the geomembrane liner. Some areas have already been graded and rolled with a smooth drum compactor. Compaction testing will need to be performed to verify subgrade is compacted to at least 95 percent of the maximum dry density (MDD).

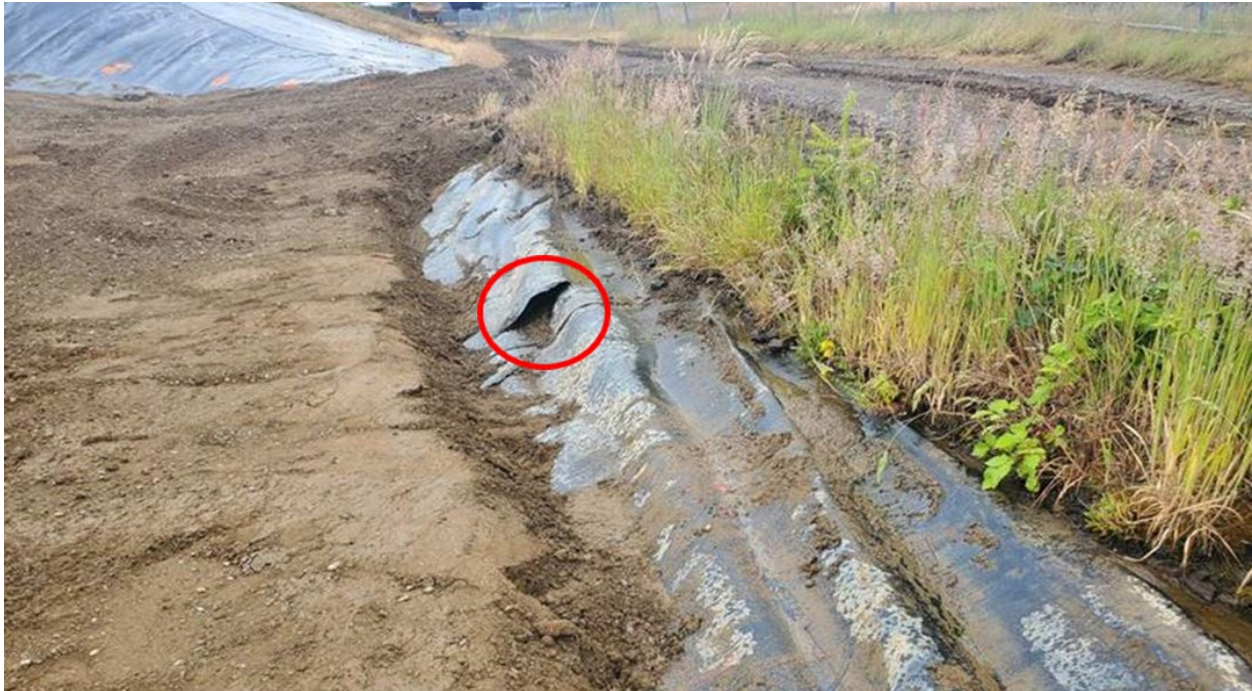
*Photo 3 – Existing landfill liner with overlying soil that needs to be removed and visible damage that needs to be repaired prior to installing new liner material.*

- Provide inspection documentation for the existing liner prior to fill soils replacement.

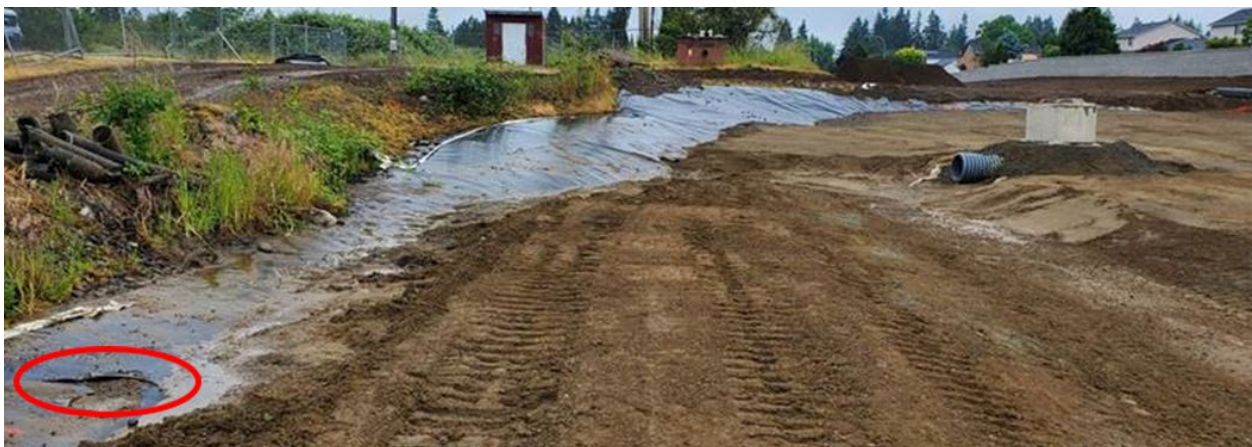
*Photo 4 – Existing landfill liner with visible damage that needs to be repaired prior to installing new liner material.*

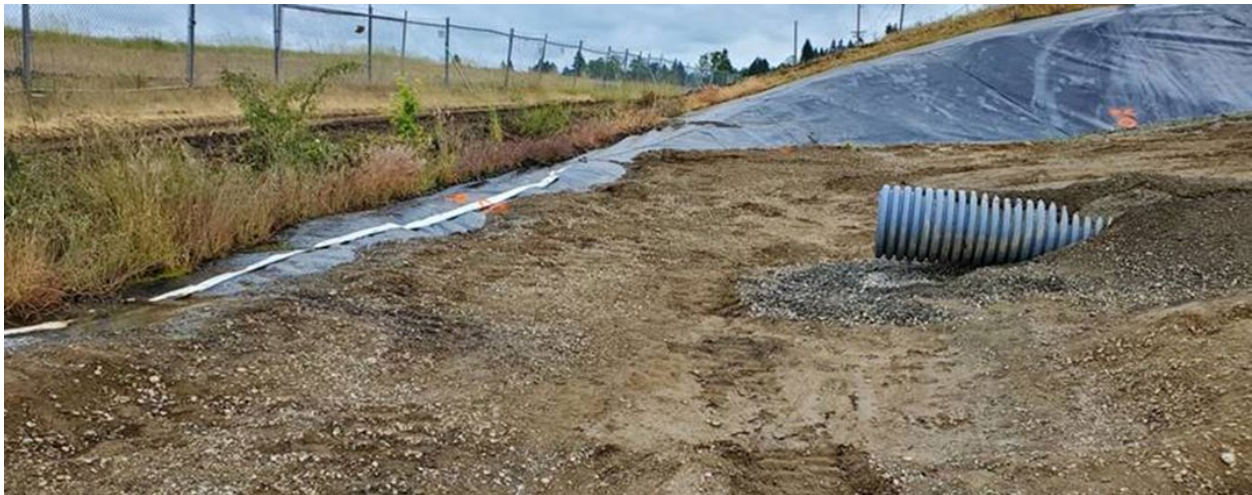
*Photo 5 – Inlet to stormwater collection pipe will be about 12 inches above the surface that will receive the new geomembrane liner.*

- Survey stormwater collection pipes and adjacent drainage areas, and adjust elevations to minimize ponding water on the liner.

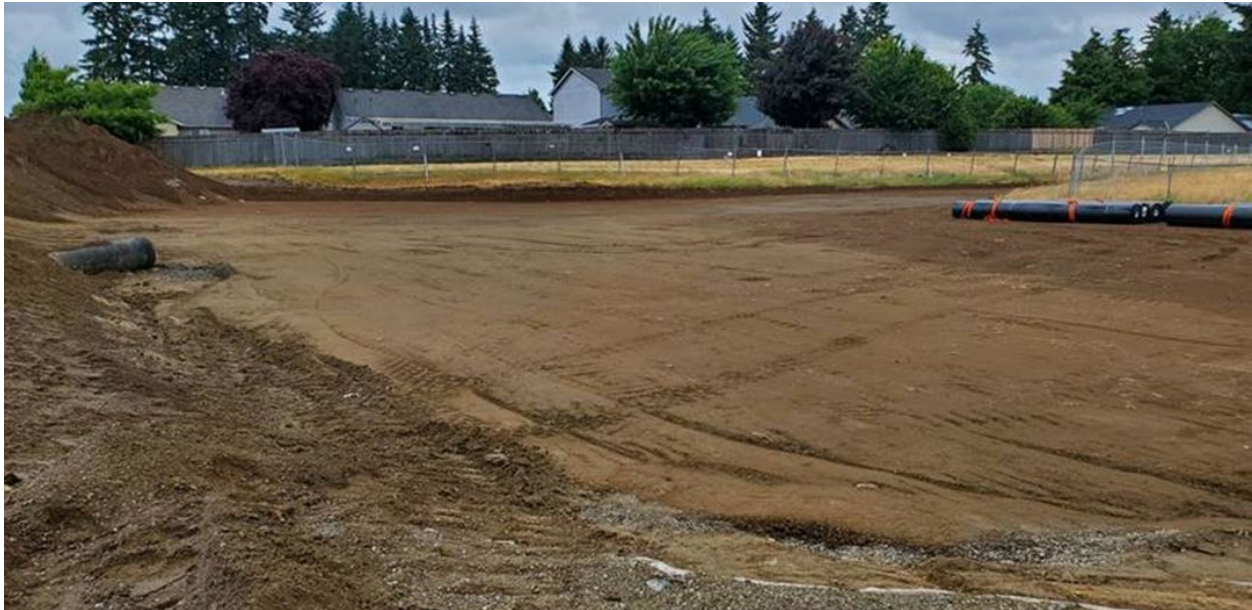
*Photo 6 - Grading appears to be inadequate for surface water drainage into the stormwater collection pipes.*

- Survey stormwater collection pipes and adjacent drainage areas, and adjust elevations to facilitate drainage and minimize ponding water on the liner.
