A Subsidiary of SoundEarth Strategies

1011 SW Klickitat Way, Suite 104

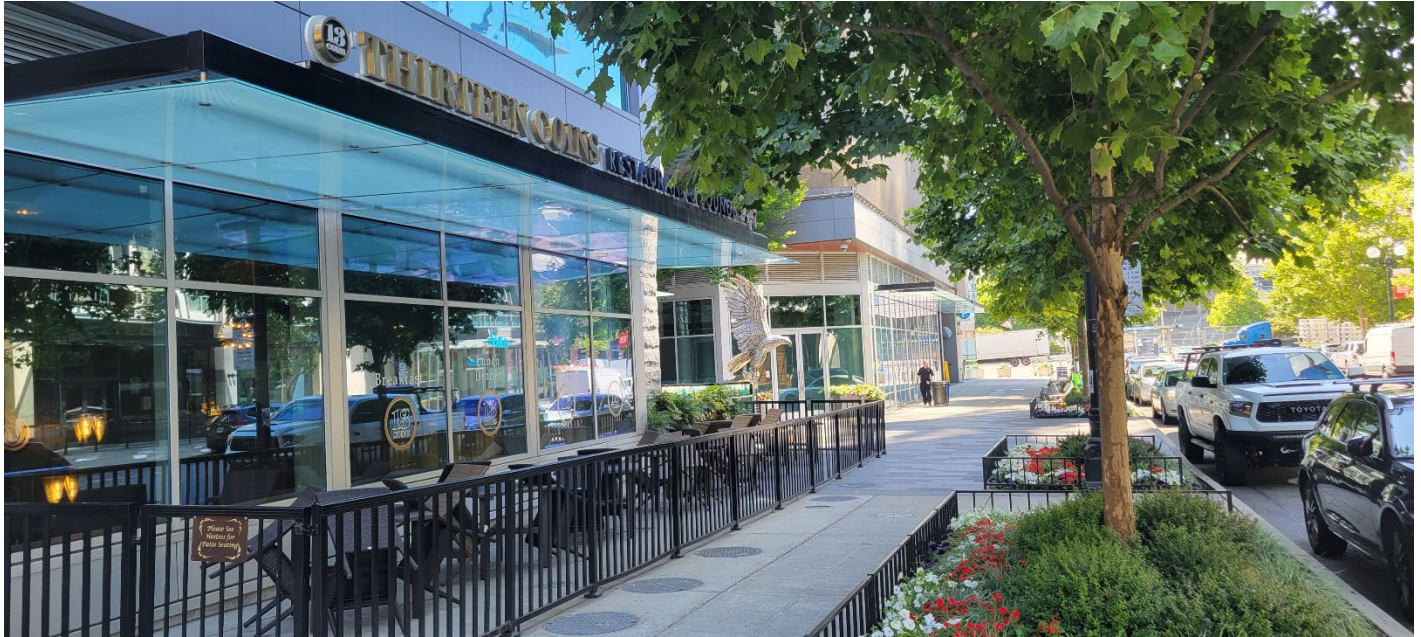
Photograph 1. Western concrete path surface conditions. Surface conditions appear to be the same as the 2021/2022 inspections.

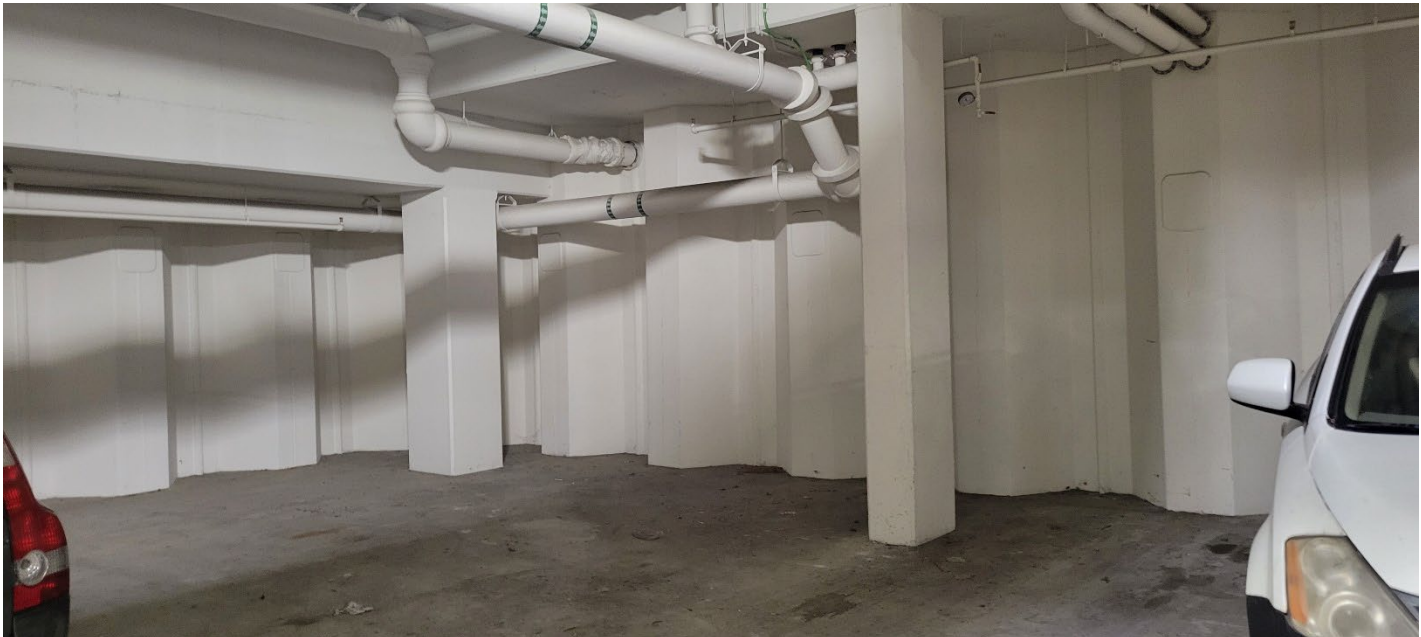
Photograph 2. Steel sheet pile walls in the parking garage. No damage or areas of concern were observed.

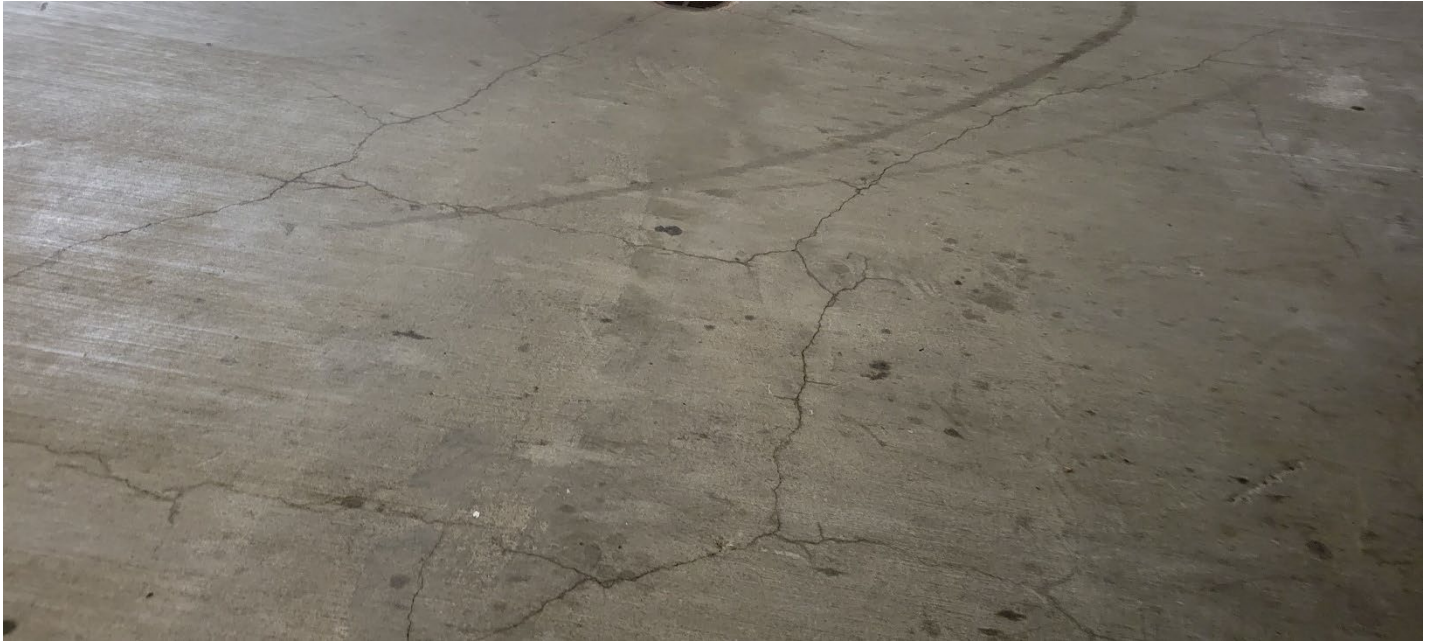
Photograph 3. Nonstructural hairline cracking in the underground parking garage. Cracking does not appear to have worsened since the 2021/2022 inspections. This area is to be monitored in the next annual inspection; repairs are not needed at this time.

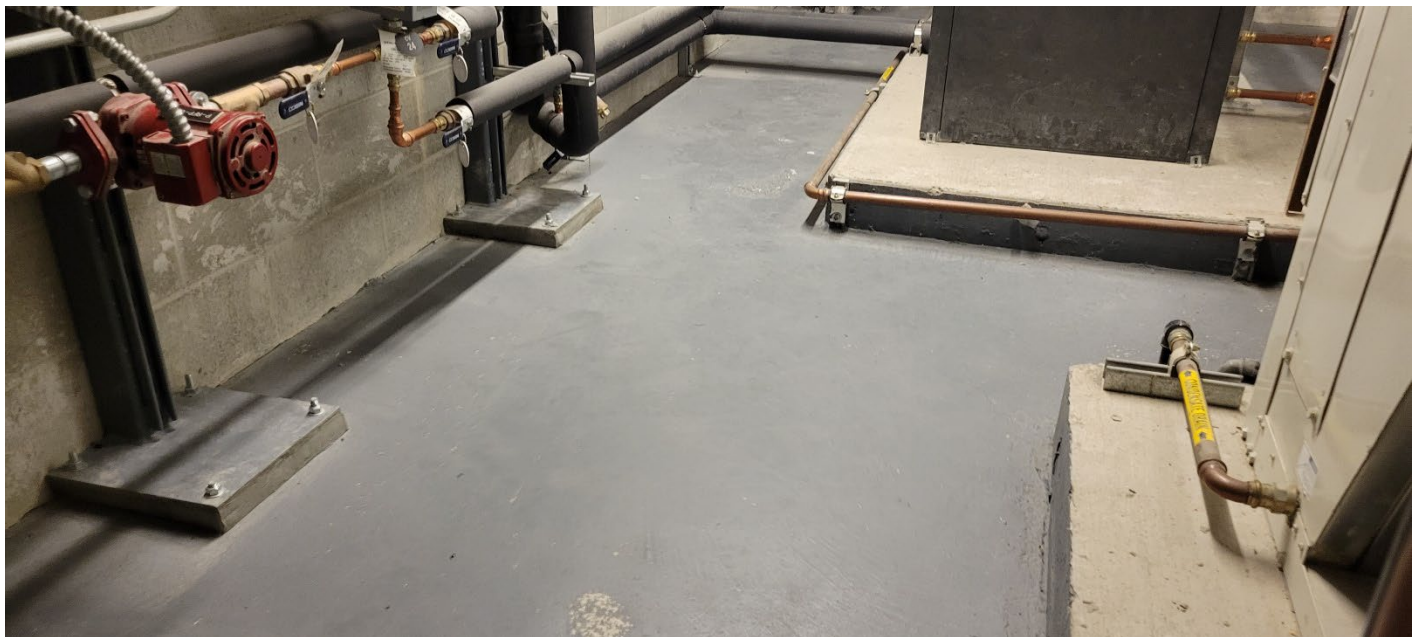
Photograph 4. Machine rooms free of visible structural cracking. Hairline cracking in maintenance areas are painted over with epoxy paint.

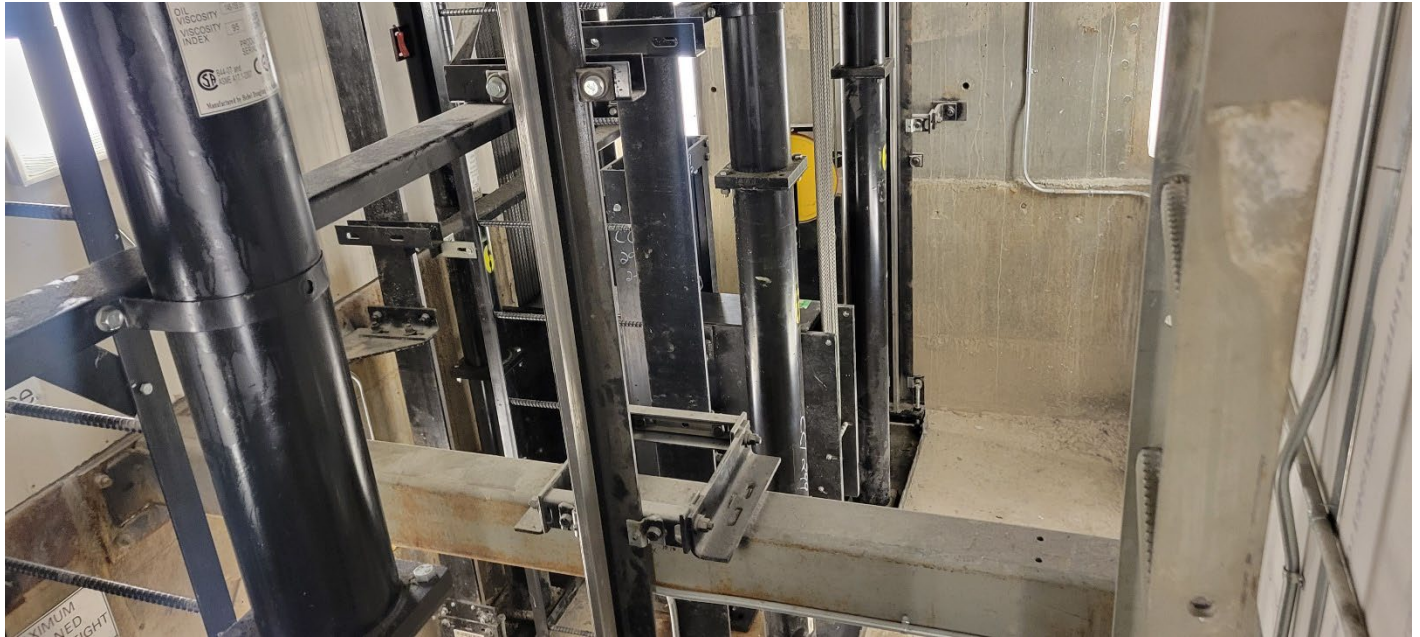
Photograph 5. Elevator pits free of visible structural cracking.

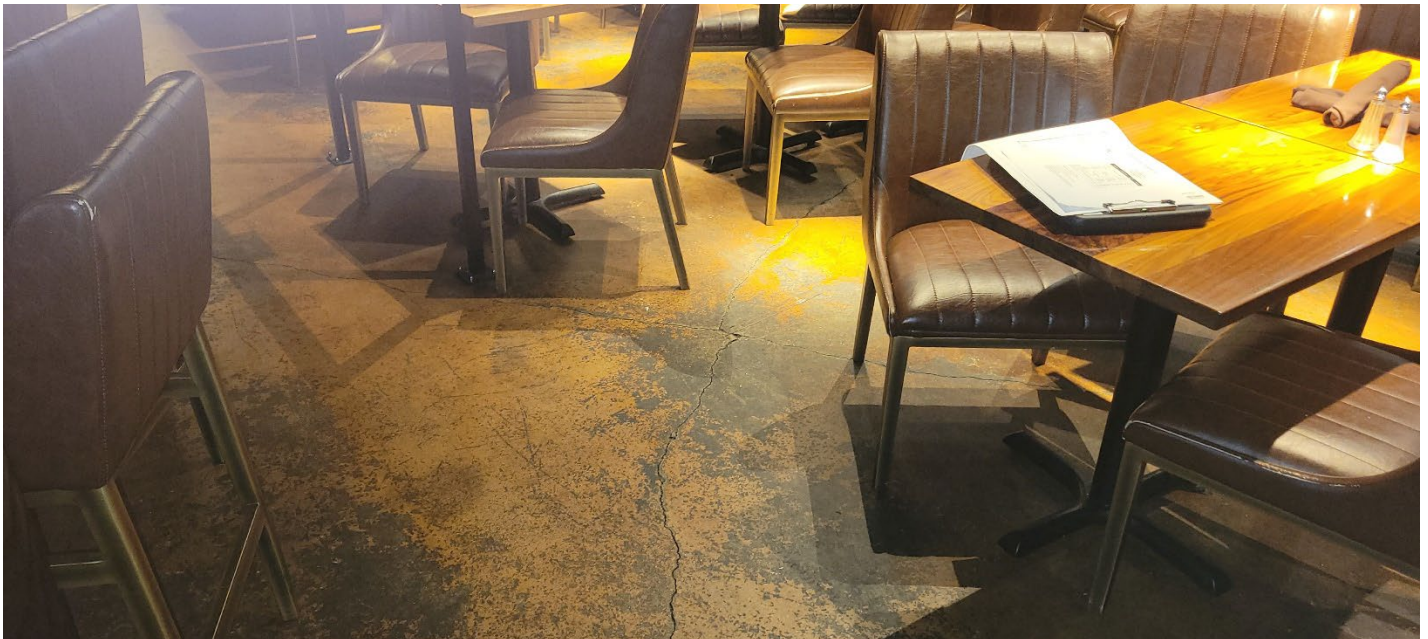
Photograph 6. Minor cracking in the northwestern portion of the 13 Coins Restaurant on the King Street property. Cracking size and amount appear to be the same as the 2021/2022 inspections.
