**Re: Geotechnical Construction Completion Letter**

Texaco Strickland Site  
Project No. 180357

**PRECONSTRUCTION CONDITION SURVEY PHOTO LOG** | September 19, 2022

**POSTCONSTRUCTION CONDITION SURVEY PHOTO LOG** | January 10, 2023 and January 25, 2023

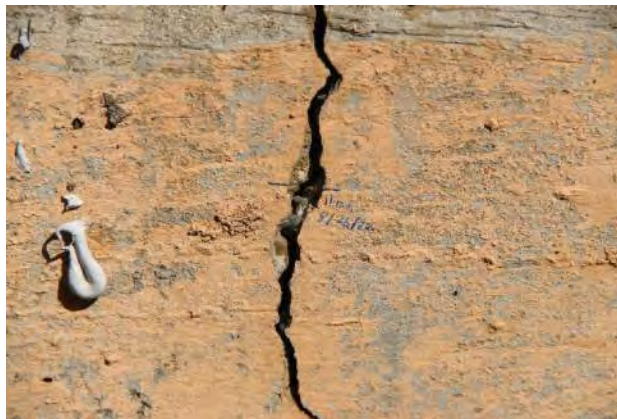
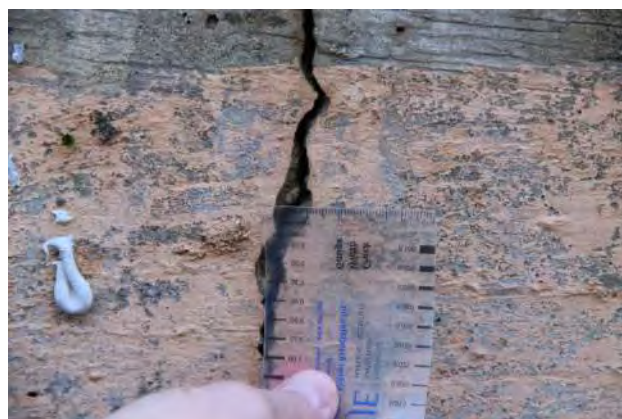
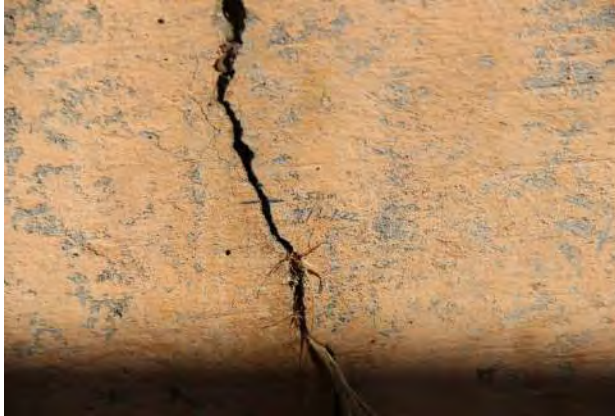
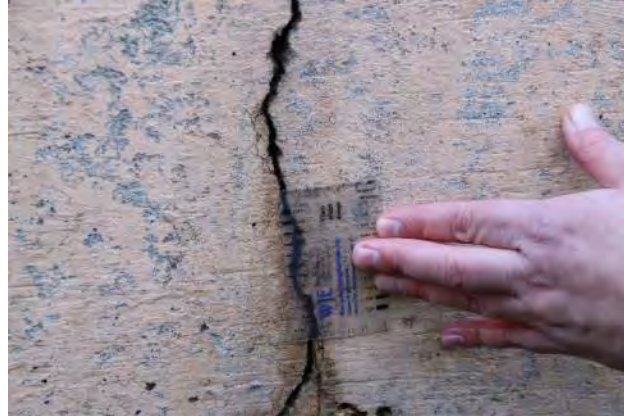
Between our preconstruction assessment on August 25, 2022 and January 10, 2023, the only measured change noted was a slightly widened crack along the loading dock on the south facade (location shown in Figure 1). On August 25, 2022, we marked two locations on the crack and measured the width of the crack in both locations. The upper portion of the crack was measured to be 11mm wide (Figure 2a), while the lower portion of the crack was measured to be 2.5mm wide (Figure 3a). When we surveyed the condition of the Subject Structure on January 10, 2023, the marks were erased; however, we were able to locate scratches in the concrete that appear to have been made by the pen used to mark the locations in August 2022 and measured the width of the crack in those locations. The upper portion of the crack was

measured to be 12mm wide (Figure 2b), while the lower portion of the crack was measured to be 3mm wide (Figure 3b).

Figure 2a. Upper portion of crack on August 25, 2022.

Figure 2b. Upper portion of crack on January 10, 2023.

Figure 3a. Lower portion of crack on August 25, 2022.

Figure 3b. Lower portion of crack on January 10, 2023.

A crack in the loading dock was measured to be marginally wider after completion of the excavation than before. Cracking is common in reinforced concrete structures, and provided that the cracking is relatively minor, it usually does not impact the ability of the reinforced concrete to carry the design loads. The most common reasons for this type of cracking are:

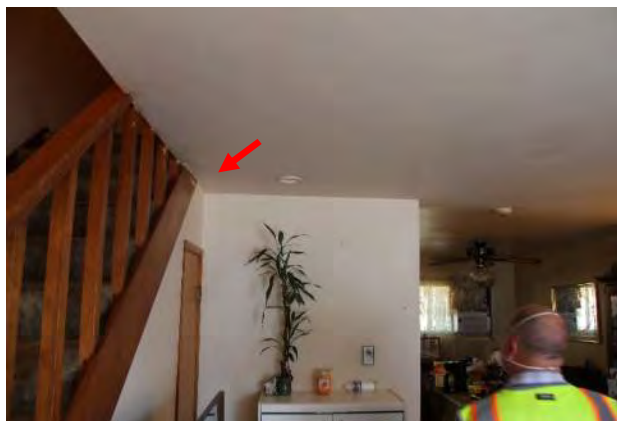
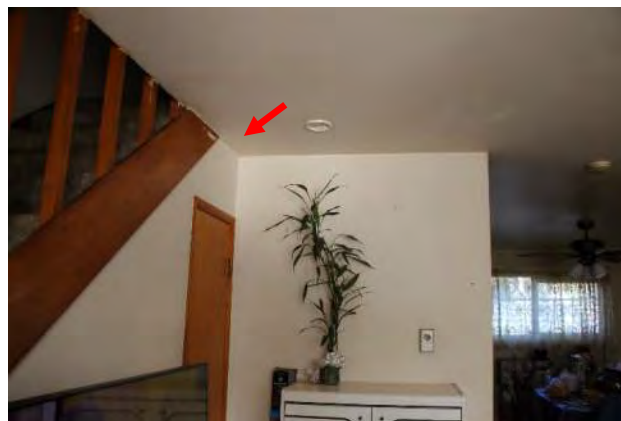
is also not visible in a photo taken on January 10, 2023 from the same angle, as shown in Figure 2. Figure 3 shows the condition of the crack on January 10, 2023 as seen from a different angle. We do not have any photos showing the crack depicted in Figure 3 on August 25, 2022, which may be due to the angles at which our photos were taken. However, our typical practice is to take a closer photo of all cracks that we observe; therefore, it is likely that the crack did not exist on August 25, 2022.

Figure 2a. Interior of Unit 131 on August 25, 2023 (red arrow indicates approximate location of crack).

Figure 2b. Interior of Unit 131 on January 10, 2023 (red arrow indicates approximate location of crack).

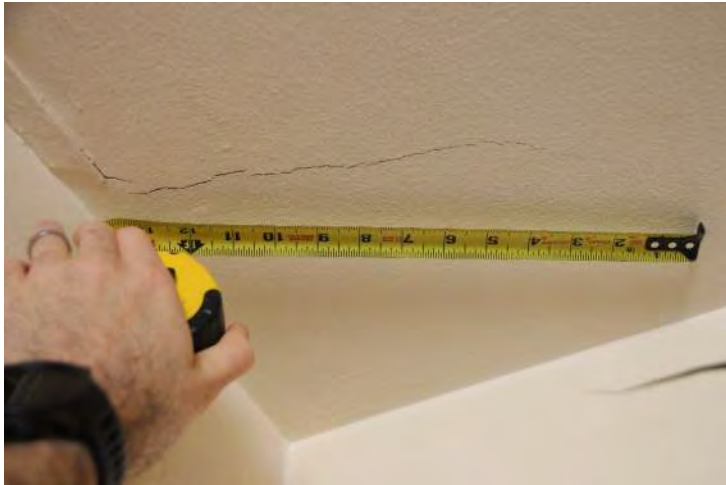
Figure 3. Closer view of crack in ceiling finish in Unit 131 on January 10, 2023

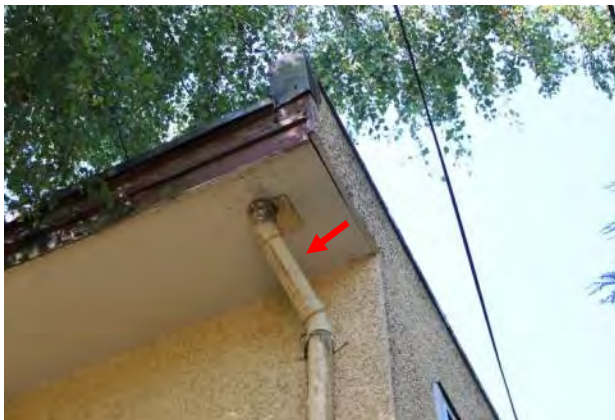
On January 10, 2023, we noted that a section of the downspout for the roof gutter at the northeast corner of the Subject Structure had separated from the rest of the downspout and had fallen off the structure, as shown in Figure 4. The fallen section of downspout was resting on the ground.

Figure 4a. Downspout at northeast corner of Subject Structure on August 25, 2022 (red arrow indicates location of section that fell).

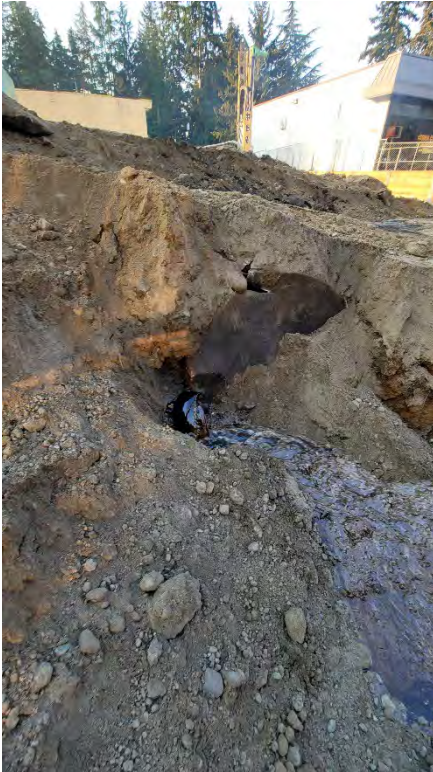
Figure 2. Photo of damage to UST.

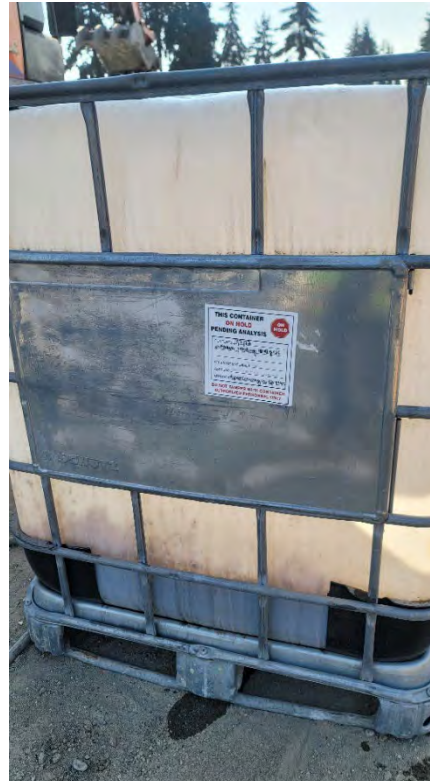
Figure 2. Photo of tote following spill cleanup.

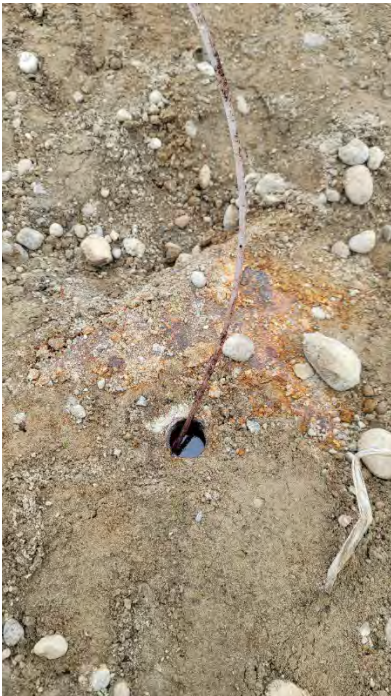
*Photo 3. Uncovered inlet of UST 3 with sample tubing showing the burgundy stain and material that sticks to the side of the tubing.*

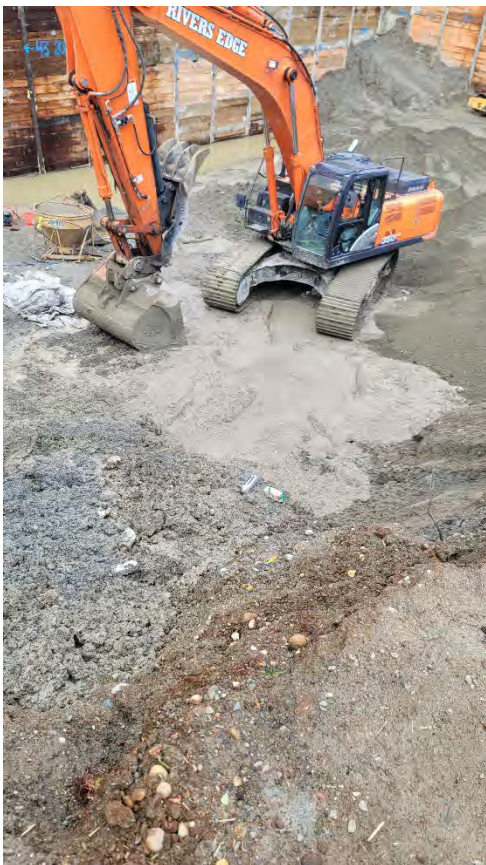
*Photo 2. Attempted mud consolidation; the mud being scraped from the base of the site is very saturated by ground and rainwater infiltration.*

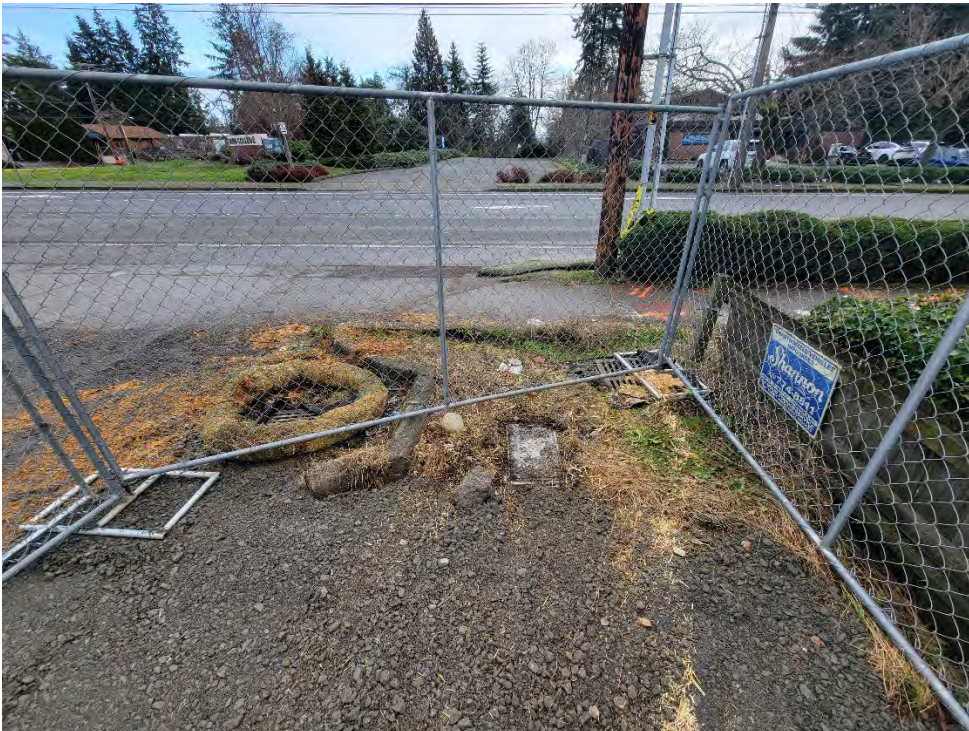
*Photo 4. Site TESC measures in-place as of 1/6/2023.*
