# North Boeing Field/ Georgetown Steam Plant Site Remedial Investigation/Feasibility Study

Assessment of Infiltration and Inflow to  
North Boeing Field Storm Drain System

## VOLUME I

February 2011

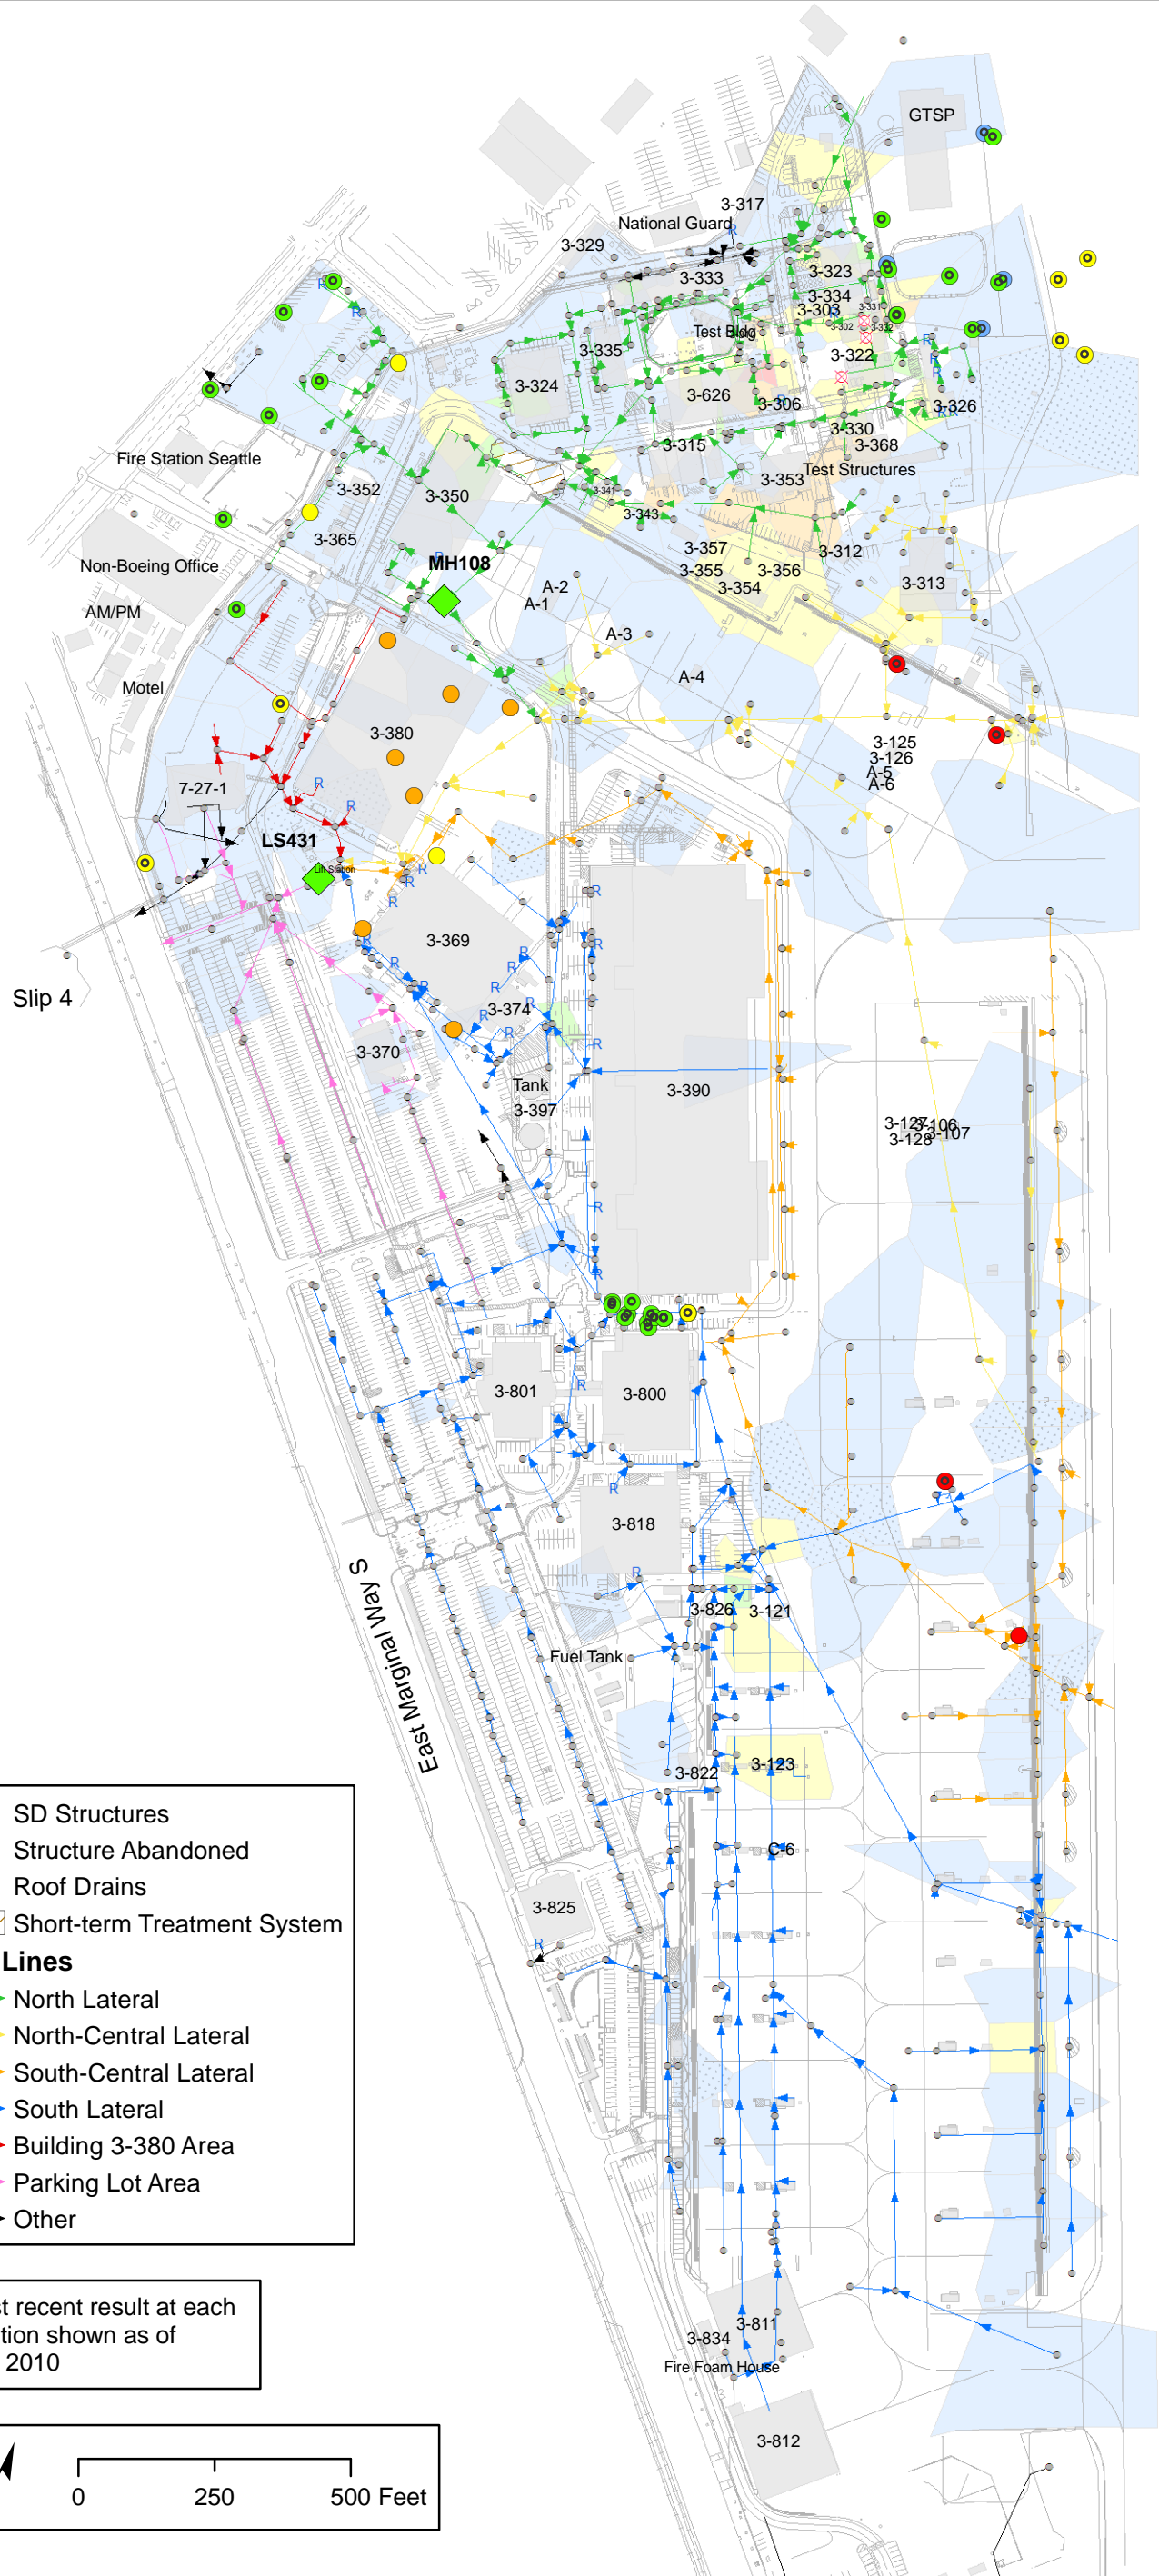
**Figure 5-22. Mercury in Groundwater and SD Base Flow at NBF-GTSP Site**

screening level exceedances for mercury, cadmium, copper, lead, and zinc. In addition, copper exceeded also at one GTSP well. Significant mercury exceedances in groundwater (red and orange symbols on Figure 5-22) are found in the flightline areas and in the vicinity of Building 3-380.

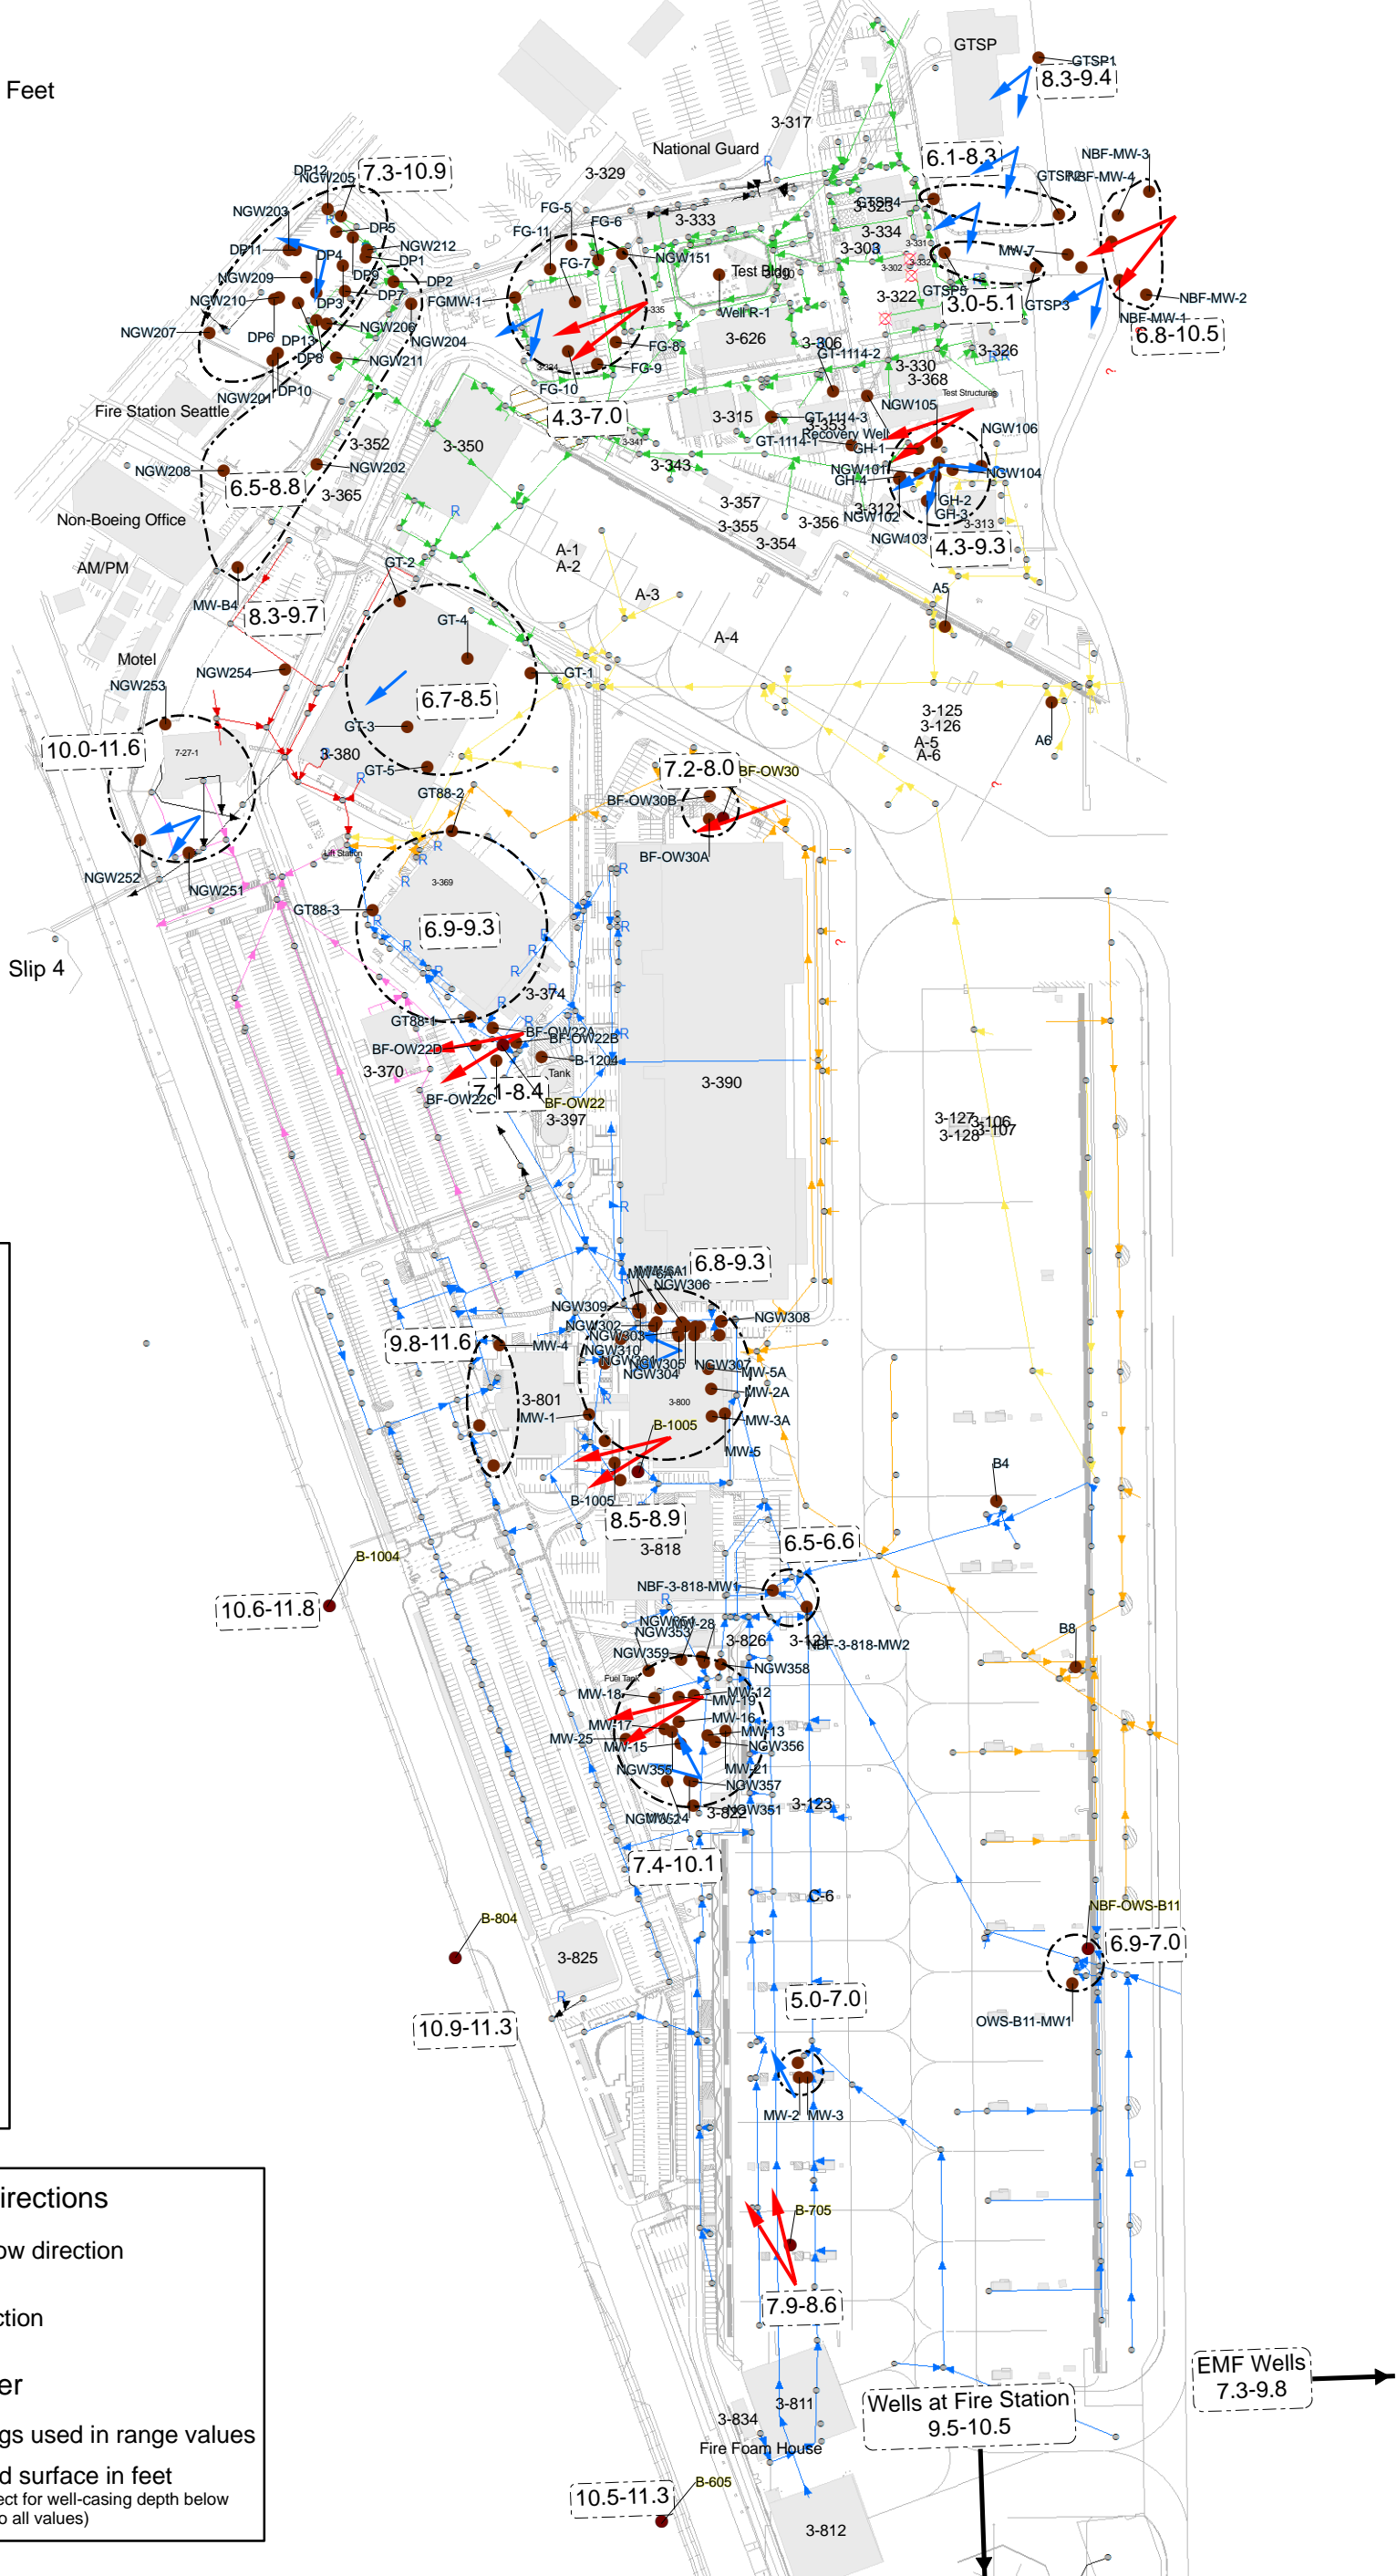
**Figure 5-29. Groundwater Flow and Depth at NBF-GTSP Site**

Groundwater at the Site occurs at shallow depths within alluvium and fill material, under unconfined conditions. Site groundwater flow direction averages toward the south-southwest (Figure 5-29), at hydraulic gradients of 0.0010 to 0.0025. Depth to the water table varies seasonally and with local tidal fluctuations, ranging from 2.6 to 11.3 feet below the well casing for all onsite wells. Approximately 81 percent of all groundwater depths were measured between 5 and 9 feet, and the average depth for the entire Site is 7.4 feet below the well casing.

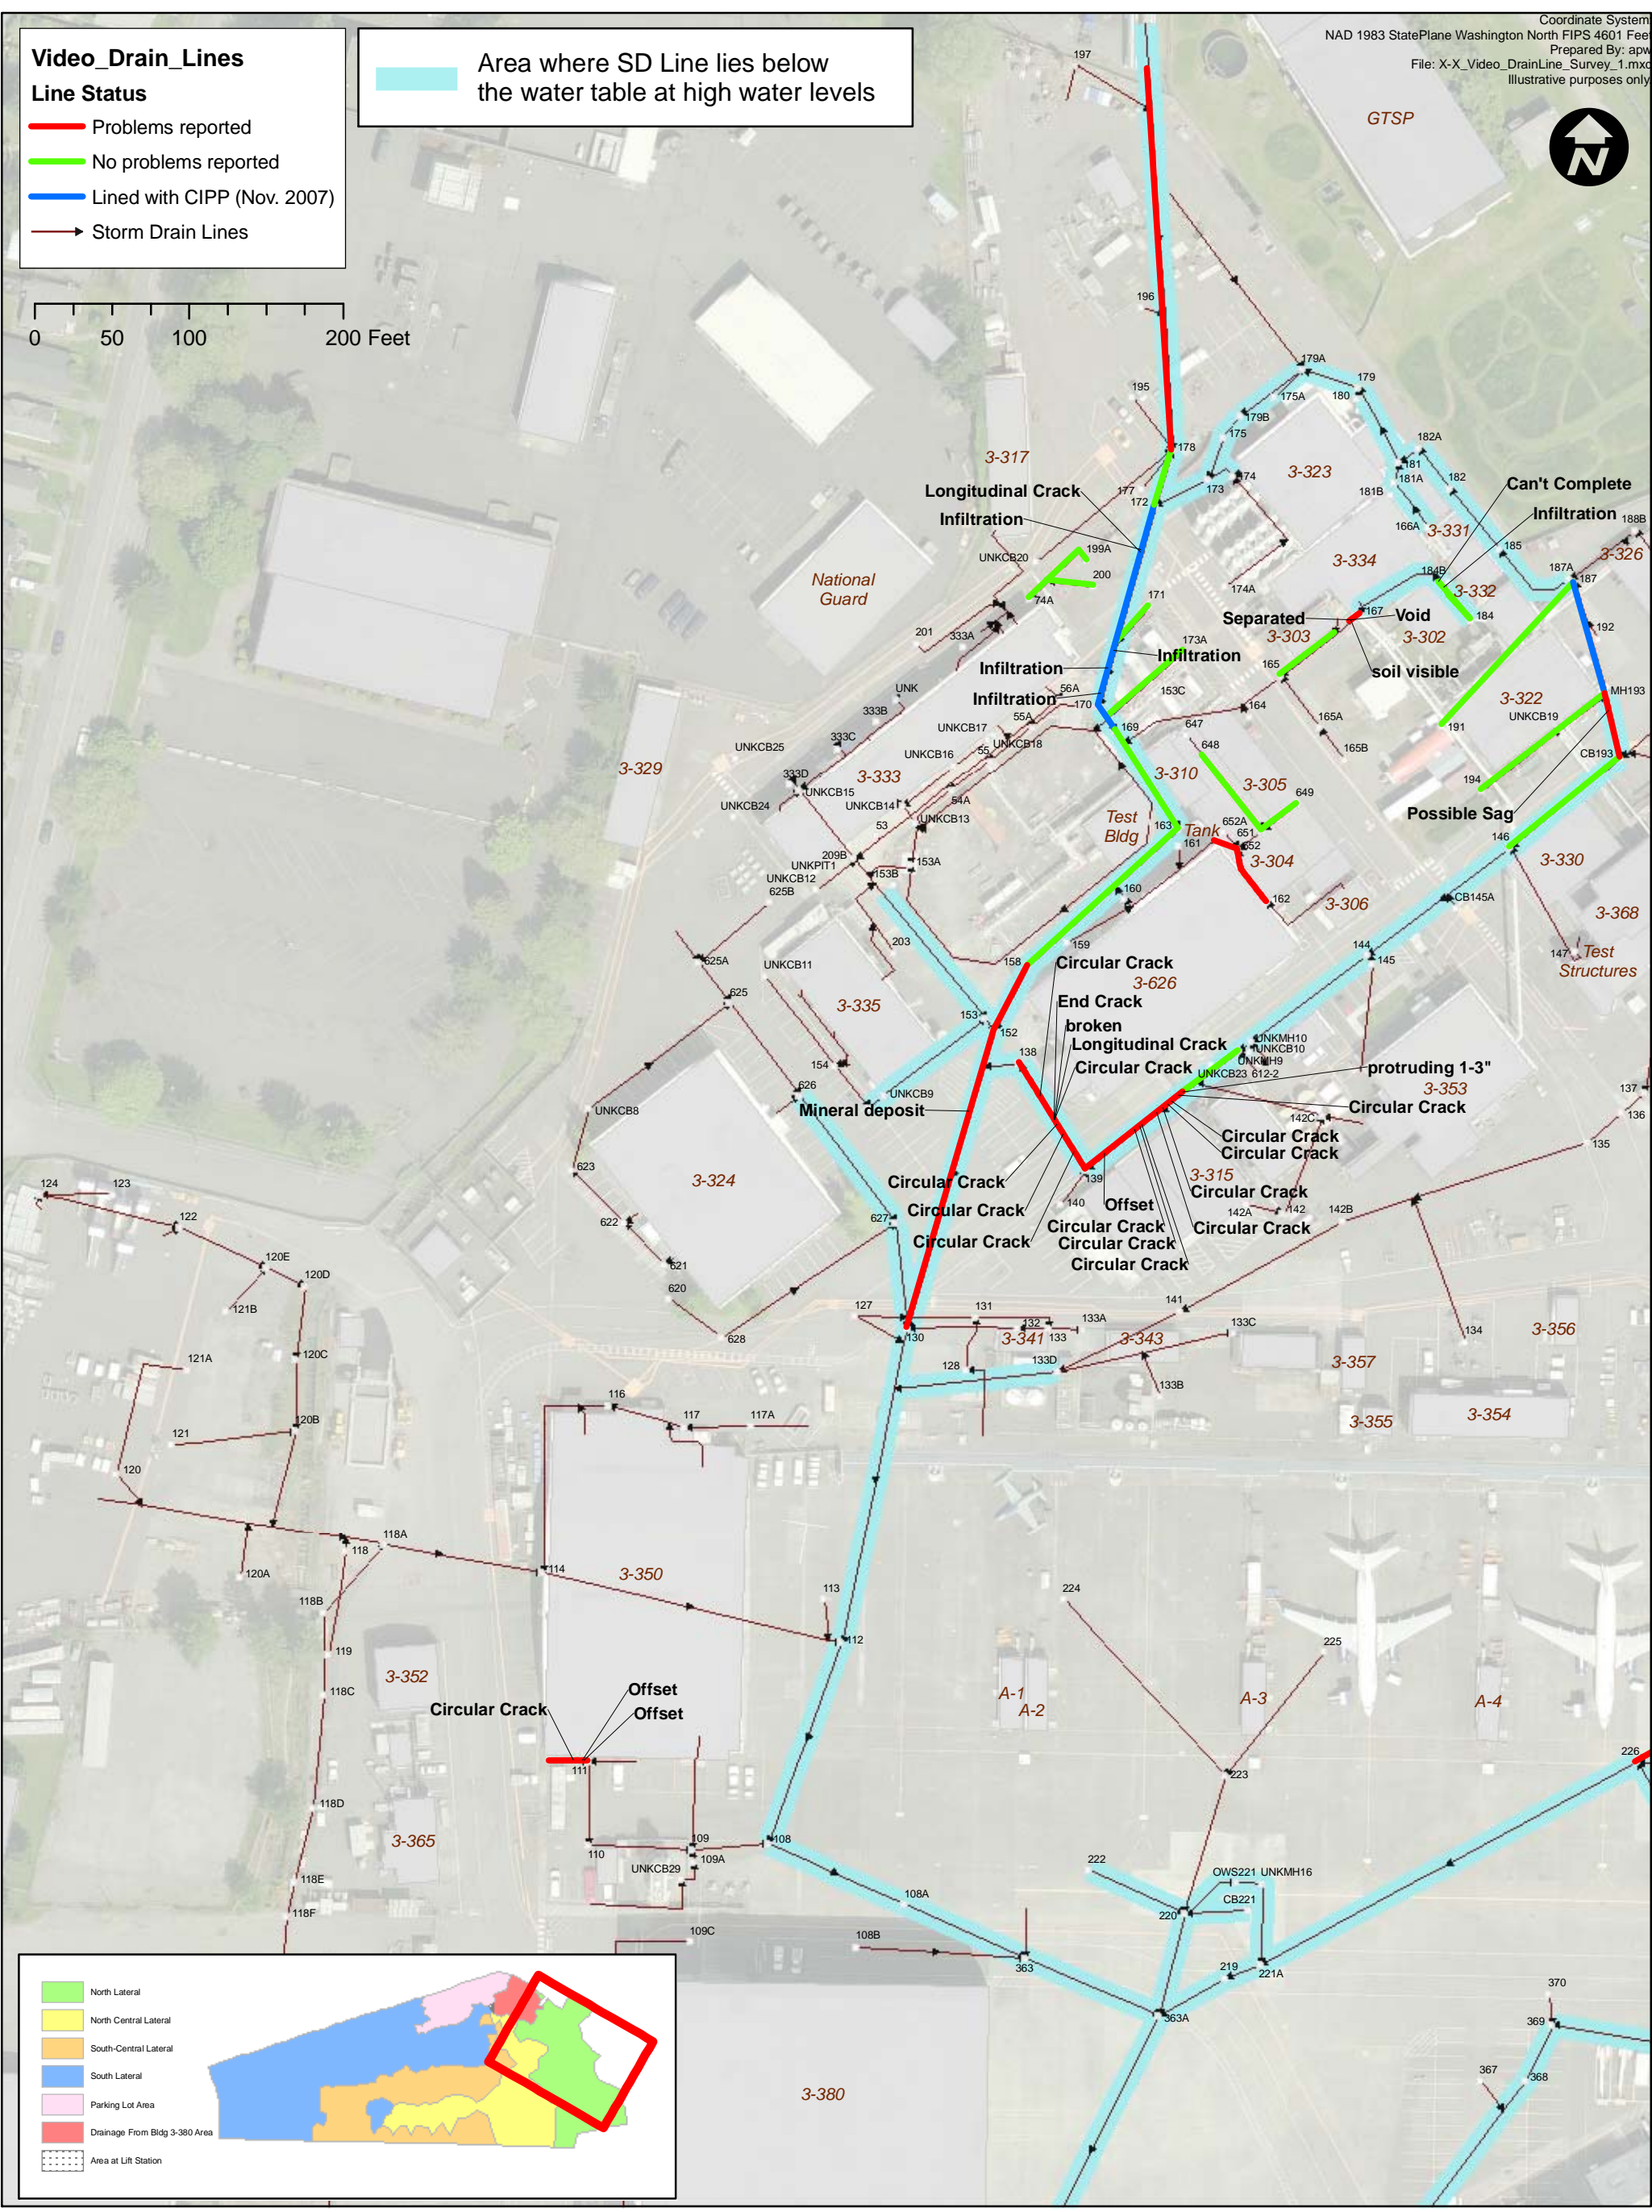
**Figure 5-31. Results of 2007 Storm Drain Video Inspection**

SD video inspections conducted in 2007, 2008, and 2010 of the NBF SD system provided information on SD lines within portions of all six drainage areas. Figures 5-31 to 5-33 document locations of gaps, breaks, or other problems and they identify structures that have been repaired. The submergence of lines with gaps or breaks could result in infiltration of contaminants to the SD system. A number of identified locations of soil and groundwater contamination are present in the vicinity of damaged and submerged SD lines, presenting the possibility for infiltration. The following is a summary of findings for damage and submergence in each drainage area.

*North lateral area:* Of the 107 segments inspected, 33 indicated signs of cracks, fractures, breaks, or other defects. Signs of soil and groundwater infiltration were confirmed in 10 segments within the following lines: N4, N5, N7, N10, and a branch of N11. Of these, generally only N7 and probably N10 are submerged by groundwater during high water-table conditions. In addition, 54 presumed inactive tap connections were observed to be unplugged or uncapped.

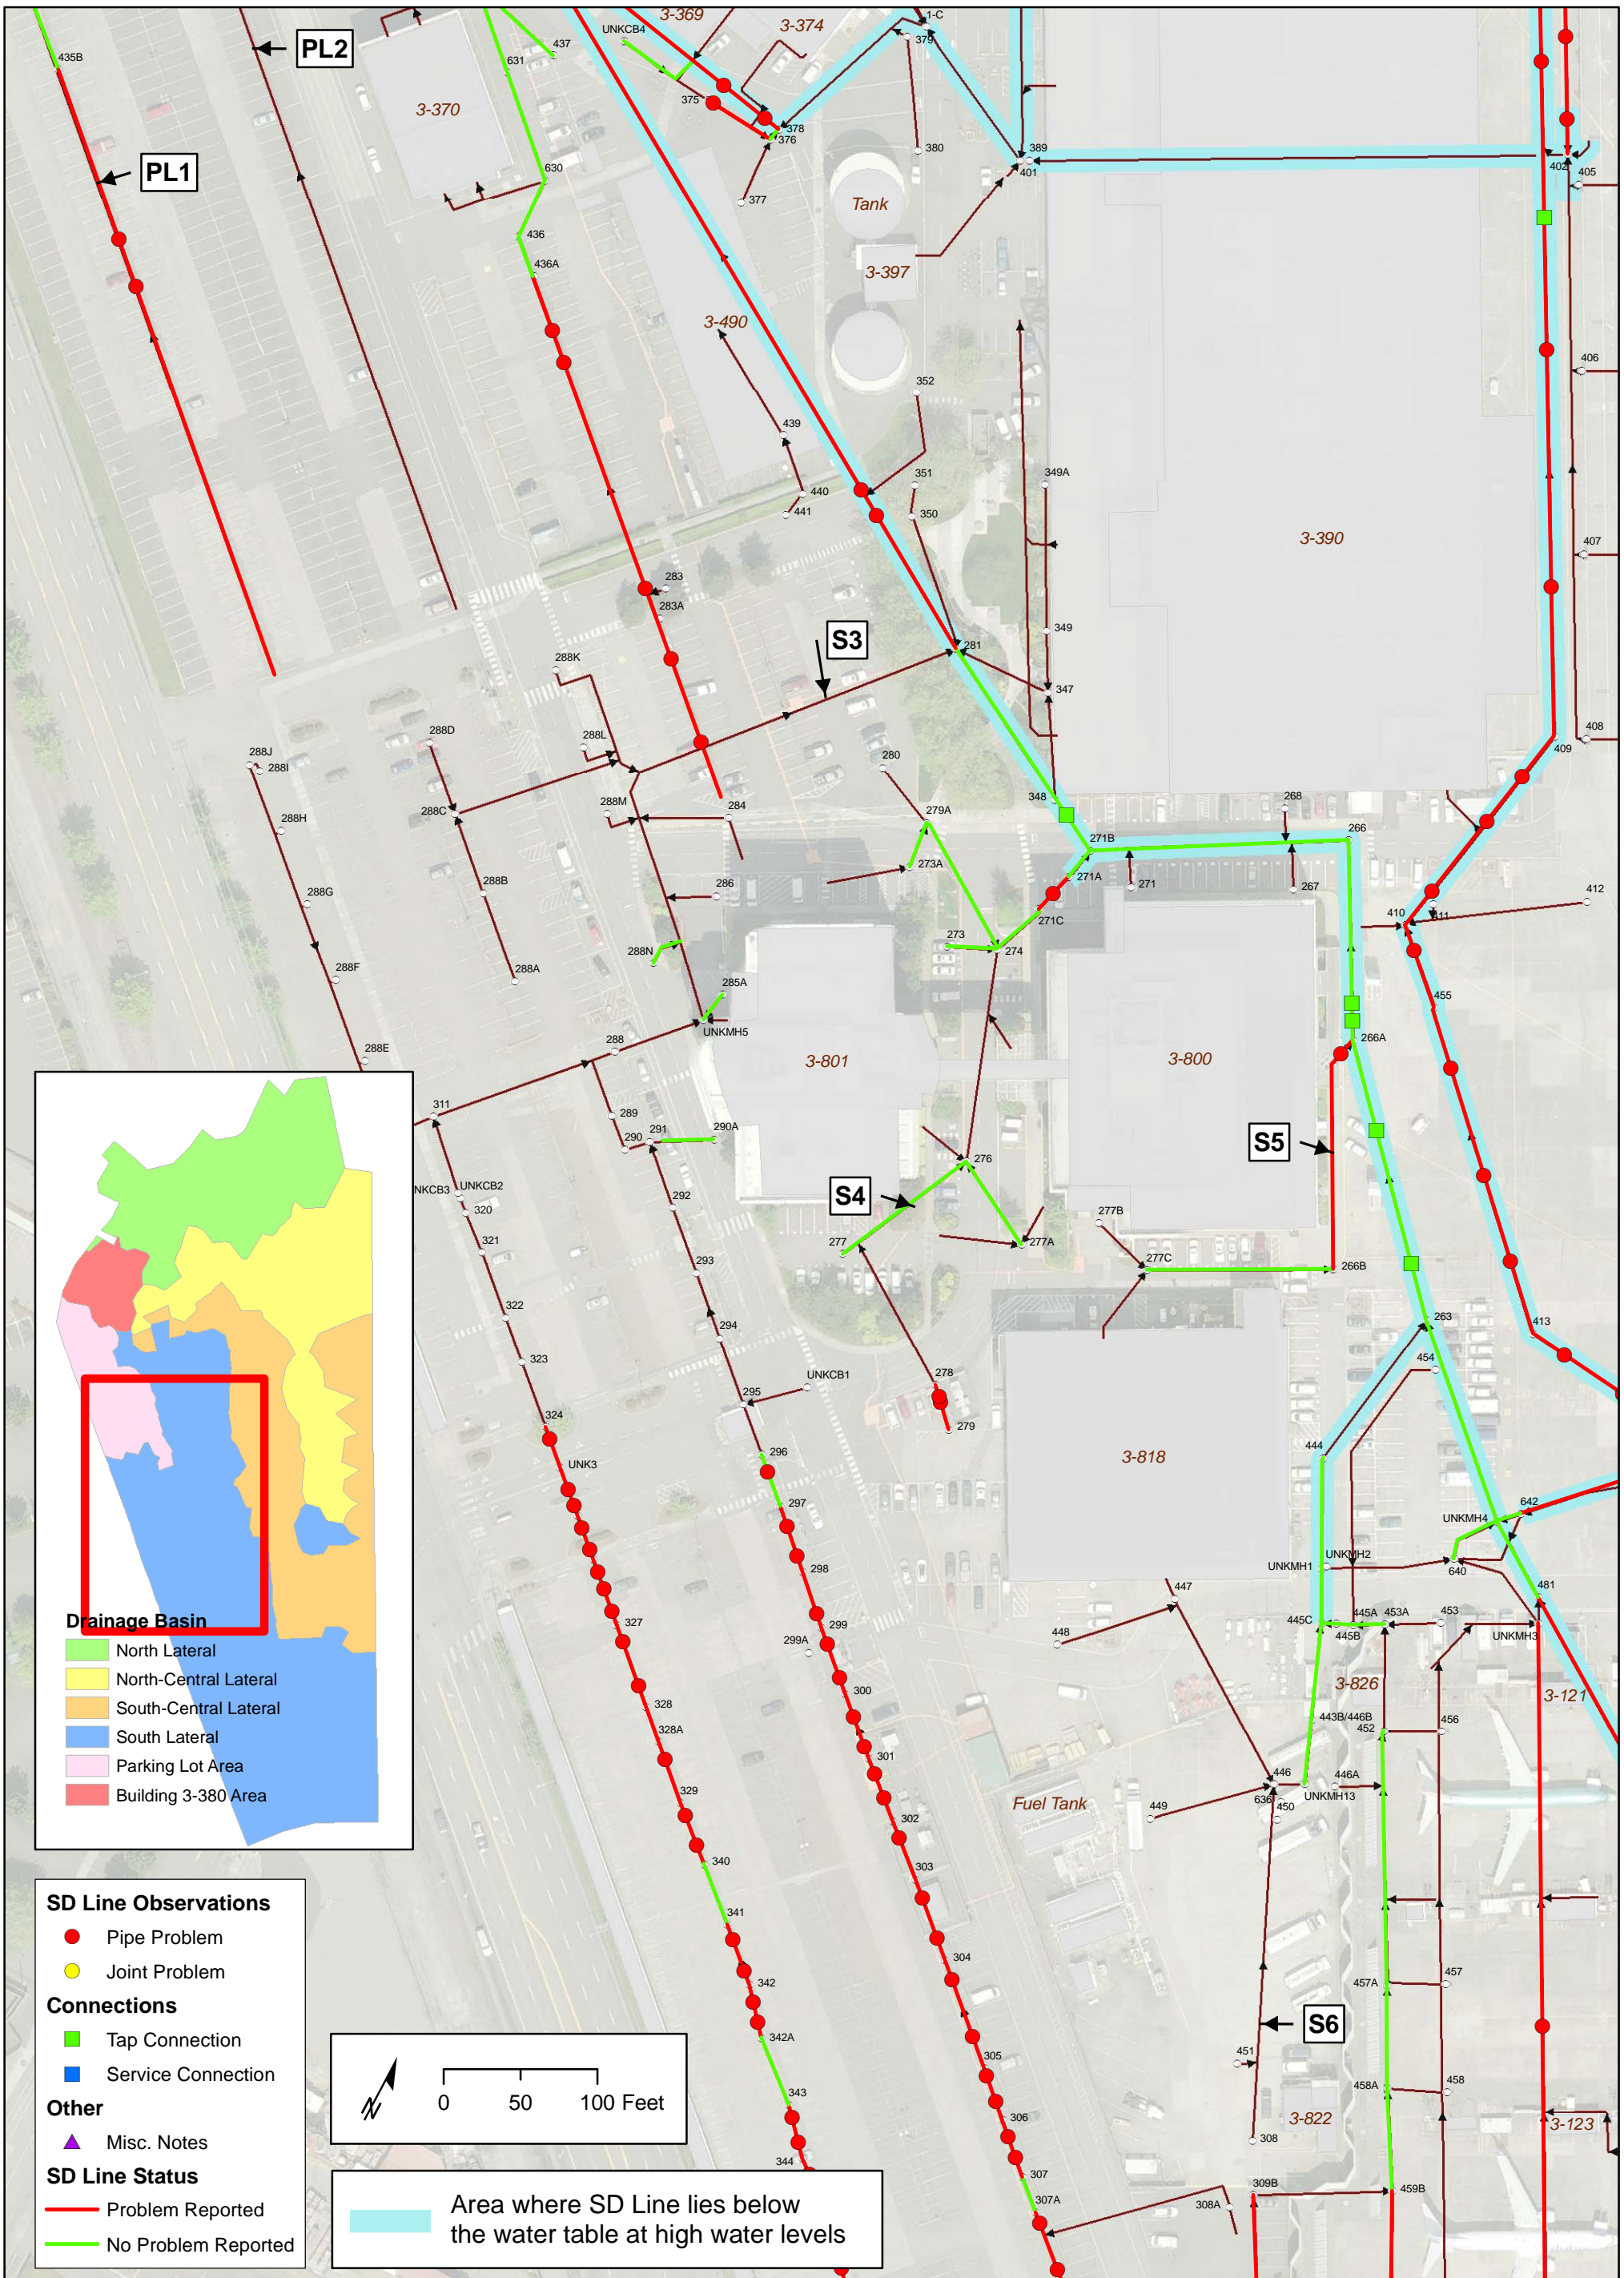
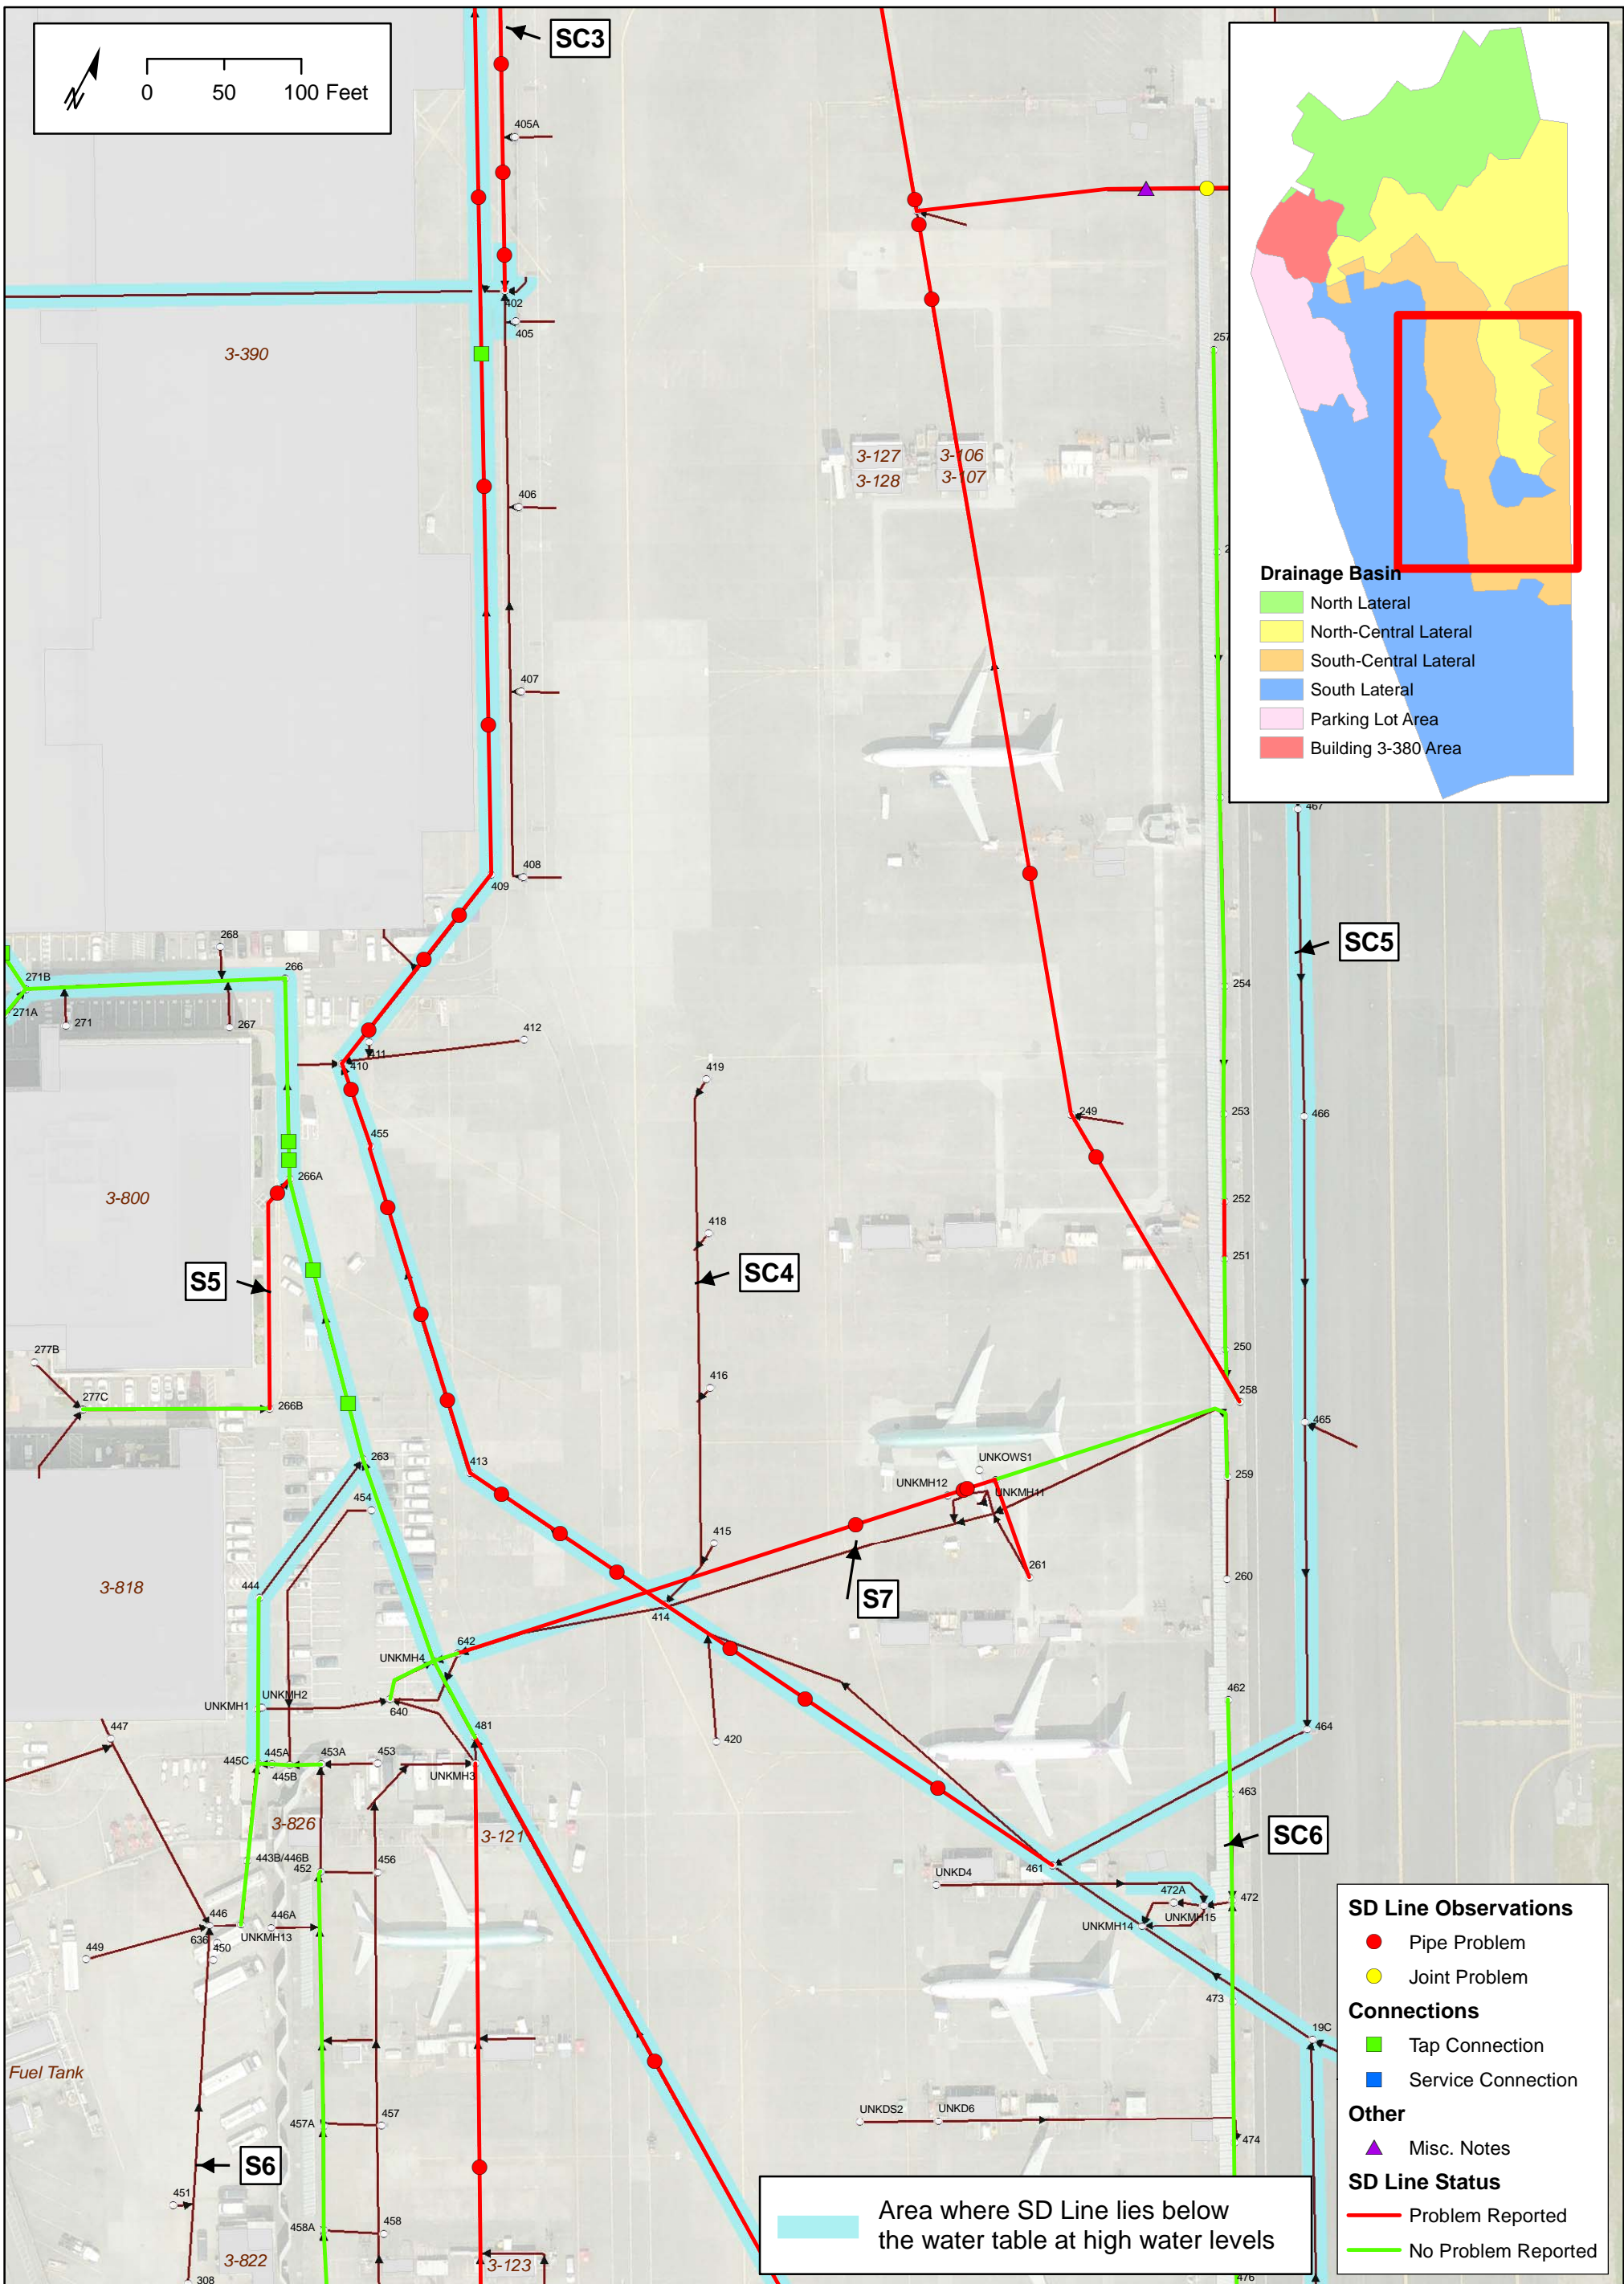
**Figure 5-33d. Results of 2010 Storm Drain Video Inspection**

*North-central lateral area:* Data containing results of the cleaning and video inspection of segments of lines NC1, NC2, NC3, and NC5 were lost due to a malfunction. Signs of soil infiltration were confirmed in line NC3, but this line is not submerged by groundwater. Five segments indicated cracks, fractures, or separated joints but showed no signs of infiltration. In addition, seven tap connections were observed to be unplugged or uncapped.

*South-central lateral area:* Of the 17 line segments inspected, 9 indicated signs of soil and/or groundwater infiltration; all were located in the main line, which is entirely submerged in groundwater. The majority of the main line, SC1, indicated signs of infiltration. In addition, four tap connections were observed to be unplugged or uncapped.

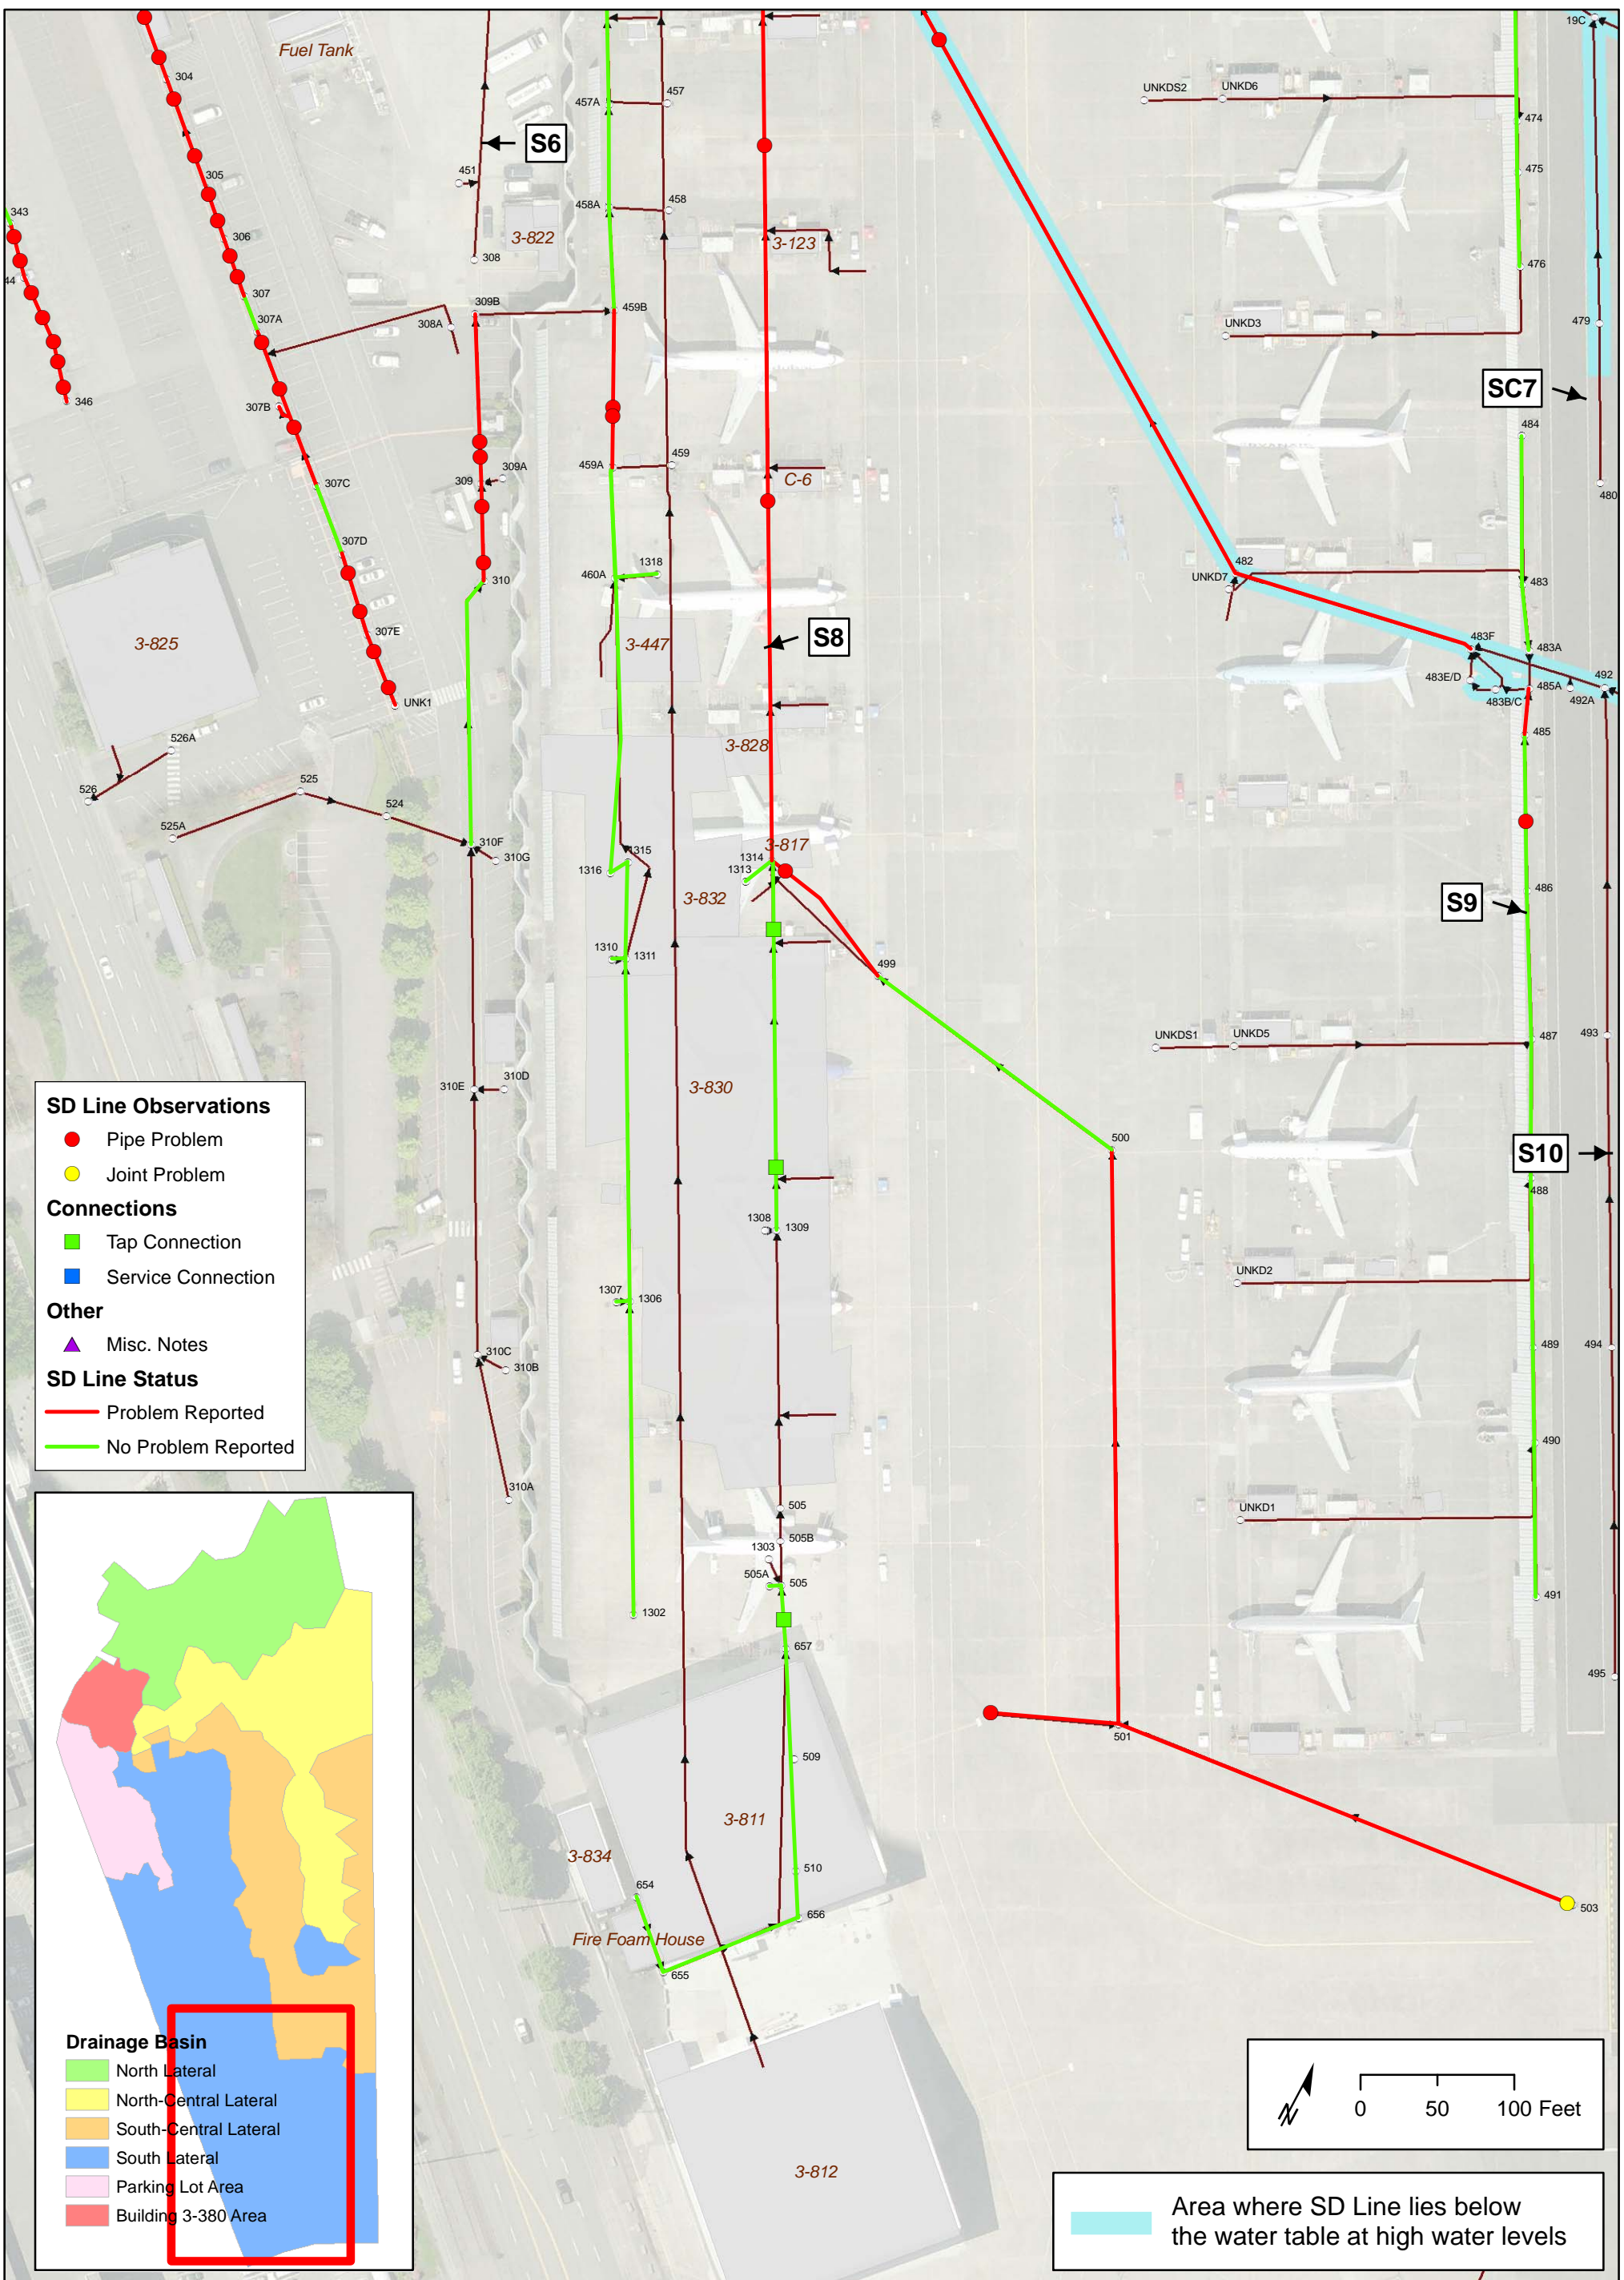
Figure 5-33e. Results of 2010 Storm Drain Video Inspection

*Building 3-380 area:* One SD line segment had minor cracks but it is shallow and not submerged, and thus not subject to groundwater infiltration.
