# Cleanup Action Completion Report

## East Bay Redevelopment Site

September 2023

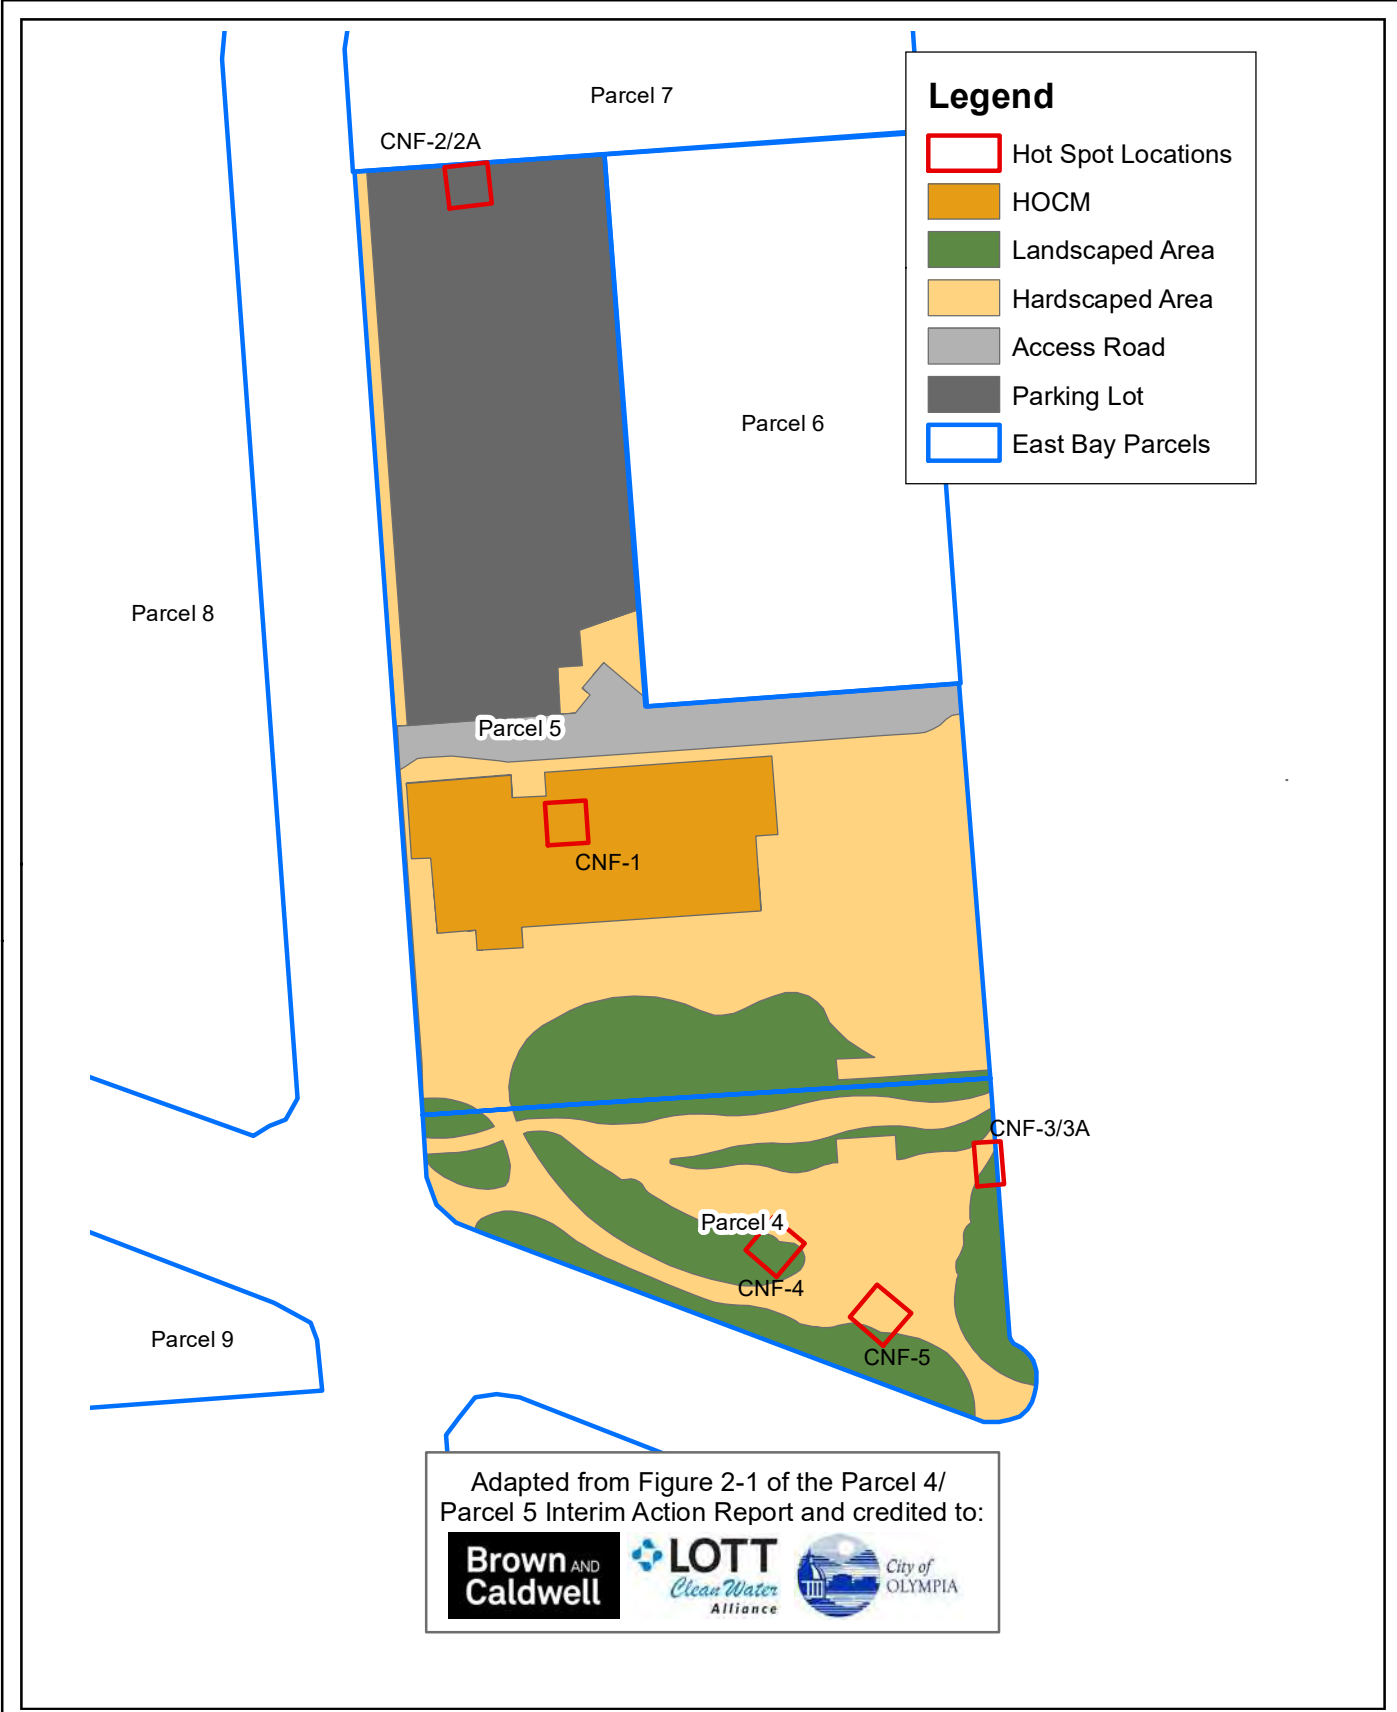
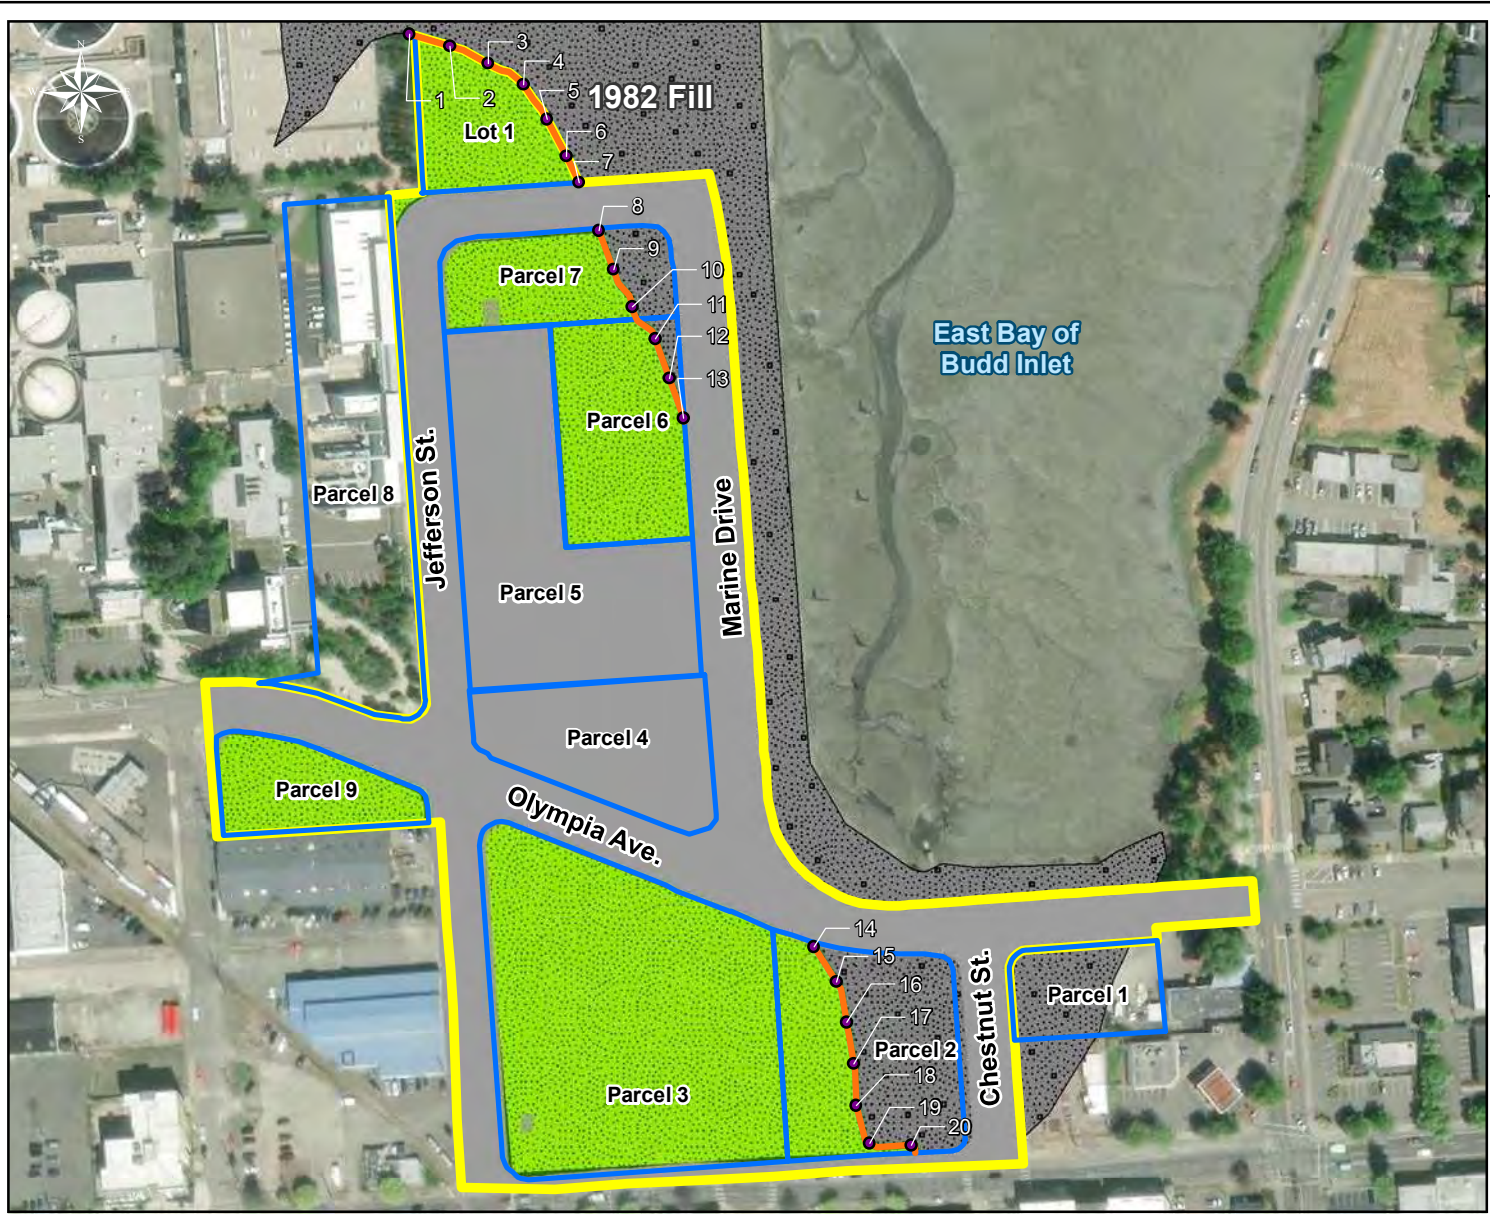
Figure 4

Fill Confirmation Hole Locations Along 1982 Fill Boundary  
 Cleanup Action Completion Report  
 East Bay Redevelopment Site

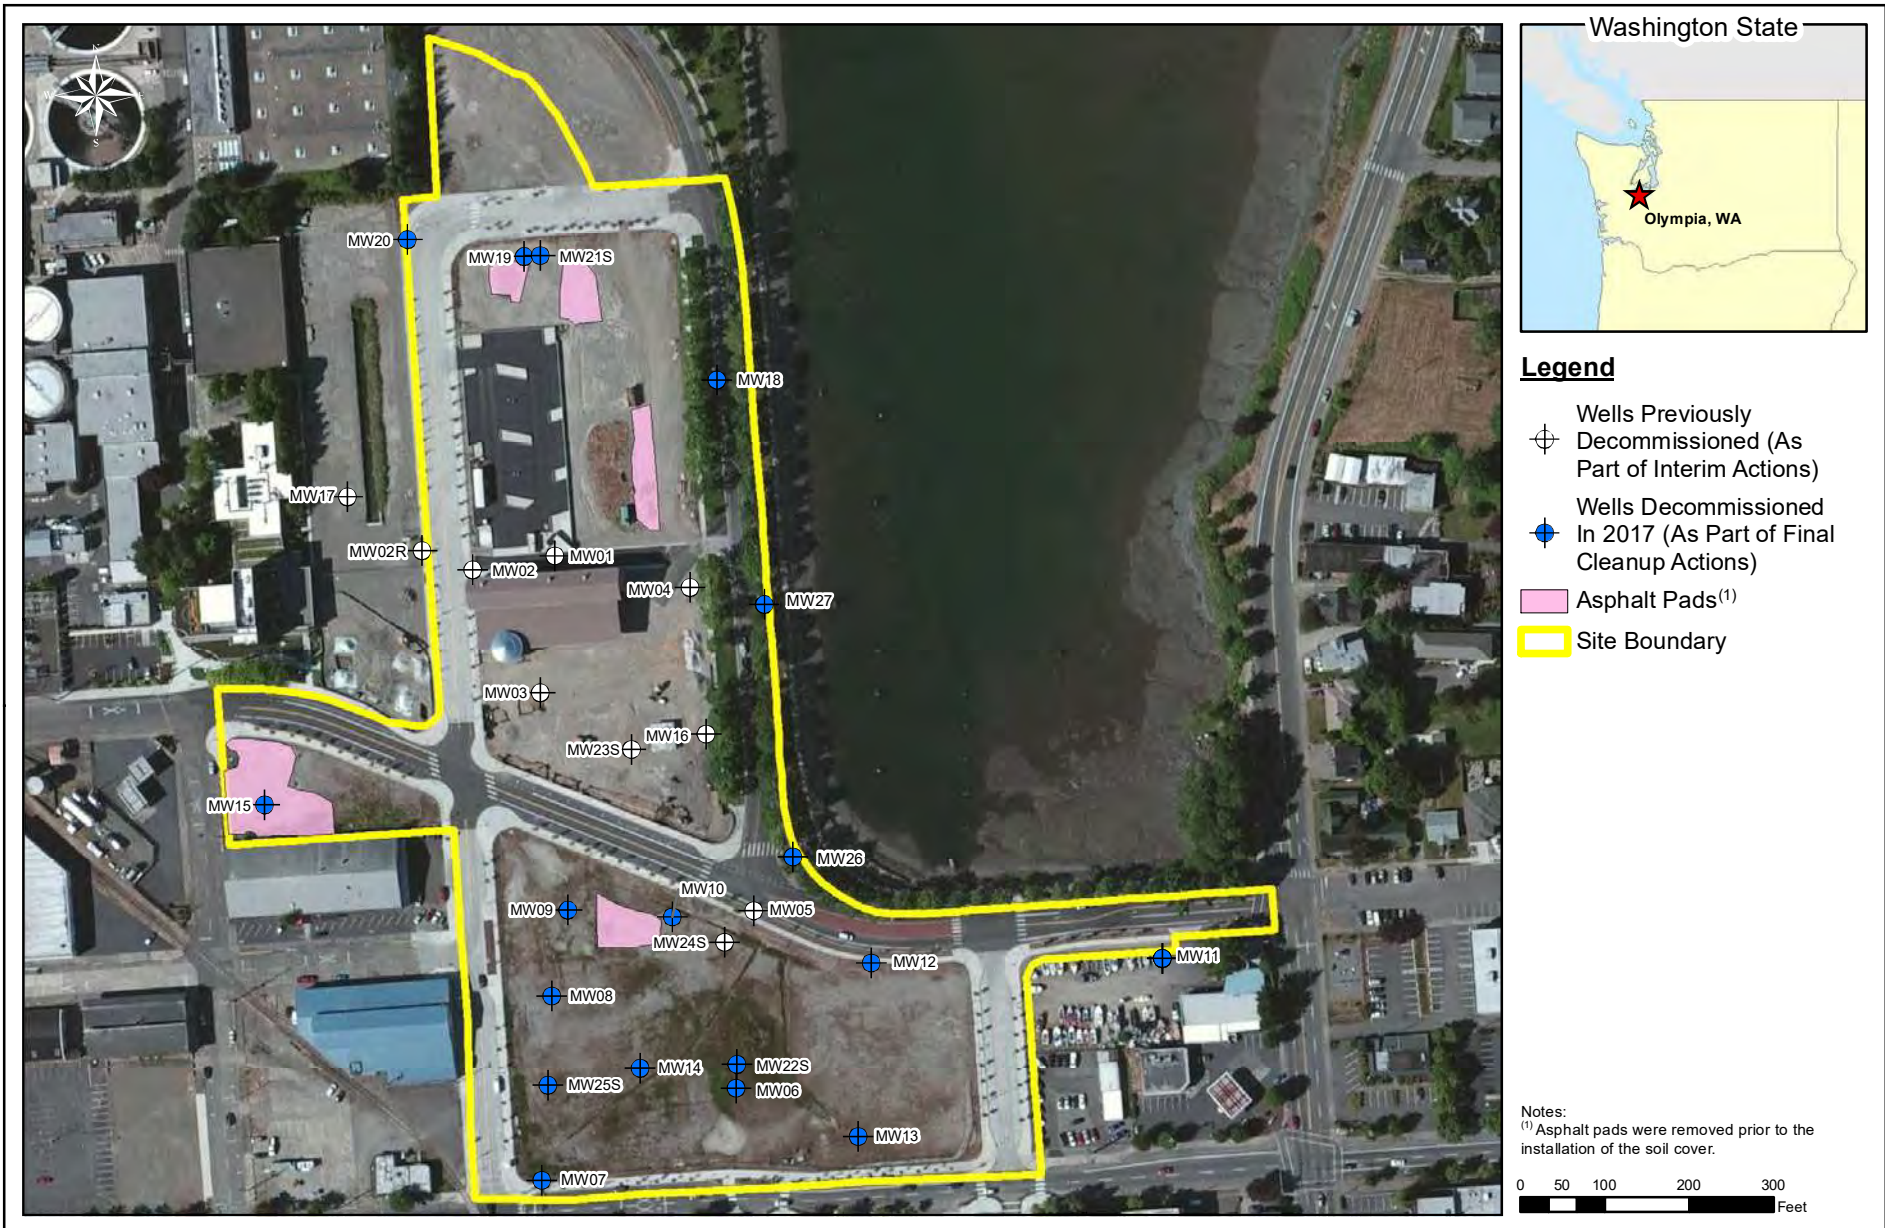
Figure 5

Locations of Decommissioned Wells and Removed Asphalt Pads  
Cleanup Action Completion Report  
East Bay Redevelopment Site

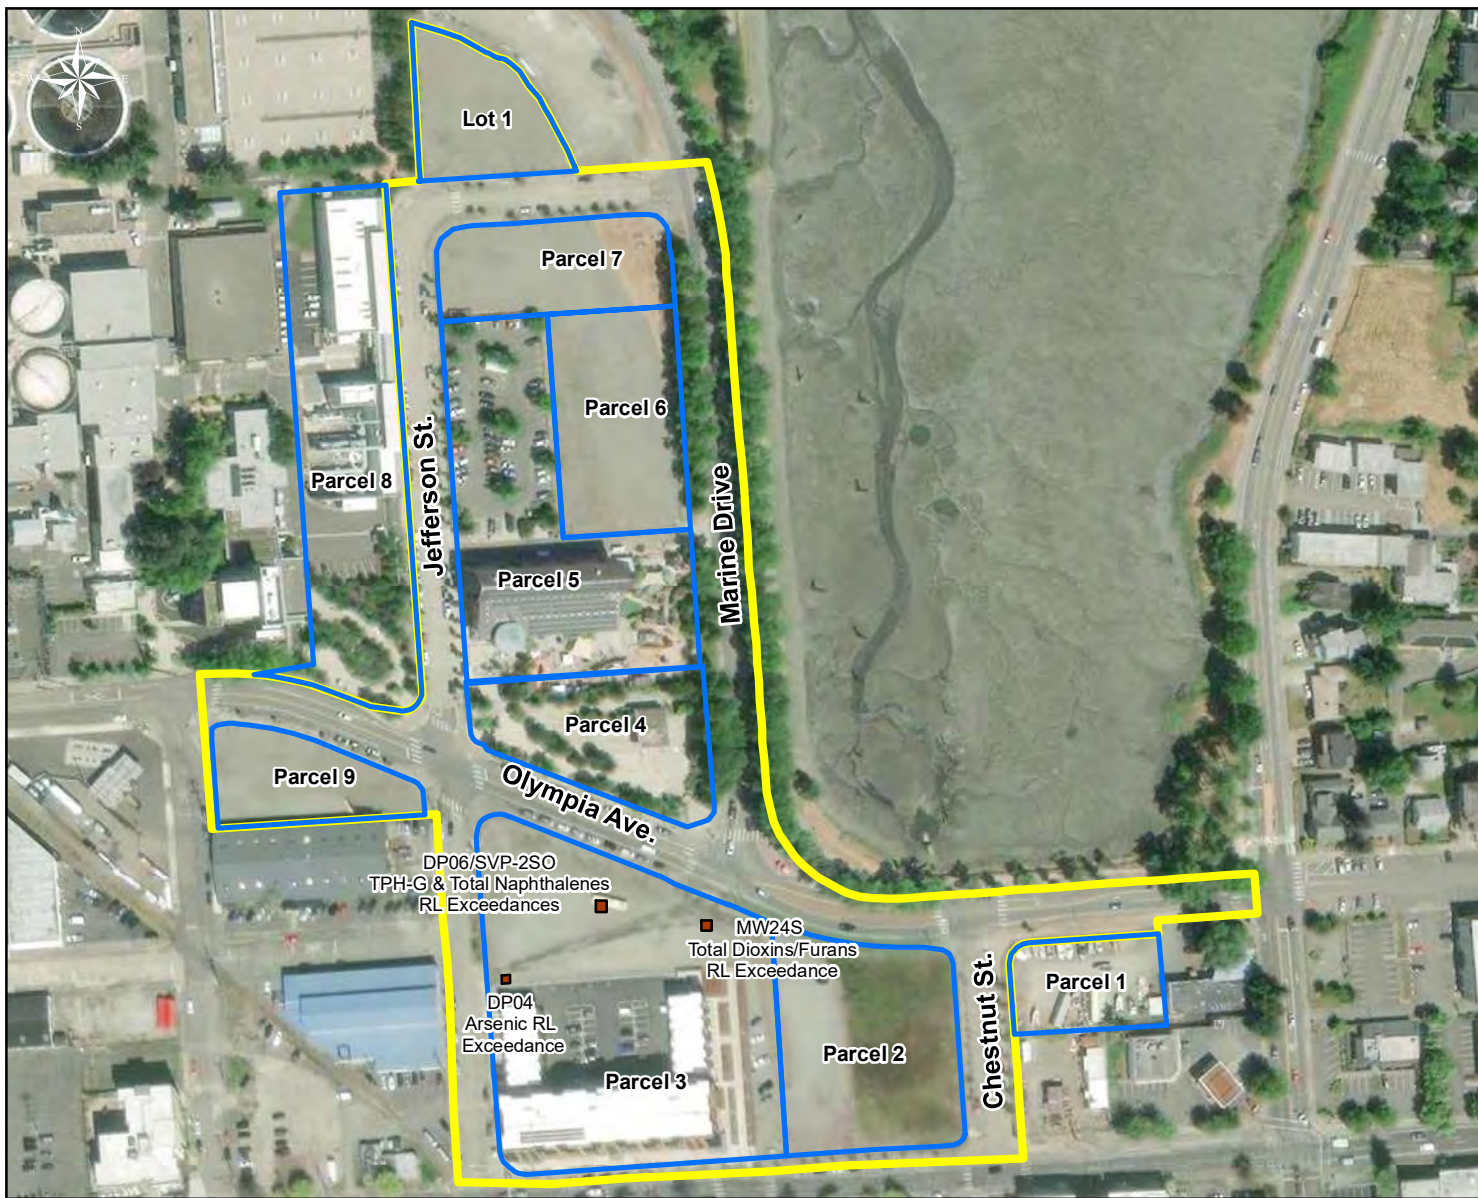
Figure 6

Soil Excavation Locations  
 Cleanup Action Completion Report  
 East Bay Redevelopment Site

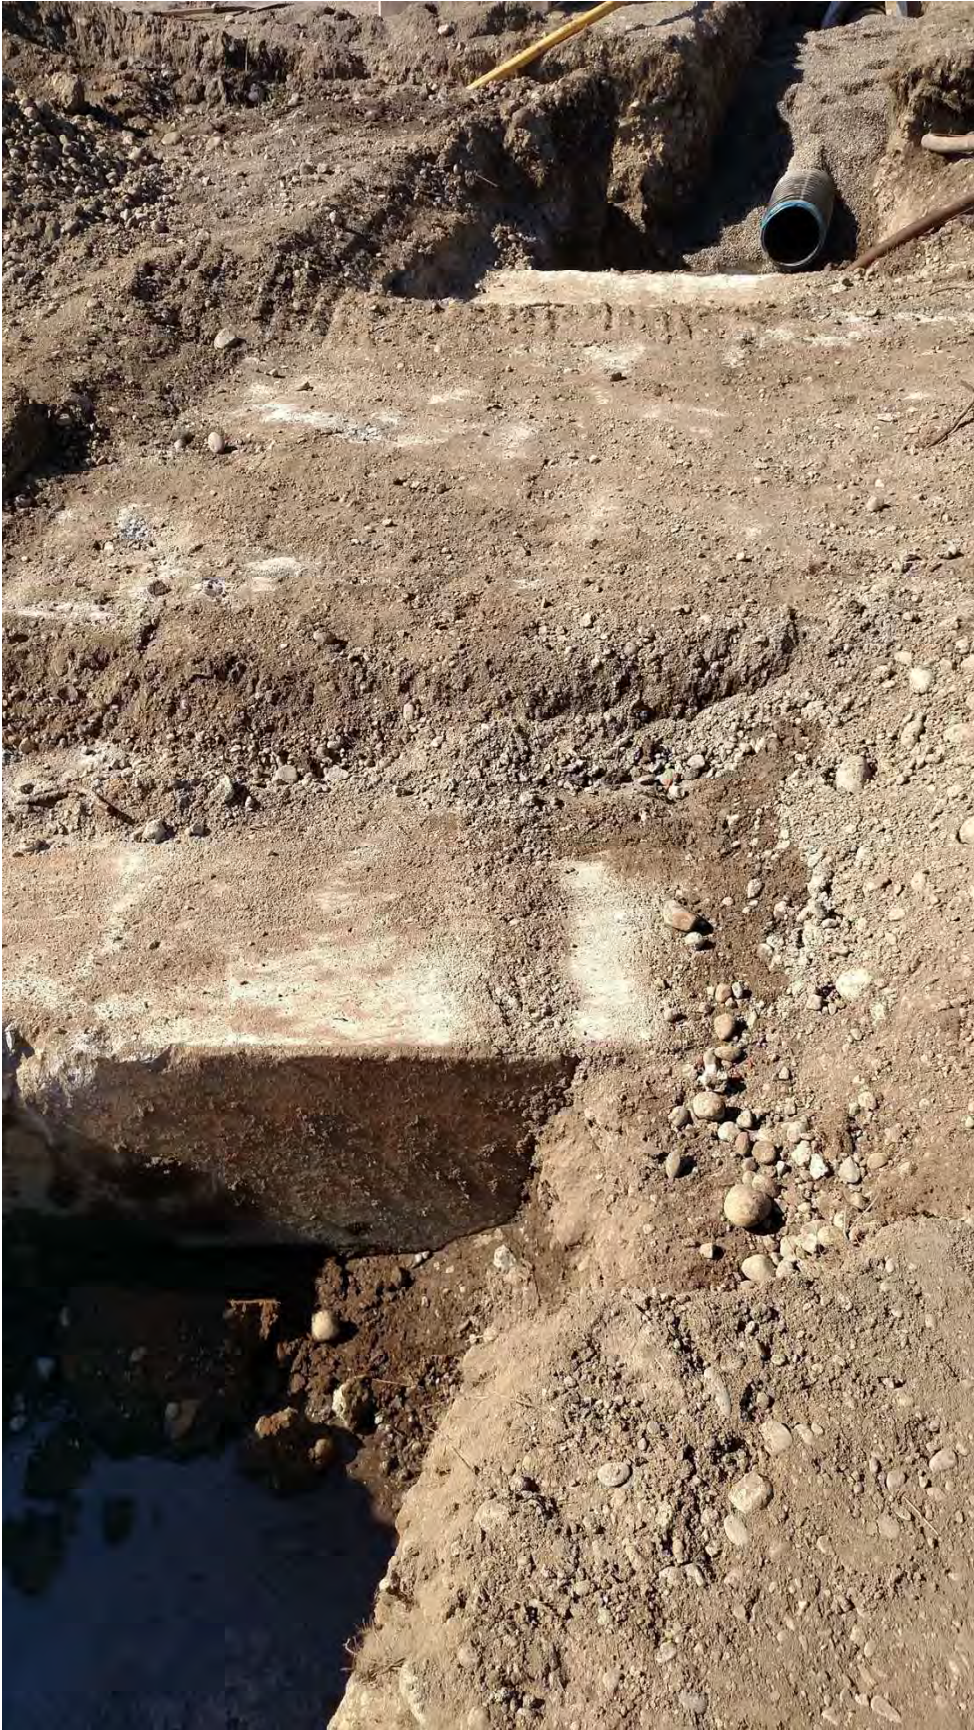
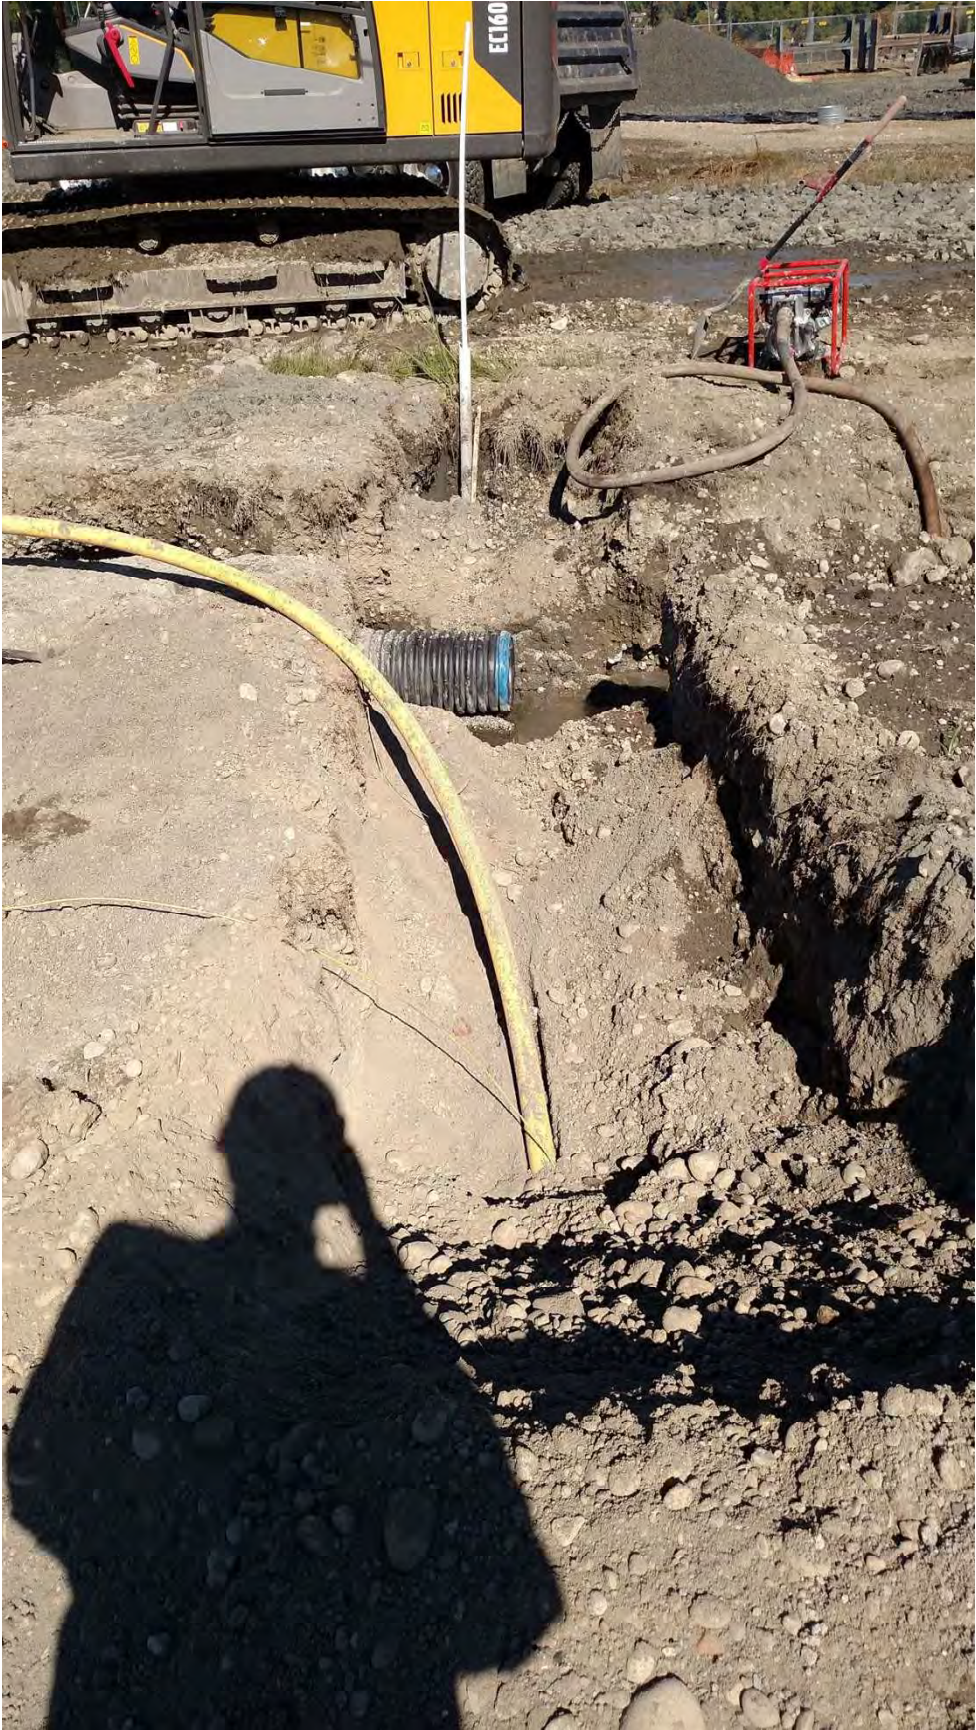
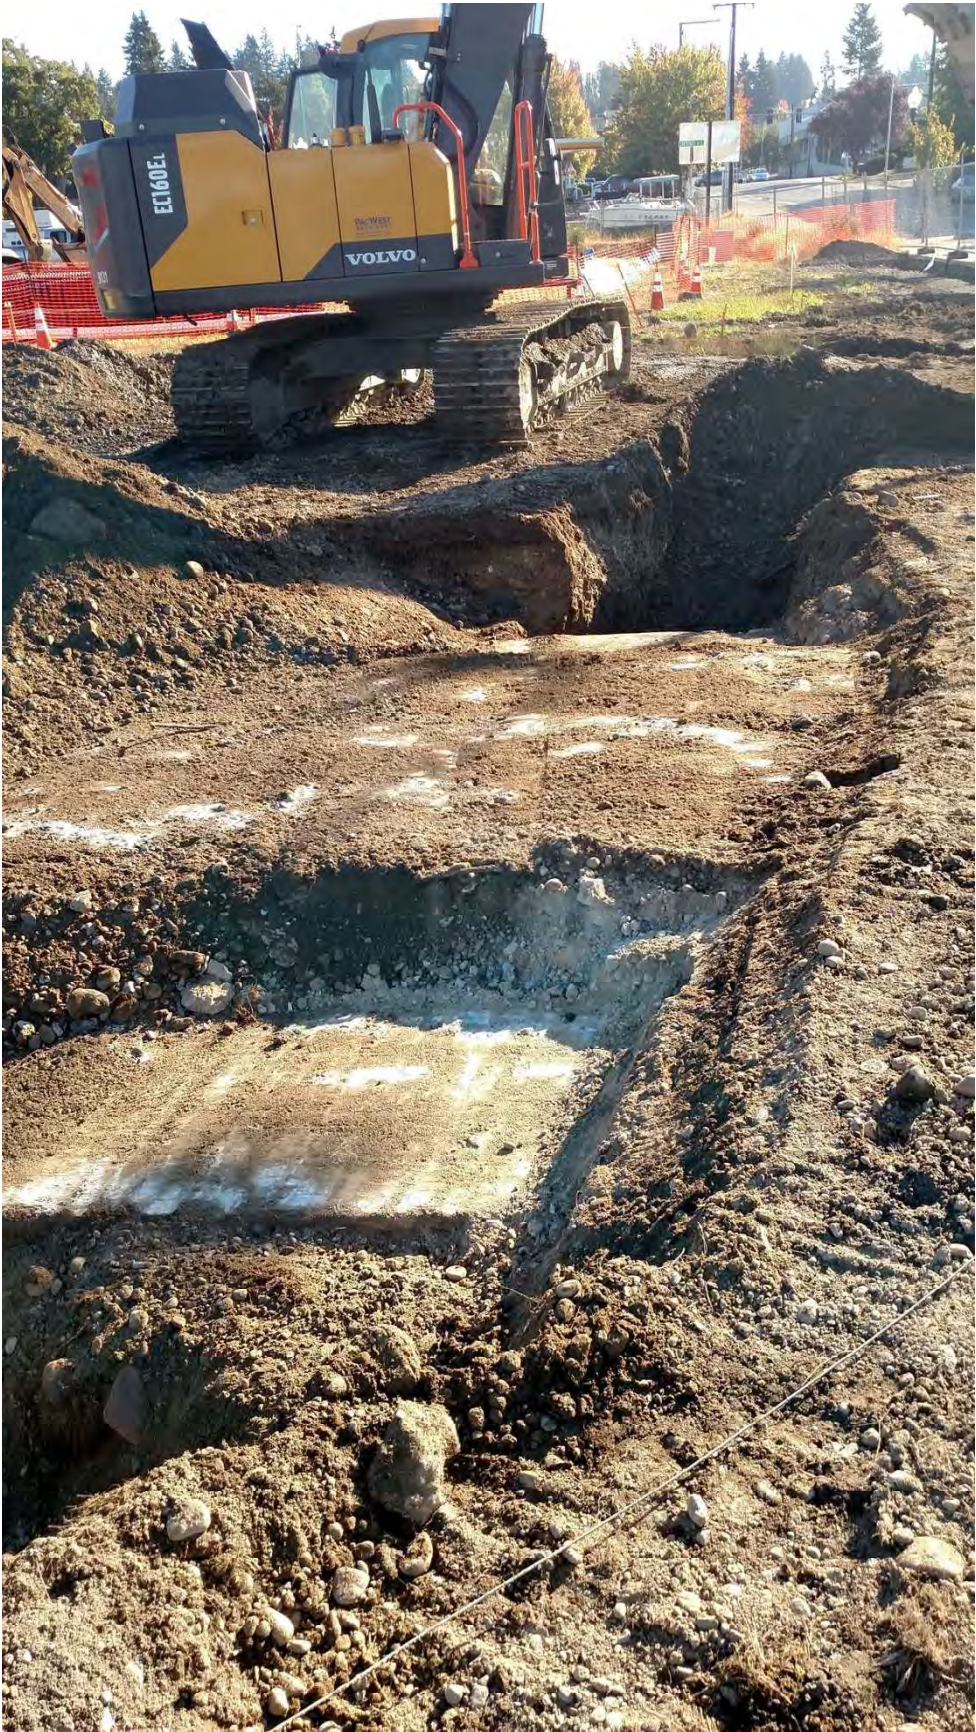
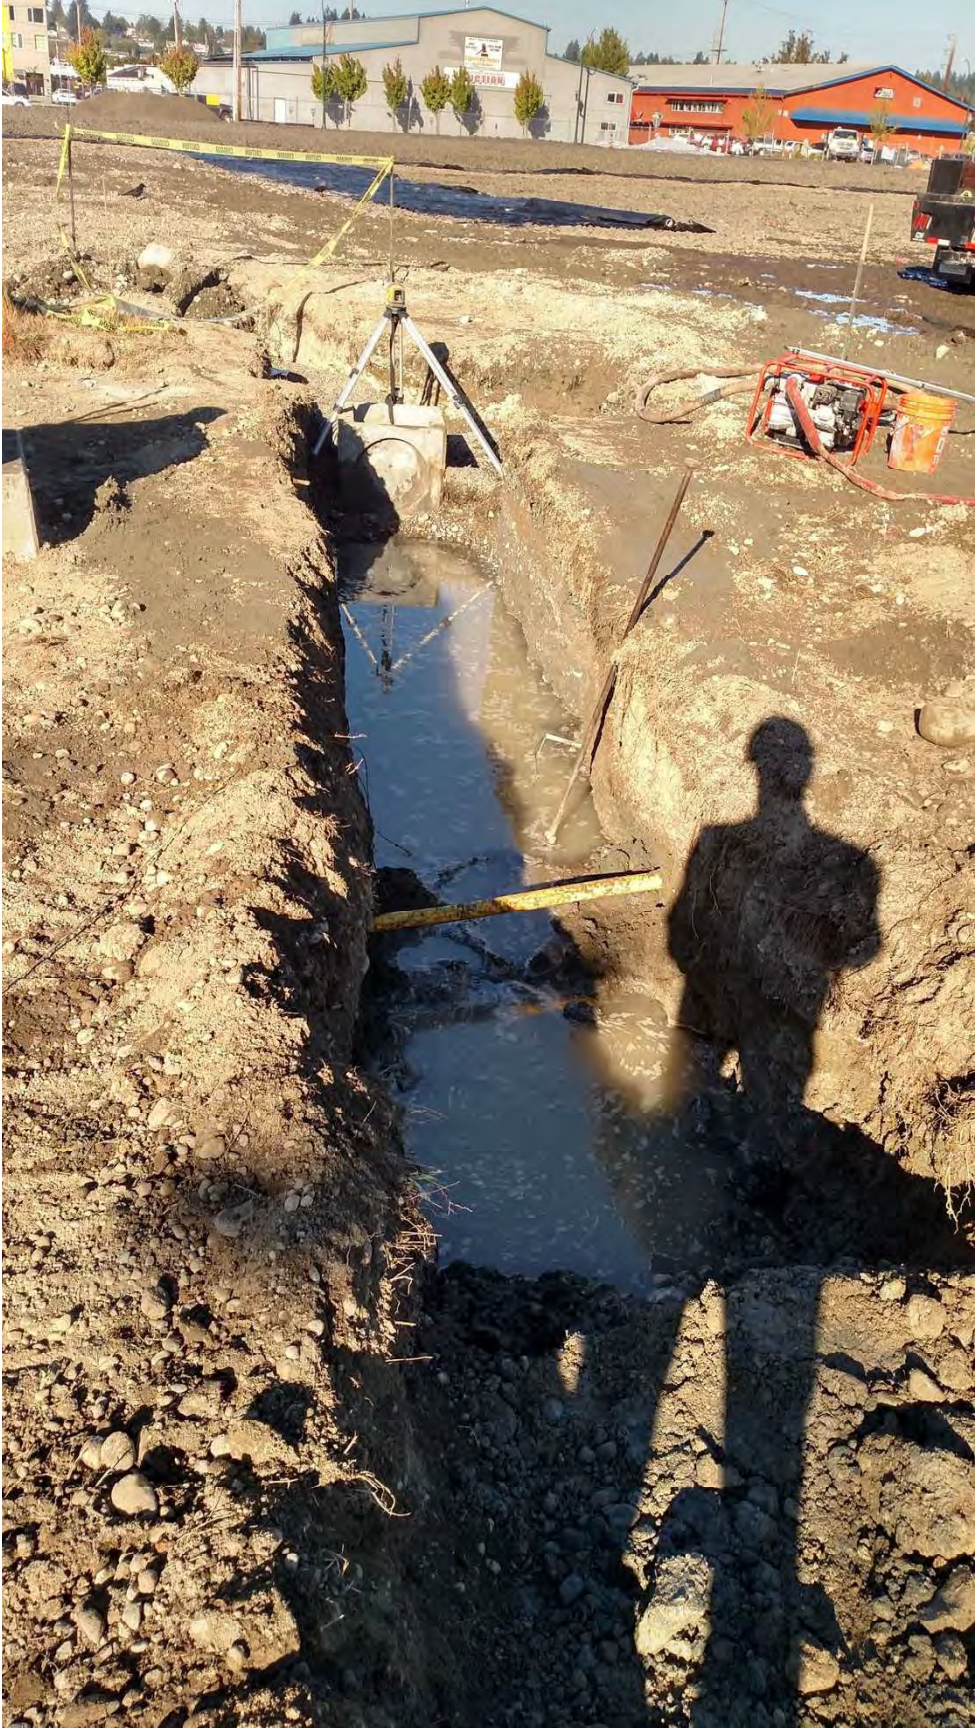
A large concrete foundation (about 15 feet wide and at least 4 feet deep) was discovered about half way between CB#2 and CB#3. It will need to be removed from the trench. IOEI was able to locate an available excavator with a rock hammer for the removal from Tyler Rental that can be delivered either Friday or Monday. Equipment rental costs is about \$2,000 per day and about \$6,000 per week.

Given the foundation obstruction, the crew moved on to installing CB#5 and the 12" storm pipe between CB#3 and CB#5.
