PIONEER DAILY FIELD REPORT

Parcel 2 and 3 Survey Points
Cleanup Action Completion Report
East Bay Redevelopment Site

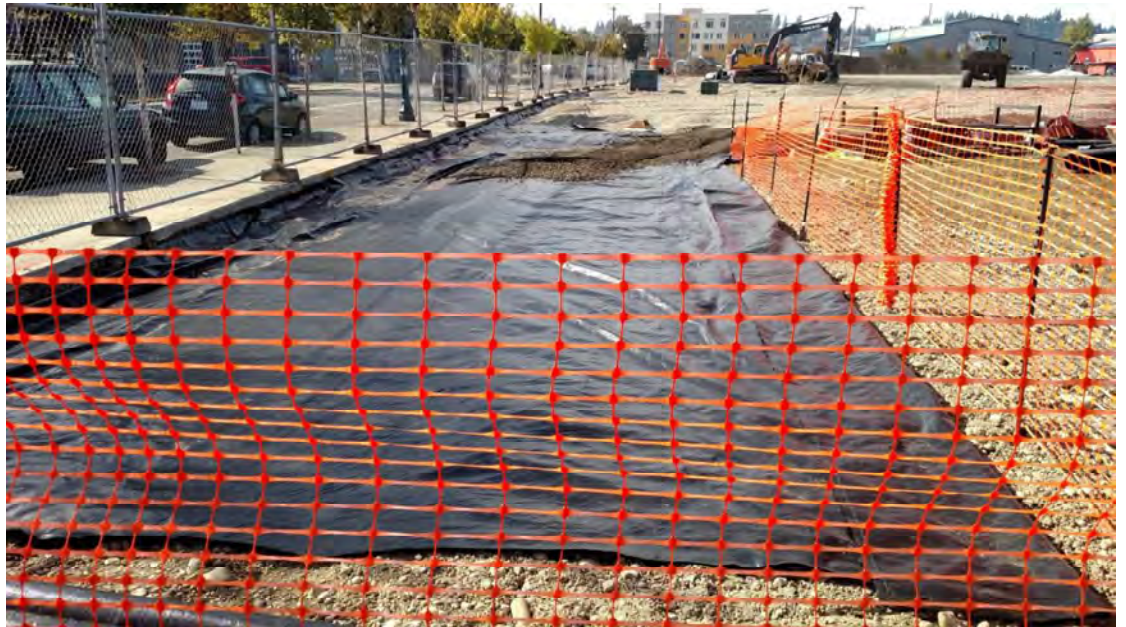
Description: High visibility, temporary construction fencing separated the area to receive the new soil cover from the area with clean 1982 fill material in place. (Parcels 2/3)

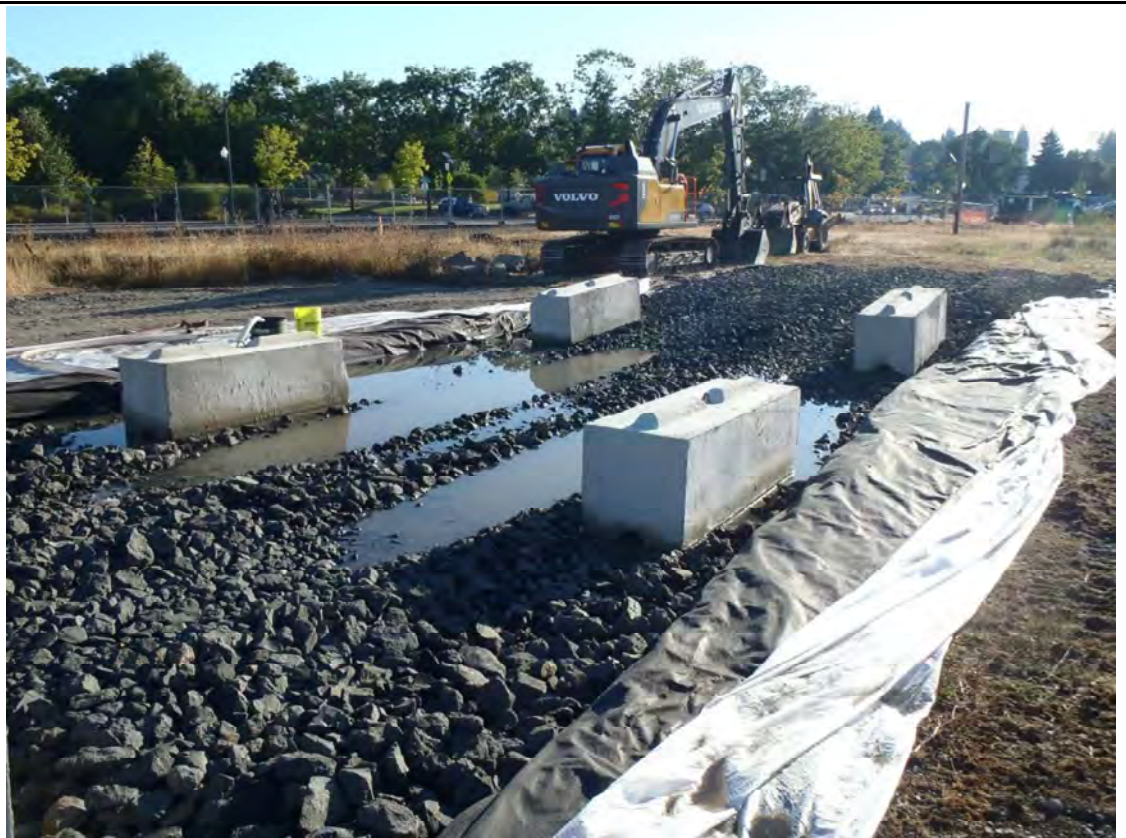
Photo No. 2: Wheel Wash (1)

Description: Wheel wash for Parcels 2/3, built into western construction entrance/exit.

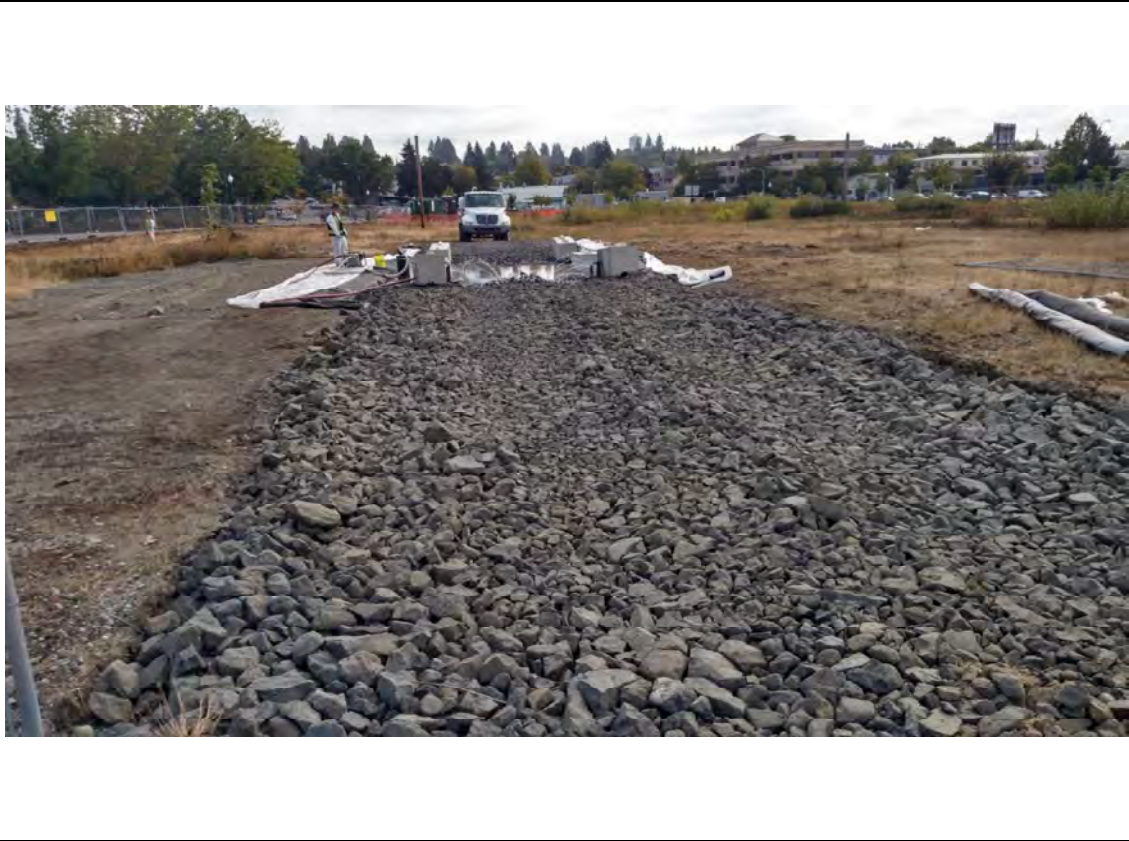
Photo No. 3: Wheel Wash (2)

Description: Wheel wash switched on / prepared for a truck to drive through (Parcels 2/3).

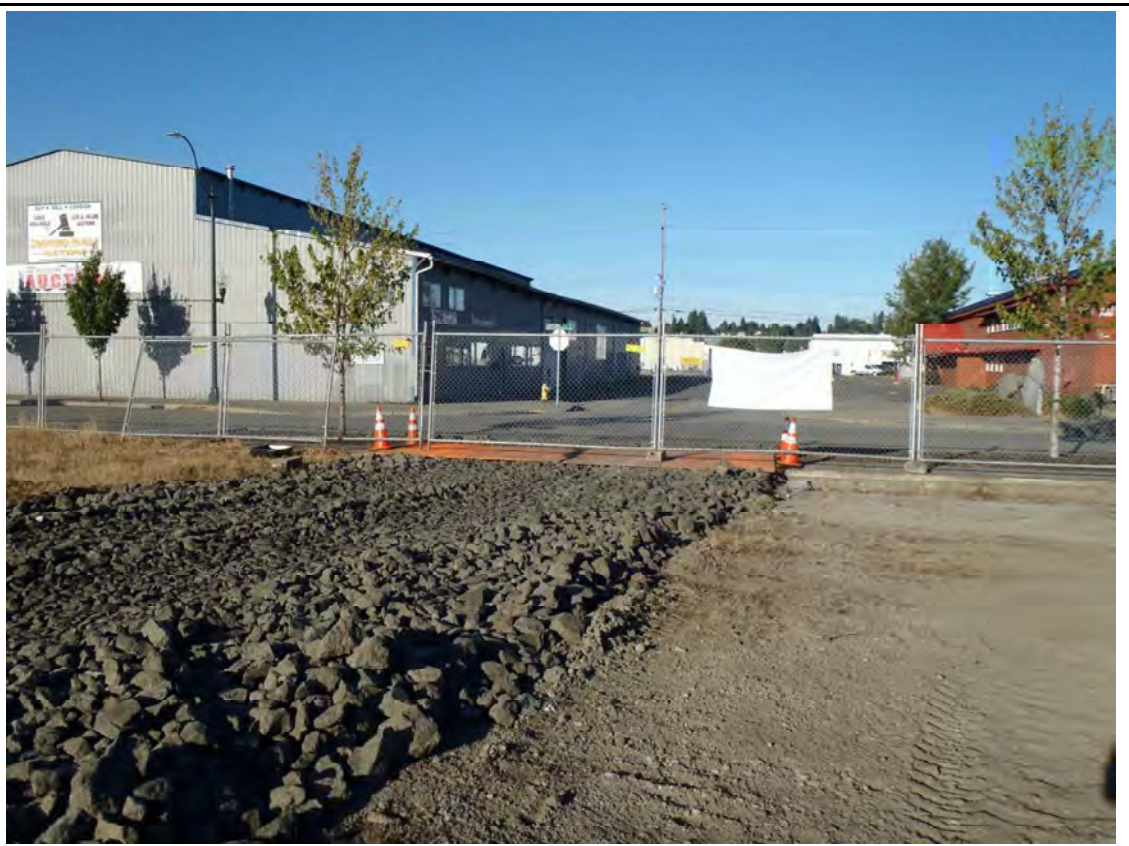
Photo No. 4: Construction Entrance (1)

Description: Jefferson Street construction entrance/exit for Parcels 2/3.

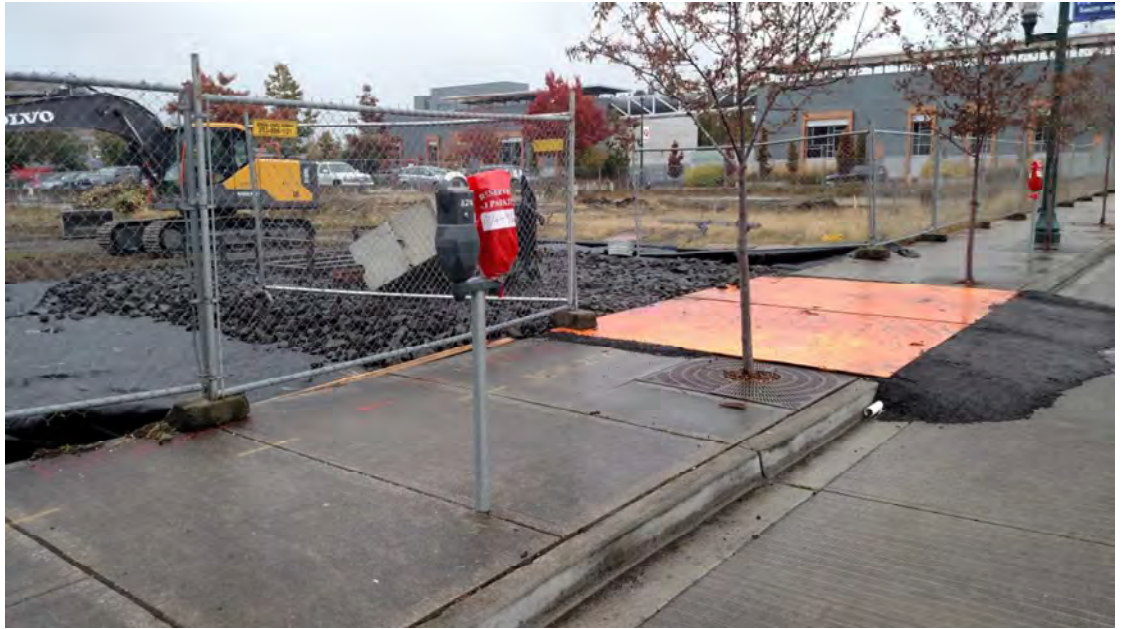
Photo No. 5:
Construction Entrance
(2)

Description:
Jefferson Street
construction
entrance/exit for
Parcels 6/7.

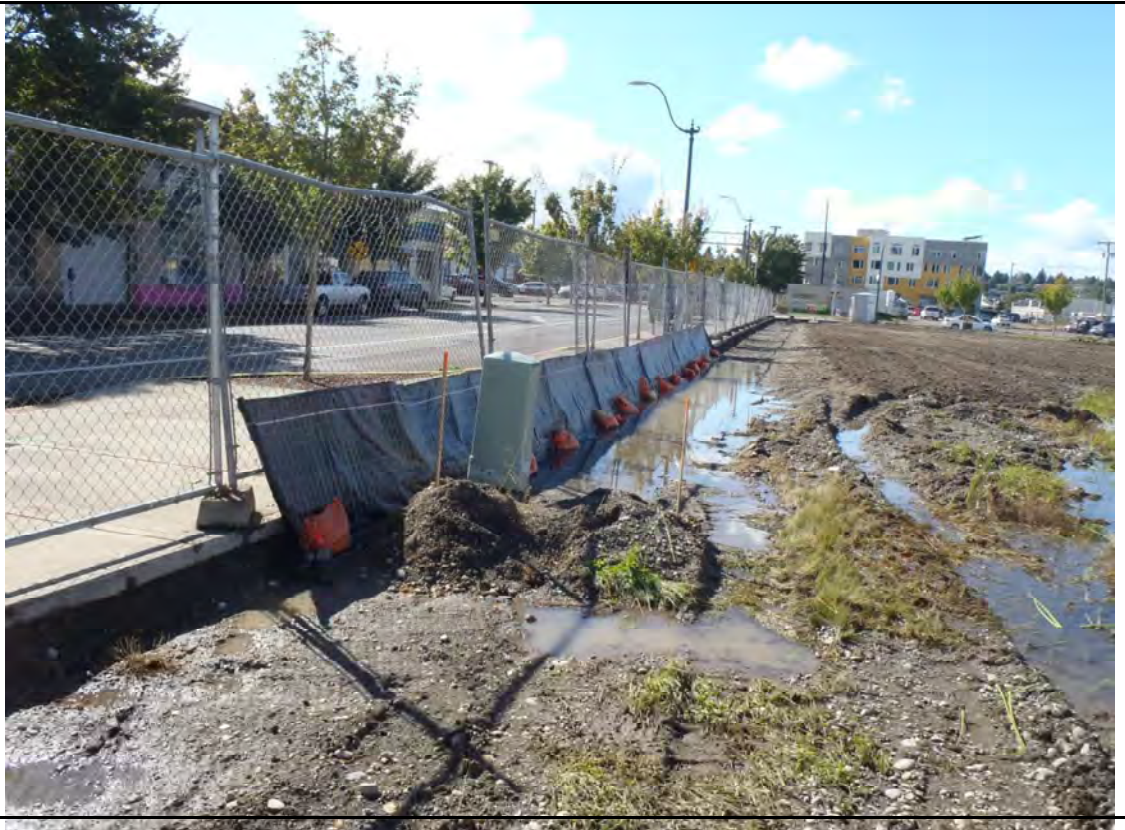
Photo No. 6: Silt Fence

Description:
A silt fence positioned
along the southern
fence line of Parcels
2/3 in an area with
pooling water.

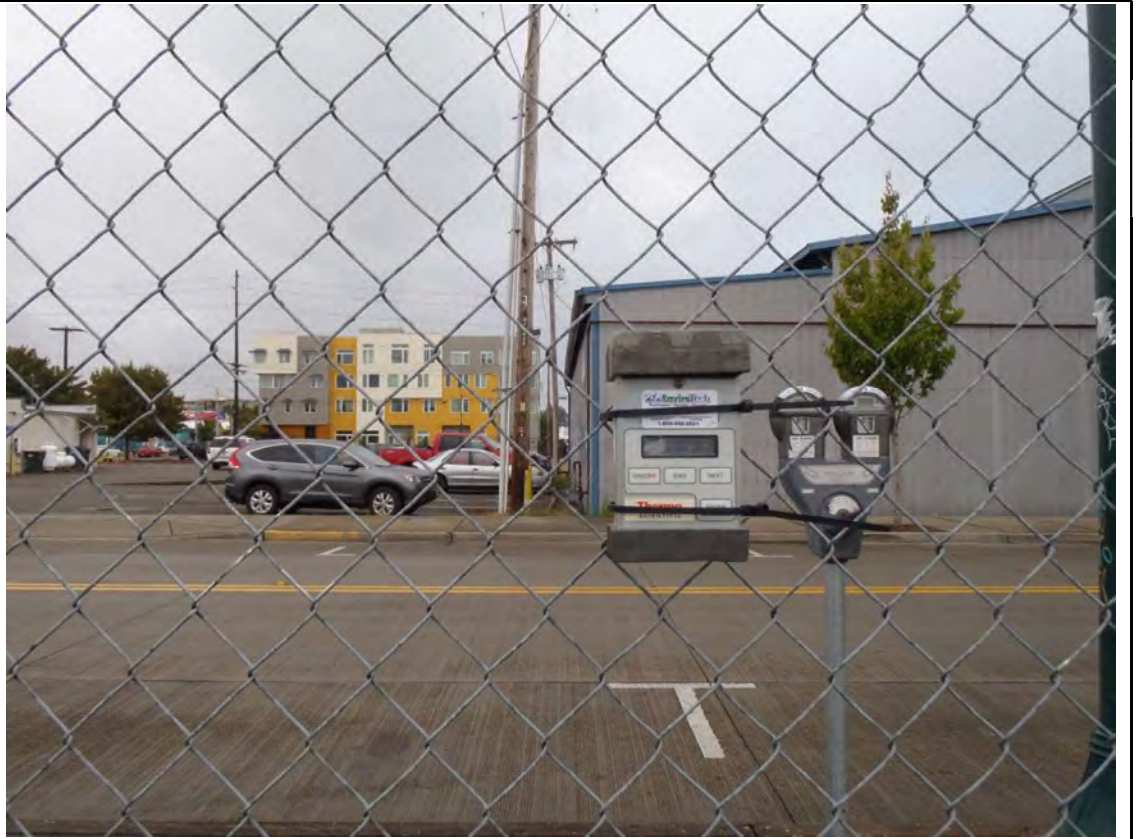
Photo No. 7: Dust Monitor

Description: One of the dust monitors used during potentially dust-generating construction activities (this one was positioned on the west fence line of Parcels 2/3).

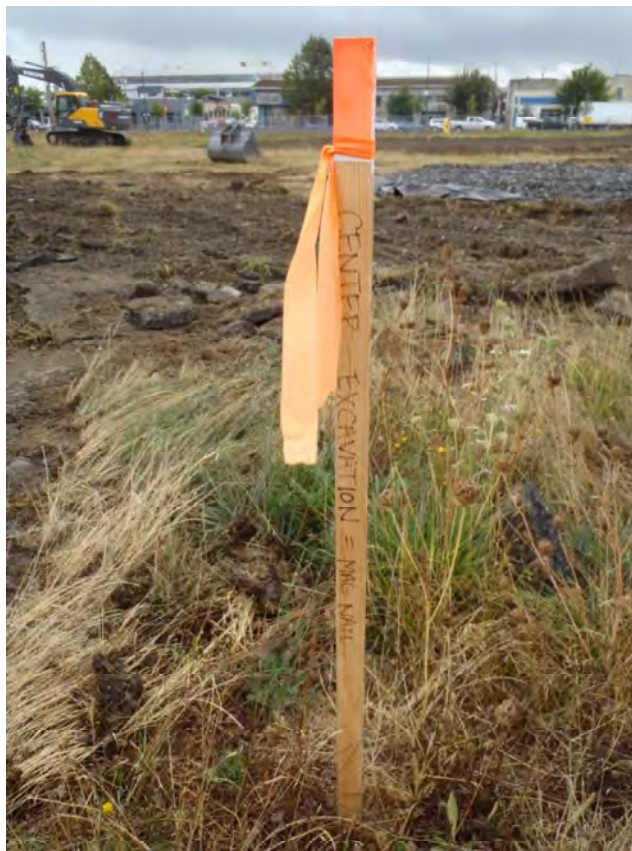
Photo No. 8:
Excavation Location Stake

Description: A stake to mark the center of excavation DP06/SVP-2SO.

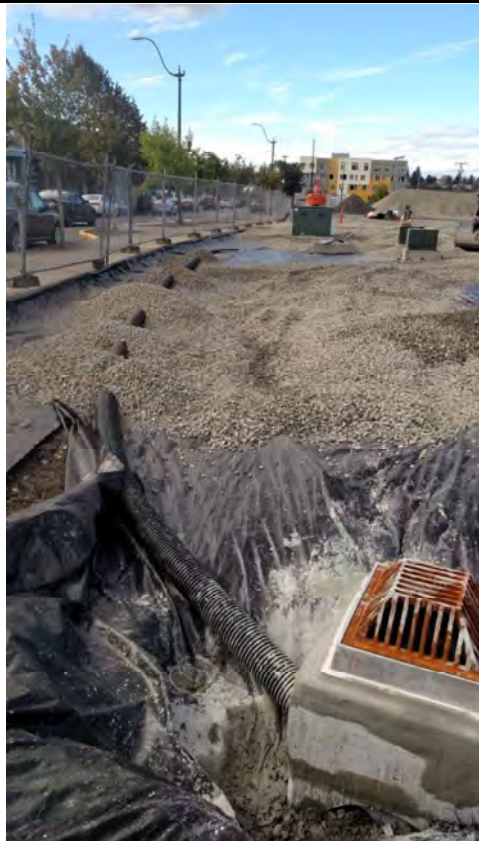
Photo No. 28:
Stormwater Routing (2)

Description:
Catch basin and stormwater piping installation prior to soil cover filling in the vicinity (Parcels 2/3).

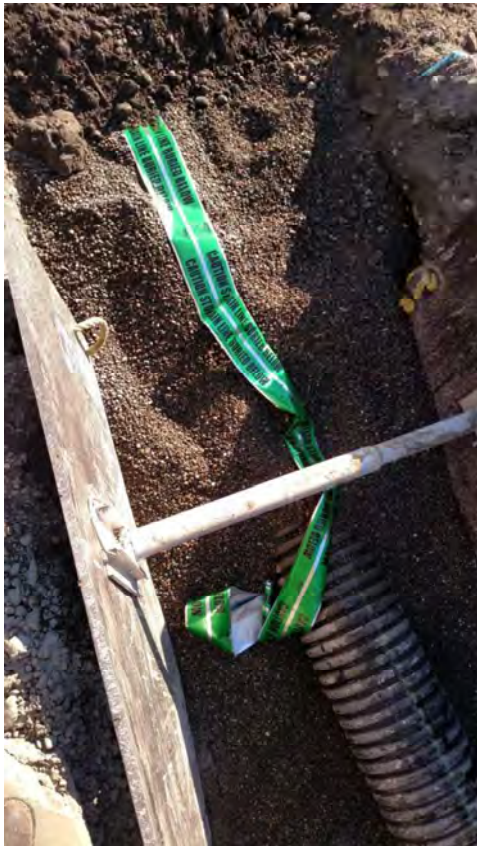
Photo No. 34: Stormwater Pipe Detectable Tape

Date: 10/5/17	
Direction Photo Taken: Unknown	
Description: Storm drain piping being installed with detectable tape strip (Parcels 2/3).

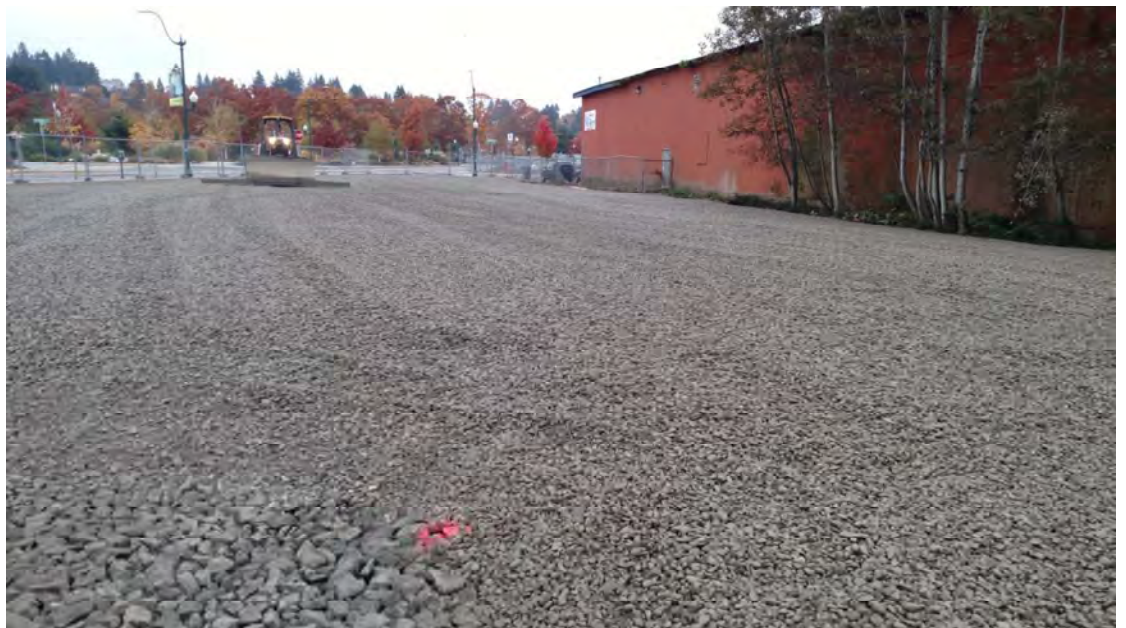
Photo No. 36: Grading
Soil Cover

Description:
A construction
crewmember working to
smooth the newly-
installed soil cover
surface (Parcel 9).

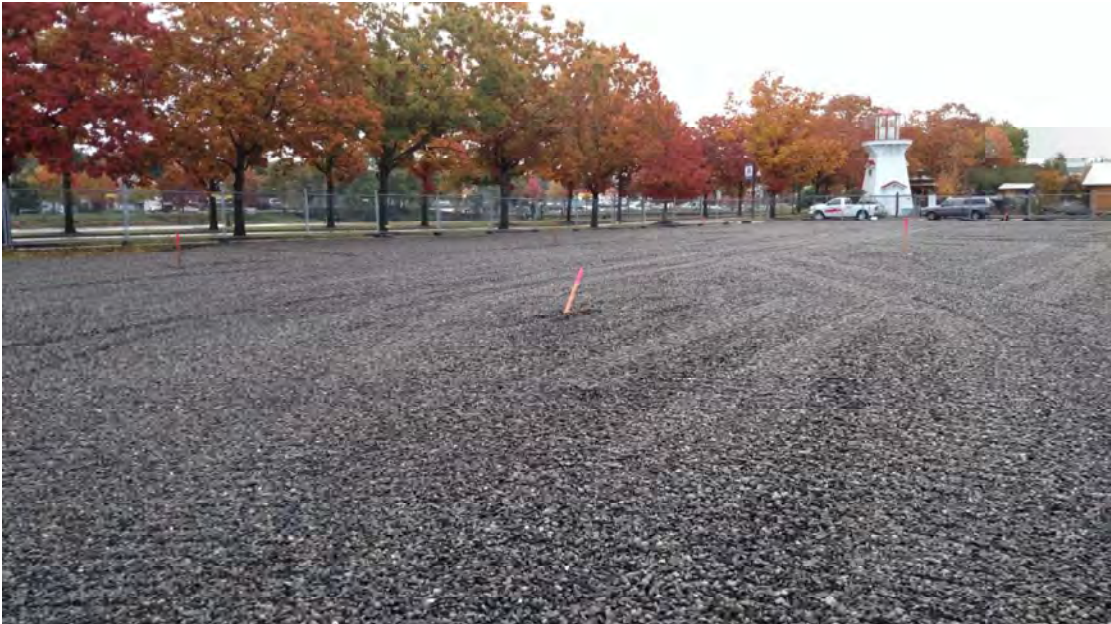
Photo No. 37: Portion of Finished Soil Cover

Date: 10/20/17	
Direction Photo Taken: Southeast	
Description: A view of the installed soil cover in Parcels 6/7. Staked elevation survey points are visible protruding from the cover.

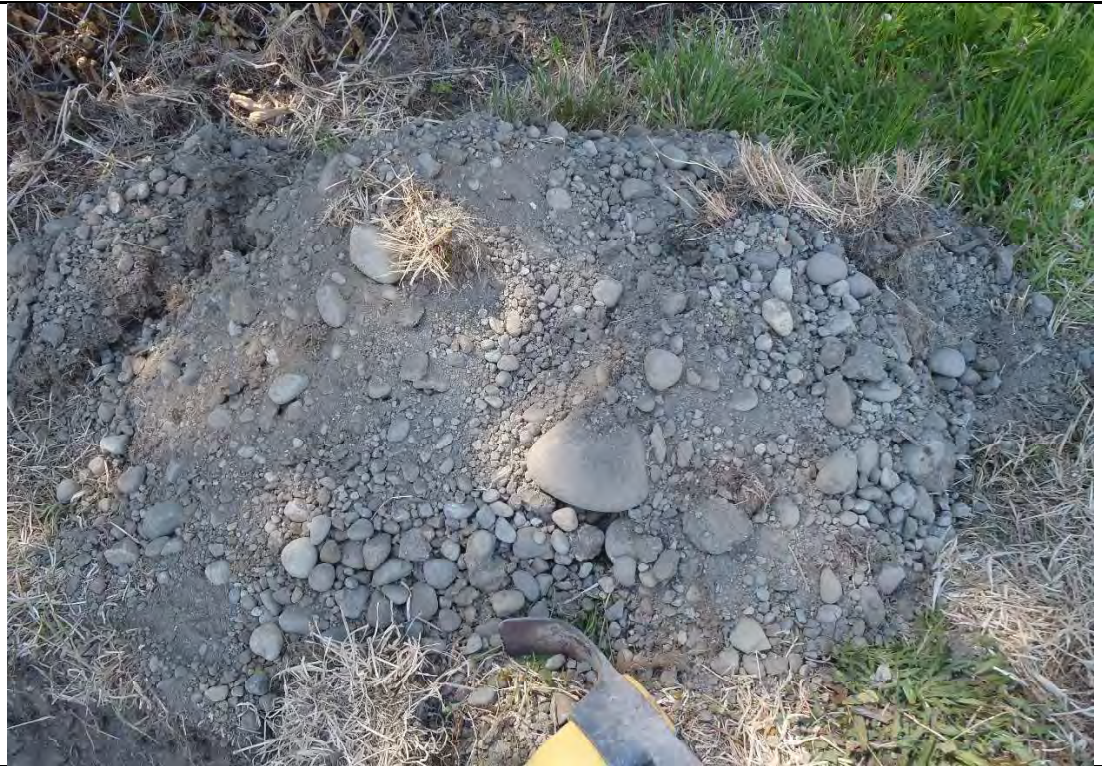
Photo No. 1b: 1982 Fill Confirmation Hole 1

Description:
Excavated spoils from Confirmation Hole.

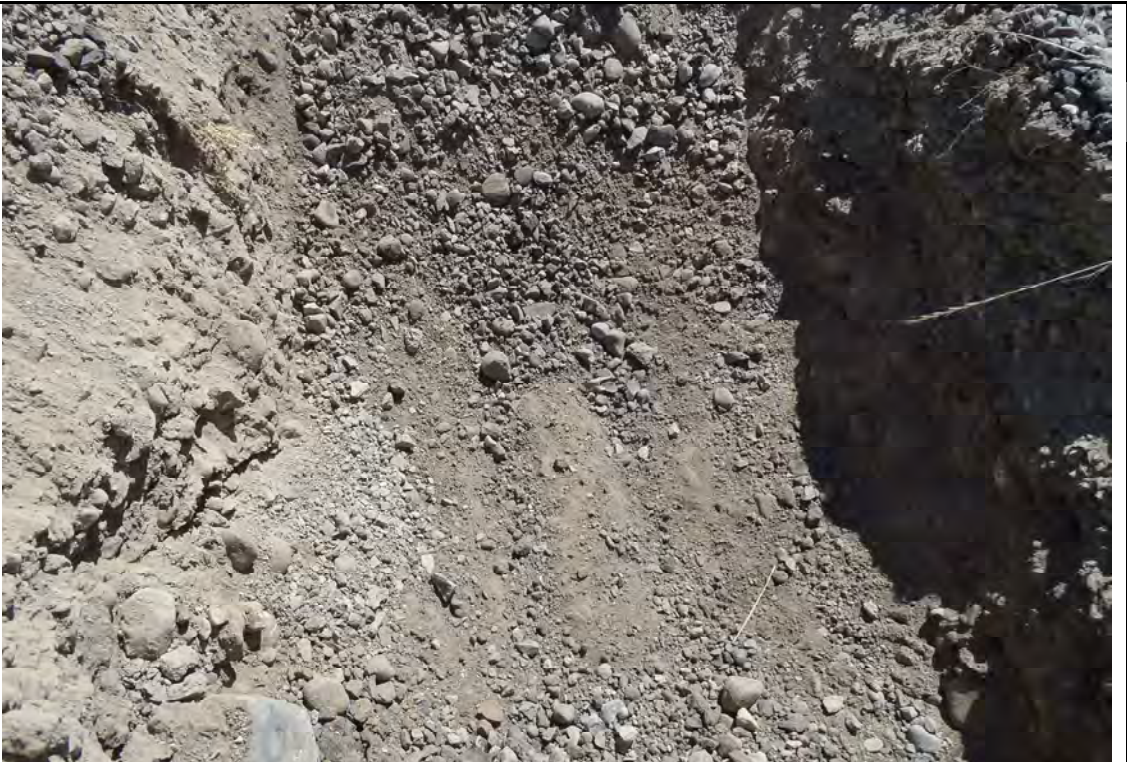
Photo No. 2c: 1982 Fill Confirmation Hole 2

Description:
Obstruction – concrete (see field notes)
