TECHNICAL MEMORANDUM

SUBJECT: Final Technical Memorandum: 2022 Naval Base Kitsap Keyport Institutional Controls Inspection and Vapor Intrusion Monitoring Results, Naval Base Kitsap, Keyport, Washington
Contract No. N4425520D60006
DCIN: EA-LTM/OM-6006-23-0051

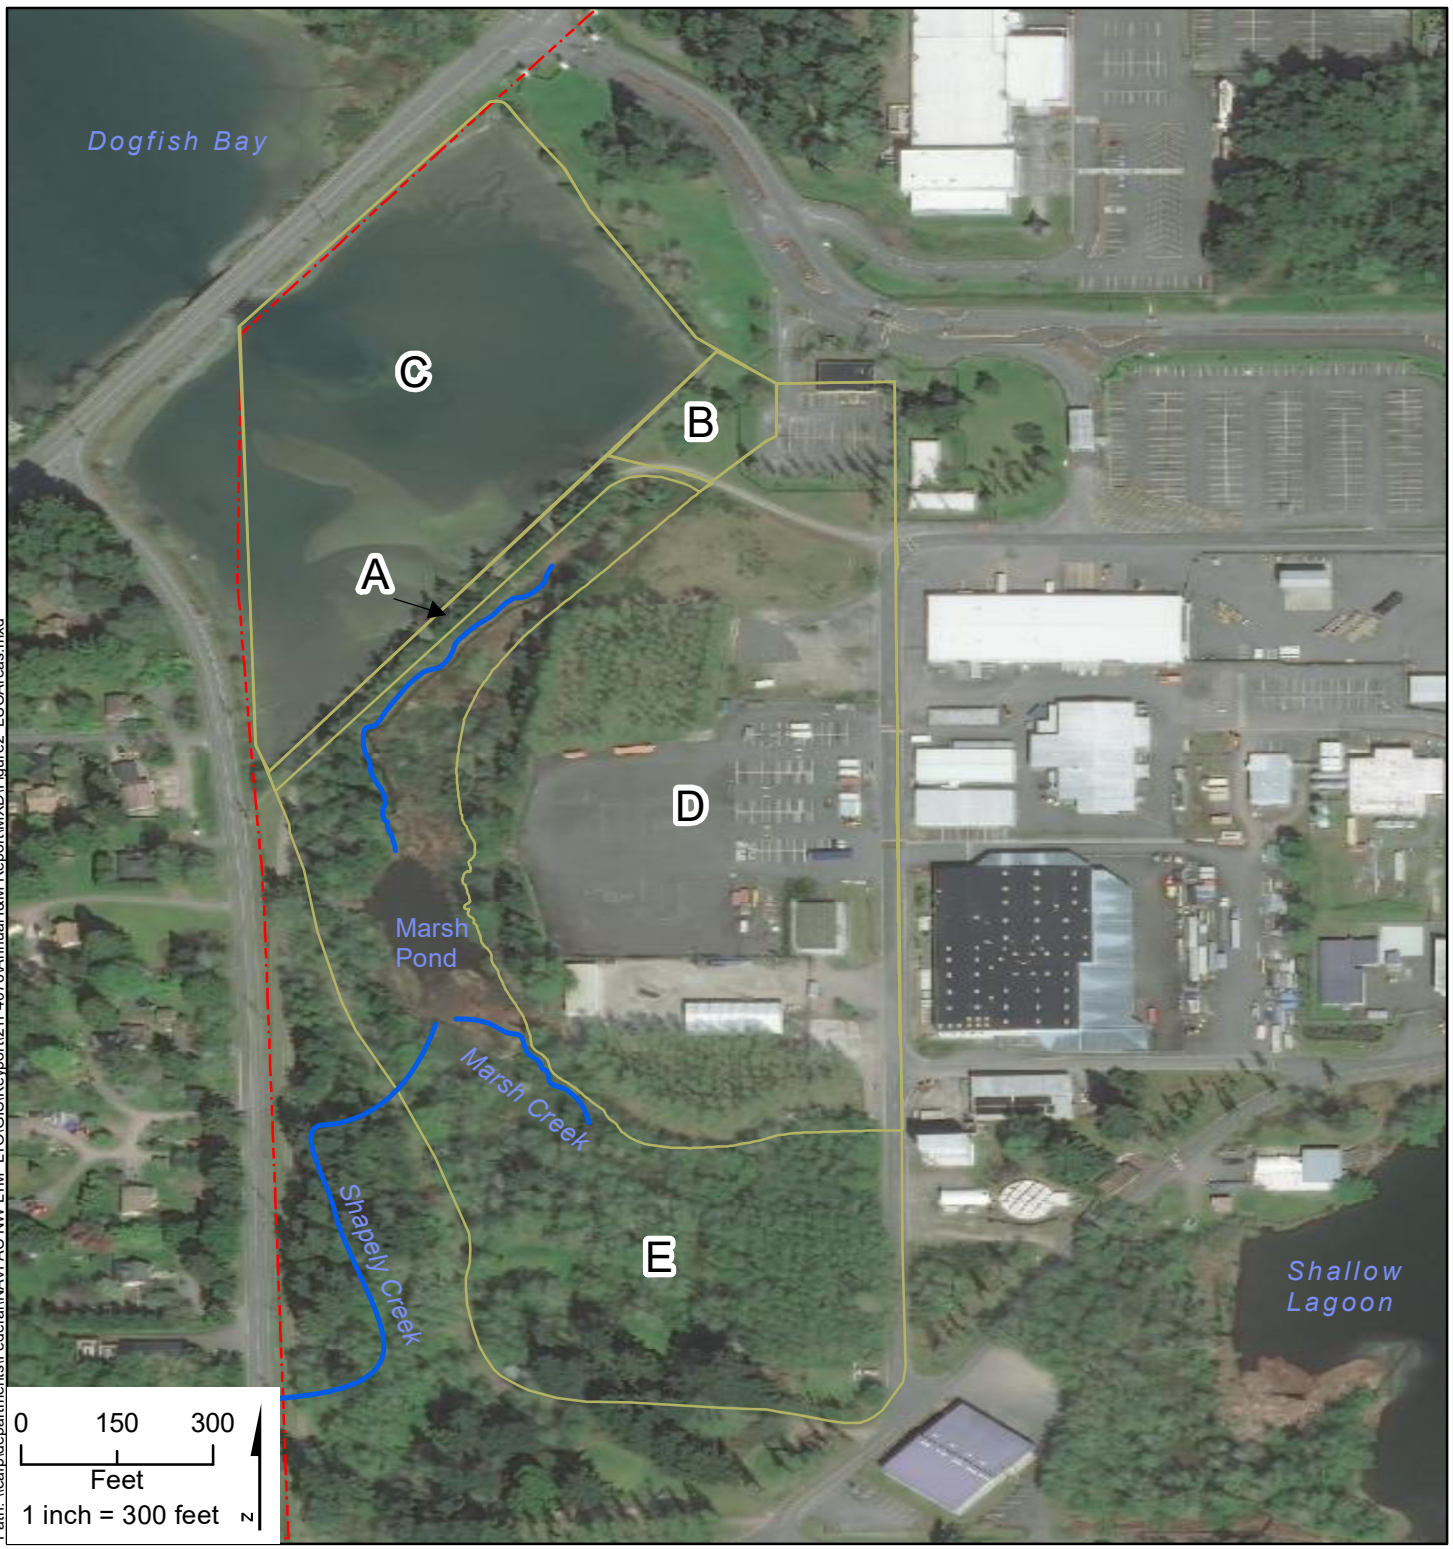
FIGURE 2
OU 1 LUC AREAS
 TECHNICAL MEMORANDUM
 2022 NAVAL BASE KITSAP KEYPORT
 INSTITUTIONAL CONTROL INSPECTION RESULTS
 NAVAL BASE KITSAP KEYPORT
 KEYPORT, WA

Protection Agency [EPA], and Washington State Department of Ecology [Ecology] 1998). Cracks from general wear, root damage, and alligatoring were noted in various parts of the asphalt cover in Area 1.

No indications of current or recent excavations were observed at the site during the inspection. Based on interviews, the excavation permit process is in place and effective in control of site excavations. Several potholes, alligatoring, and cracks were noted throughout the asphalt cover in Area 22.

No indications of current or recent excavations were observed at the site. Based on interviews, the excavation permit process is in place and effective in control of site excavations. Minor root damage to the asphalt cover was noted throughout portions of Area 7.

The OU 1 Record of Decision (DON, EPA, and Ecology, 1998) does not require a landfill cap, and only requires an asphalt cover to prevent contact with the waste body. Therefore, cracks from general wear and root damage in Area 1, Area 22, and Area 7 should continue to be monitored and will be repaired if/when the cracks expand or worsen. Furthermore, additional investigations are ongoing at Area 1 which may result in changes to the remedy at OU1. The need for replacement/repair of the asphalt cover will be evaluated once changes to the remedy are decided. Additionally, the open soil understory of the plantations at Area 1 allows for potential infiltration of precipitation to the waste body, which should be considered in the future Focused Feasibility Study (FFS). No other corrective actions were identified or completed in 2022.

Area 7 should continue to be monitored and will be repaired if/when the cracks expand or worsen. Furthermore, additional investigations are ongoing at Area 1 which may result in changes to the remedy at OU1. The need for replacement/repair of the asphalt cover will be evaluated once changes to the remedy are decided. Additionally, the open soil understory of the plantations at Area 1 allows for potential infiltration of precipitation to the waste body, which should be considered in the future FFS. No unauthorized uses were observed in IC controlled areas.

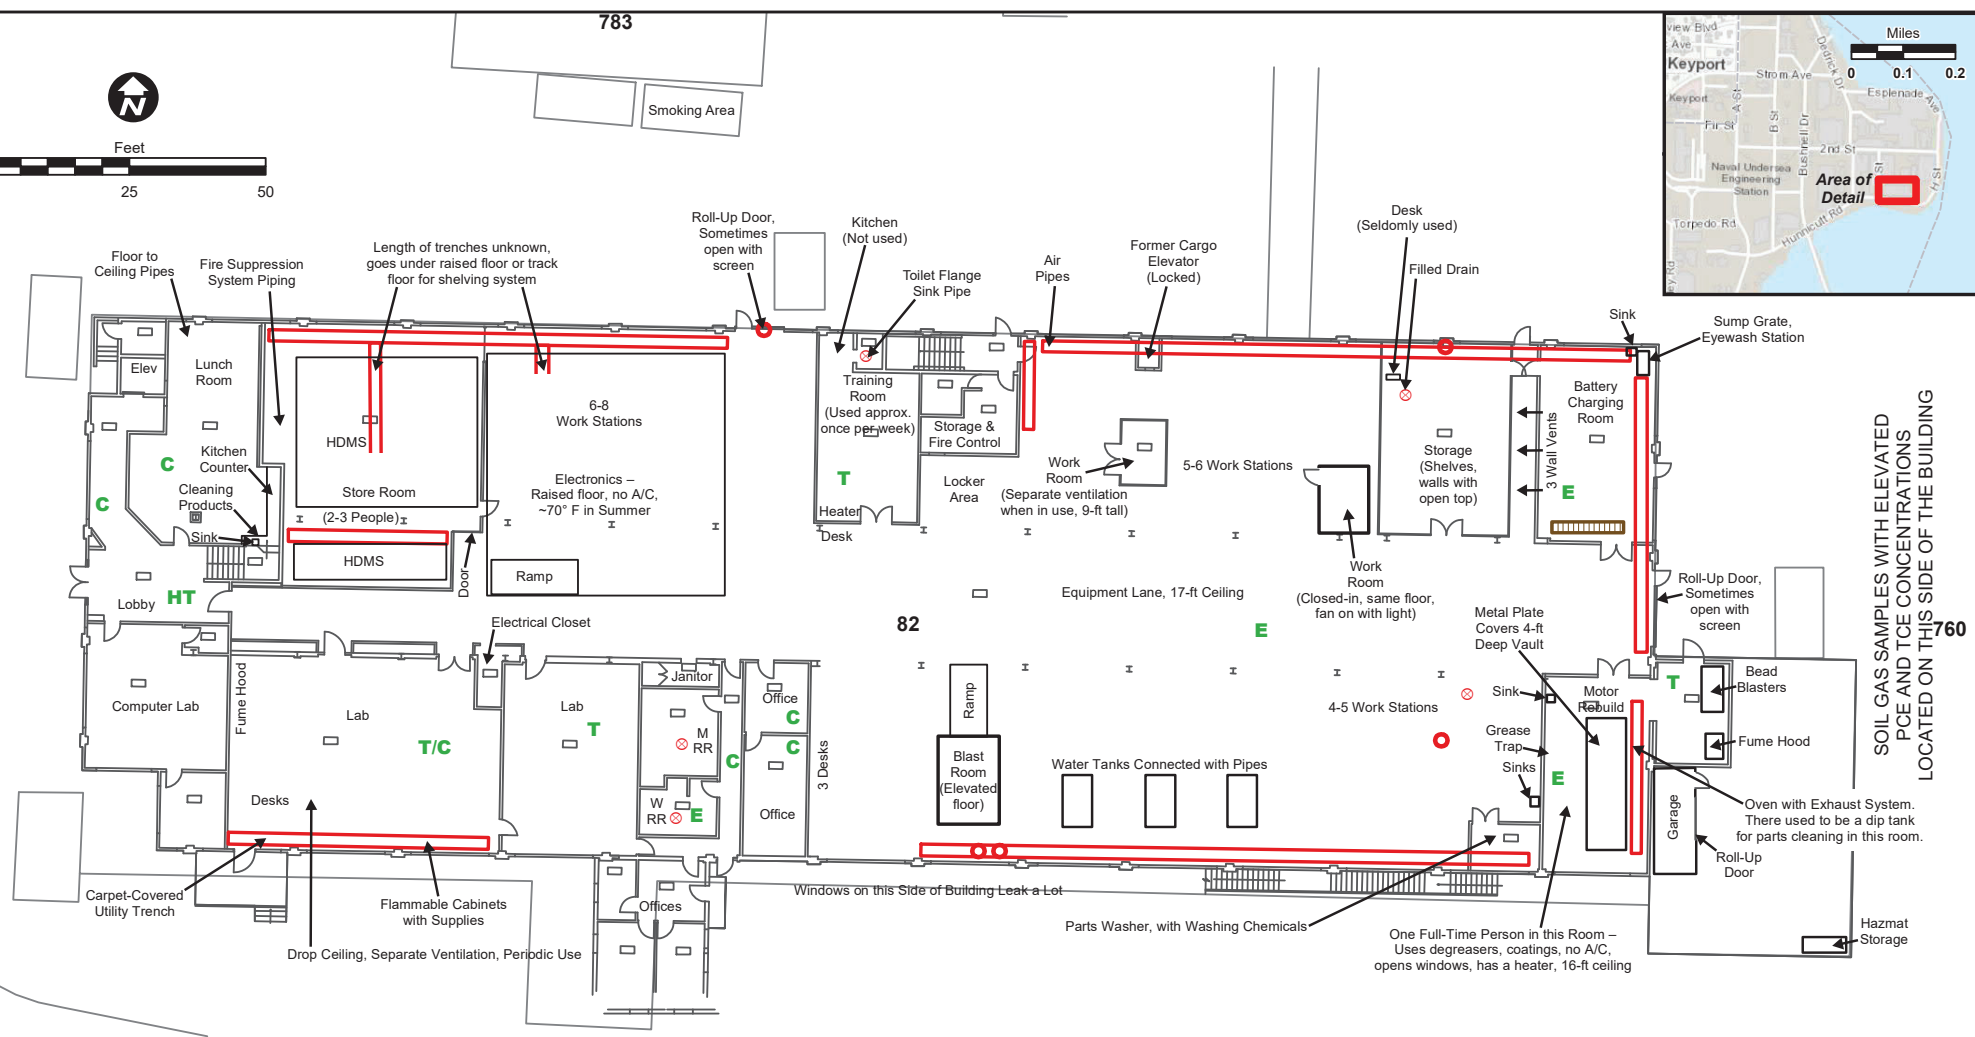
FIGURE 3
BUILDING 82 FLOOR PLAN
 TECHNICAL MEMORANDUM
 2022 NAVAL BASE KITSAP KEYPORT
 INSTITUTIONAL CONTROL INSPECTION
 RESULTS NAVAL BASE KITSAP KEYPORT
 KEYPORT, WA

Building 82 consists of a concrete slab on grade construction with partial second and third stories, epoxy-coated concrete, carpet, and tile covered floors, with natural gas and electric heating, and central air conditioning. The second story is primarily office work stations and the third floor consists of only a meeting room. The first floor of the building was the only floor inspected, since the VI issues would arise from subslab contaminant concentrations. The building is currently occupied and primarily used for electronics and materials testing, with testing rooms, office cubicles, and open space. No changes in building occupancy or use were observed at the time of inspection. There were no

changes in the condition of the building floor slab, floor coverings, or ventilation from the previous assessment conducted in 2018 or from the prior VI inspection conducted in 2021. The current condition of Building 82 is shown on Figure 3.

SOIL GAS SAMPLES WITH ELEVATED PCE AND TCE CONCENTRATIONS LOCATED ON THIS SIDE OF THE BUILDING

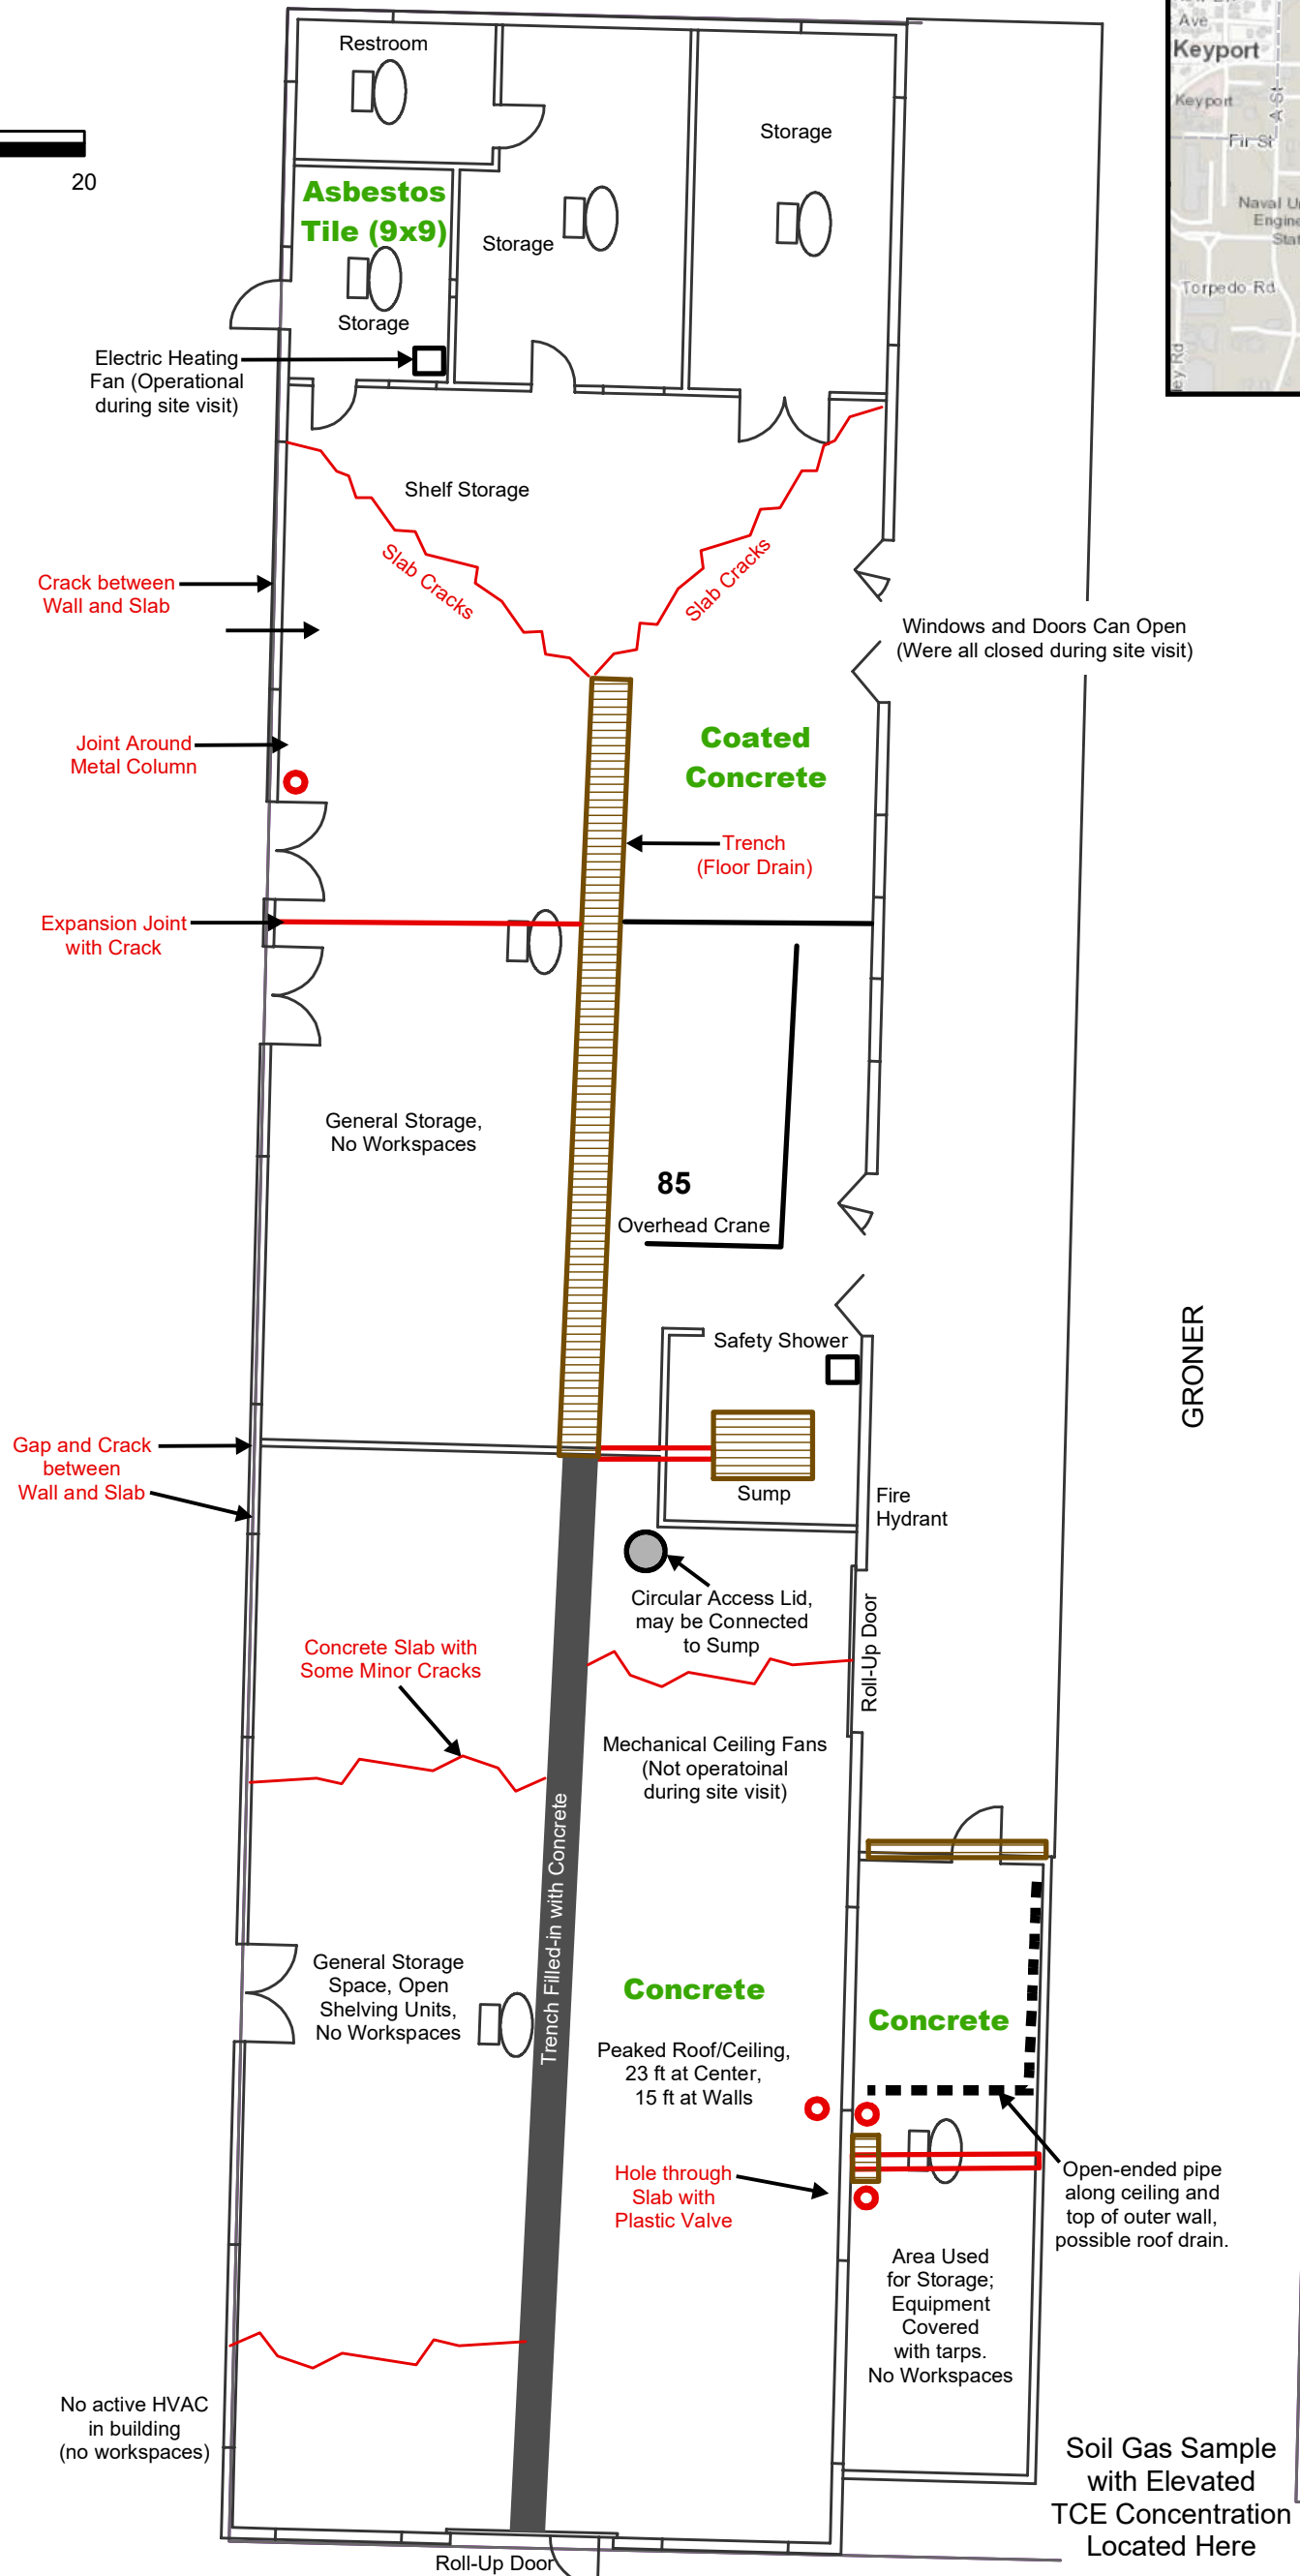
**FIGURE 4
BUILDING 85 FLOOR PLAN**

Building 85 consists of a concrete slab on grade construction with infrared and electric heating, and mechanical ceiling fans, windows, and roll-up doors for ventilation. It is currently not occupied and primarily used for storage. No changes in building occupancy or use were observed at the time of the inspection. Although minor cracks were observed in several areas, there were no changes in the condition of the building floor slab or building ventilation from the previous assessment conducted in 2018 or from the prior VI inspection conducted in 2021. The current condition of Building 85 is shown on Figure 4.

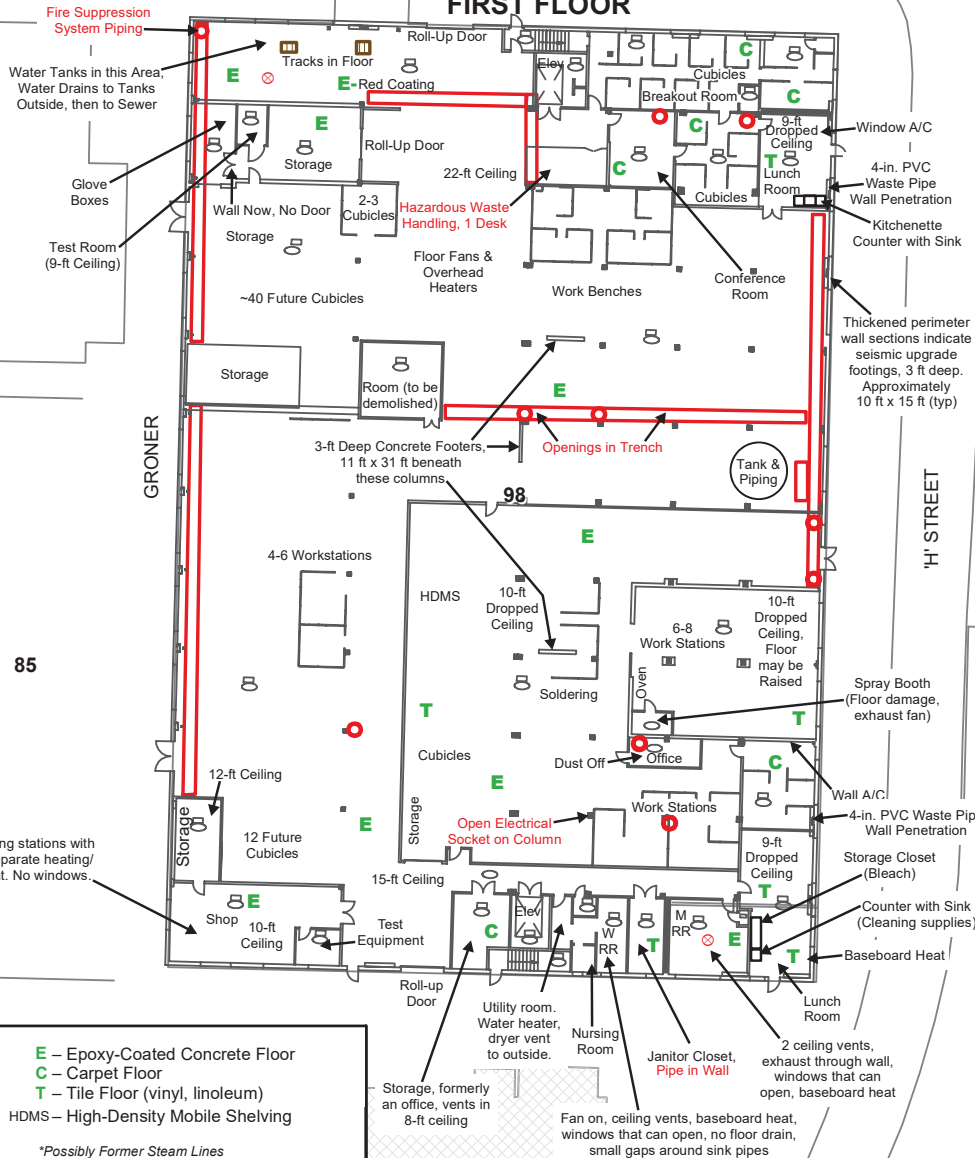
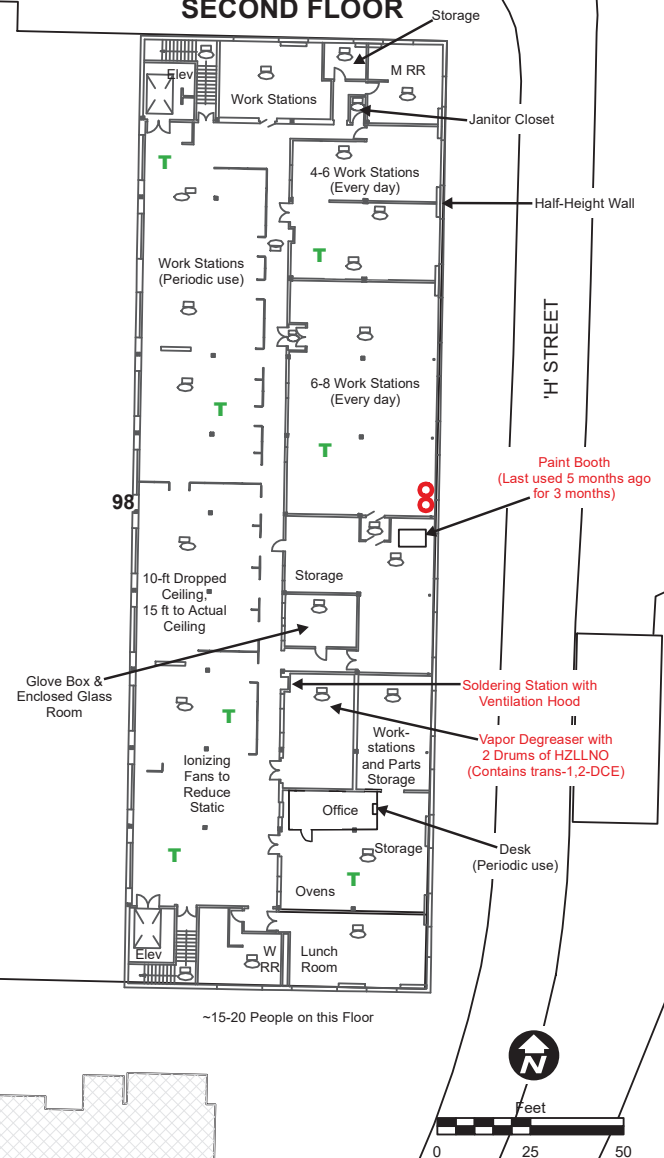
Building 98 consists of a two story concrete slab on grade construction with epoxy-coated concrete floors, carpet, and tile covered floors. Hot air circulation and electric space heaters are used for heating and central air conditioning and windows for ventilation. A natural gas heater and mini-split air conditioner have been added to the shop area. It is currently occupied and primarily utilized as mixed use for electronics and materials manufacturing and testing, with testing rooms, office cubicles, storage, and open space. The second story is primarily office work stations; however, a vapor degreaser, identified in 2018 as a potential indoor air contaminant source remains on the second floor of the building, as it is a mission-critical piece of equipment for operations in the building. According to occupant interviews, building occupancy hours have changed from the previous 8 hour shift to occasional 9 to 10 hour shifts. There were no changes in the condition of the building floor slab, floor covering, or ventilation from the previous assessment conducted in 2018 or from the prior VI inspection conducted in 2021. The current condition of Building 82 is shown on Figure 5.
