THIRD PERIODIC REVIEW REPORT FINAL

**Xytec Clorox Lakewood
Facility Site ID#: 1287
Cleanup Site ID#: 3913**

**9314 47th Avenue SW, Building 10
Tacoma, Washington 98499**

**Southwest Regional Office
TOXICS CLEANUP PROGRAM**

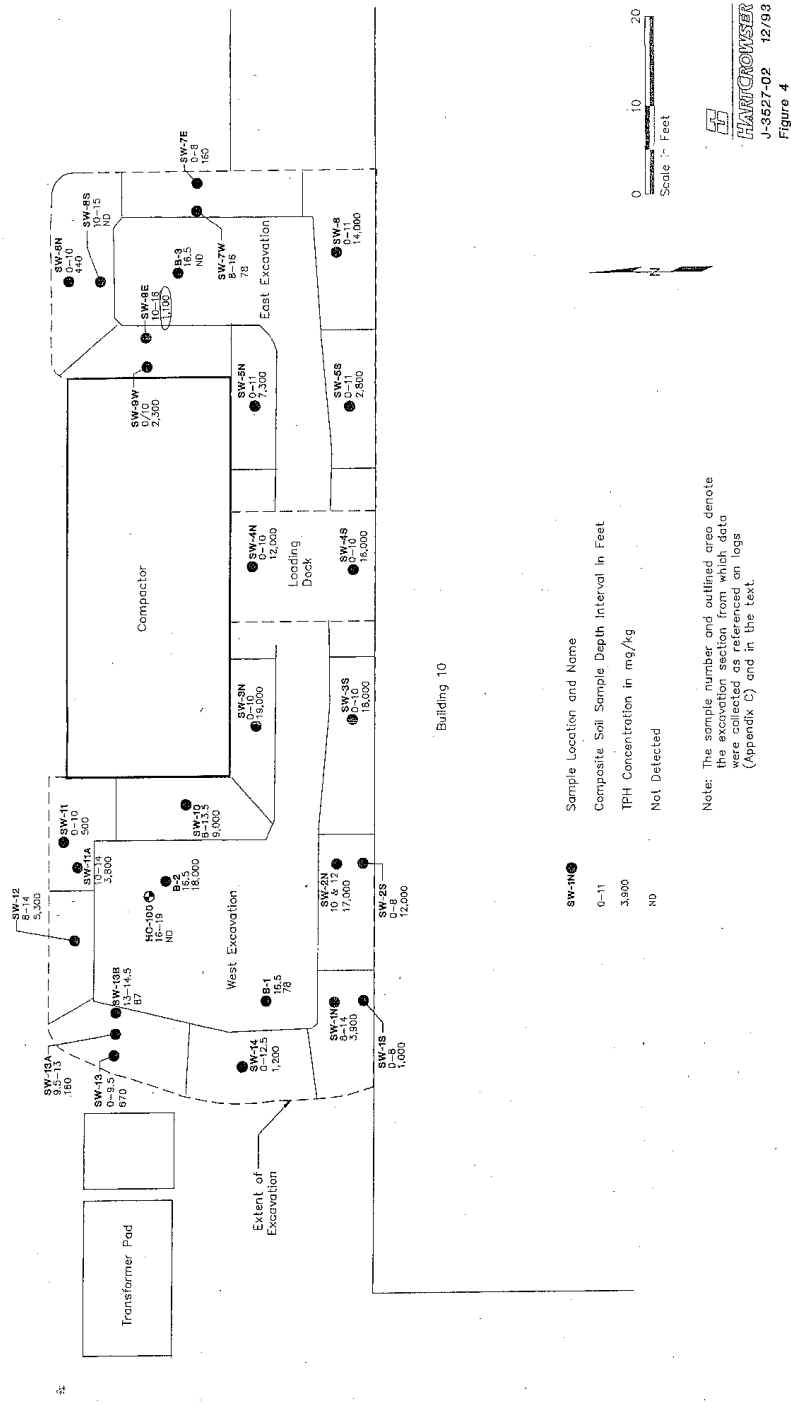
Excavation and Soil Sample Location Plan

Thirty-four confirmation soil samples were collected from the excavation side walls and bottom. The sampling results indicated the base of the excavation to be relatively clean. However, elevated concentrations of petroleum hydrocarbons remained along the sides of the excavation to the south, west, and more limited to the north, and around the west, south, and east sides of the compactor. Soil samples collected along the excavation side walls generally contained TPH concentrations exceeding 200 mg/kg. Further excavation along the side walls could not be accomplished due to the presence of Building 10 to the south, the active railroad line to the east, buried industrial park utility lines (including 2-foot-diameter high voltage power) to the north, and the transformer and associated power lines to the west. Based on soil sampling data collected as part of the Site characterization studies, it is unlikely that petroleum-containing soils extend beyond 10 to 20 feet from the excavation side walls. The soil sampling locations and results are presented in Appendix 6.3.

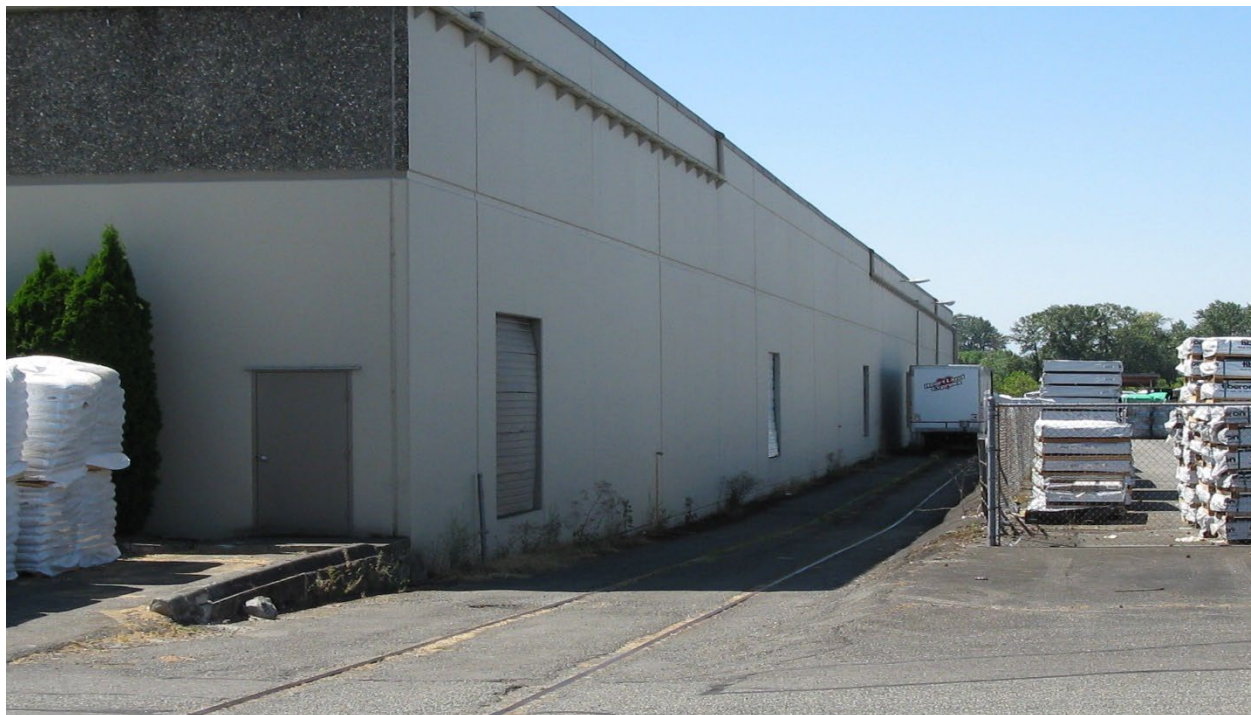
Photo 1: Northside of Building 10, abandoned railroad tracks and asphalt pavement - from the northeast.

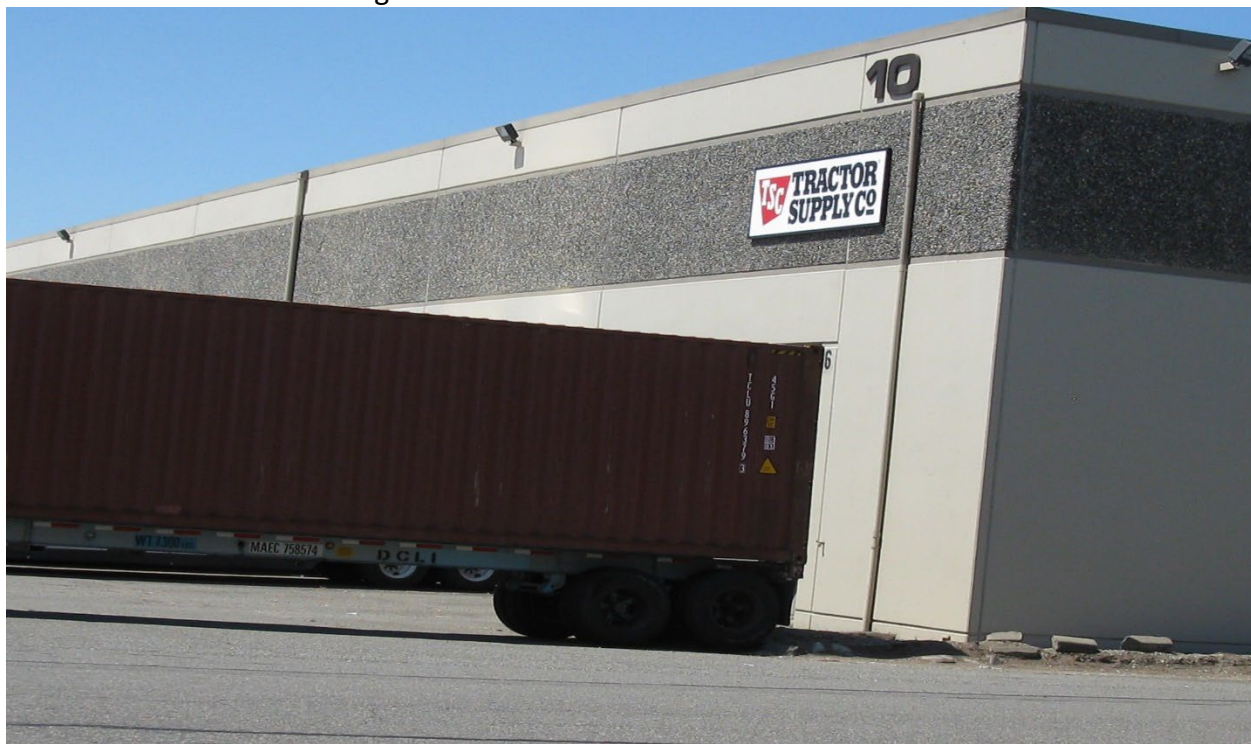
Photo 2: Westside of Building 10– from the southeast.

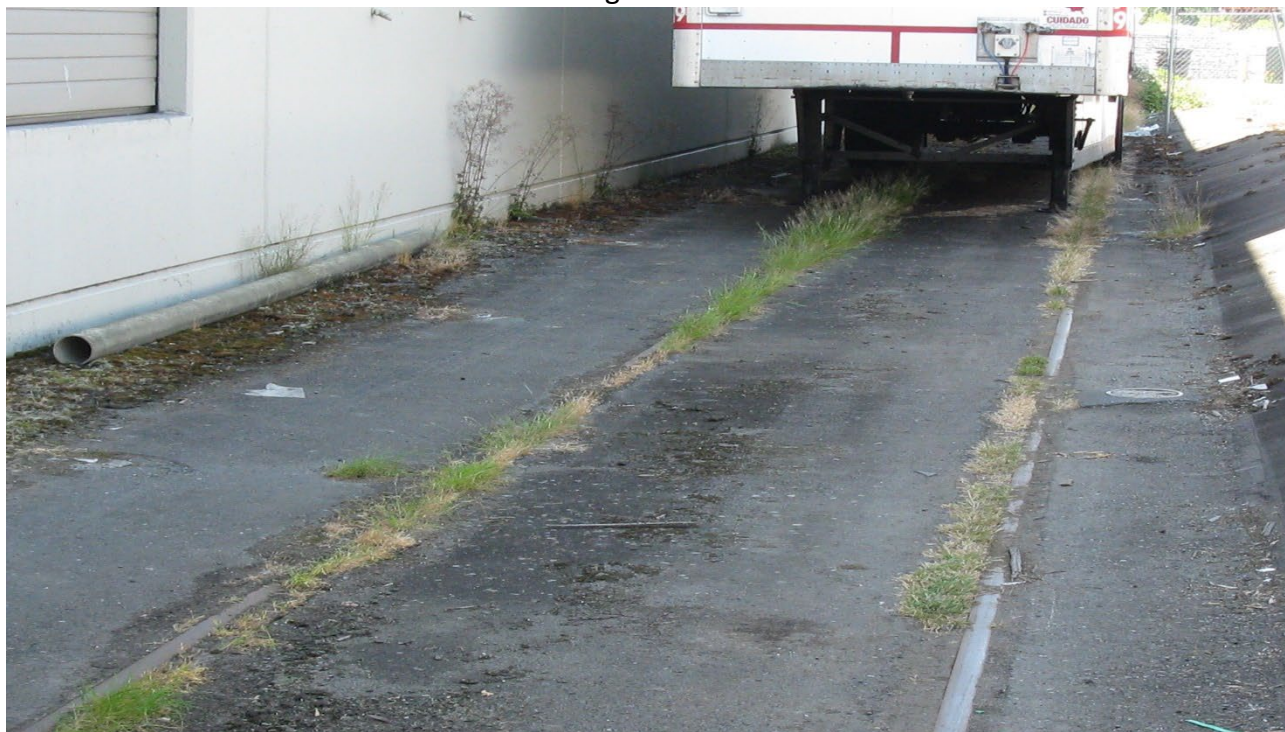
Photo 3: Abandoned groundwater monitoring well and soil boring, asphalt cap/pavement over the contaminated soil behind Building 10 – from the northeast.

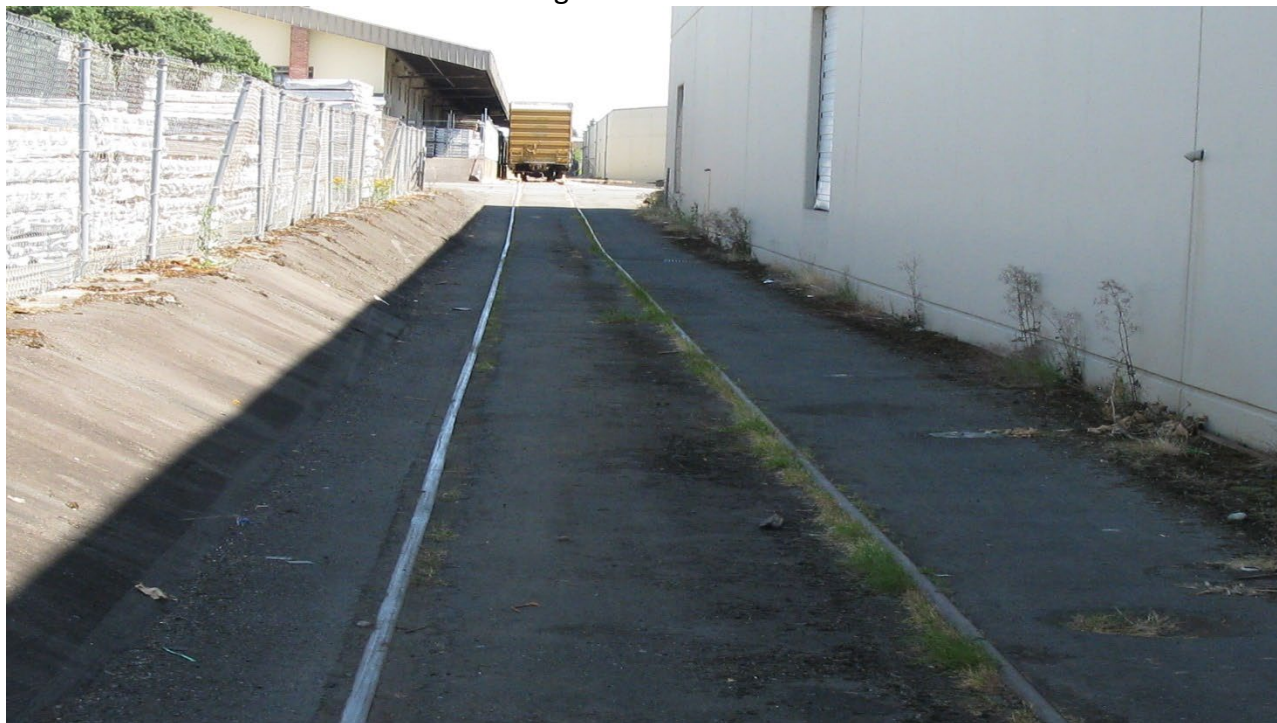
Photo 4: Abandoned groundwater monitoring well and asphalt cap/pavement over the contaminated soil behind Building 10– from the southeast.

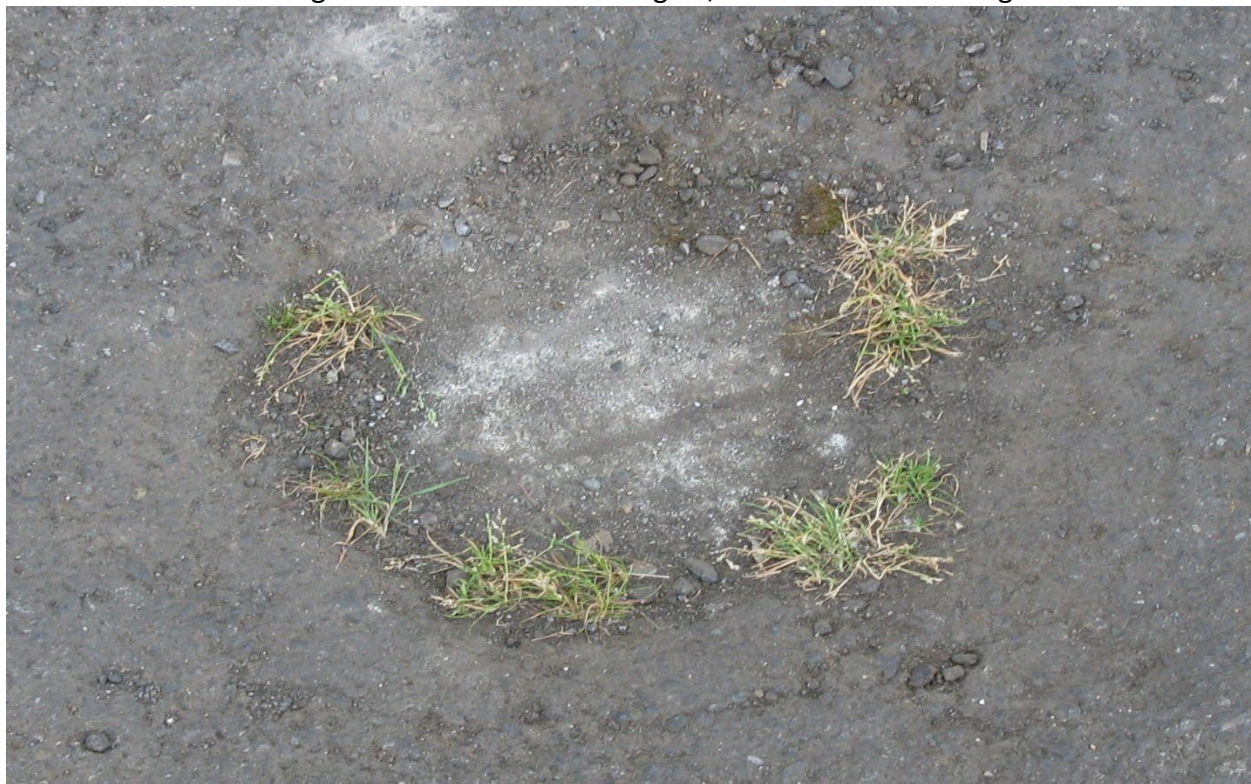
Photo 5: Former investigation area behind Building 10, abandoned soil boring.

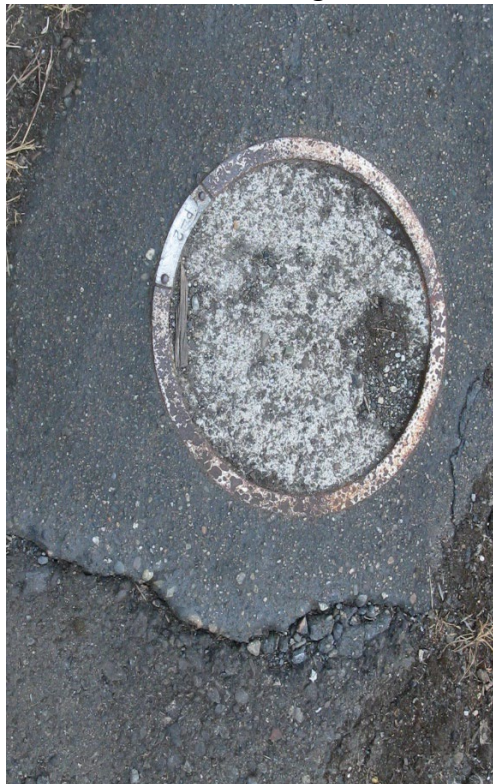
Photo 6: Former investigation area behind Building 10, abandoned soil boring.

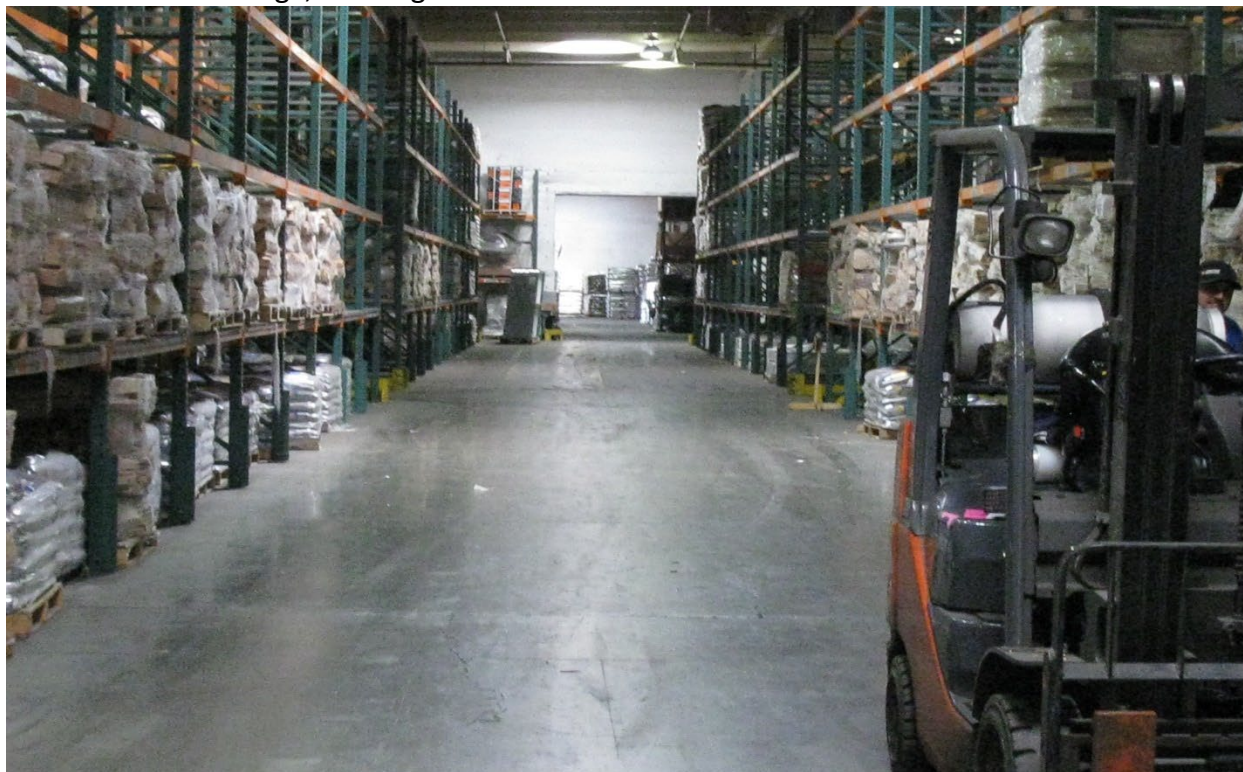
Photo 7: Inside storage, Building 10 – from the west.

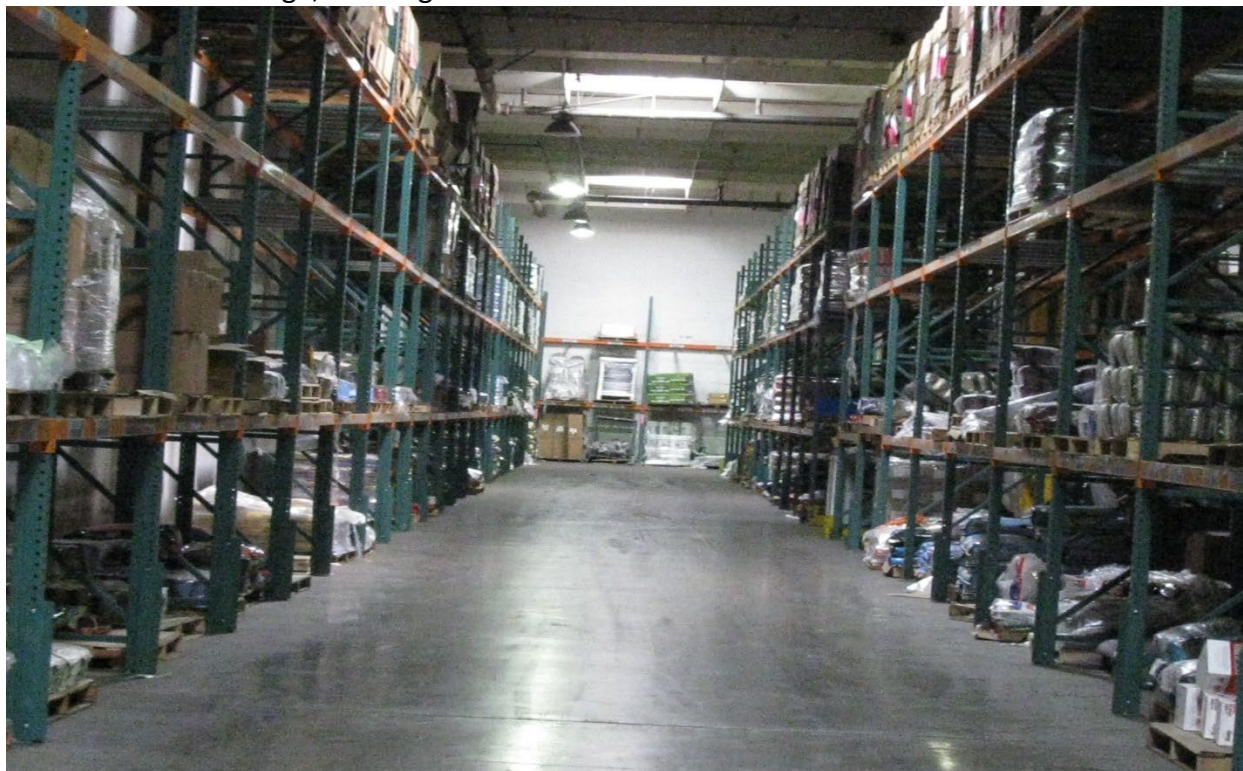
Photo 8: Inside storage, Building 10 – from the Southwest.

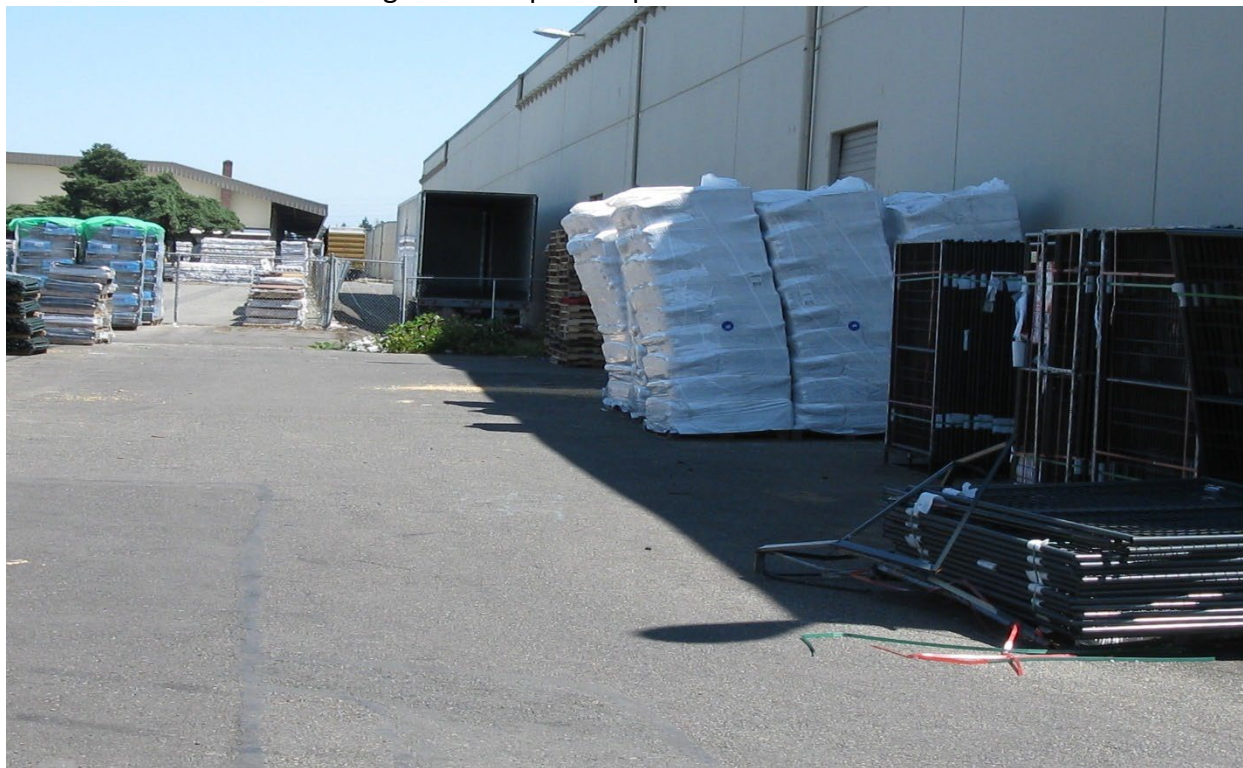
Based upon the Site visit conducted on July 15, 2021, the building and asphalt cover at the Site continue to eliminate exposure to contaminated soils by ingestion and direct contact. The Site continues to operate as a commercial facility. A photo log is available as Appendix 6.6.

Photo 9: Northside of Building 10 and asphalt cap– from the northwest.

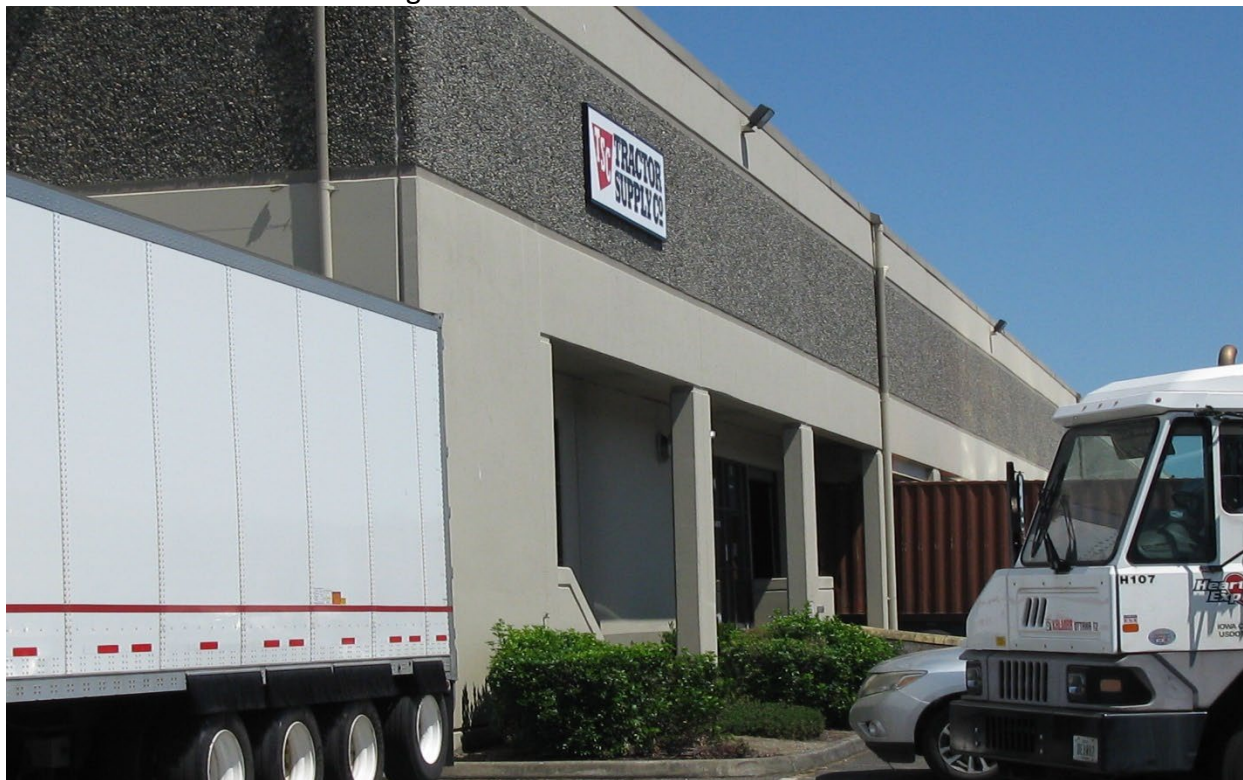
Photo 10: Southside of Building 10 – from the southeast.
