Completion Report

North Cascade Ford Site 116 W Ferry Street, Sedro-Woolley, WA

Facility/Site No. 68313566 Cleanup Site No. 12075

October 27, 2023 Project No. M2584.01.002

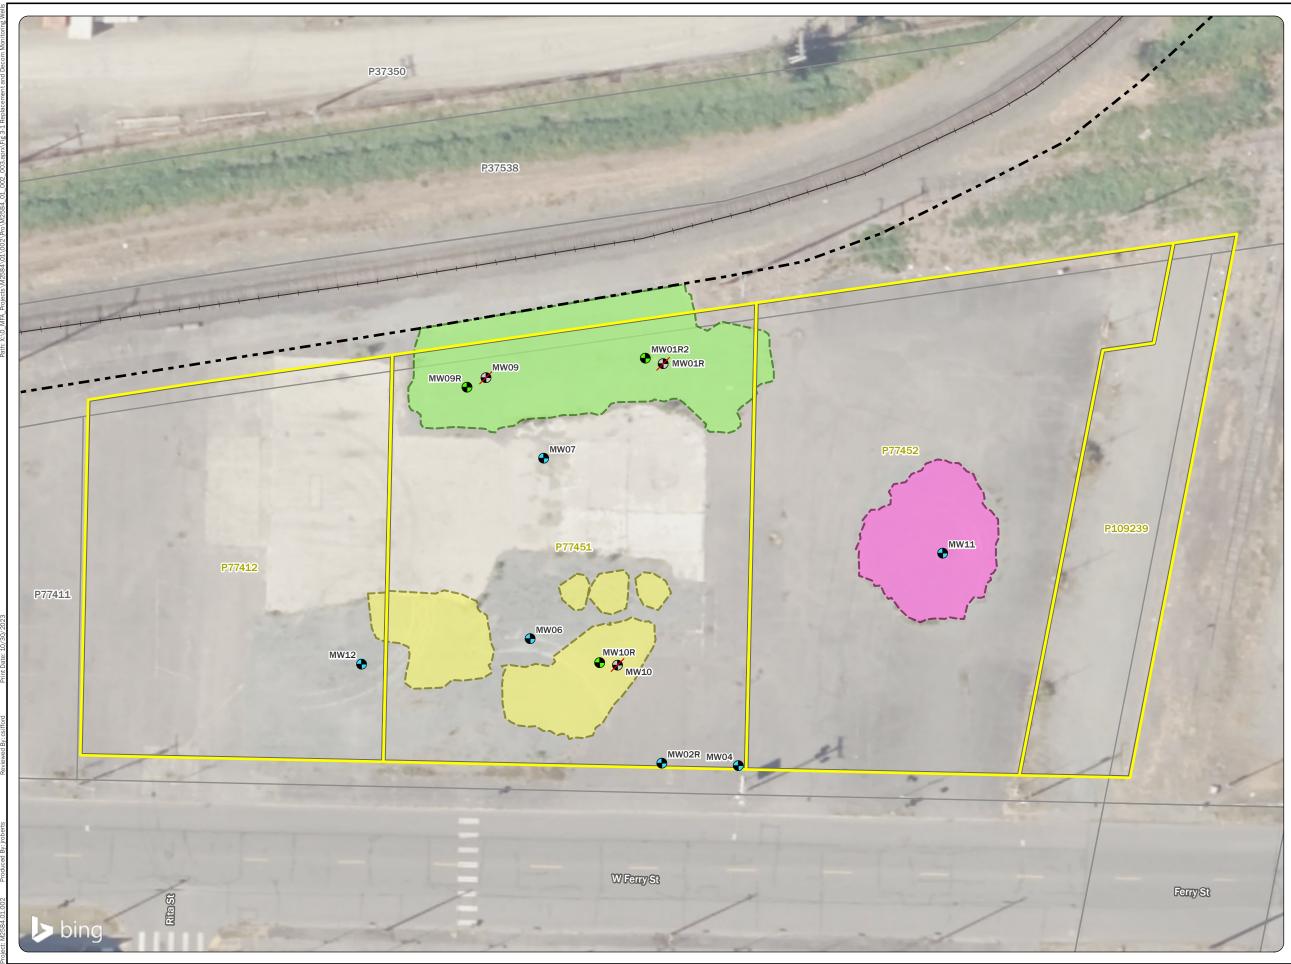
Figure 3-1 Replacement and Decommissioned

Three monitoring wells (MW01R, MW09, and MW10) were damaged and required replacement. Replacement monitoring wells have been named MW01R2, MW09R, and MW10R, respectively (see Figure 3-1).

Monitoring wells MW09 and MW10 were decommissioned in-place using bentonite chips hydrated with potable water. Due to soil debris present in the damaged casing of MW01R, the well was decommissioned by over-drilling using a hollow stem auger. The entire well casing was removed.

The locations of the existing wells in relation to the decommissioned wells are shown in Figure 3-1. In general, the replacement monitoring wells were installed approximately three feet west of the decommissioned wells.

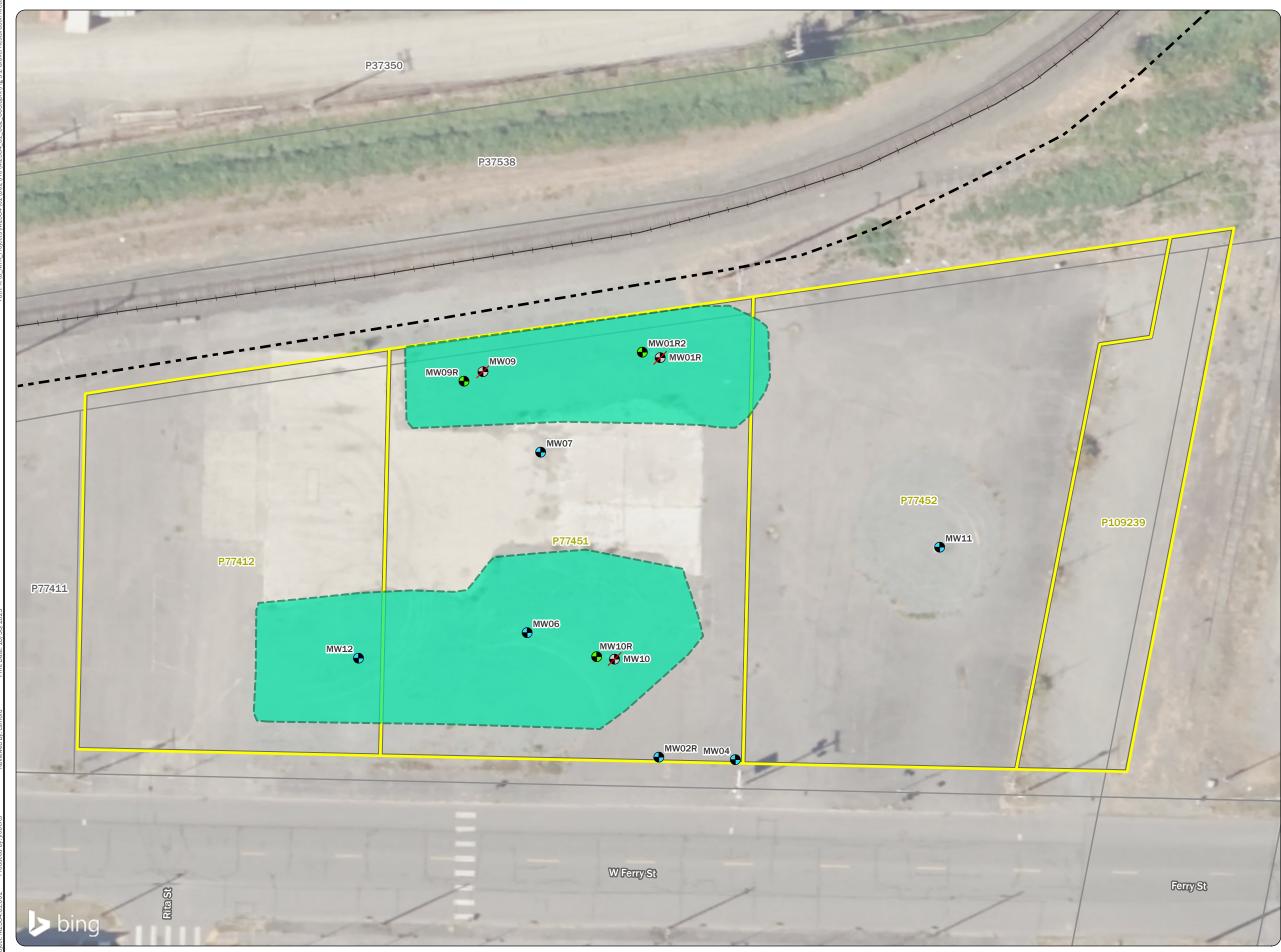
During the July 20, 2023, monitoring well assessment, MFA observed railroad tie debris in the gravel area in the central portion of the Site (see Figure 3-2 and the photographs in Appendix B). MFA conducts ongoing compliance groundwater monitoring in this area as a component of the remedial action and requirement of the EC. If left in place, the residual treated wood debris from the railroad ties would have the potential to contribute to groundwater contamination by leaching chemicals into areas of ongoing remediation. Therefore, in accordance with Section 1(a) of the EC, gravel containing railroad tie debris was removed from the Site.

The lateral extent of gravel areas mixed with railroad tie debris is shown on Figure 3-2. Between September 27 and 29, 2023, BAI Environmental Services (BAI) of Lynden, Washington, with oversight from MFA field personnel, completed the gravel removal and restoration activities on the Site. During gravel removal activities, railroad tie debris was observed to be mixed with surficial gravel up to six inches bgs in the eastern end of the two gravel areas tapering to approximately one-inch bgs in the western ends of each gravel area. During excavation, the intermixed railroad tie debris and gravel was distinguishable from the unimpacted gravel by a color change from dark reddish brown to greenish gray, respectively. Additionally, a change in texture from the fibrous pulverized railroad tie to the sandy gravel was a further indicator of intermixed gravel and railroad tie debris removal. Approximately 204 cubic yards of gravel intermixed with railroad tie debris was removed from the Site (see Figure 3-2).

Consistent with previous gravel placement, permeable ballast material consistent with the Washington State Department of Transportation standard specification 9-03.9(2) was used to restore the gravel of the Site in areas where intermixed railroad debris and gravel material was removed.

The permeable ballast material was sourced directly from Skagit Aggregates Big Rock Pit at 14101 SR 9 in Mount Vernon, Washington. Approximately 420 cubic yards of material was placed on the Site to restore the gravel areas.

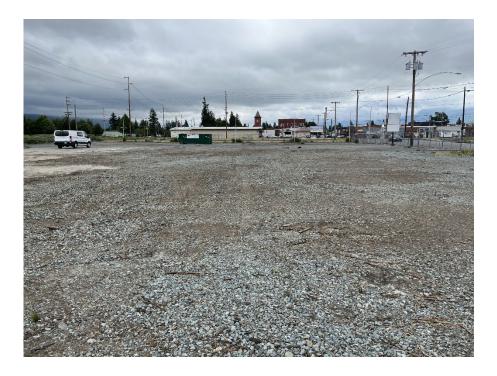
Photo No. 2.

Photo looking southwest at the southern gravel area <u>prior to</u> removing intermixed railroad tie debris and gravel.

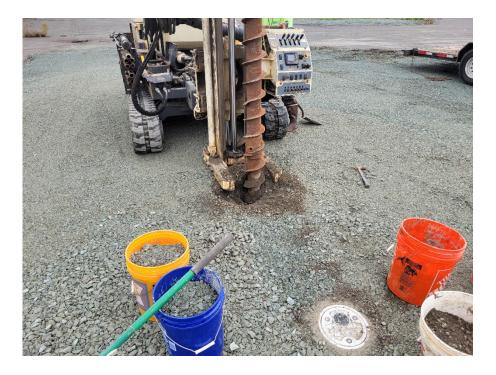
Photo No. 30.

Photo looking southeast from near MW01R2 showing the location of the decommissioned MW01R after the over drilled boring had been filled with bentonite and covered with gravel.

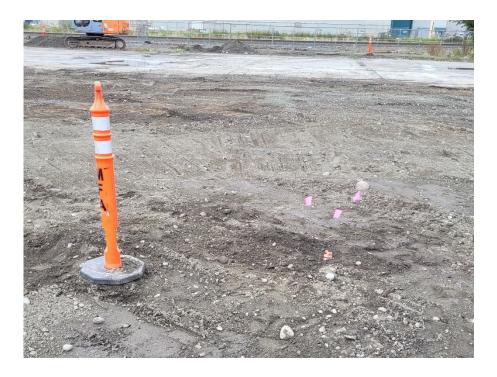
Photo looking east at the completed replacement well MW10R.

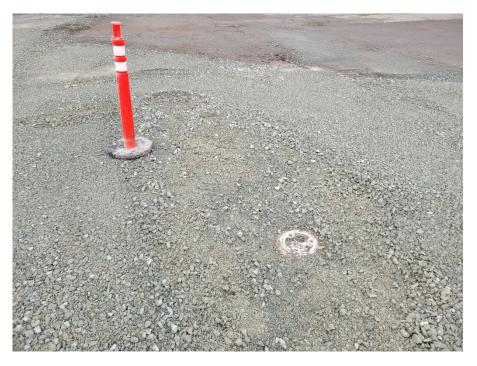
Photo No. 33.

Photo looking northeast at decommissioned MW09 filled with hydrated bentonite chips and MW09R under the traffic cone on the left, prior to gravel replacement.

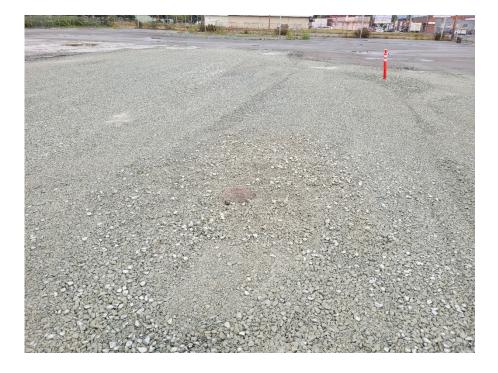
Photo No. 36.

Photo looking northeast from the west side of the southern gravel area showing the monument for MW12.
