Site Assessment

**Rosario Resort
One Rosario Way
Eastsound, WA**

Prepared For
**APS Services, Inc.
3515 South 154th
Seattle, WA**

Prepared By
**Materials Testing & Consulting, Inc.
P.O. Box 309
Mount Vernon, WA 98273
April 1991**

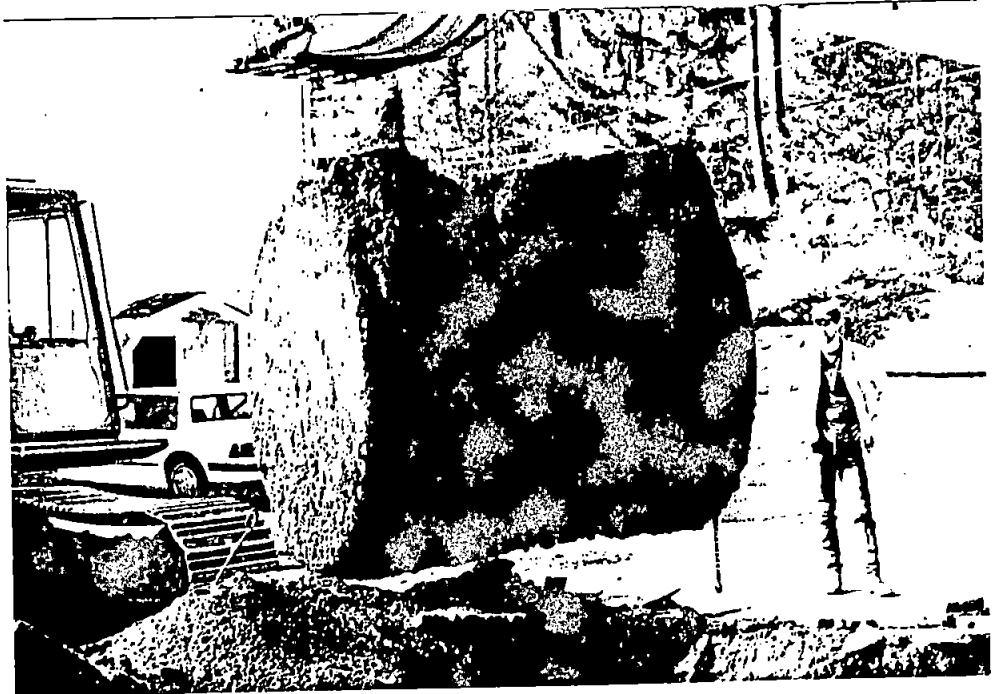
This pit, closest to the service island, contained tanks 4 and 5 (Figures 2 through 5). Gasoline fumes were present in the pit when these tanks were removed from the ground. Tank 5 was covered with iron scales along the bottom half of the tank. No holes were observed though a complete search was not concluded due to the extent of the scale covering. Tank pitting was observed where the scale was removed. Soil samples from the north wall and from beneath the tank were collected.

Figure 3. Tank 5. After Removal.

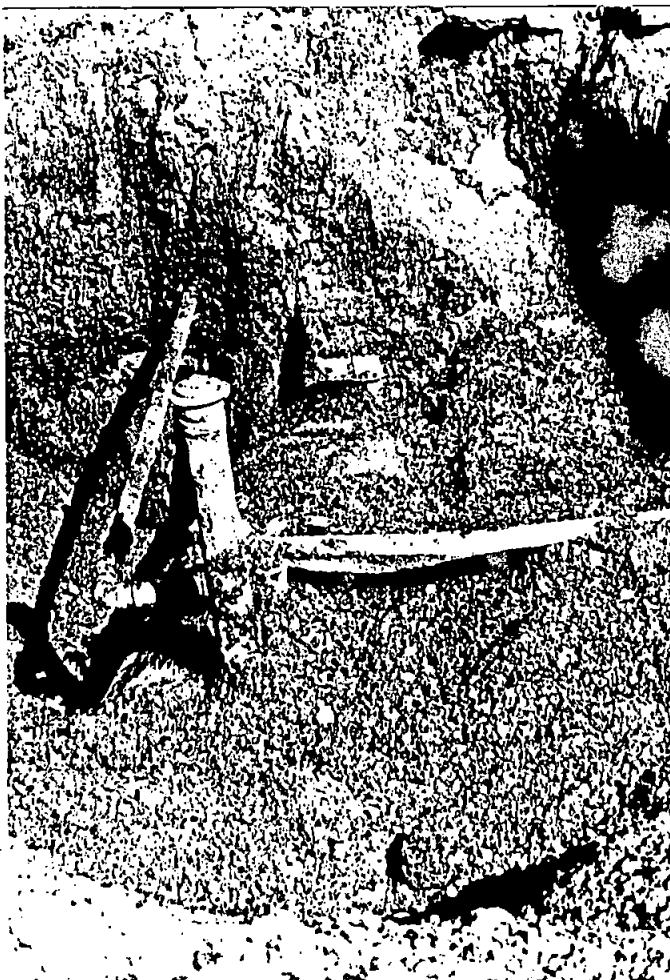
Tank 4 was apparently encased in tar/creosote as a protective measure before it was placed in the ground. This was evident from the collection of the paper and tar/creosote covering on the underside of the tank (Figure 4). While no holes were detected in tank 4 a pocket of heavily gasoline contaminated soil was found under this tank. Approximately 10 yards of this contaminated soil was removed from the pit after which a bottom soil sample and a pit water sample were taken. The analytical results from Pit 1 are presented in Table 1. The initial results indicated that while the water was grossly contaminated, the soil samples were below the maximum contamination level (MCL) set by the Washington State Department of Ecology (WSDOE) both total petroleum hydrocarbons (TPH) and benzene, toluene, ethylbenzene, and xylenes (BTEX). Subsequent excavation of pit 1 disclosed another pocket of gas laden soil under Tank 4. This soil was excavated to a depth of 12ft with no further contamination observed. Additional samples were collected on April 2, 1991, from below tank 4 and along the west side of the pit. The results indicate that the pit was sufficiently free of contamination. The lack of protective covering on the upper two-thirds of the tank indicates that the tank was likely overfilled on numerous occasions thus washing the tar/creosote off the tank.

Figure 4. Tank 4. Before
Removal. Looking East.

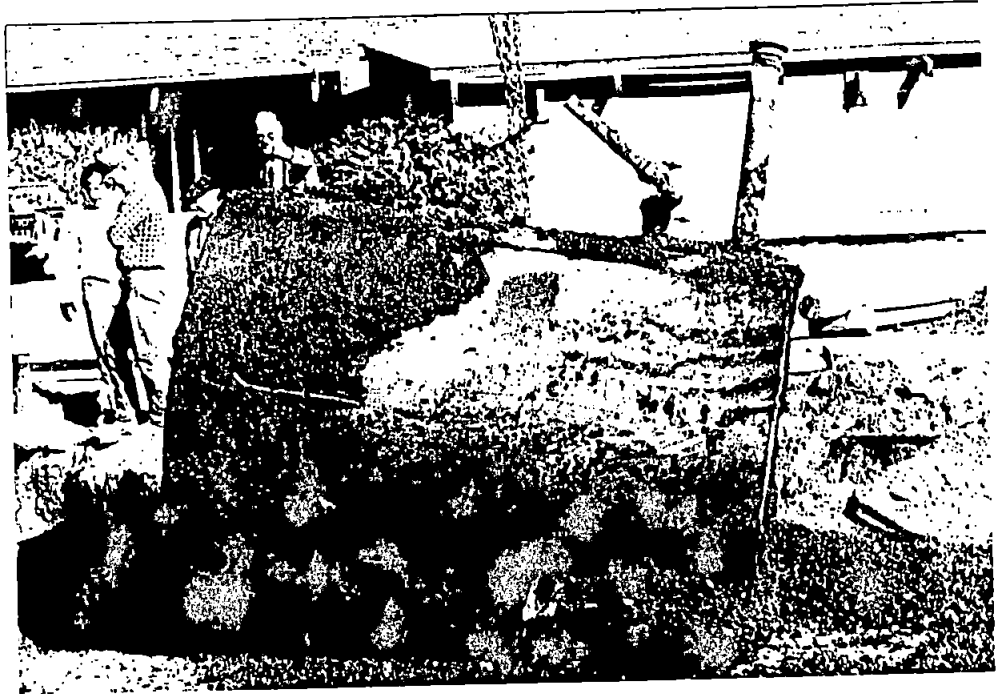
Figure 5. Tank 4. After Removal.

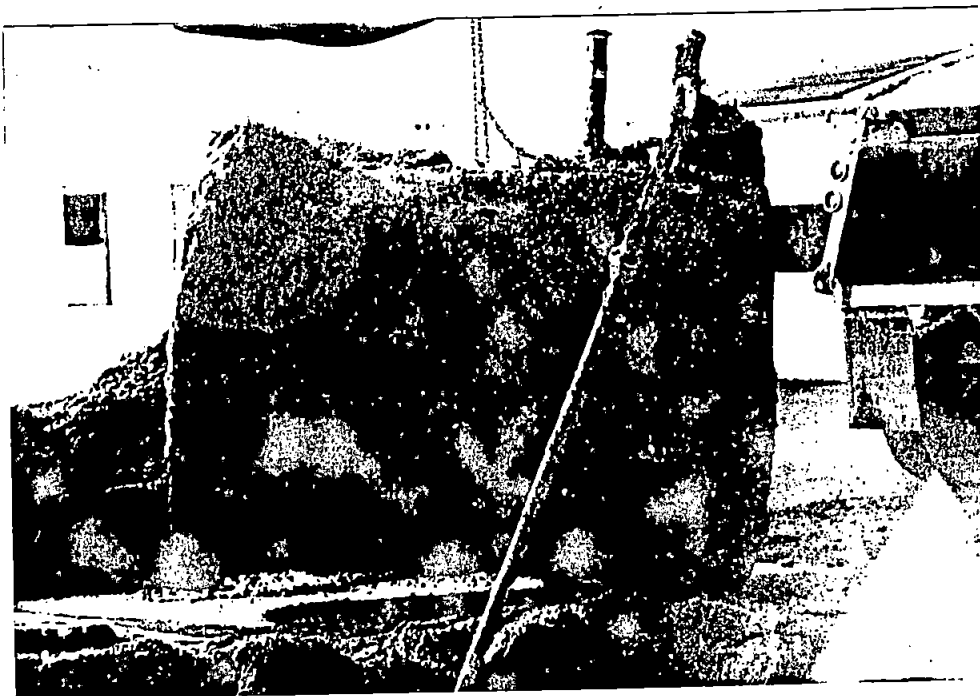
This pit held a single 2000 gallon gasoline tank. This tank was similar in appearance to tank 5 when it was removed from the ground (Figures 6 and 7). No holes were observed in the tank, though as noted before, the tank bottom was covered with scales. The pit appeared free of gas with no odors being present in the soil samples from beneath the tank and from the north and south pit walls. All samples were collected from the 7ft to 8ft depth. Analytical results confirmed that the soil surrounding Tank 3 was below the MCL for both (TPH) and (BTEX) (Table 1).

Figure 7. Tank 3. After Removal.

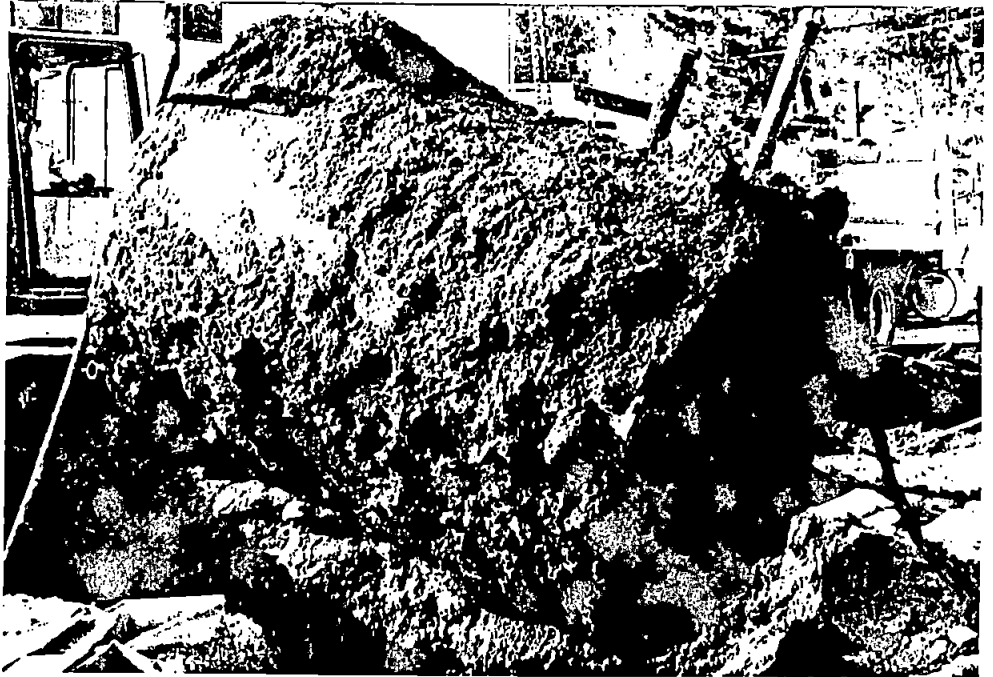
This pit was located closest to the shoreline. Tanks 1 and 2, 2000 gallon diesel and 6000 gas, respectively, were situated in this pit with tank 1 being furthest south (Figure 8 through 11). Gas contaminated soil was observed beneath tank 1 and diesel contaminated soil was seen beneath tank 2. The area in pit 3 was excavated until the contamination was no longer observed. Soil samples from beneath both tanks and from the north and south walls were collected at depths below the bottom of the tank. Additionally, a pit water sample was taken from the pit. Lab results indicated that the soil beneath the diesel tank was 560 ppm TPH (above the 200ppm MCL for diesel in soil). The other soil samples were below the MCL for both TPH and BTEX. The pit water contained benzene, toluene and xylene at levels above the MCL for those components in water while the TPH was just slightly below the MCL (Table 1). Further excavation below tank 2 disclosed a pocket diesel that extended toward pit 2. After the excavation was completed samples were collected from beneath tanks 2 and 3. The lab data indicated that the soils were sufficiently free of petroleum contamination.

Figure 9. Tank 2. After Removal.

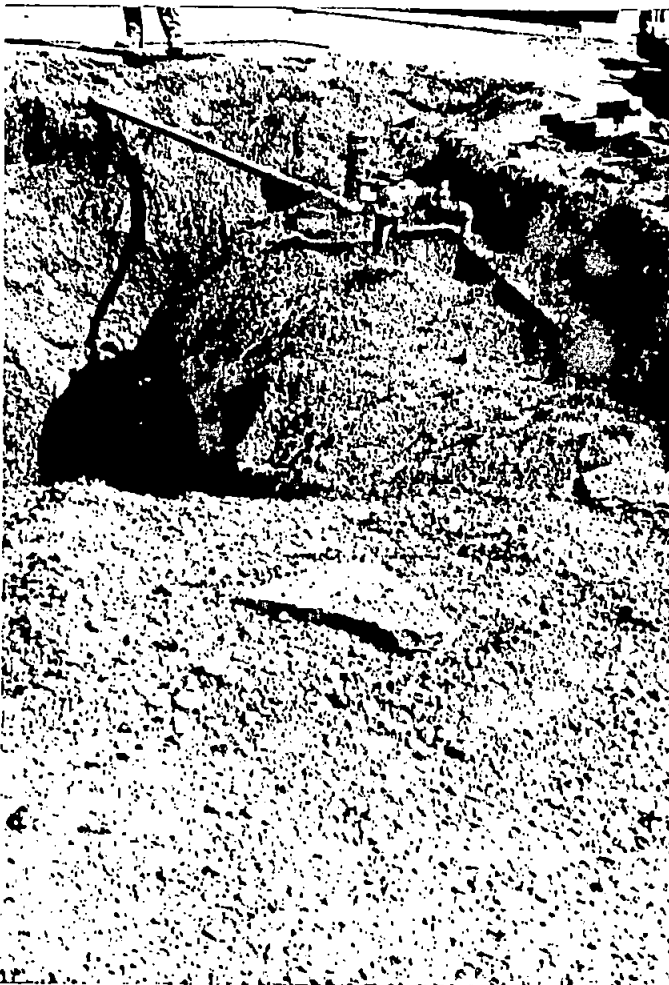
Figure 10. Tank 1. Before
Removal. Looking East.

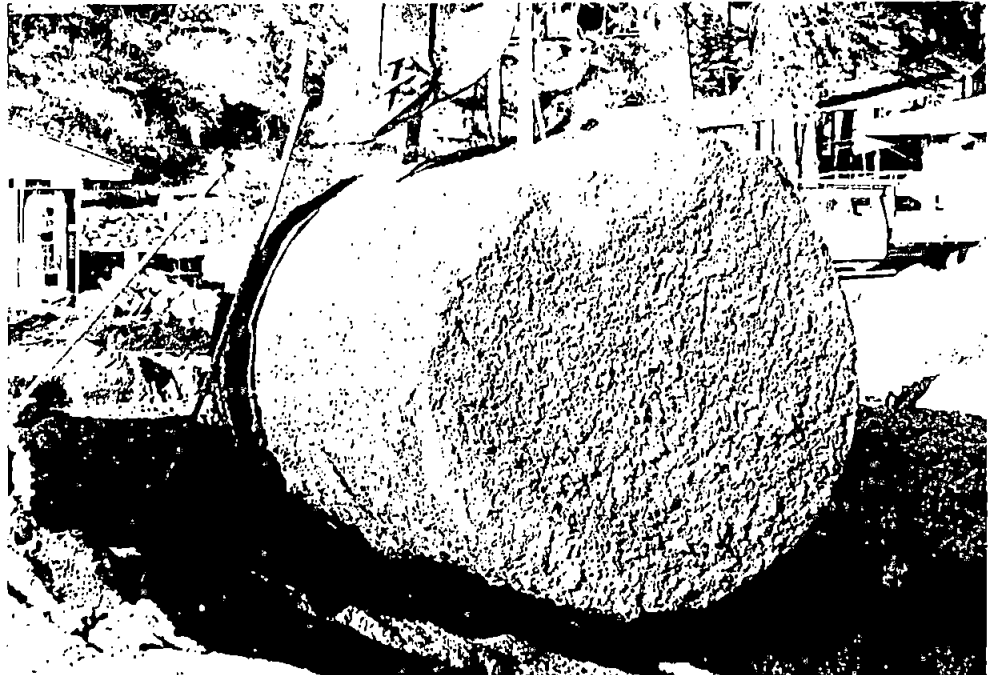
Figure 11. Tank 1. After
Removal.

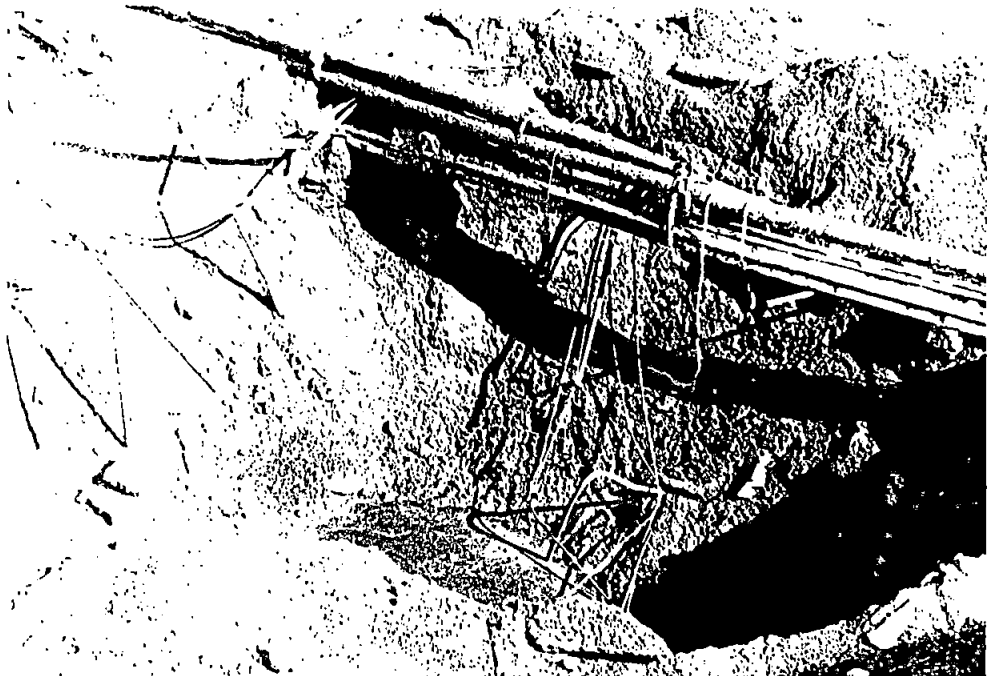
The pit water was clear and without petroleum films by the April 2nd visit. The ground water depth in this area is directly related to the tidal action. The movement of the tide helped to breakup and wash out the petroleum contaminants from the open pit. In addition to the effect of the tide natural groundwater flow comes from off the hill on the north side of the pit. Now that the source of contamination has been removed (the old tanks and the contaminated soil) the pit water will be cleansed by the forces of the water movement described above. Periodic water testing in the pit area should help to determine if the site is indeed free of contamination.

In all, approximately 300 cubic yards of soil was removed from the combined pits. This soil was a mixture of clean and contaminated materials and therefore does not accurately estimate the amount of contamination. A view of pits 1 and 3 is presented in Figures 12 and 13, respectively.

Figure 12. Pit 1 after excavation.
Looking Southeast.
