Kent Poulsbo RV  
aka Valley I-5  
LSI Adapt

June 14, 2004

LSI Adapt Project No. WA04-11238-PH1

Subject: Phase I Environmental Site Assessment  
Poulsbo RV  
23051 Military Road South  
Kent, Washington 98032  
(RETECHS File No. CCV04-316/2300 SEA)

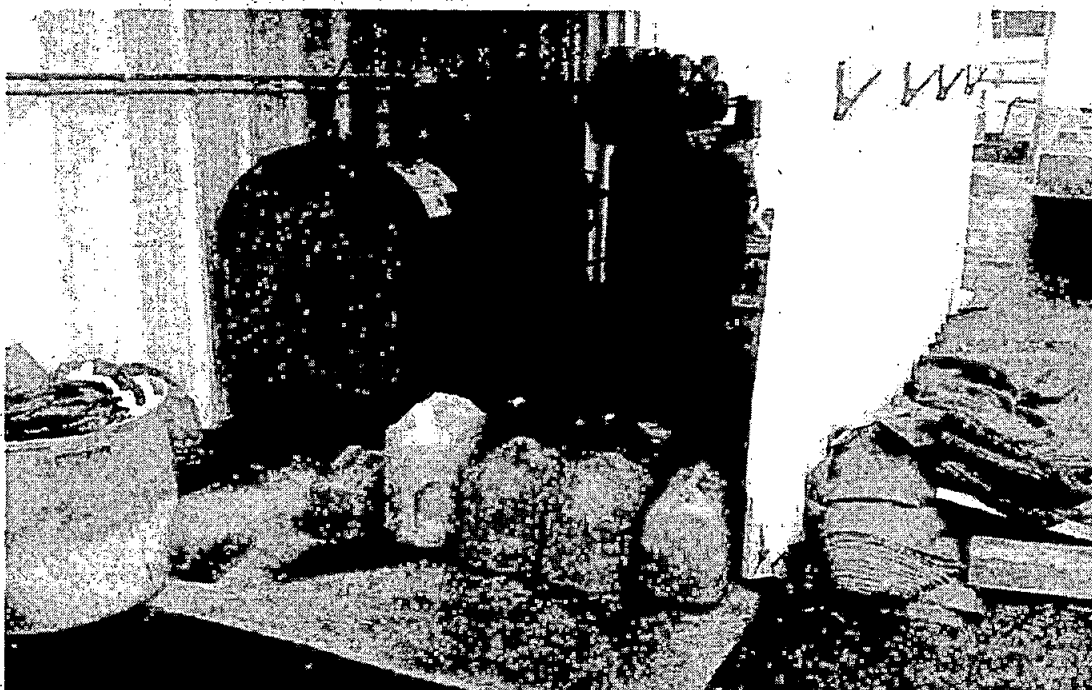
**Lack of Secondary Containment:** An approximately 150-gallon new oil AST and several small gasoline containers were observed within a partially enclosed steel shed located immediately adjacent the southeast exterior wall of the south building. The AST and gasoline containers were standing on level concrete pavement within the shed, but without benefit of containment. Each of the containers appeared in good, non-leaking physical condition. Minor oil-like staining was observed upon the concrete flooring within the shed, but no staining was observed immediately outside the shed.

steel storage sheds located immediately adjacent the north side of the north building and the southeast exterior wall of the south building, where ASTs and other stored chemical substance containers were observed. The staining appeared localized and confined to paved surface areas, and therefore non-representative of a significant adverse environmental condition, although it should be noted that the AST and other chemical substance containers within the storage shed adjacent the south building were stored without benefit of secondary containment.

View of new oil AST and gasoline containers within steel storage shed immediately adjacent the southeast exterior wall of the south building. Note lack of secondary containment.

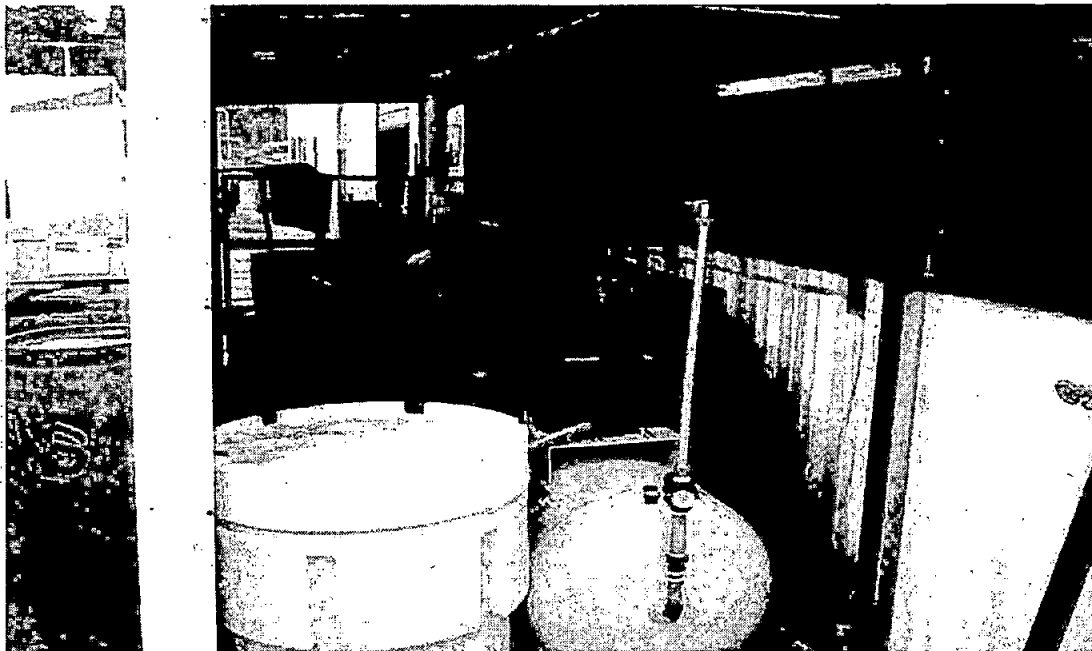
View of two ASTs (far side of shed), compressor, and white container of spill absorbent within storage shed on north side of north building. ASTs are situated within a steel containment. Blue drum at left of photo was empty.
