Subject:
Pipe Penetrations

Location:
Level 1

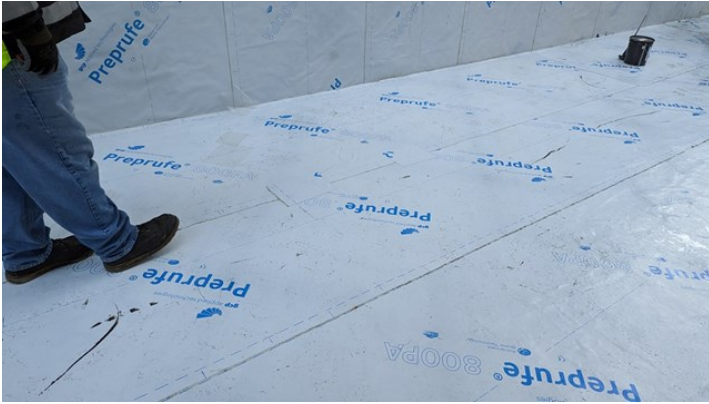
SV.04.02.E - View of patch repair

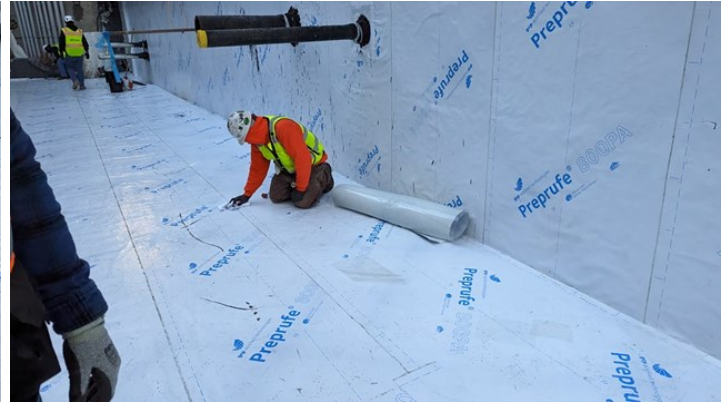
SV.04.02.F - View of membrane cleaning prior to installation of membrane patch

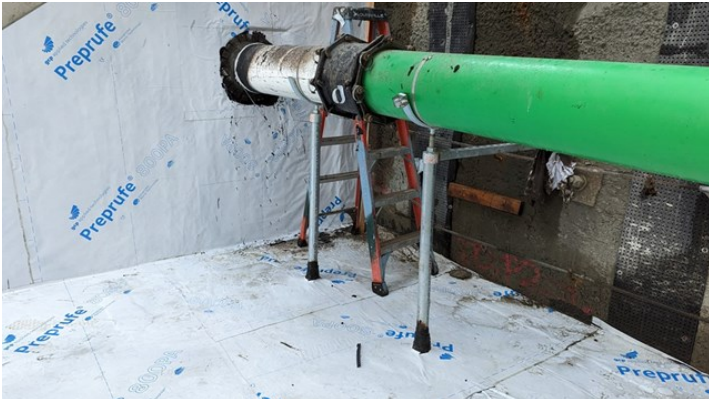
While on site, MH observed that the majority of the pipe penetrations had been waterproofed. Hot fluid applied membrane had been extended onto the pipe penetration by 4". The termination was sealed with a pipe clamp and protected by the protection course. Sound waterproofing noted on site that all of the pipe penetrations were to be waterproofed in a similar fashion. In general, MH understands this is work in progress and takes no exception.

SV.04.03.A - Example of typical pipe penetration detailing

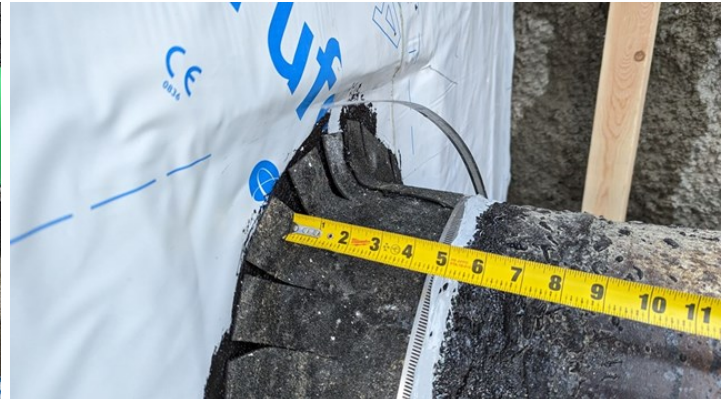
SV.04.03.B - Lap joint of waterproofing onto pipe penetration

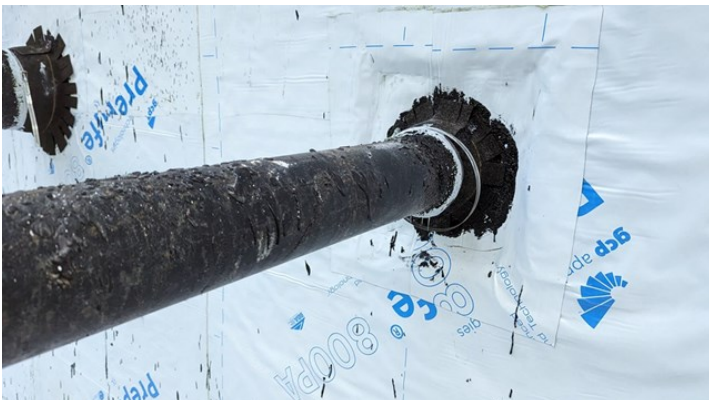
SV.04.03.C - Example of typical pipe penetration detailing

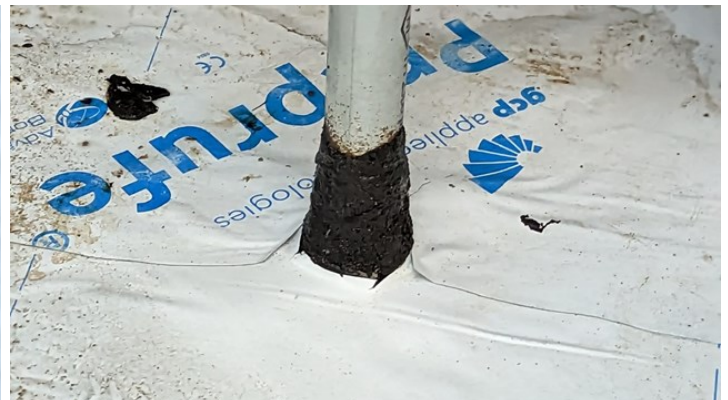
SV.04.03.D - Pipe penetration not yet detailed

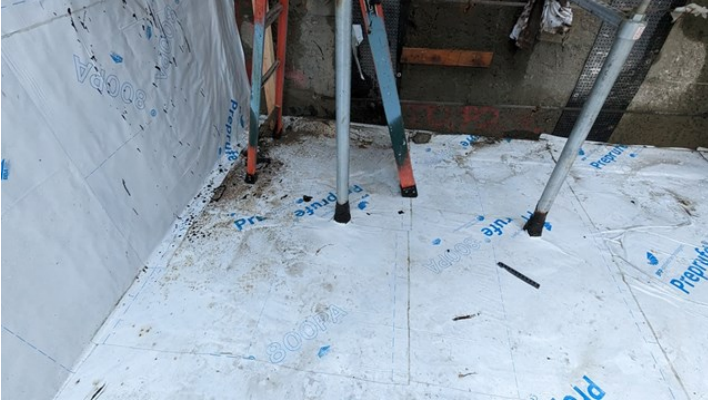
SV.04.03.E - Pipe penetration not yet detailed

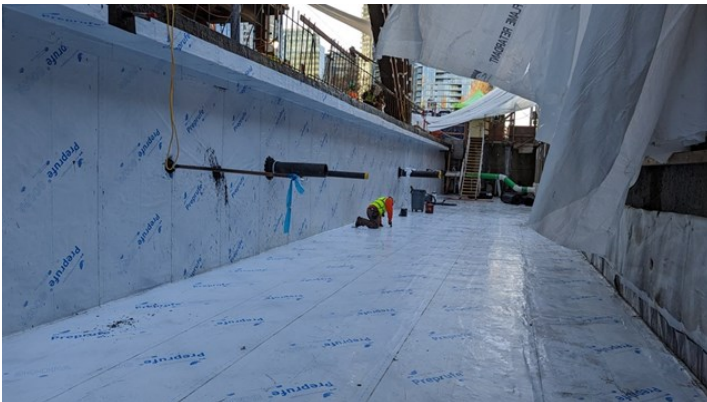
Prior to MH arriving on site, the Preprufe 800PA had been extended up onto the majority of the east wall of the reviewed area. The lap joint between at the vertical to horizontal transitions were measured to be 8". The membrane terminated roughly 6" on the upper most vertical face. Per discussions on site, MH understands this will be tied into the above waterproofing at a later date.

SV.04.04.A - Overview of Preprufe installation progress on vertical wall

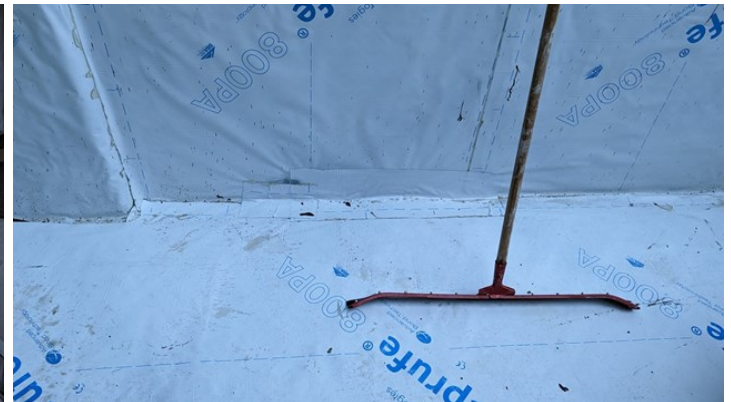
SV.04.04.B - Typical vertical to horizontal transition

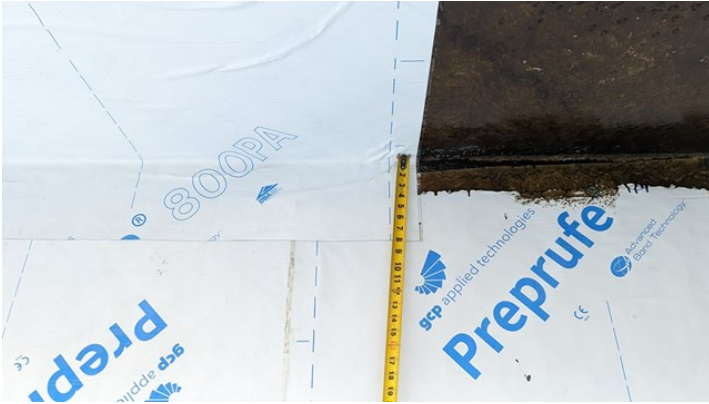
SV.04.04.C - Typical lap joint dimension at corner transition

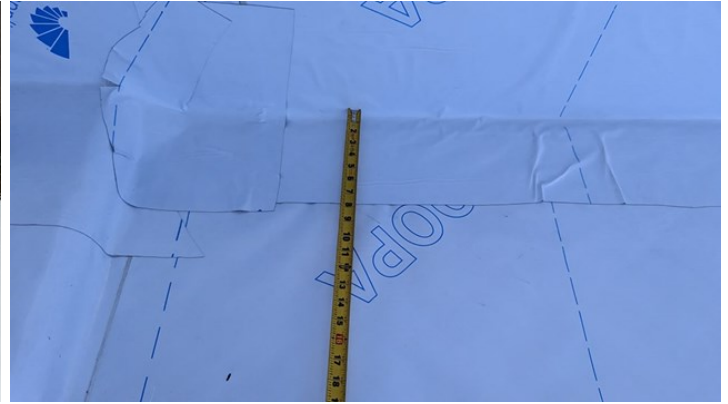
SV.04.04.D - Typical lap joint dimension at corner transition

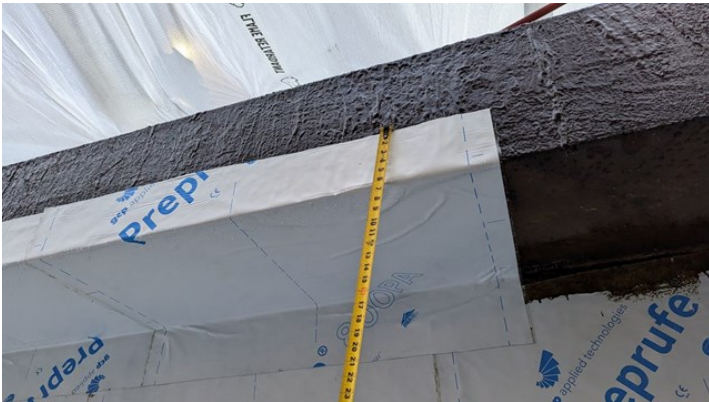
SV.04.04.E - Extent of preprufe installation onto vertical wall above.

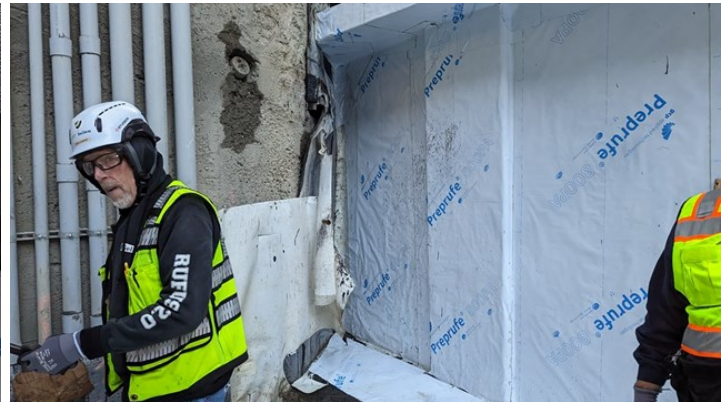
At the north side of the area reviewed, the Preprufe membrane had been tied into the existing below grade waterproofing on along the north elevation. A similar detail is to be adopted at the south side of the area reviewed, but installation had not yet been completed. MH understands this is work in progress and takes no exception.

SV.04.04.F - Transition at north side of area reviewed

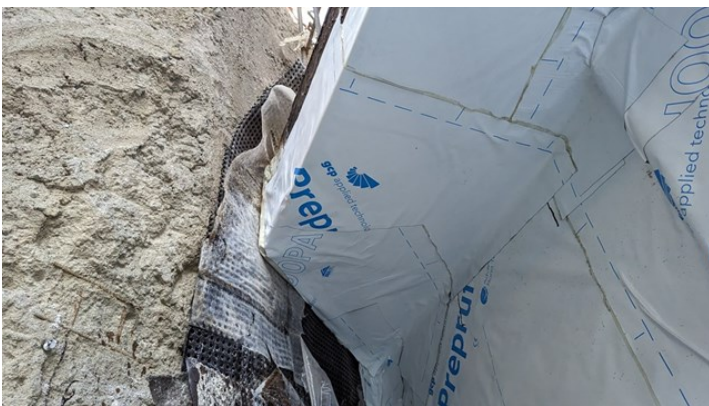
SV.04.04.G - Transition at north side of area reviewed

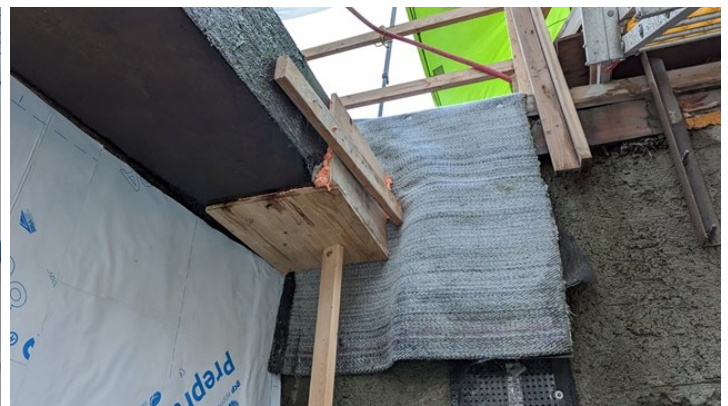
SV.04.04.H - Transition at south side of area reviewed

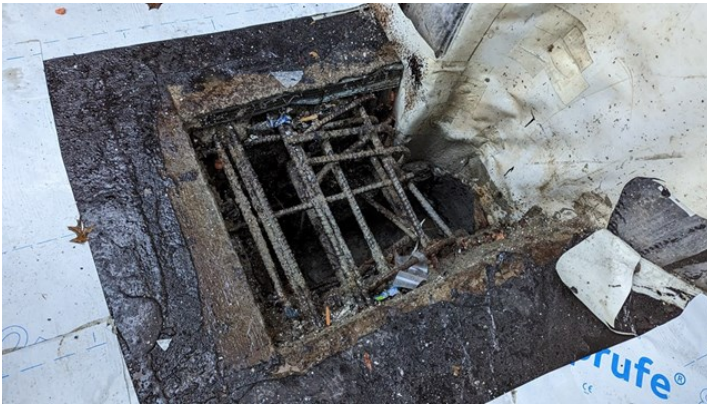
MH observed an area where there was a leave out in the slab on the north side of the reviewed area. Per discussions on site, MH understands the leave out in the slab was for destressing a tieback and grouting back the head. The team will work to complete tie in of the Preprufe waterproofing to the adjacent waterproofing at a later date. MH understands this is work in progress and takes no exception.

SV.04.05.A - Overview of leave out in slab

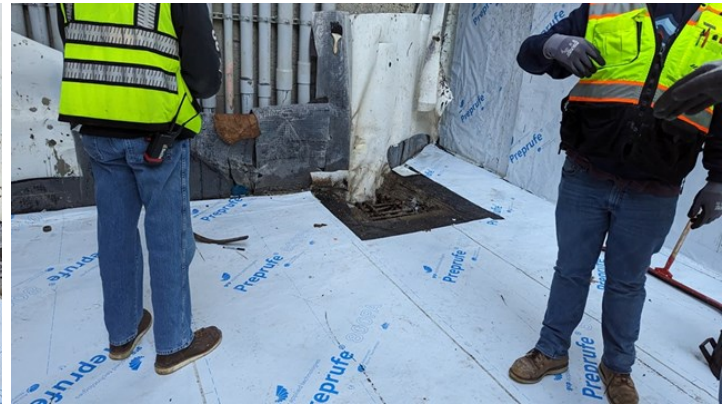
SV.04.05.B - Overview of leave out in slab

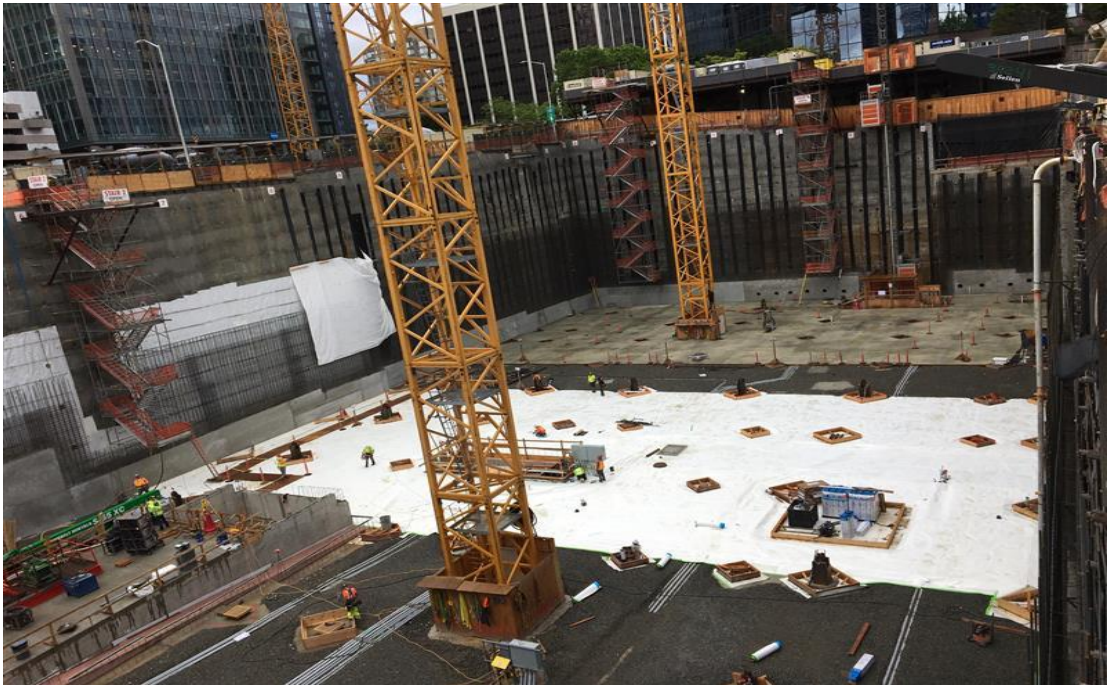
Photograph 1. Vapor barrier bottom

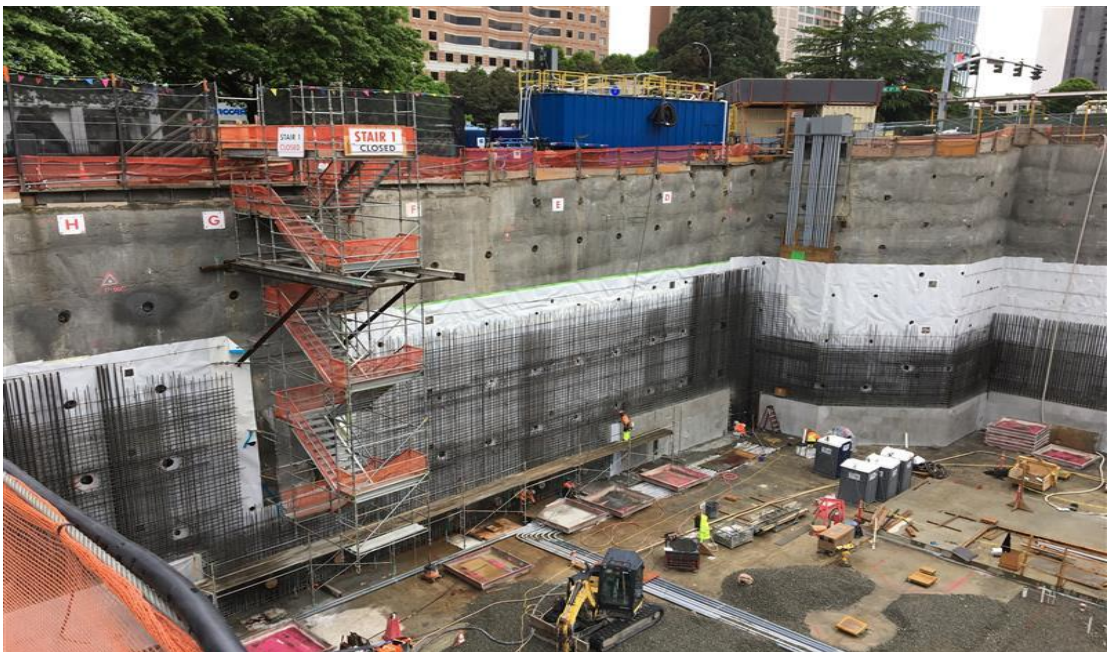
Photograph 2. Vapor barrier sidewall
