Reference: Maralco Aluminum Project
Work Assignment Number MRLC2, PIC JIK25
MKES Work Order Number 3987
Task 4 - Interim Remedial Action - "Construction
As-Built" Reports and Photo Records

TASK 4 - INTERIM REMEDIAL ACTIONS

RE-ROUTING OF ROOF DRAINS

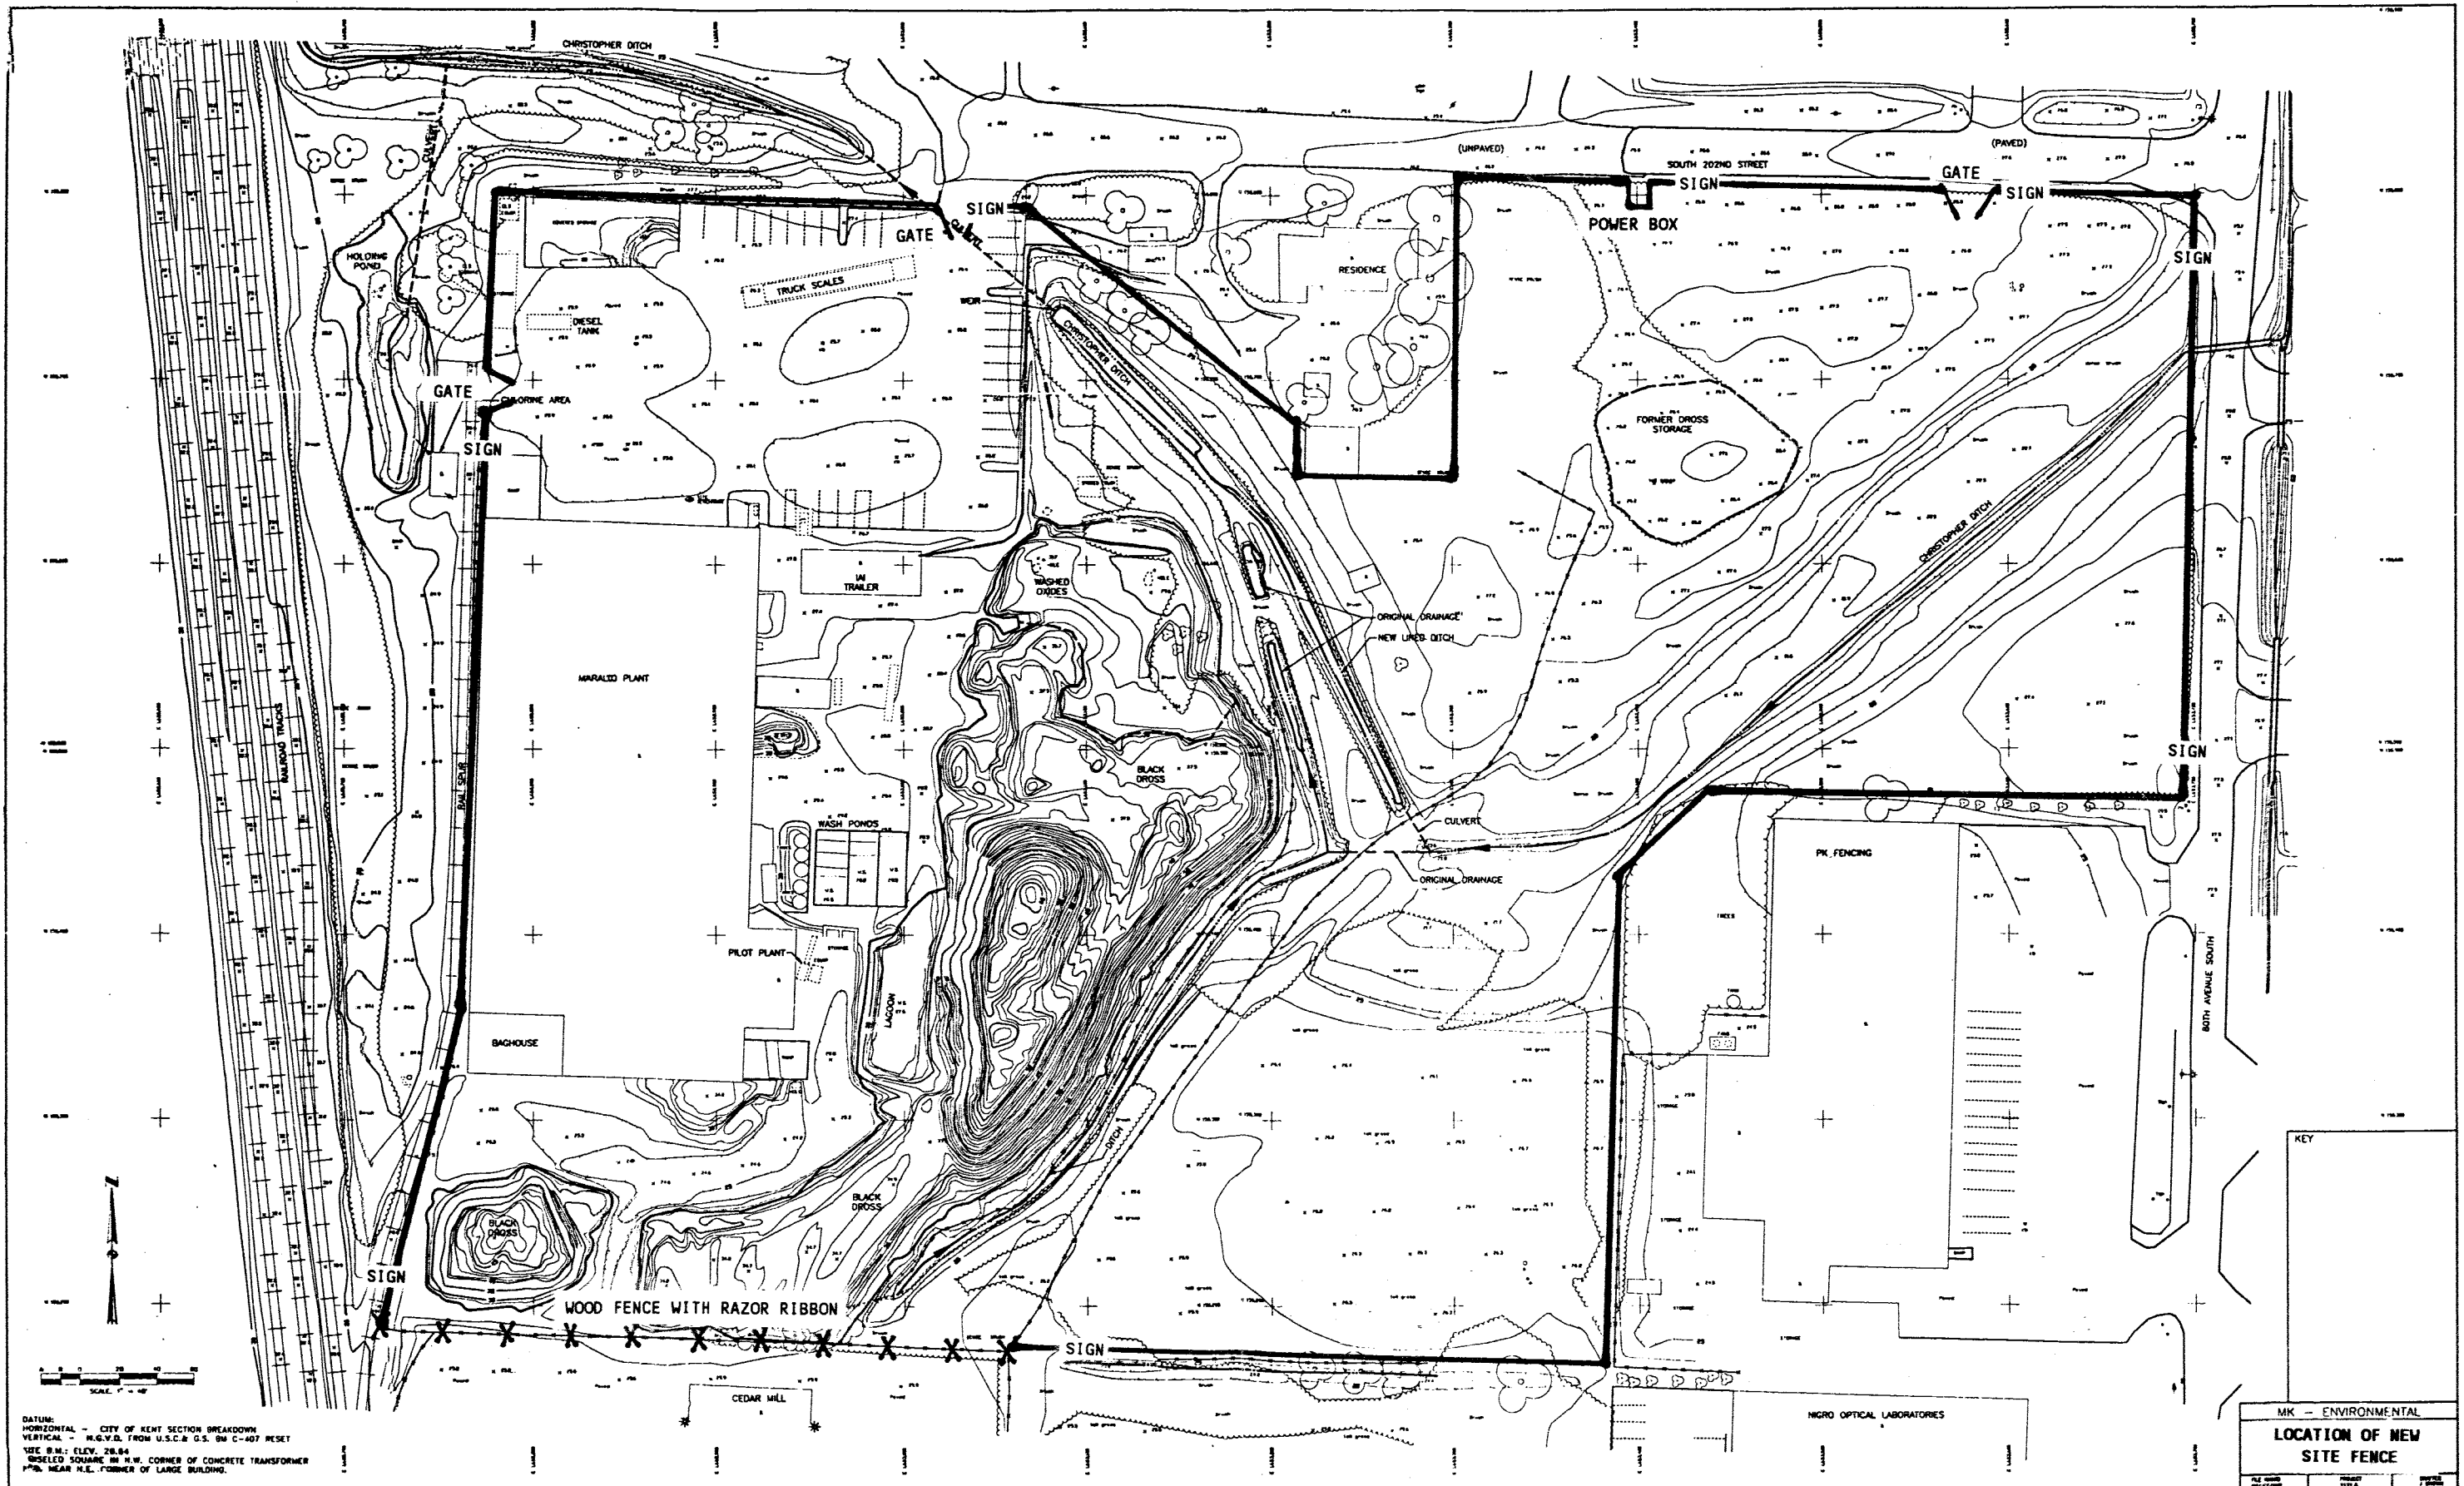
LOCATION OF NEW SITE FENCE

The locations of the new fence, the gates and the signs are shown on the attached figure.

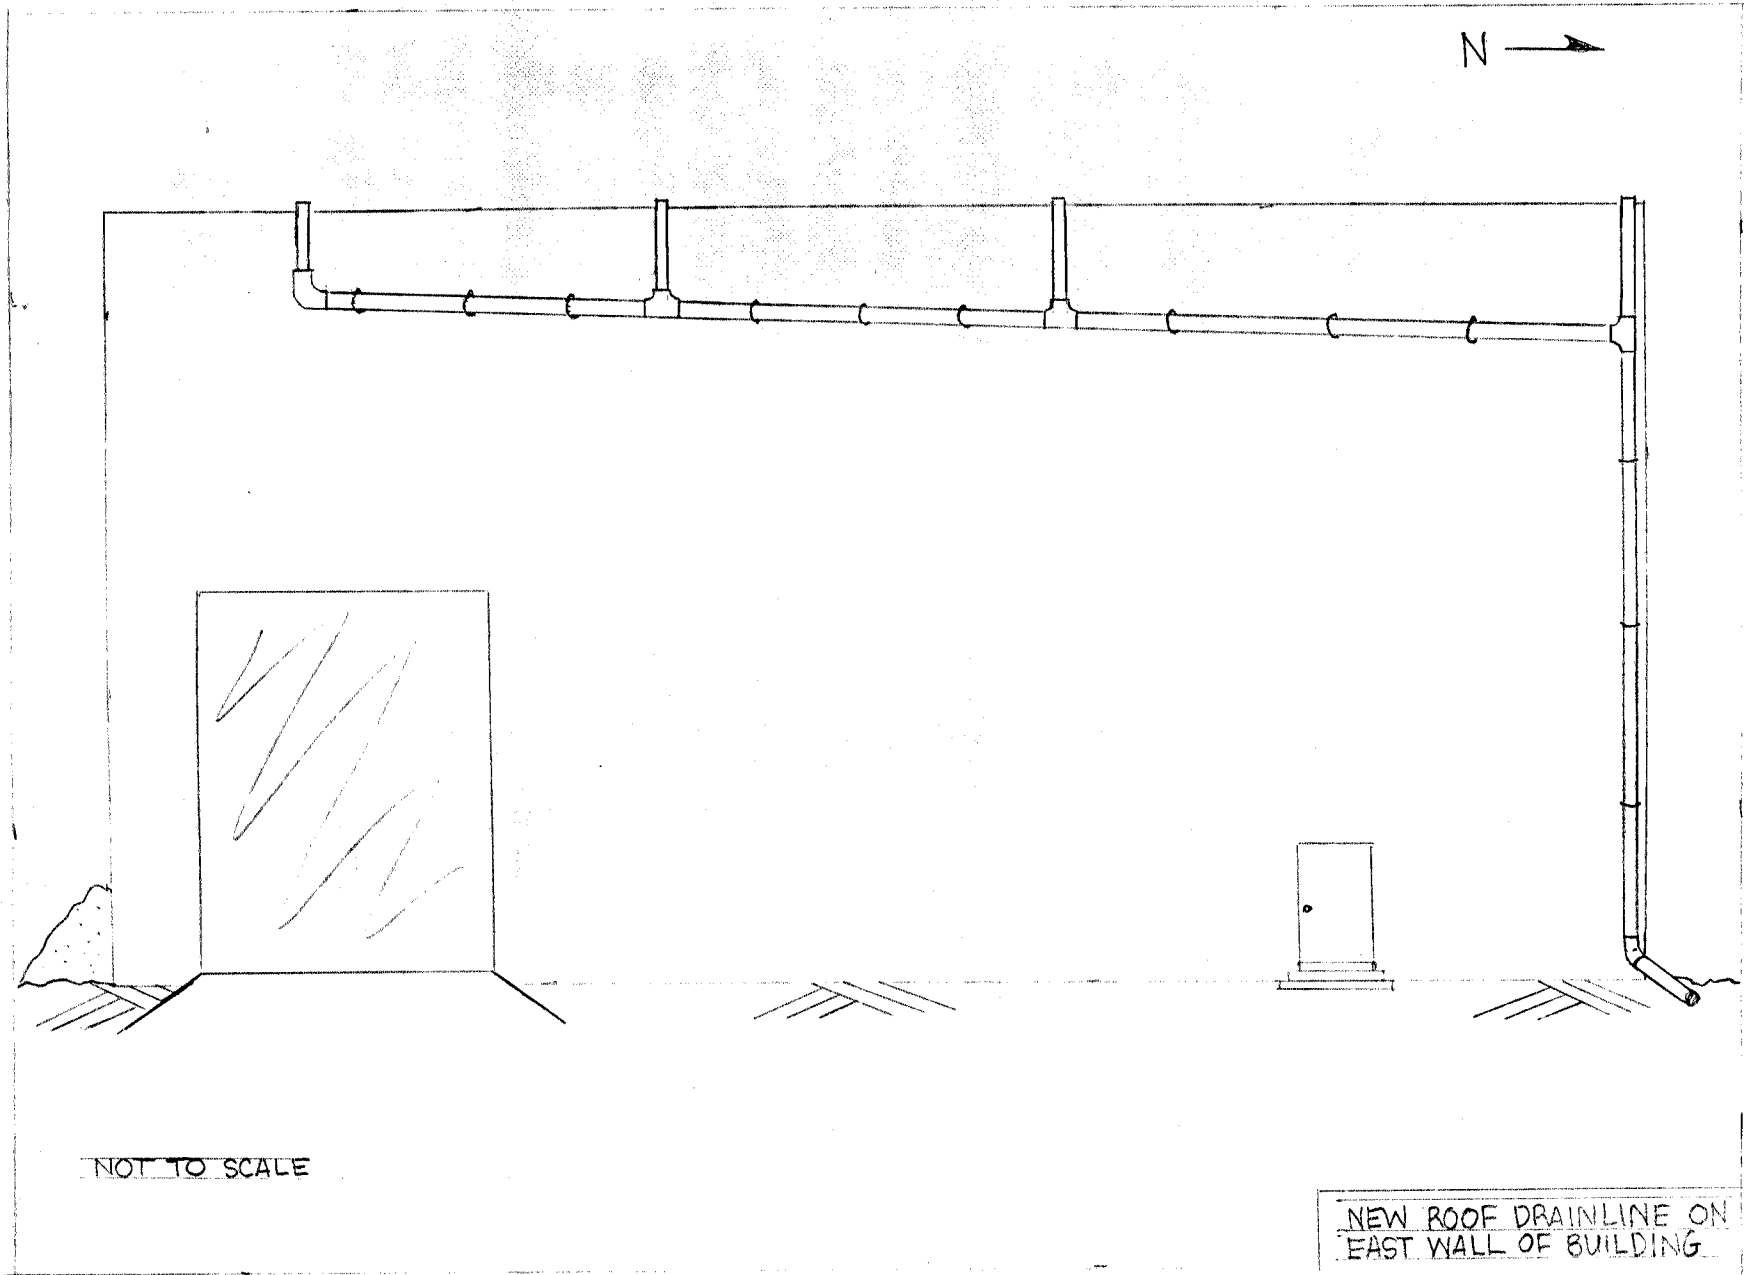
FIGURE 1

The new drainline was tied into the existing drainline at the first downspout near the south end of the east wall with a 90-degree elbow. The new pipe was hung in 20' lengths at a slope of approximately 1 percent along the length of the wall. Where existing downspouts were encountered, they were cut off and tied into the new drainline with tees. The new drainline was secured by wrapping lengths of chain around the pipe and bolting the ends of the chain to the wall.

NEW ROOF DRAINLINE ON
EAST WALL OF BUILDING

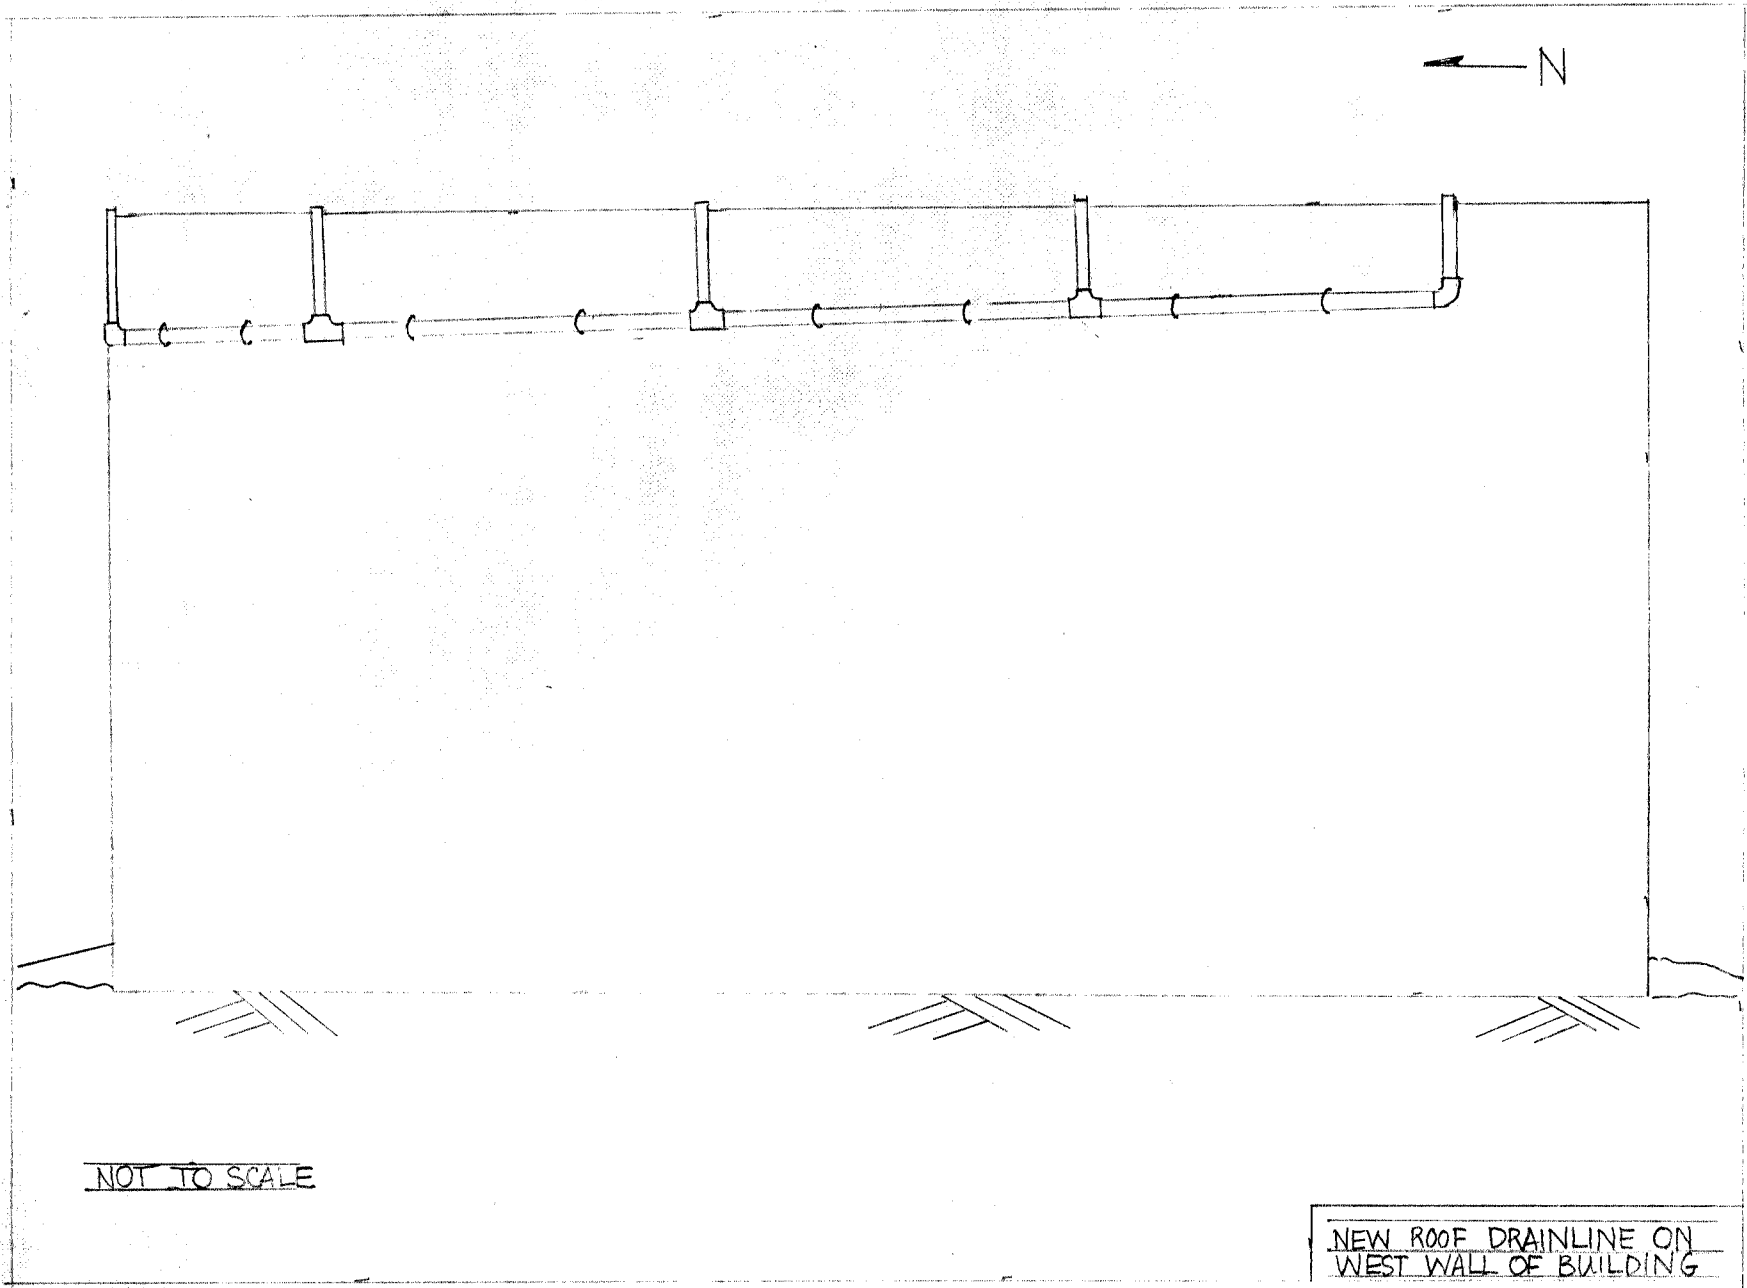
FIGURE 2

At the north end of the east wall, the new pipe was tied into the existing downspout with a tee and run down the corner of the building to the ground. A 10' section of pipe was then attached to the new downspout and the runoff directed to the parking lot.

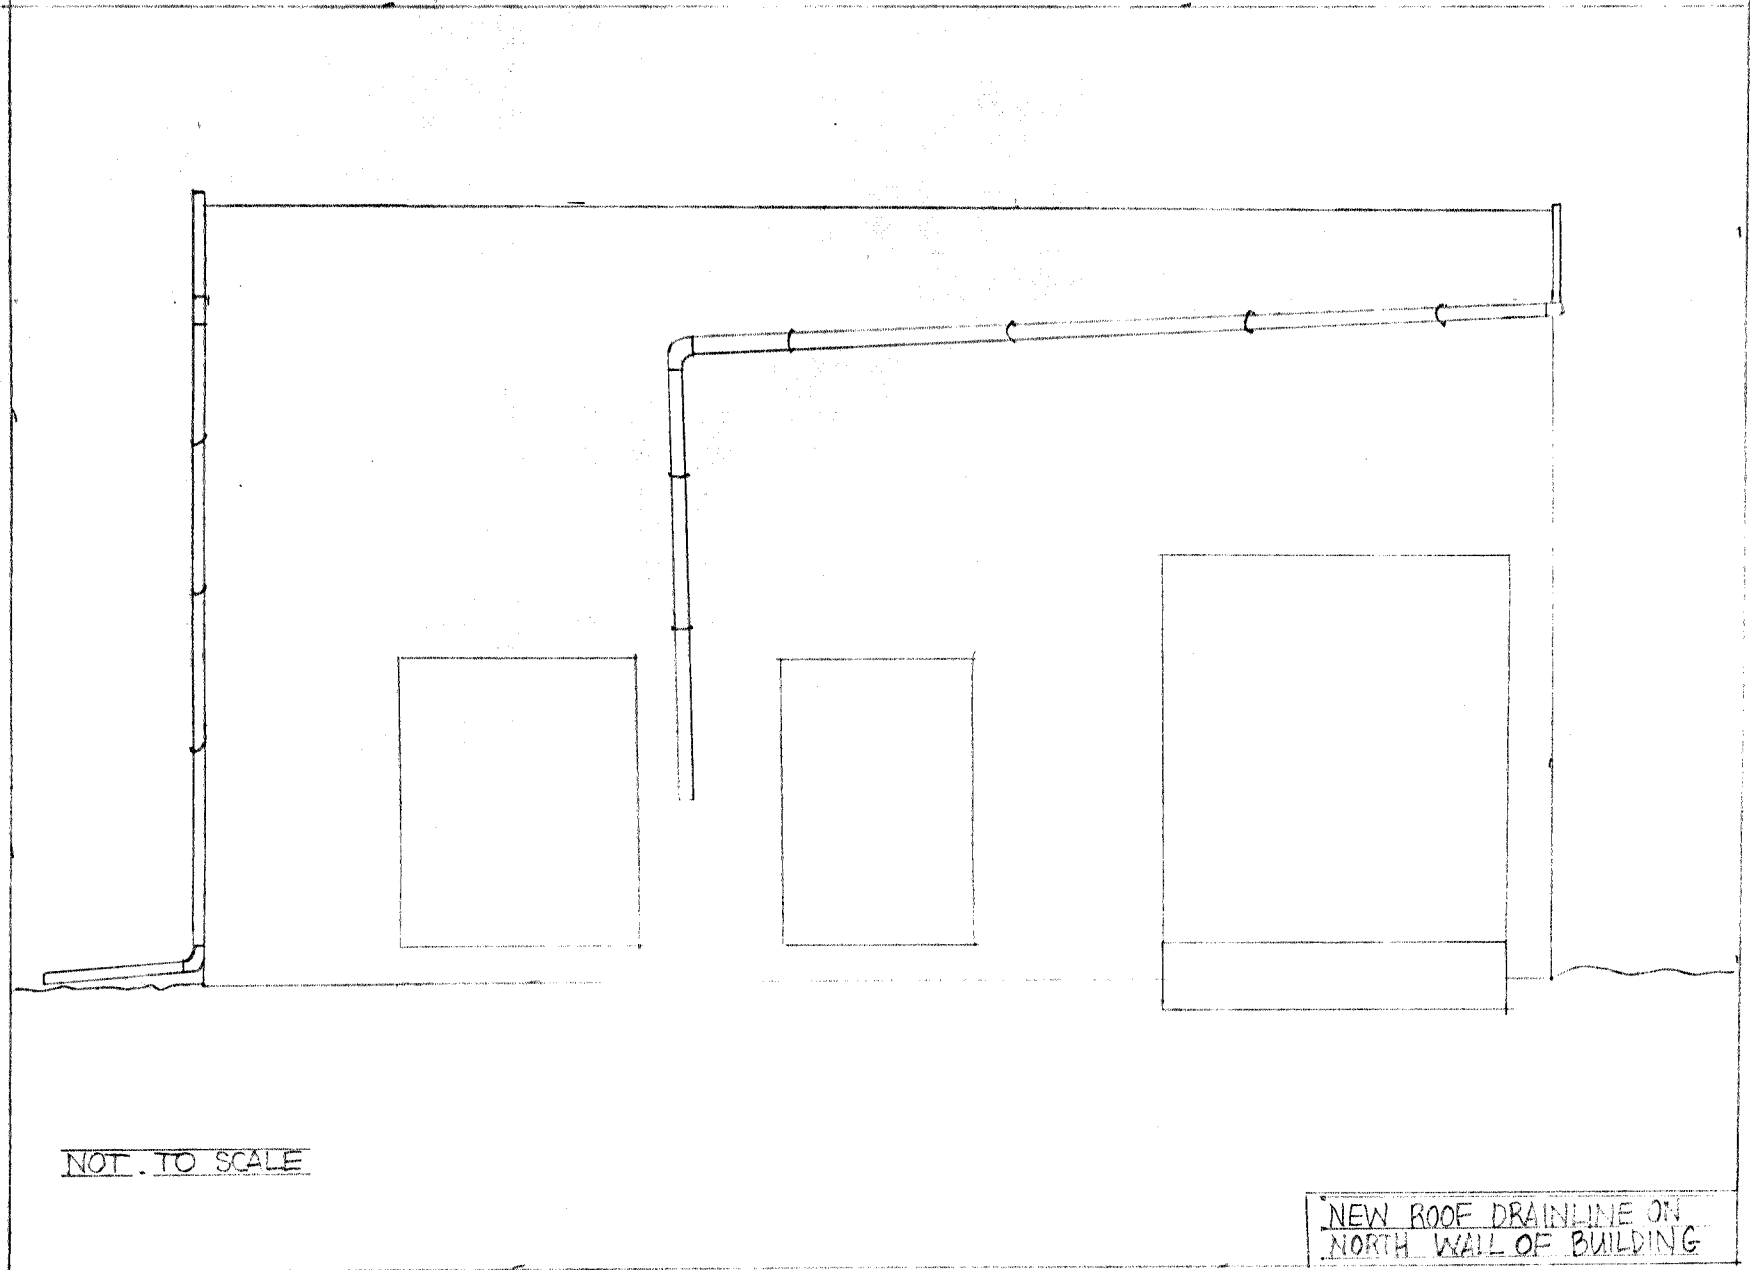
FIGURE 3

The drainline on the west side of the building was re-routed the same way as the east side until the north corner of the building was reached. Here, the new drainline was wrapped around the corner to the north wall of the building and hung at a slope of approximately 1-2 percent until the middle of the wall. A downspout was then added to allow drainage to the parking lot.
