State of Washington
POLLUTION LIABILITY INSURANCE AGENCY
PO Box 40930 • Olympia, Washington 98504-0930
(360) 407-0520 • (800) 822-3905
www.plia.wa.gov

Re: No Further Action (NFA) for the Following Site:

- **Facility/Site Name:** Town Center Mini Mart
- **Facility/Site Address:** 15410 Main Street, Duvall, WA 98019
- **Facility Site ID:** 48143795
- **Technical Assistance Program No.:** PNW017

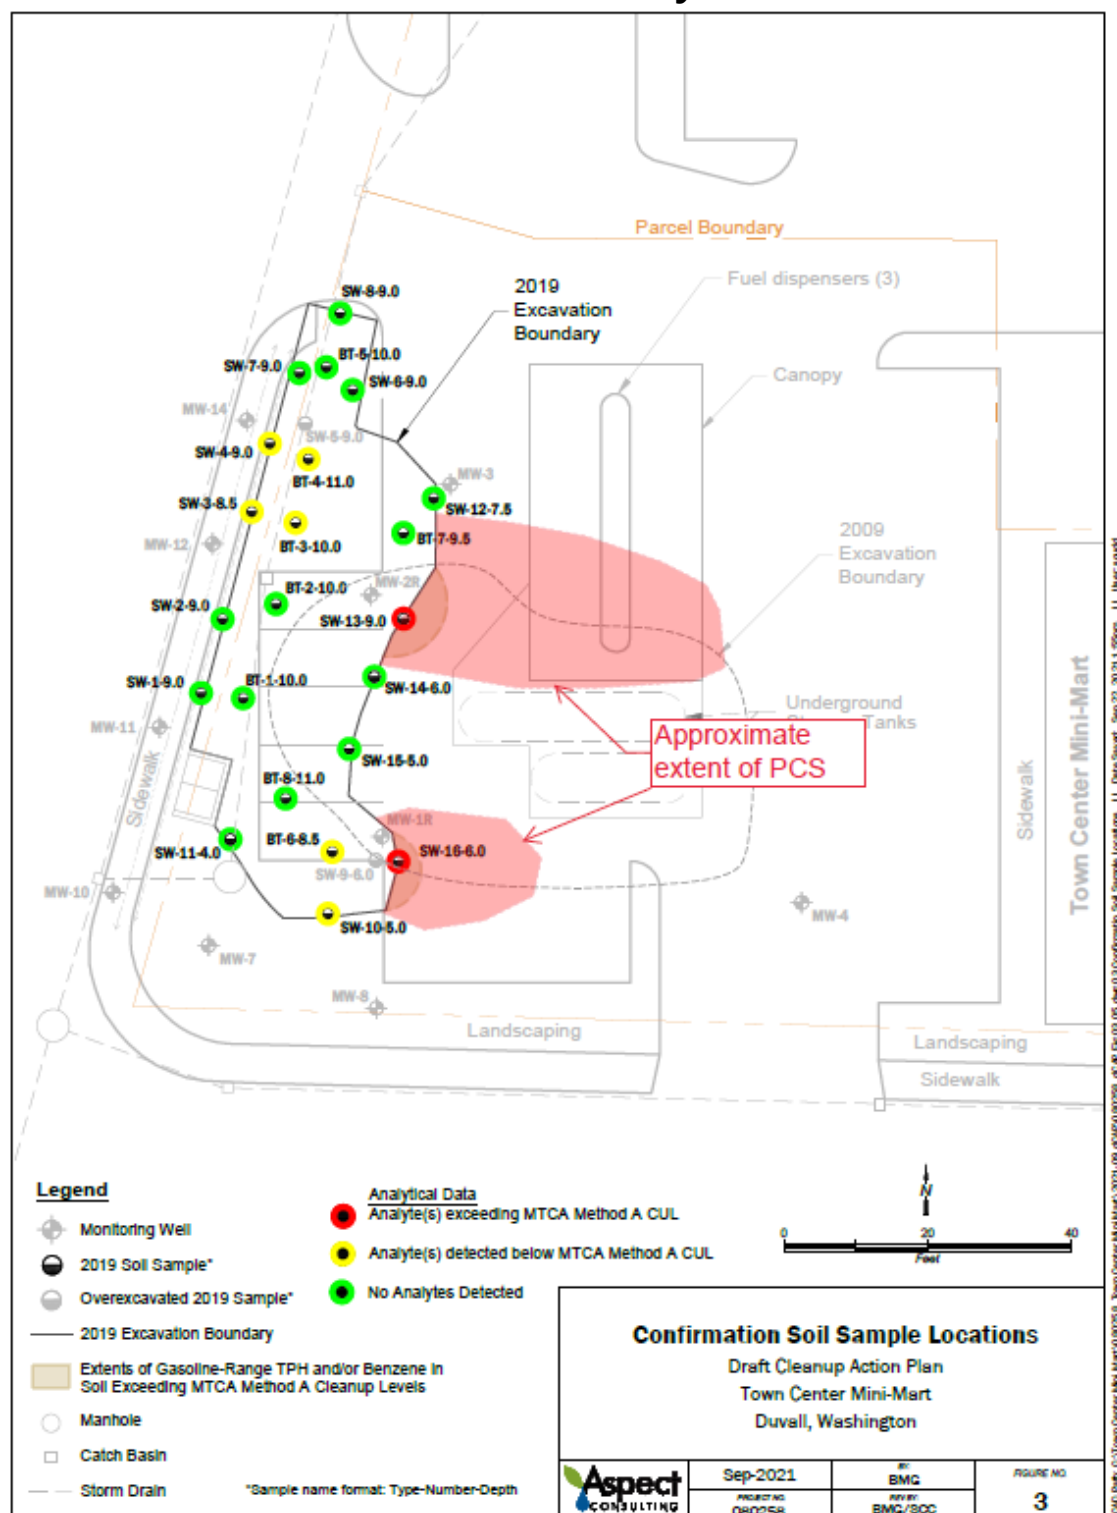
Figure 2: Estimated Extent of Petroleum Contaminated Soil – Modified by PLIA

- Confirmation samples collected from the excavations and borings demonstrate that all known PCS with concentrations of Site COCs exceeding the applicable CULs was removed from the Site, with the exception of inaccessible areas proximate to current Site infrastructure (Figure 2). Soil sampling results are listed in the following tables:

- Institutional and engineering controls will serve to limit future contact with residual PCS at the Site. An impervious paved surface is in place over the remaining PCS with concentrations of COCs exceeding MTCA Method A CULs.
- Environmental Covenant: The impacted area, and any necessary safety protocols to address concerns with the soil direct contact exposure pathway, must be detailed in an environmental covenant filed with King County.
- Inspection: Annual inspection of engineering controls as outlined in the PLIA-approved Site Inspection Form (Enclosure B) is required to evaluate compliance with the institutional controls in the Environmental Covenant.

- No drilling; digging; piercing the cap with a sampling device, post, stake or similar device; grading; excavation; installation of underground utilities; removal of the cap; or application of loads in excess of the cap load-bearing capacity in the areas with PCS identified on Figure 2.
- No construction of buildings or other enclosed structures without previous approval from PLIA.

If cracks greater than 1-inch wide are observed within the asphalt cap during annual inspections, the contingency action is to reseal and/or patch the cracks to prevent infiltration of surface runoff.
