**PHASE I ENVIRONMENTAL SITE ASSESSMENT**

**FRUHLING SAND AND TOPSOIL  
1010 228TH STREET SW  
BOTHELL, WASHINGTON 98021**

October 11, 2005

053-1649.100

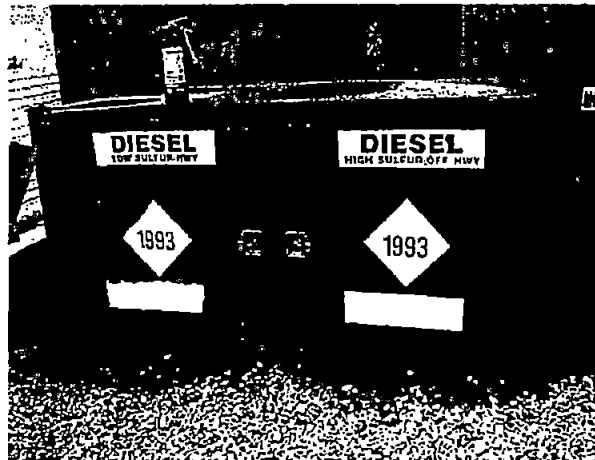
Exterior soil staining was observed at various locations throughout the subject property. De minimis amounts of soil staining was observed in the employee and refueling truck parking areas surrounding the facility. Soil staining was also observed around all of the fixed equipment onsite. Extensive soil staining was observed around the Power Screen 408 machine adjacent to the settling pond and around the cabinet containing diesel fuel in the fuel area.

Photo 11 – Cabinet containing diesel fuel with soil staining.

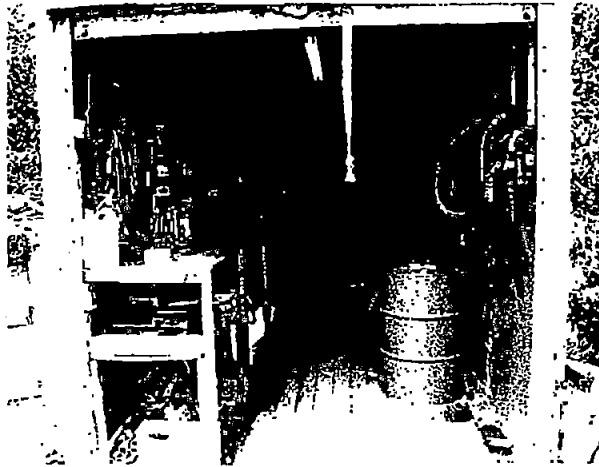
The Maintenance Shop located on the west side of the north border of the property primarily contained tools and a 55-gallon drum of unleaded gasoline. No secondary containment was present for this drum. Adjacent to the Maintenance Shop was a wood shed that housed an air compressor. West of the Maintenance Shop was the fueling area. The fueling area consisted of four 55-gallon drums, an approximately 20,000 gallon diesel AST, and a metal cabinet containing low and high sulfur diesel fuel. Stained soil was observed around the cabinet of diesel fuel. A small trailer with an exhaust stack was observed west of the AST. Access to the trailer was not possible as it was locked. Golder observed sever piles of refuse surrounding this general area. The refuse included plastic and metal items.

Photo 13 – Maintenance Shop.

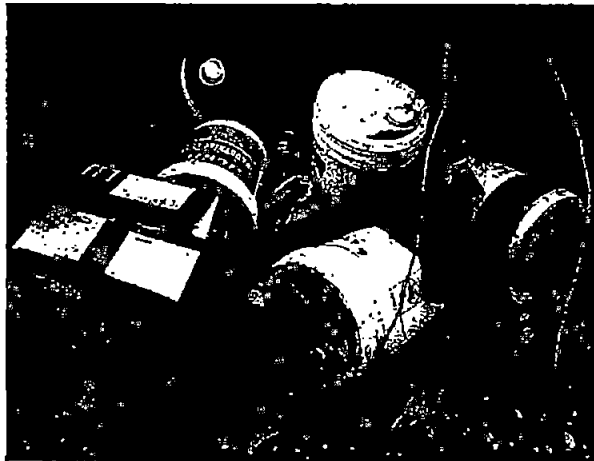
Golder observed empty 5-gallon buckets of hydraulic oil and paint as well as a box of six empty 1-gallon heavy duty motor oil bottles located in the area of the Site that is leased by Asplundh. The Site reportedly collects all of its hazardous waste (motor oil, hydraulic oil, gasoline, and diesel fuel) and transports it to the Fruhling's Kenmore, Washington office where it is picked-up for disposal by Safety Kleen.

Photo 17 – 5-gallon buckets adjacent to Asplundh leased property.

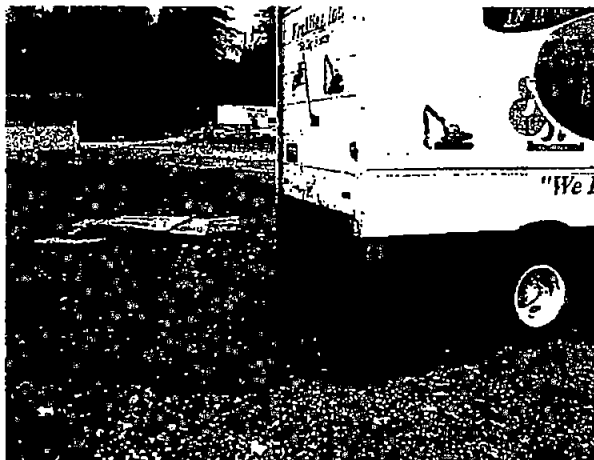
On the west side of the third tier of the Site was a conveyor machine that had hydraulic lines connecting to a Fruhling Inc. truck. Access inside of the truck was not allowed as it was locked. Reportedly, the truck housed the engine for the conveyor machine. Stained soil was observed adjacent to the truck, possibly caused by leaking hydraulic lines. On the east side of the 3<sup>rd</sup> tier was the space leased by Asplundh. The area appeared to primarily be used for parking of Asplundh trucks, employee vehicles, and two shipping containers (one of which was locked and the other contained a 5-gallon bucket of hydraulic fluid). This area was littered with garbage including nine empty 5-gallon buckets. The northeast corner of the site is developed with a cell tower.

Photo 18 – Staining under hydraulic lines to Fruhling truck and conveyor.

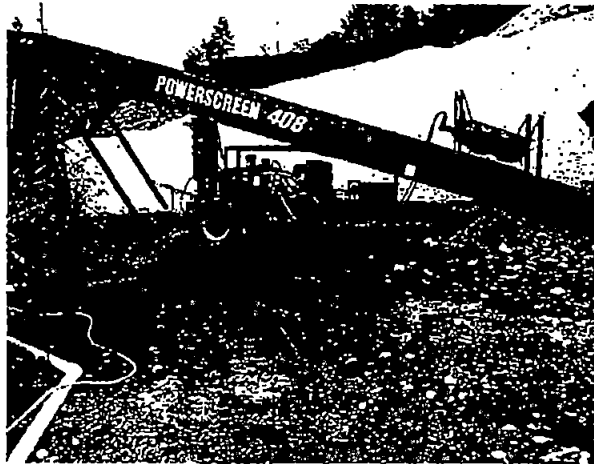
- The amount of soil staining observed onsite, particularly under the Power Screen 408 adjacent to the settling pond. It is possible that petroleum products from the machine have significantly impacted the soil. Groundwater may be affected as well, since the staining is located adjacent to a major onsite pond.

- Extensive soil staining was observed around the Power Screen 408 machine north of the settling pond. This staining could be an indication that the soil in that area is contaminated by petroleum products.

Photo 20 – Soil Staining under screener.
