Subject: 2023 Annual Inspection Summary
Former Harbour Pointe Cleaners Lynnwood (Facility Site ID 41352598)

Project No.: C3163

**Former Harbour Pointe Cleaners Lynnwood
13619 Mukilteo Speedway, Lynnwood, WA 98037
Photographs from 2023 Annual Inspection**

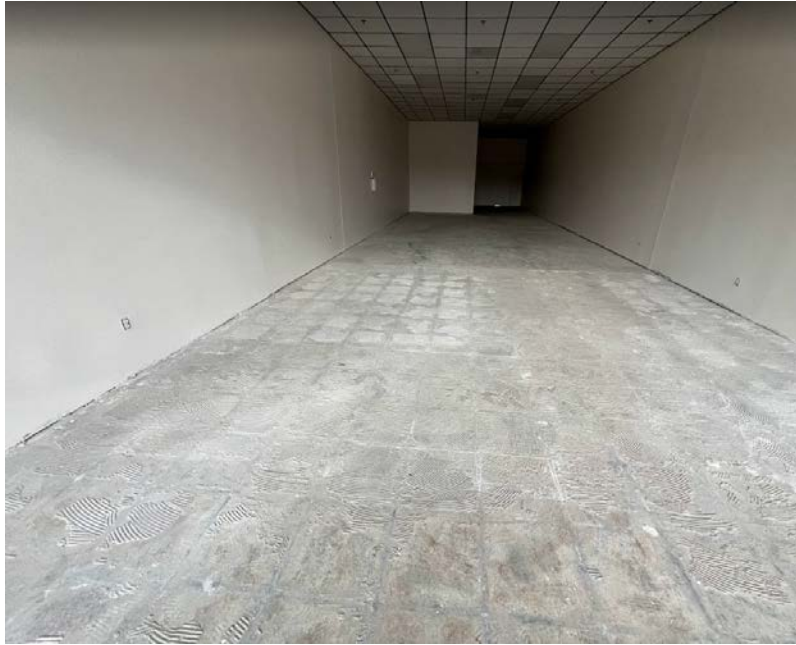
Photograph 1. Floor Slab in Former Harbour Pointe Cleaners (Suite B6)
(December 8, 2023)

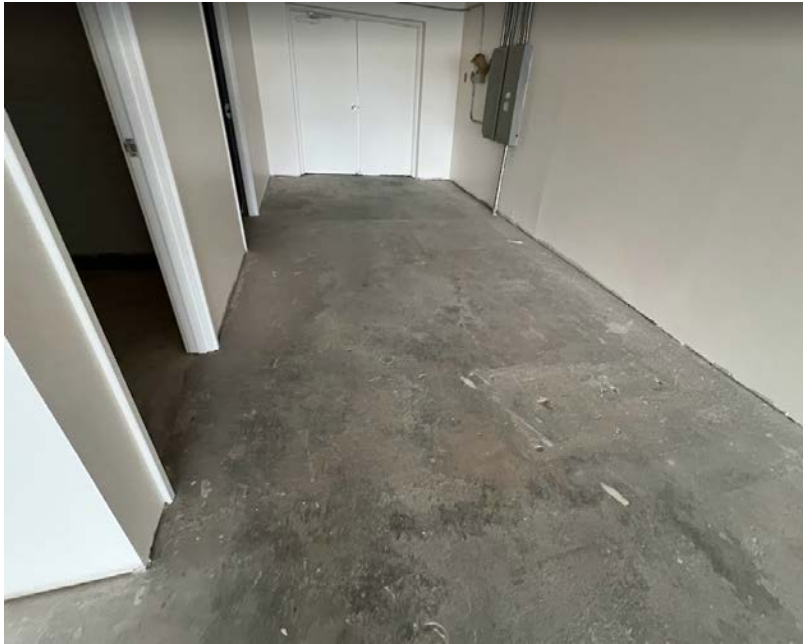
Photograph 2. Floor Slab in Rear of Former Harbour Pointe Cleaners (Suite B6)
(December 8, 2023)

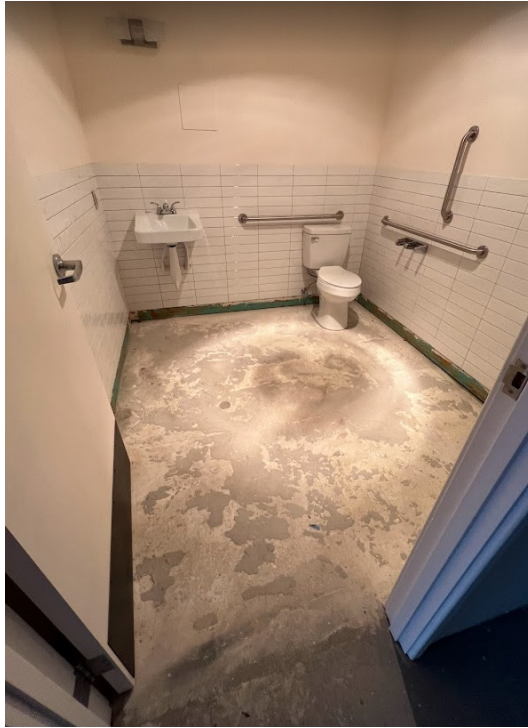
Photograph 3. Floor Slab in Bathroom of Former Harbour Pointe Cleaners (Suite B6) (December 8, 2023)

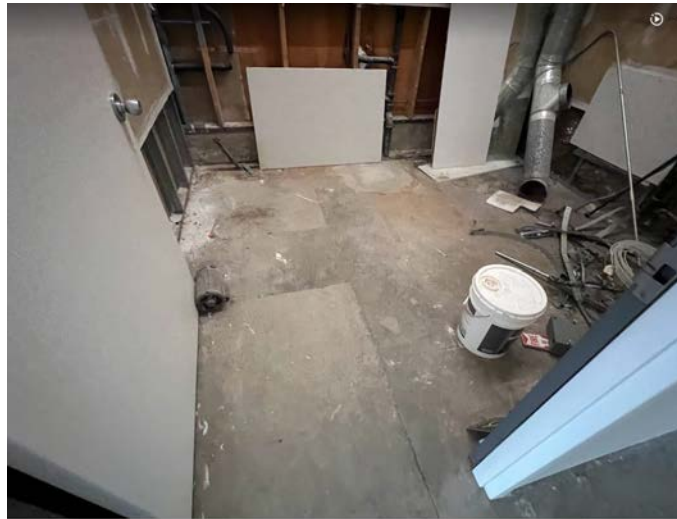
Photograph 4. Floor Slab in Rear Utility Room of Former Harbour Pointe Cleaners (Suite B6) (December 8, 2023)

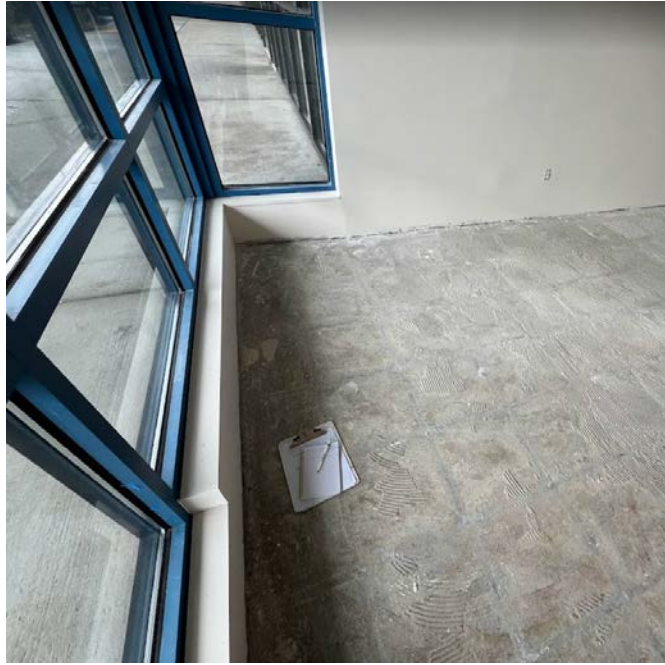
Photograph 5. Floor Slab in Front of Former Harbour Pointe Cleaners, Facing West (Suite B6) (December 8, 2023)

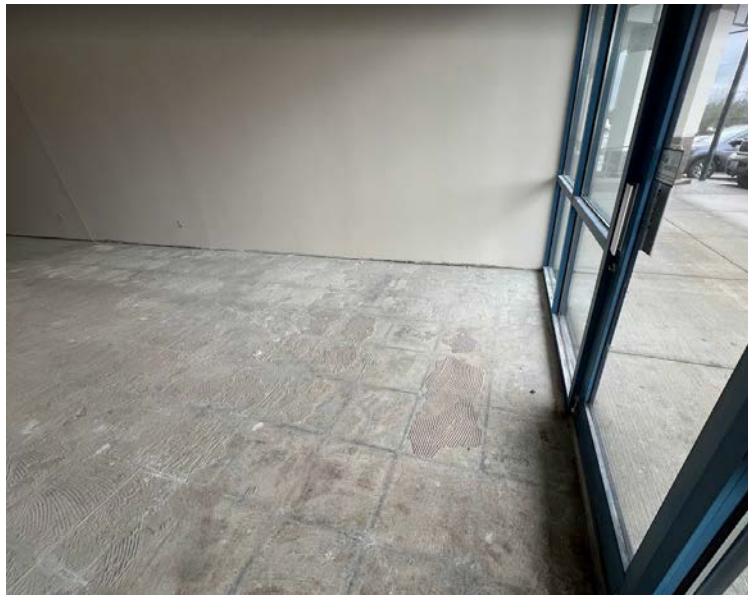
Photograph 6. Floor Slab in Front of Former Harbour Pointe Cleaners, Facing East (Suite B6) (December 8, 2023)

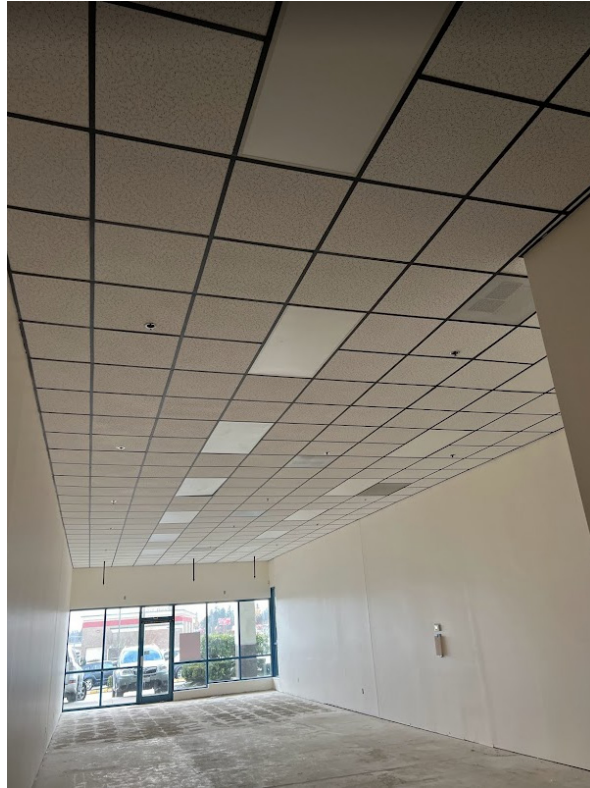
Suite B6 (Former Harbour Pointe Cleaners), B7: A demising wall was added to separate Suites B6 and B7, and walls were painted. Residual excess glue from pre-2022 floor tile removal was cleaned from the floor by sanding. Ceiling tiles were re-installed.

Photograph 7. Ceiling of Former Harbour Pointe Cleaners (Suite B6)
(December 8, 2023)

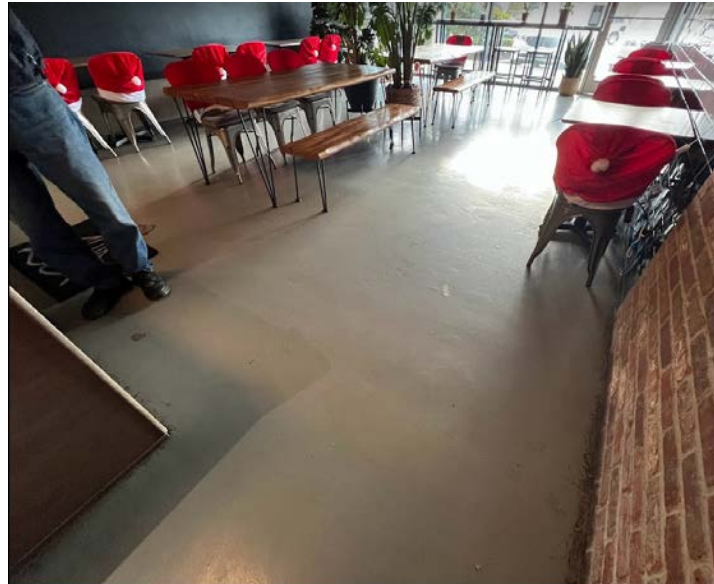
Photograph 8. Floor Slab in Adjacent-West Tenant Space (Suite B5)
(December 8, 2023)

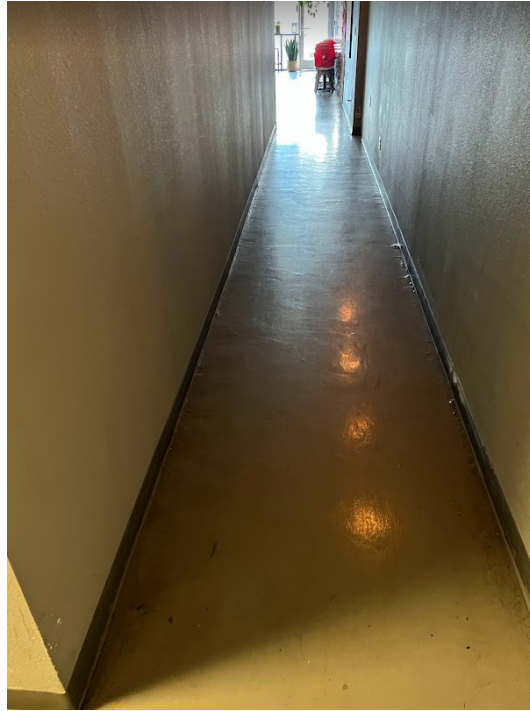
Photograph 9. Floor Slab in Hallway of Adjacent-West Tenant Space (Suite B5)
(December 8, 2023)

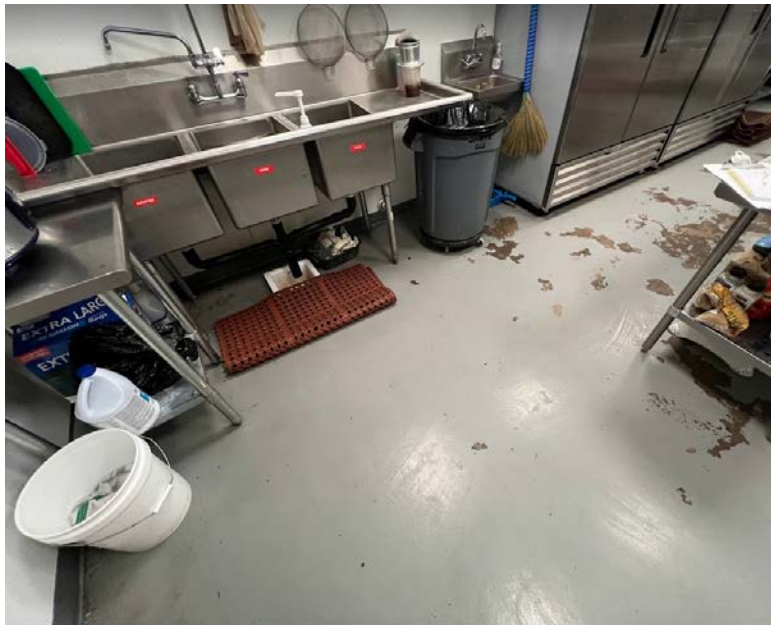
Photograph 10. Floor Slab in Kitchen of Adjacent-West Tenant Space (Suite B5)
(December 8, 2023)

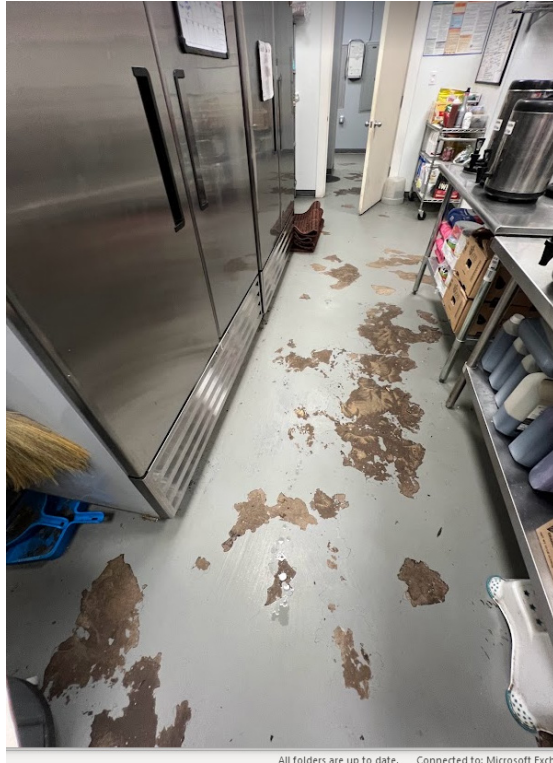
Photograph 11. Floor Slab in Kitchen of Adjacent-West Tenant Space (Suite B5)
(December 8, 2023)

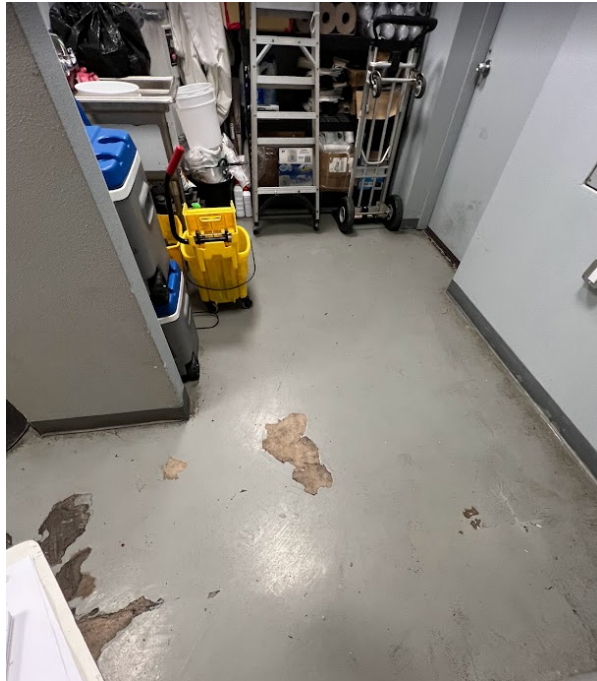
Photograph 12. Floor Slab in Rear Hallway of Adjacent-West Tenant Space
(Suite B5) (December 8, 2023)

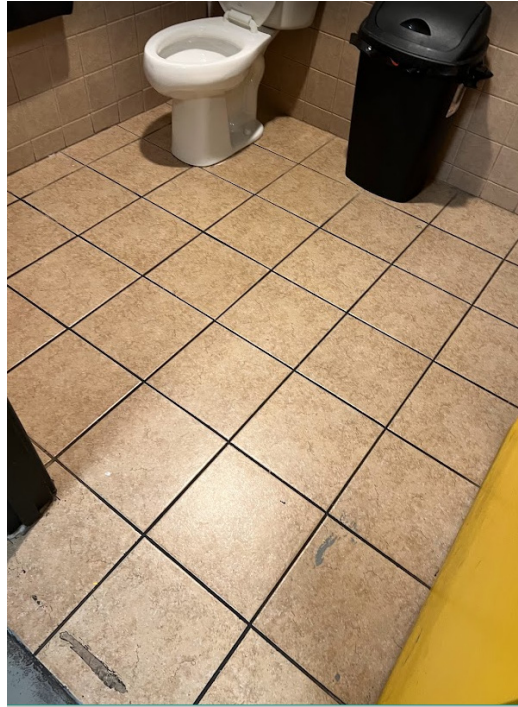
Photograph 13. Floor Slab in Bathroom 1 of Adjacent-West Tenant Space (Suite B5) (December 8, 2023)

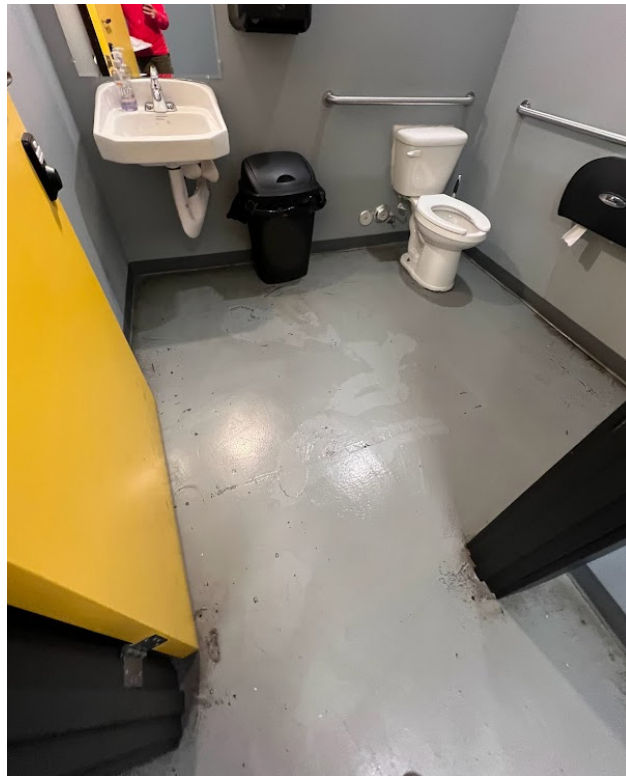
Photograph 14. Floor Slab in Bathroom 2 of Adjacent-West Tenant Space (Suite B5) (December 8, 2023)

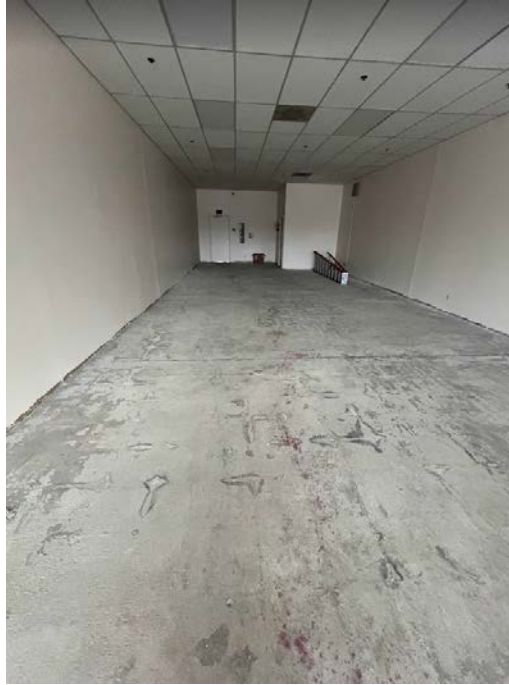
Photograph 15. Floor Slab and Ceiling in Suite B7 (December 8, 2023)

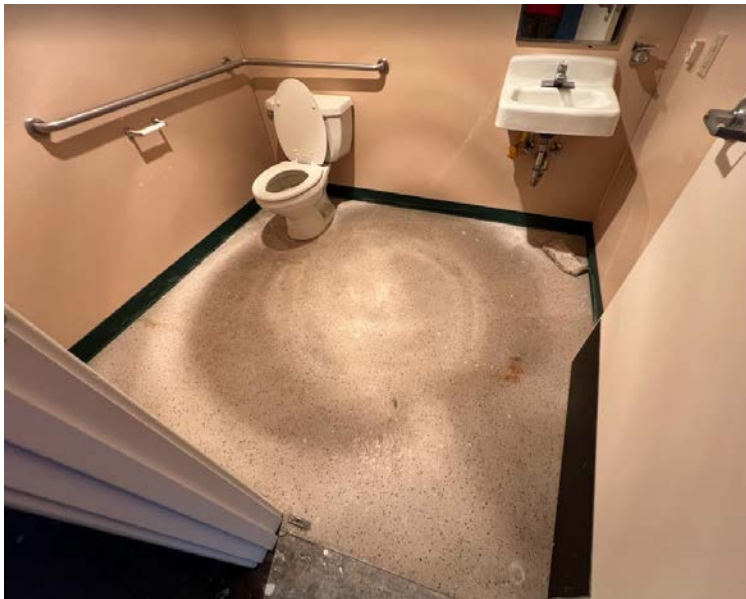
Photograph 16. Bathroom Floor in Suite B7 (December 8, 2023)
