ENVIRONMENTAL CAP AND DRAINAGE SYSTEM INSPECTION REPORT

FORMER LOUISIANA PACIFIC/PONY LUMBER FACILITY

June 15, 2022

Enforcement Order No. DE 92TC-S312 (December 21, 1992)
Washington State Department of Ecology Facility Site ID # 1209
Inspection Dates: February 24, 2022

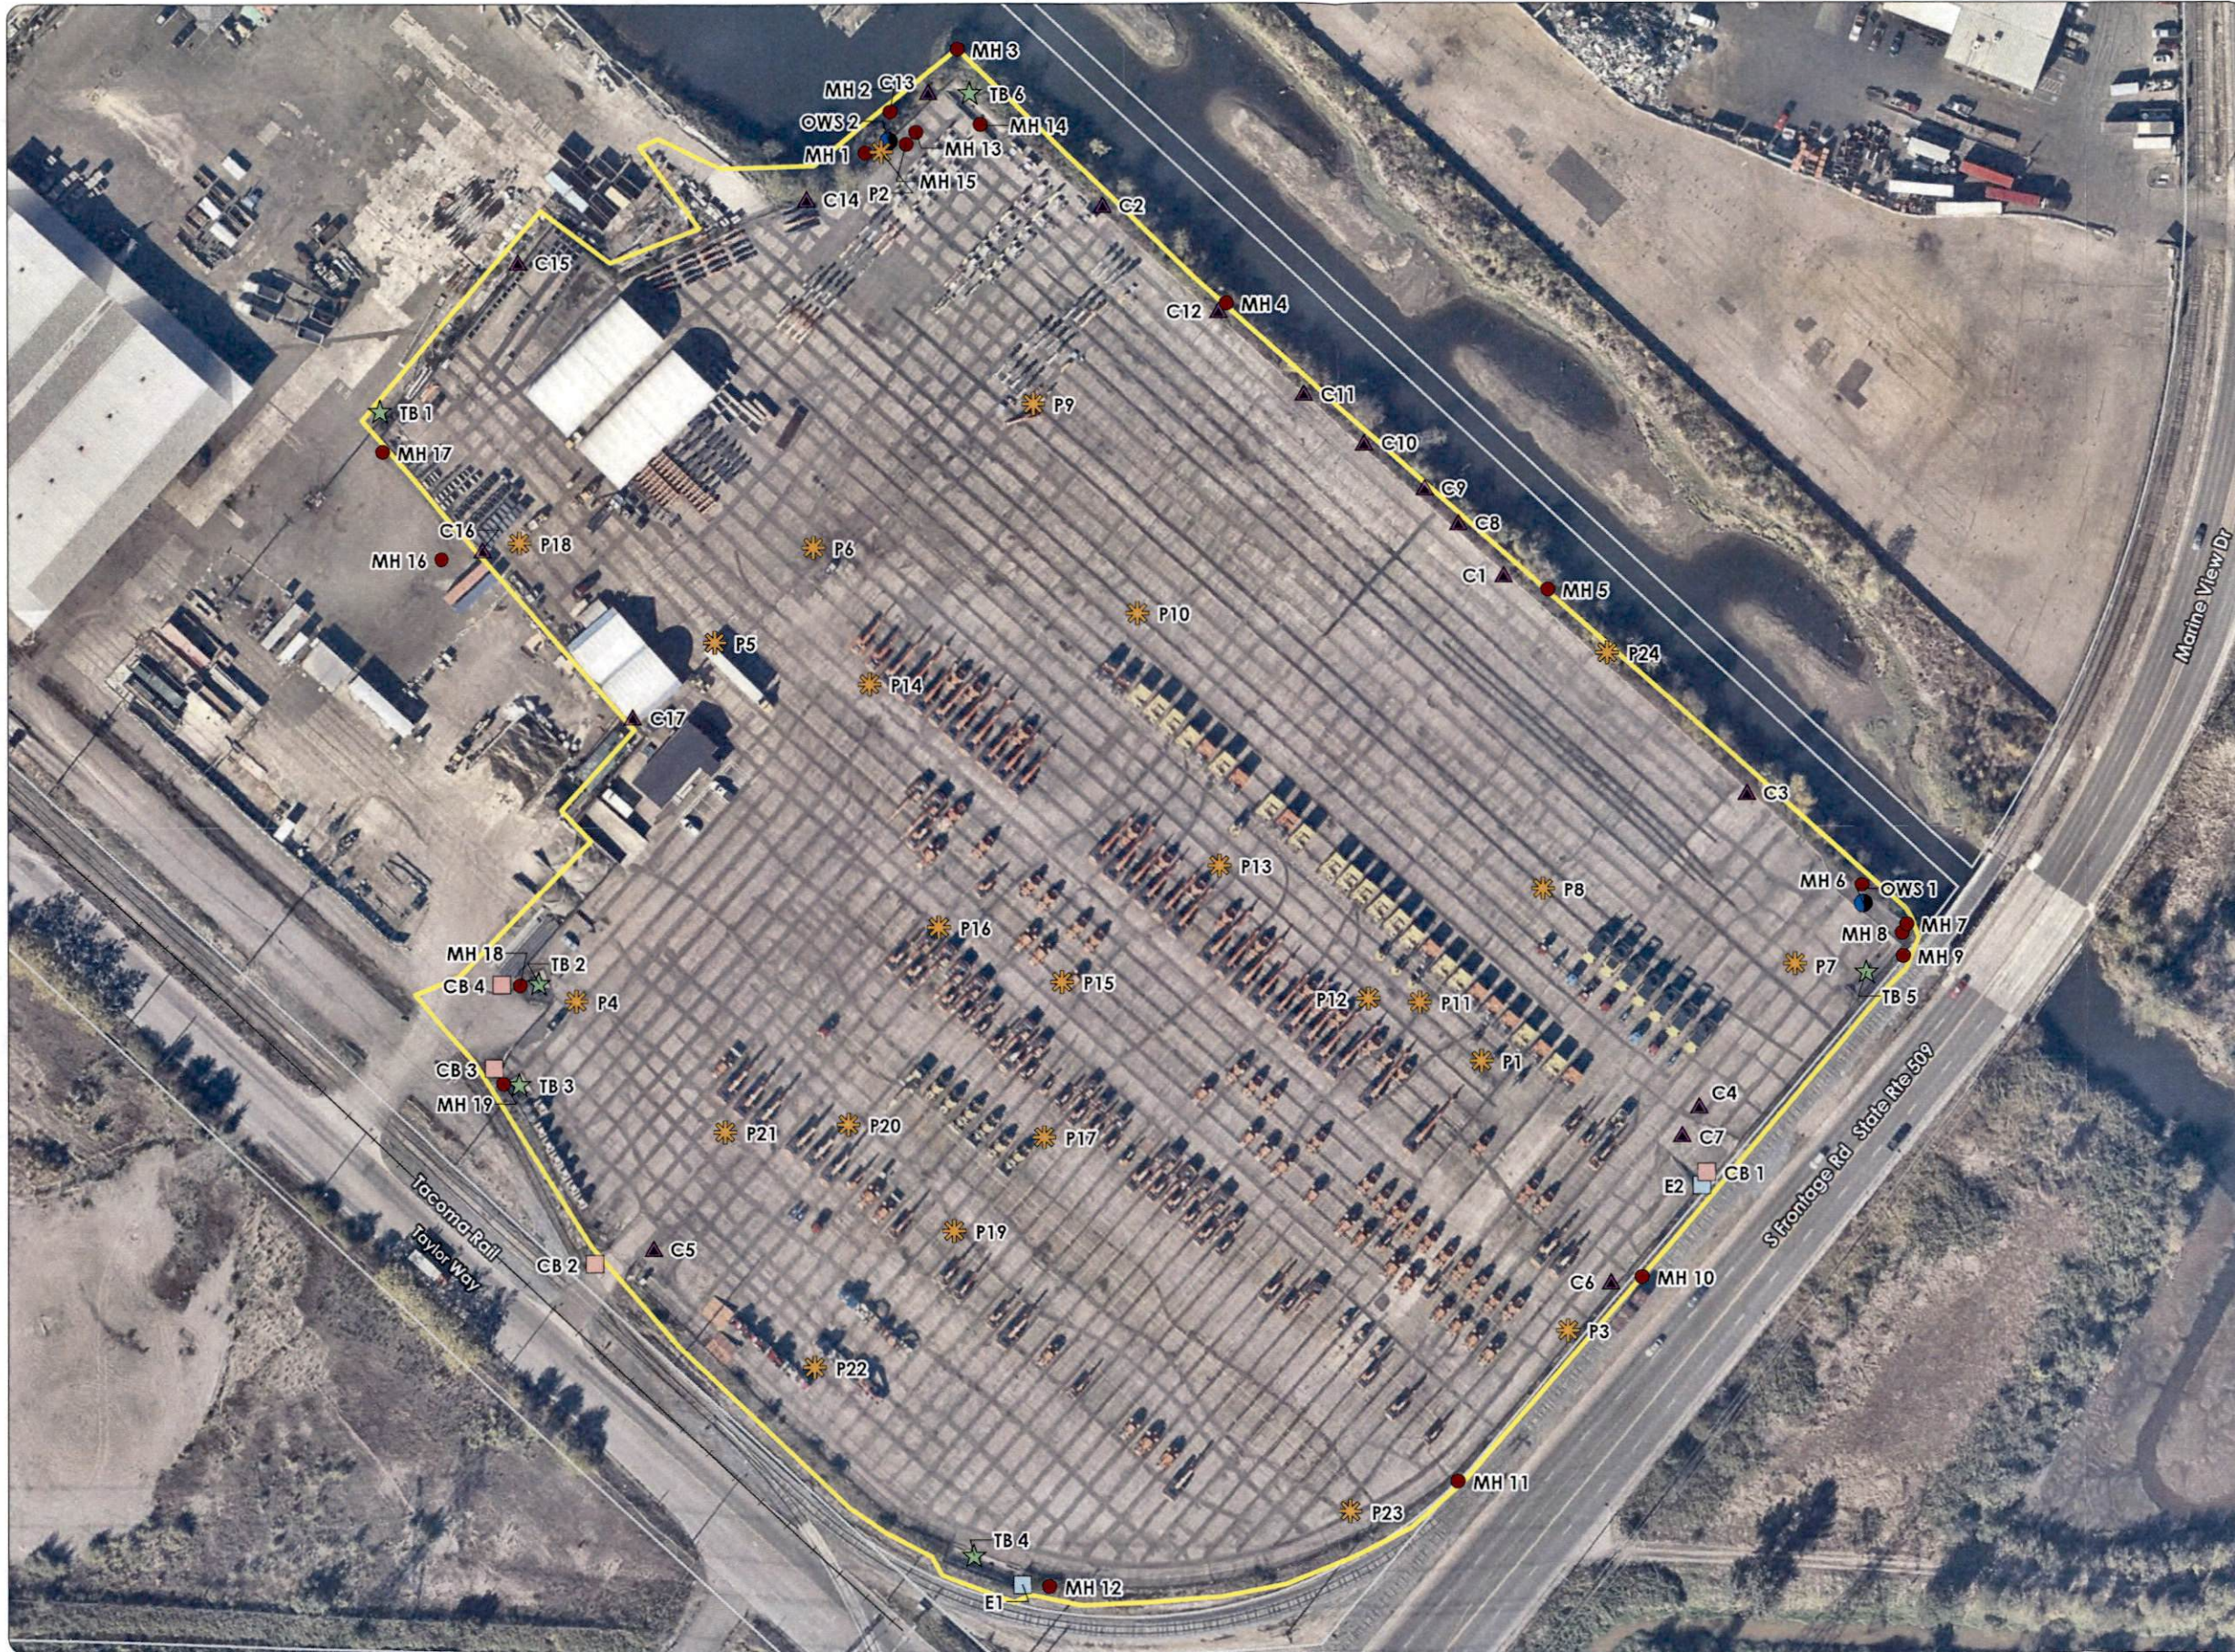
Figure 2
Environmental
Cap Observations

The cap generally showed consistent wear across the Site, with most of the damaged asphalt located in the portions of the Site used for heavy equipment storage. A slurry seal was previously applied over cracks running across the cap; the slurry seal is showing signs of wear and damage consistent with the previous inspection. Damage observed to the slurry seal appears to be the result of heavy equipment and includes chipping, cracking, divots, and flaking. No exposed sub-base material was observed during the inspection.

Cracking wider than 1/8 inch observed across the cap generally run parallel with rows of equipment. Several linear cracks were identified as being previously sealed, but the sealant has since worn to a point where there is visible unsealed gapping in cracks wider than 1/8 inch. Linear cracking in areas with old slurry seal was the primary damage observed across the Site during the inspection; a few areas with alligator cracking (interlaced or interconnected cracks) and divots were also observed. There are 17 sections of curb with damage, including several portions with cracks that extend through the vertical profile of the curb.

Two areas of erosion were observed near the cap edge (Table 1). The first erosion area, located along the fence line near MH12, shows subgrade undercut concrete. There does not appear to be cracking or damage to the cap at this time, but if erosion continues to undercut the cap, the cap may fail due to stress. The second area of erosion, located outside of the fence near catch basin CB1, included some gravel and concrete chunks observed outside of the fence near catch basin CB1.

| Required Inspection Element | Observed Condition | Recommended Action |
|---|---|--|
| Presence of cracks wider than 1/8 inch | Cracks wider than 1/8 inch were observed across the equipment storage area. | Repair pavement areas shown in Figure 2 and described in Table 1. |
| Pavement edge deterioration | 17 areas of curb damage were observed along cap edge. | Locations of pavement edge deterioration are shown in Figure 2 and described in Table 1. Repair as recommended in Table 1. |

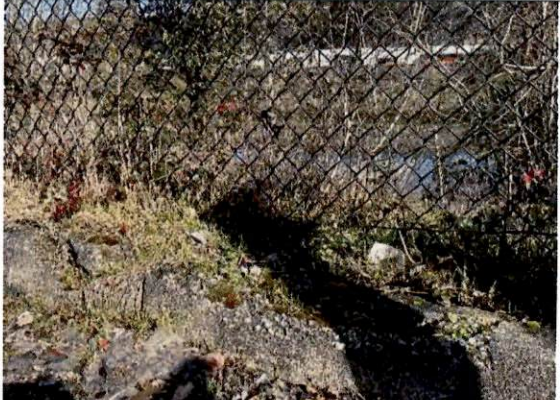
| ID | Type of Structure | Observation | Recommended Actions | Photographs |
|---|---|--|---|--|
| C1 | curb | curb damage extending approximately 4 feet; damage limited to top 2-3 inches of curb; curb continues to function to control runoff | monitor and reevaluate for repair during next inspection cycle | A photograph showing a section of a concrete curb that has been damaged, with a gap of approximately 4 feet. The curb is made of concrete and is surrounded by vegetation and a chain-link fence. |

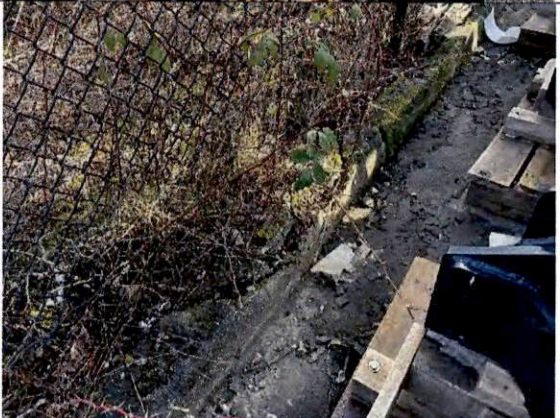
| ID | Type of Structure | Observation | Recommended Actions | Photographs |
|---|---|--|---|--|
| C2 | curb | curb damage extending approximately 2 feet; damage limited to top 2 inches of curb; loose pieces falling out; curb continues to function to control runoff | monitor and reevaluate for repair during next inspection cycle. | A photograph showing a section of a concrete curb that has been damaged, with a gap of approximately 2 feet. The curb is made of concrete and is surrounded by vegetation and a chain-link fence. There are some wooden pallets and debris visible in the foreground. |

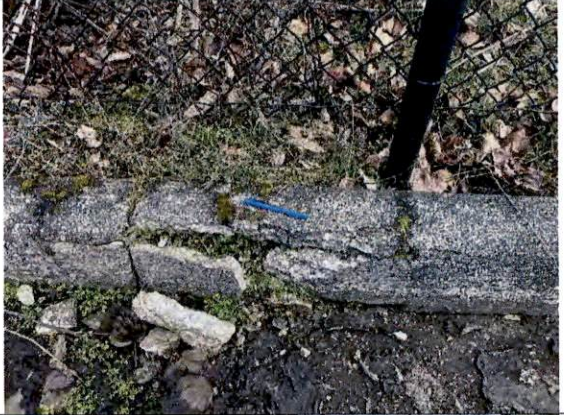
| ID | Type of Structure | Observation | Recommended Actions | Photographs |
|---|---|---|---|--|
| C3 | curb | curb damage through vertical profile; concrete crumbling and loose pieces falling out | repair curb | |

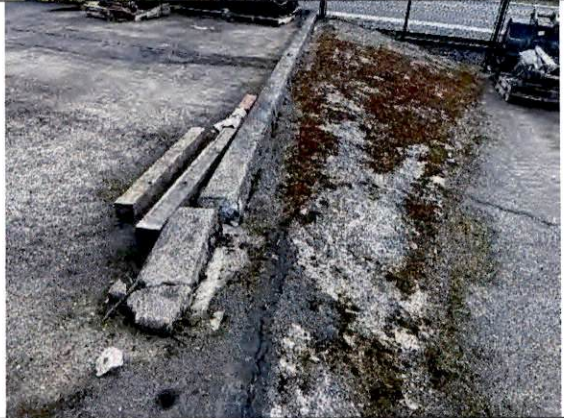
| ID | Type of Structure | Observation | Recommended Actions | Photographs |
|---|---|---|---|--|
| C4 | curb | piece of curb approximately 2 feet long broken off from end of curb; does not appear to be impacting drainage | Remove loose debris; monitor and reevaluate during next inspection cycle. | |

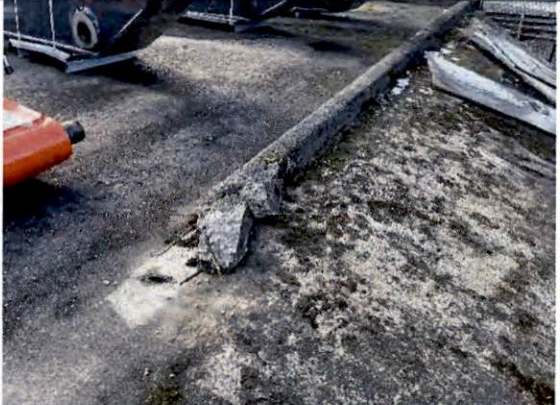
| ID | Type of Structure | Observation | Recommended Actions | Photographs |
|---|---|--|---|--|
| C5 | curb | curb damage approximately 3 feet long at end of curb; rebar exposed and chunks of curb missing; does not appear to be impacting drainage | Remove loose debris; monitor and reevaluate during next inspection cycle. | A photograph showing a concrete curb with significant damage at its end. A section of the curb is missing, exposing rebar. Debris is scattered on the ground nearby. |

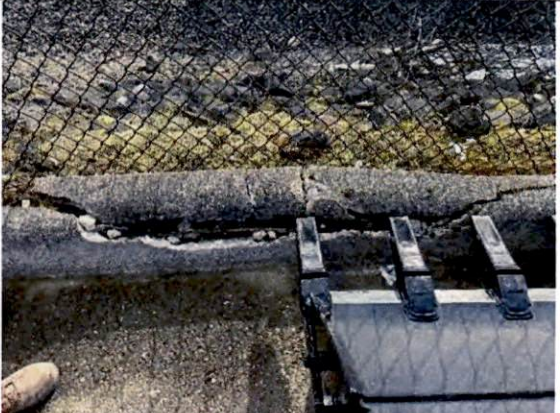
| ID | Type of Structure | Observation | Recommended Actions | Photographs |
|---|---|--|---|--|
| C6 | curb | curb damage approximately 4-5 feet long; exposed rebar and cracked top; does not appear to be impacting drainage | monitor and reevaluate during next inspection cycle | A photograph showing a concrete curb with a long, deep crack and exposed rebar. The top surface of the curb is cracked and crumbling. A metal grate is visible in the foreground. |

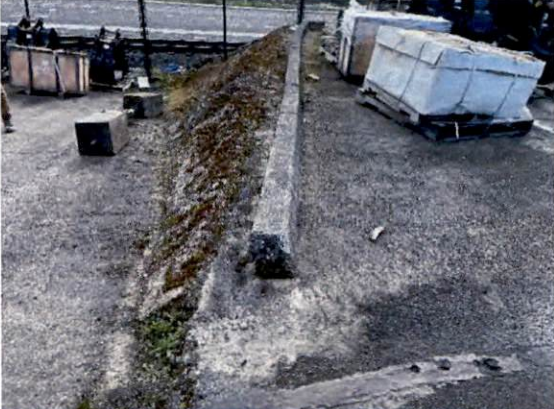
| ID | Type of Structure | Observation | Recommended Actions | Photographs |
|---|---|---|---|--|
| C7 | curb | piece of curb approximately 2 feet long broken off from end of curb; does not appear to be impacting drainage. | Remove loose debris; monitor and reevaluate during next inspection cycle. | |

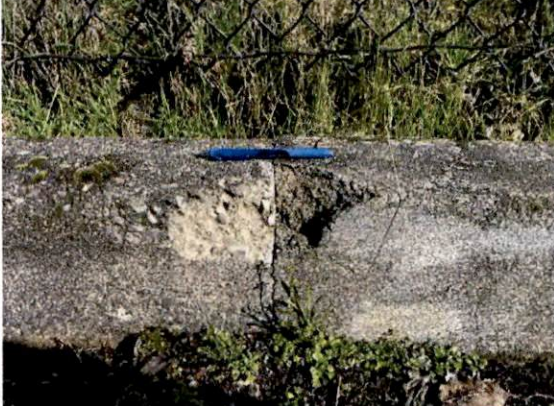
| ID | Type of Structure | Observation | Recommended Actions | Photographs |
|---|---|---|---|--|
| C8 | curb | piece of curb with chunk of concrete missing from top 2 inches of curb; does not appear to be impacting drainage. | monitor and reevaluate during next inspection cycle | |

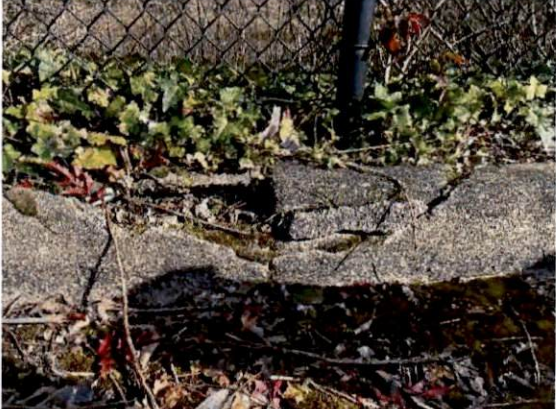
| ID | Type of Structure | Observation | Recommended Actions | Photographs |
|---|---|--|---|--|
| C9 | curb | curb damage approximately 3 feet long; chunks of concrete breaking; damage limited to top 2-3 inches; does not appear to be impacting drainage | monitor and reevaluate during next inspection cycle | A photograph showing a concrete curb with significant surface damage. The top layer of concrete is broken and crumbling, exposing the aggregate underneath. The damage is approximately 3 feet long. There are some plants and debris in the background. |

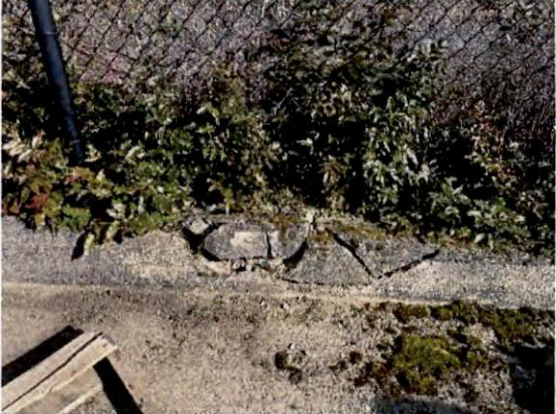
| ID | Type of Structure | Observation | Recommended Actions | Photographs |
|---|---|--|---|--|
| C10 | curb | curb damage approximately 2 feet long; chunks of concrete breaking off; damage limited to top 4-5 inches of curb; does not appear to be impacting drainage | monitor and reevaluate during next inspection cycle | A photograph showing a concrete curb with surface damage. The top layer of concrete is broken and crumbling, exposing the aggregate underneath. The damage is approximately 2 feet long. There are some plants and debris in the background. |

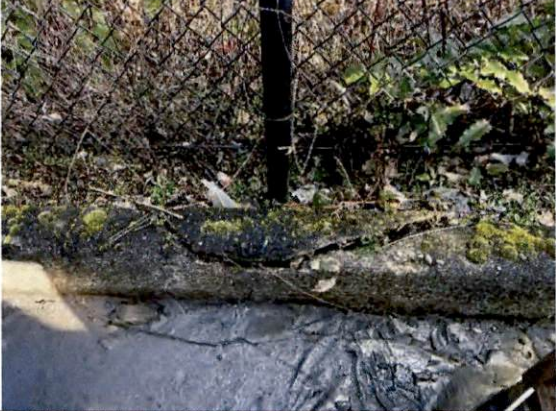
| ID | Type of Structure | Observation | Recommended Actions | Photographs |
|---|---|---|---|--|
| C11 | curb | curb damage approximately 2 feet long; damage limited to top 2-3 inches; does not appear to be impacting drainage | monitor and reevaluate during next inspection cycle | A photograph showing a concrete curb with a significant longitudinal crack. The crack runs across the top surface of the curb. The surrounding area is overgrown with weeds and grass. |

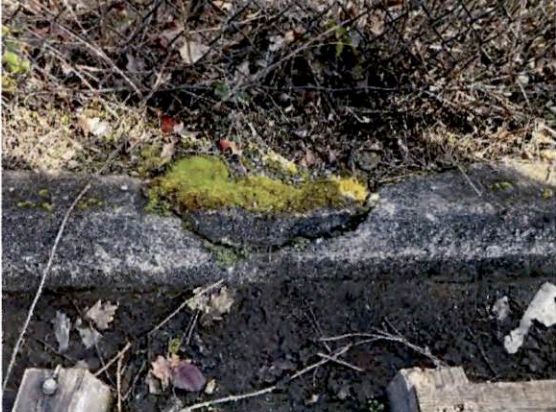
| ID | Type of Structure | Observation | Recommended Actions | Photographs |
|---|---|---|---|--|
| C12 | curb | curb damage approximately 1 foot long; damage limited to top 2-3 inches; does not appear to be impacting drainage | monitor and reevaluate during next inspection cycle | A photograph showing a concrete curb with a smaller longitudinal crack. The crack is shorter and less deep than the one in C11. The area is covered with dry leaves and some moss. |

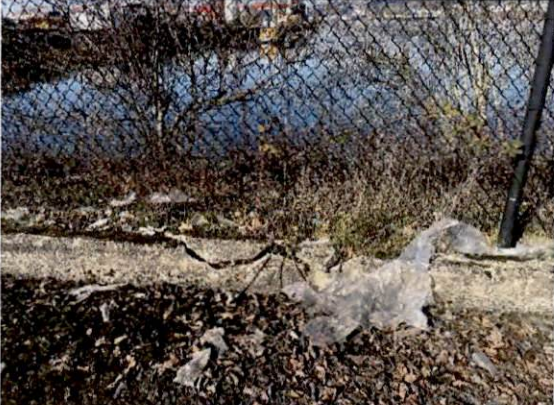
| ID | Type of Structure | Observation | Recommended Actions | Photographs |
|---|---|--|---|--|
| C13 | curb | curb damage approximately 3 feet long; chunks of concrete breaking off; damage limited to top 2-3 inches; does not appear to be impacting drainage | monitor and reevaluate during next inspection cycle | A photograph showing a concrete curb that is cracked and crumbling. The curb is situated next to a chain-link fence. There is some debris and a plastic bag on the ground near the curb. |

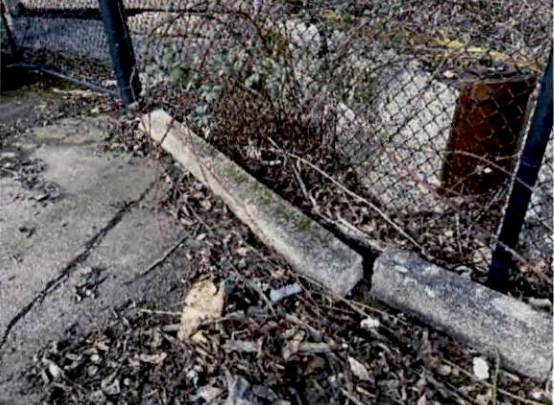
| ID | Type of Structure | Observation | Recommended Actions | Photographs |
|---|---|--|---|--|
| C14 | curb | curb damage through vertical profile | repair curb | A photograph showing a concrete curb that is severely damaged and broken through. The curb is situated next to a chain-link fence. There is a large amount of debris and a rusted metal barrel on the ground near the curb. |

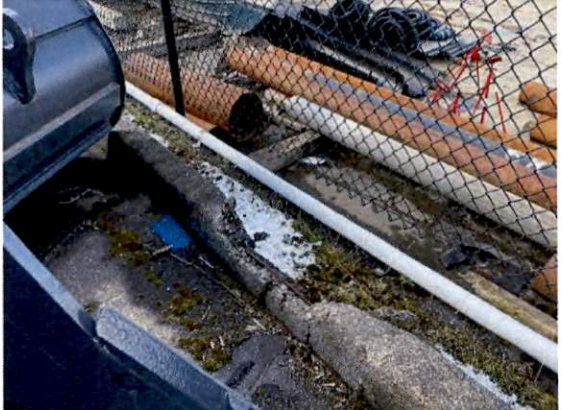
| ID | Type of Structure | Observation | Recommended Actions | Photographs |
|---|---|--|---|--|
| C15 | curb | curb damage approximately 3 feet long; exposed rebar; damage limited to top 2-3 inches; does not appear to be impacting drainage | monitor and reevaluate during next inspection cycle | |

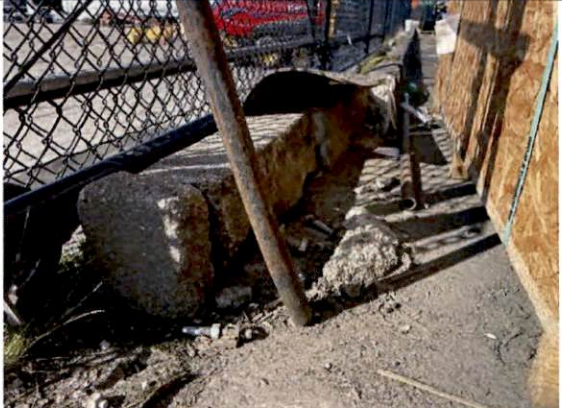
| ID | Type of Structure | Observation | Recommended Actions | Photographs |
|---|---|--|---|--|
| C16 | curb | curb damage approximately 5 feet long; multiple breaks through vertical profile | repair curb | |

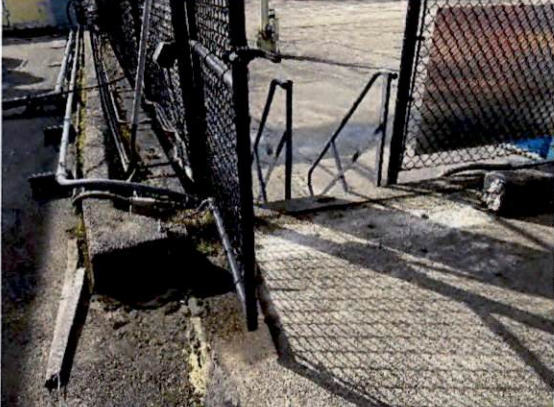
| ID | Type of Structure | Observation | Recommended Actions | Photographs |
|---|---|--|--|--|
| C17 | curb | approximately 4 feet long section of curb removed for installation of stairs and gate; damage through vertical profile adjacent to missing section | extend curb or add a structural control to prevent stormwater runoff from sheet flowing off-site | |

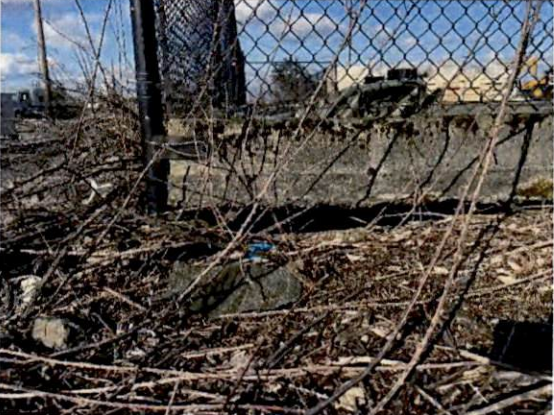
| ID | Type of Structure | Observation | Recommended Actions | Photographs |
|---|---|--|--|--|
| E1 | cap edge | material eroding from underneath cap near treatment basin 4 | fill void under concrete slab to prevent further erosion and/or cap failure | |

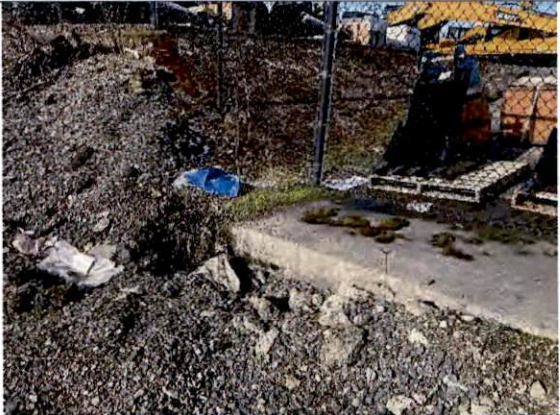
| ID | Type of Structure | Observation | Recommended Actions | Photographs |
|---|---|---|---|--|
| E2 | cap edge | potential erosion near cap boundary; concrete chunks and gravel debris observed near cap edge | monitor and reevaluate during next inspection cycle | |

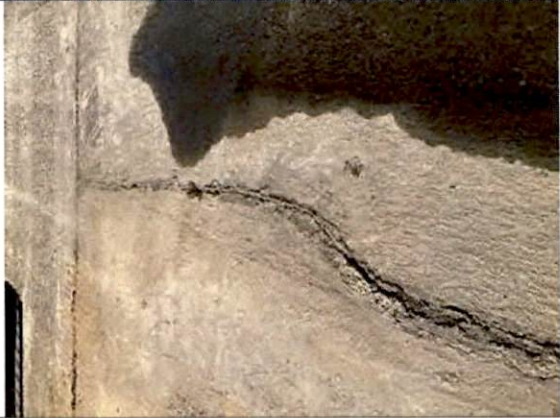
| ID | Type of Structure | Observation | Recommended Actions | Photographs |
|---|---|---|---|--|
| P1 | pavement | crack wider than 1/8 inch, approximately 12 lf; sealant missing in some places | reseal crack | |

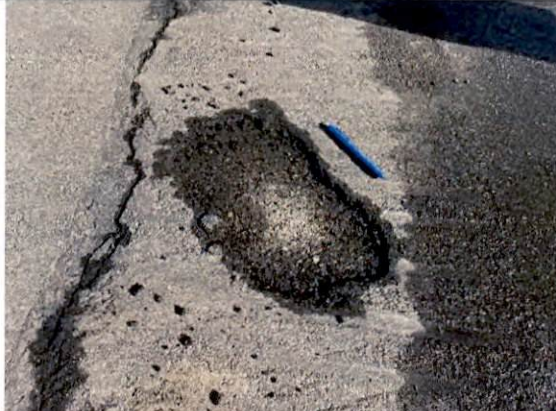
| ID | Type of Structure | Observation | Recommended Actions | Photographs |
|---|---|--|--|--|
| P3 | pavement | missing chunk of previous slurry seal; approximately 1 foot by 1 foot long | monitor and reevaluate for repair during next inspection cycle | |

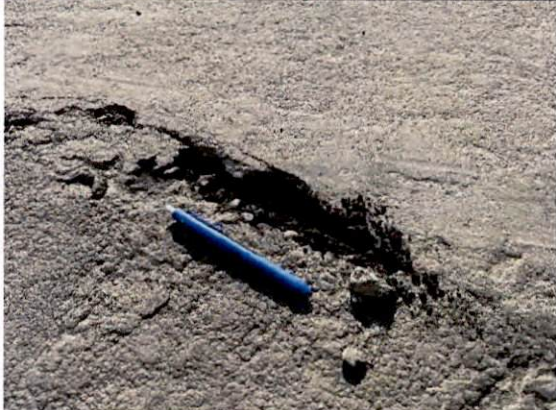
| ID | Type of Structure | Observation | Recommended Actions | Photographs |
|---|---|--|--|--|
| P4 | pavement | damage to old asphalt patch; crack approximately 1 inch wide along seam of patch | monitor and reevaluate for repair during next inspection cycle | |

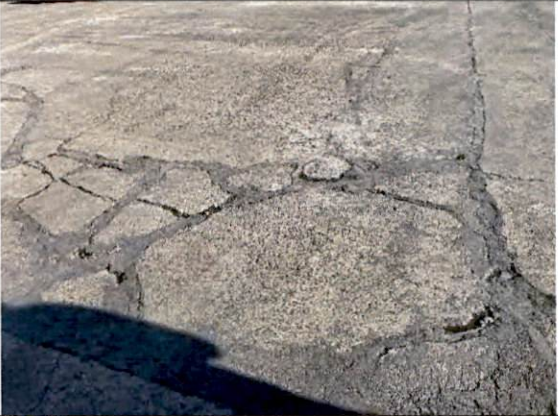
| ID | Type of Structure | Observation | Recommended Actions | Photographs |
|---|---|---|---|--|
| P5 | pavement | sealant wear in crack network; approximately 100 square feet across; sealant missing in portions of sealed alligator cracks | reseal cracks | |

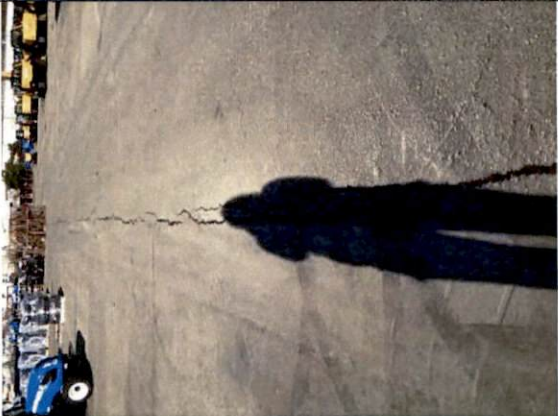
| ID | Type of Structure | Observation | Recommended Actions | Photographs |
|---|---|---|---|--|
| P6 | pavement | unsealed crack wider than 1/8 inch; two adjacent cracks approximately 200 lf | seal cracks | |

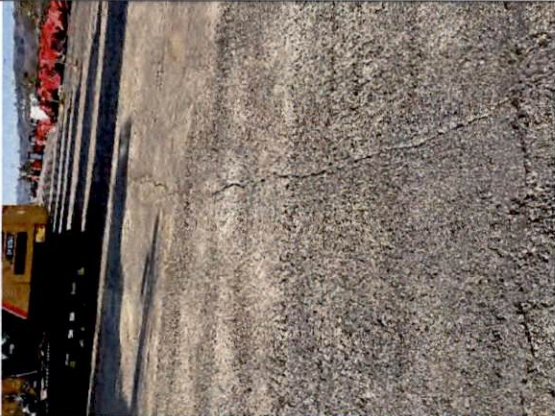
| ID | Type of Structure | Observation | Recommended Actions | Photographs |
|---|---|---|---|--|
| P7 | pavement | unsealed crack wider than 1/8 inch; approximately 100 lf | seal crack | |

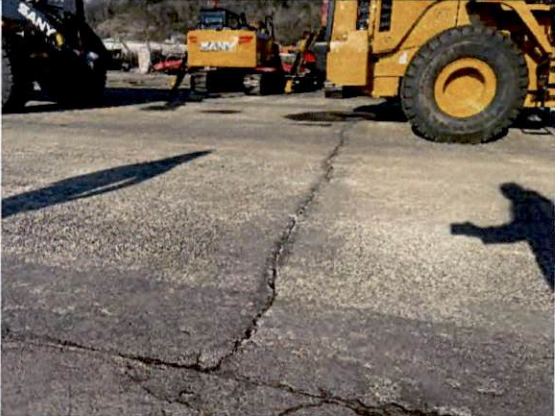
| ID | Type of Structure | Observation | Recommended Actions | Photographs |
|---|---|---|---|--|
| P8 | pavement | partially unsealed crack with vegetation growth; approximately 50 lf; previously sealed but sealant missing in places | remove vegetation and reseal crack | |

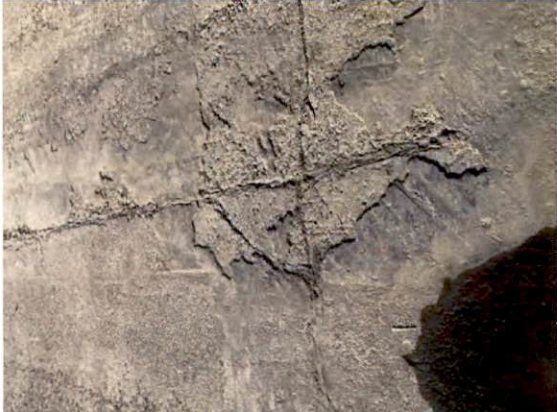
| ID | Type of Structure | Observation | Recommended Actions | Photographs |
|---|---|---|--|--|
| P9 | pavement | slurry seal wear chipping and cracking | monitor and reevaluate for repair during next repair cycle | |

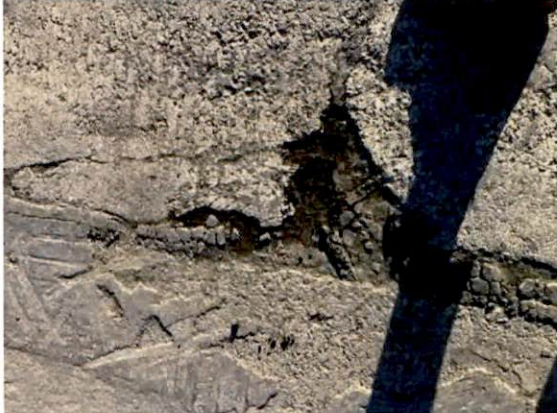
| ID | Type of Structure | Observation | Recommended Actions | Photographs |
|---|---|---|--|--|
| P10 | pavement | partially unsealed crack as wide as 4 inches in places; extends length of equipment row several hundred feet; previously sealed but sealant missing in places | reseal crack | |

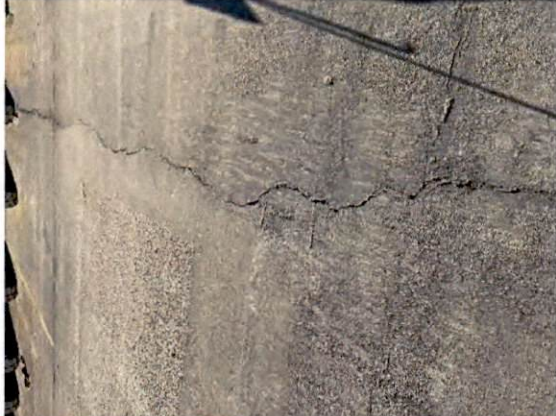
| ID | Type of Structure | Observation | Recommended Actions | Photographs |
|---|---|---|--|--|
| P11 | pavement | unsealed crack wider than 1/8 inch; approximately 20 lf | seal crack | |

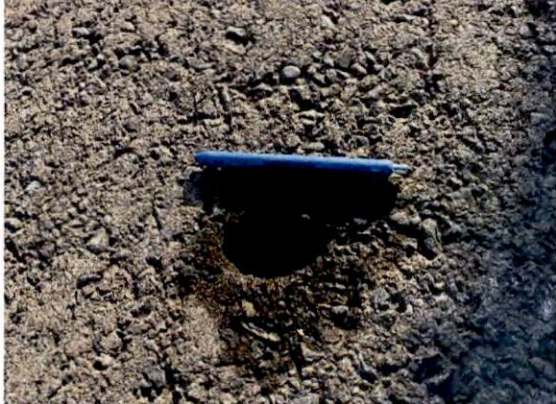
| ID | Type of Structure | Observation | Recommended Actions | Photographs |
|---|---|---|--|--|
| P12 | pavement | pock marks in pavement; approximately 1 inch deep | monitor and reevaluate for repair during next inspection cycle | |

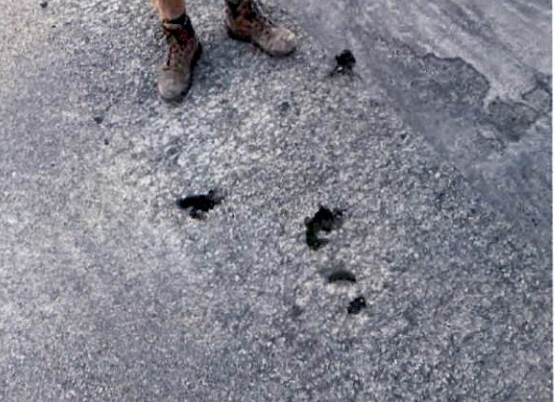
| ID | Type of Structure | Observation | Recommended Actions | Photographs |
|---|---|--|--|--|
| P13 | pavement | pock marks in pavement; approximately 1 inch deep | monitor and reevaluate for repair during next inspection cycle | A close-up photograph of a grey asphalt or concrete pavement surface. Several small, dark, irregularly shaped pits or pock marks are visible, some of which are approximately 1 inch deep. The top edge of the image shows the lower portion of a person's legs wearing brown work boots. |

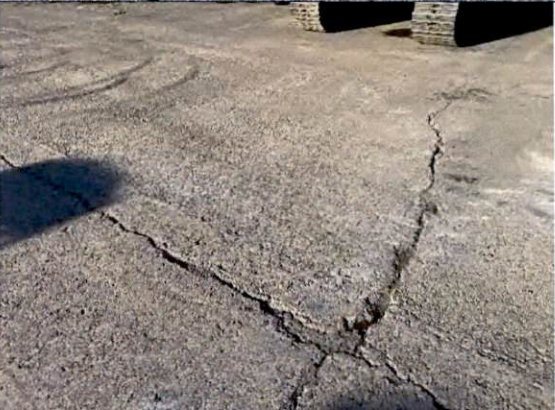
| ID | Type of Structure | Observation | Recommended Actions | Photographs |
|---|---|--|--|--|
| P14 | pavement | unsealed crack as wide as 1.5 inches in some places; approximately 15 lf | seal crack | A photograph of a concrete or asphalt pavement surface showing a significant, unsealed crack. The crack runs diagonally across the frame and is approximately 1.5 inches wide in some sections. The surrounding pavement is a light grey color, and the crack is filled with dark material, possibly dirt or old sealant. |

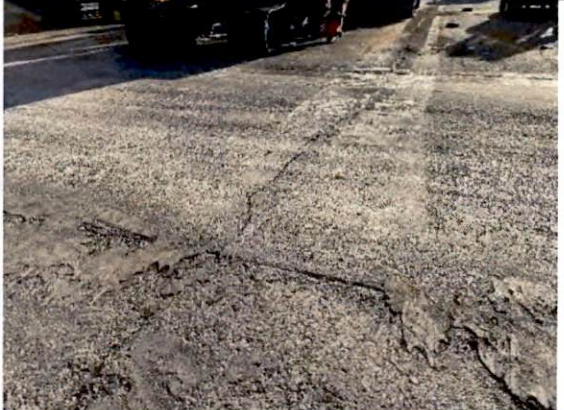
| ID | Type of Structure | Observation | Recommended Actions | Photographs |
|---|---|---|---|--|
| P15 | pavement | unsealed crack wider than 1/8 inch; approximately 15 lf; previously covered with slurry seal, but seal has degraded | reseal crack | |

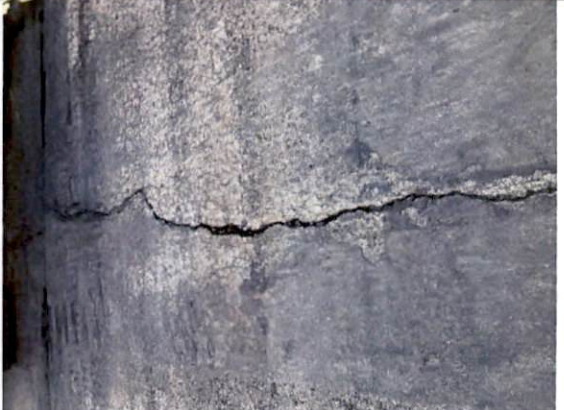
| ID | Type of Structure | Observation | Recommended Actions | Photographs |
|---|---|---|---|--|
| P16 | pavement | unsealed crack wider than 1/8 inch; approximately 20 lf; previously covered with slurry seal, but seal has degraded | reseal crack | |

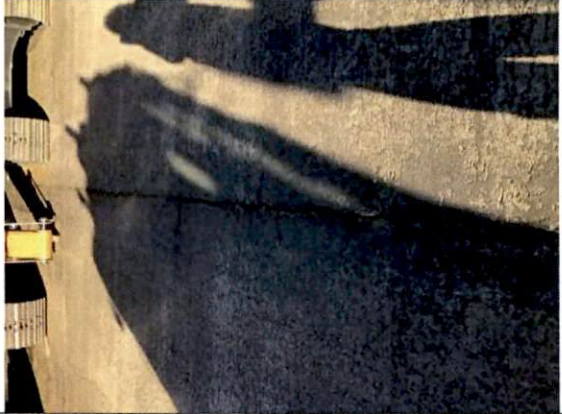
| ID | Type of Structure | Observation | Recommended Actions | Photographs |
|---|---|---|--|--|
| P17 | pavement | unsealed crack wider than 1/8 inch; approximately 40 lf; previously sealed but sealant missing in most places | reseal crack | |

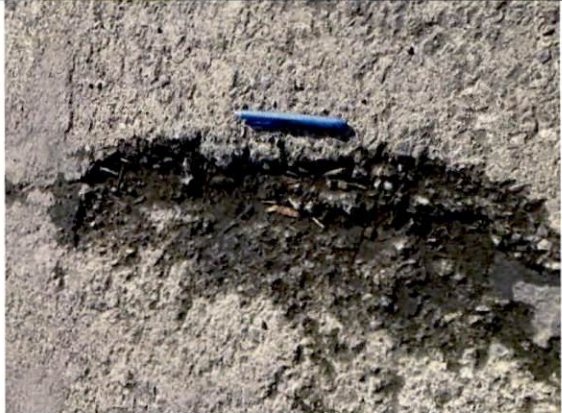
| ID | Type of Structure | Observation | Recommended Actions | Photographs |
|---|---|---|--|--|
| P18 | pavement | pavement gouging and cracking as wide as 5 inches in places; approximately 30 lf; does not appear to extend through cap | monitor and reevaluate for repair during next inspection cycle | |

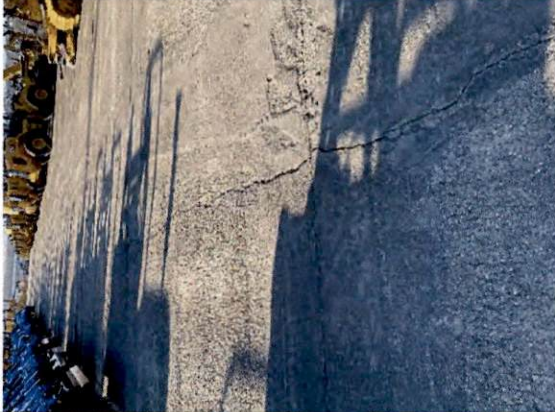
| ID | Type of Structure | Observation | Recommended Actions | Photographs |
|---|---|--|---|--|
| P19 | pavement | unsealed crack with vegetation growth; approximately 30 lf | remove vegetation and seal crack | |

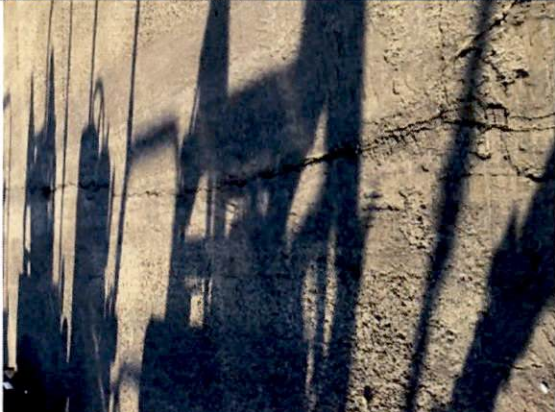
| ID | Type of Structure | Observation | Recommended Actions | Photographs |
|---|---|--|---|--|
| P20 | pavement | unsealed crack wider than 1/8 inch; approximately 40 lf long | seal crack | |

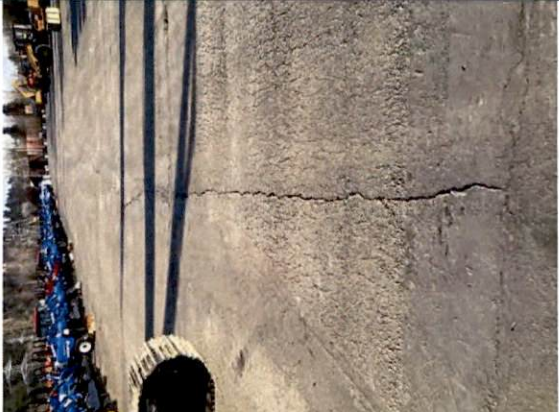
| ID | Type of Structure | Observation | Recommended Actions | Photographs |
|---|---|---|---|--|
| P21 | pavement | partially unsealed crack wider than 1/8 inch; approximately 50 lf | seal crack | |

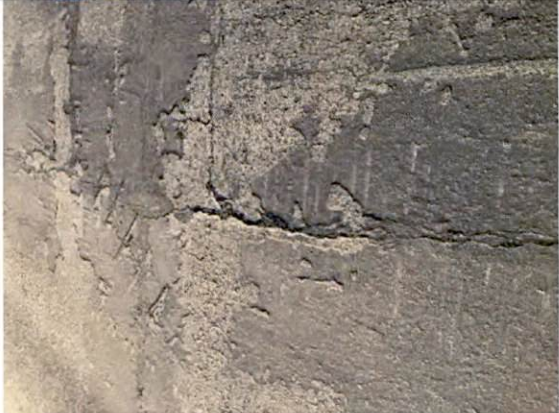
| ID | Type of Structure | Observation | Recommended Actions | Photographs |
|---|---|---|---|--|
| P22 | pavement | unsealed crack with vegetation growth; approximately 5 lf | remove vegetation and seal crack | |

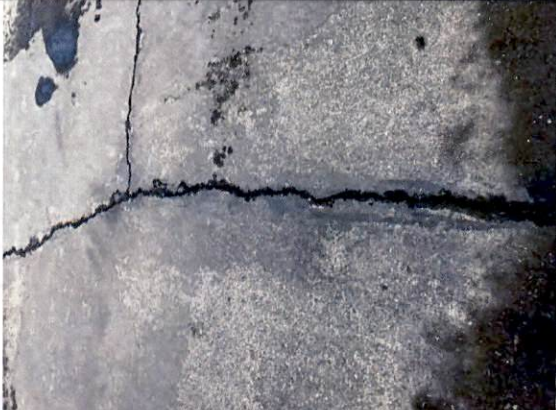
| ID | Type of Structure | Observation | Recommended Actions | Photographs |
|---|---|--|---|--|
| P23 | pavement | previously sealed crack with sealant missing; approximately 20 lf | reseal crack | |

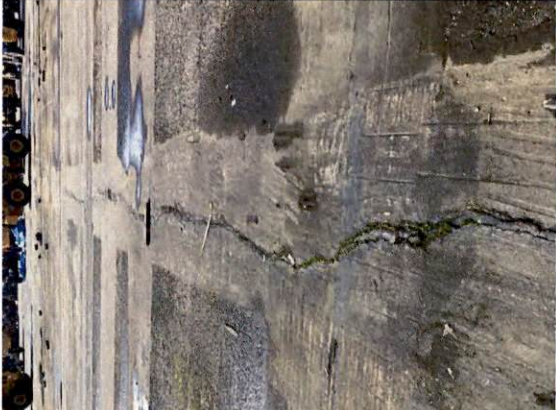
| ID | Type of Structure | Observation | Recommended Actions | Photographs |
|---|---|--|---|--|
| P24 | pavement | previously sealed crack with sealant missing; vegetation growth in portions of crack; approximately 50 lf east of this point | remove vegetation and reseal crack | |

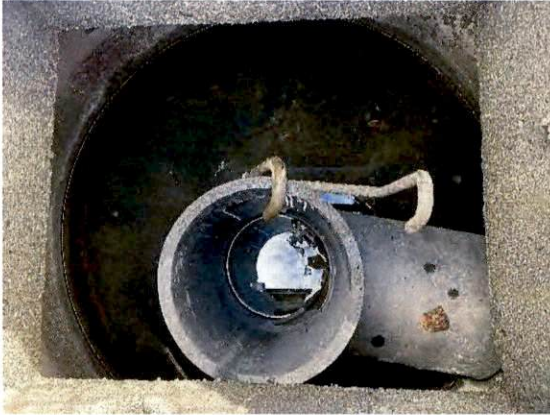
| ID | Type of Structure | Observed Condition | Sediment Accumulation | Additional Observations | Recommended Actions | Photographs |
|---|---|--|--|---|---|--|
| CB1 | catch basin | structurally sound; functioning normally | 4 inches in insert; visible sediment accumulation in bottom of structure; water in structure and too deep to measure | insert in catch basin; no floatables or debris | remove sediment and debris from insert and structure in accordance with stormwater maintenance requirements | |

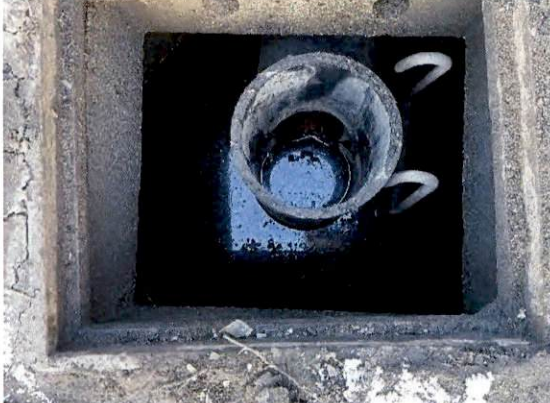
| ID | Type of Structure | Observed Condition | Sediment Accumulation | Additional Observations | Recommended Actions | Photographs |
|---|---|--|--|---|---|--|
| CB2 | catch basin | structurally sound; functioning normally | 5-6 inches in insert; structure full of water and too deep to measure | insert in catch basin; sediment accumulation and fabric tear in insert; floatables on surface | replace insert; remove floatables in accordance with stormwater maintenance requirements | |

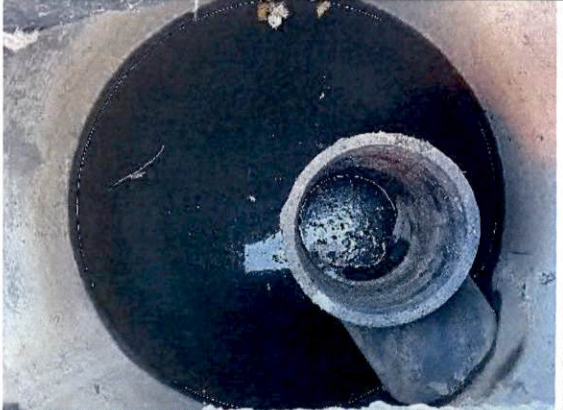
| ID | Type of Structure | Observed Condition | Sediment Accumulation | Additional Observations | Recommended Actions | Photographs |
|---|---|---|--|---|---|--|
| CB3 | catch basin | structurally sound; functioning normally | debris in insert; structure full of water and too deep to measure | insert in catch basin; minor floatables in riser | remove floatables in accordance with stormwater maintenance requirements | |

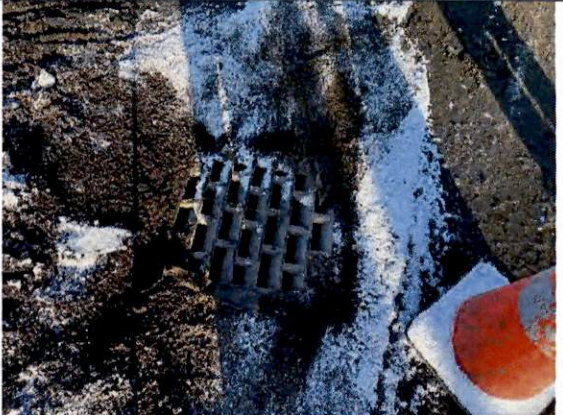
| ID | Type of Structure | Observed Condition | Sediment Accumulation | Additional Observations | Recommended Actions | Photographs |
|---|---|---|--|---|---|--|
| CB4 | catch basin | could not observe interior of structure | several inches of sediment accumulated in insert | insert in catch basin; unable to open structure due to tight fit of grate | restore accessibility; replace insert; observe interior of structure during next inspection | |

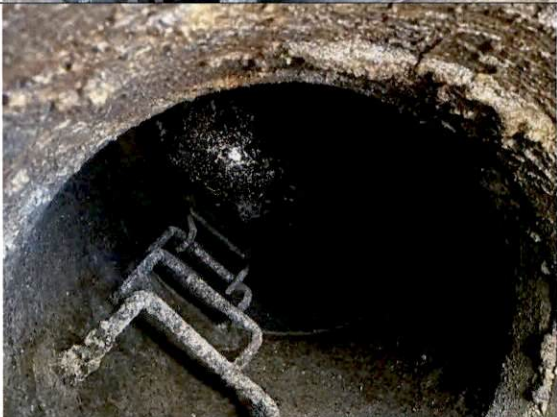
| ID | Type of Structure | Observed Condition | Sediment Accumulation | Additional Observations | Recommended Actions | Photographs |
|---|---|--|--|--|--|--|
| MH2 | maintenance hole | structurally sound; functioning normally | trace sediment accumulation on pipe; water in structure and too deep to measure | organic debris and floatables on surface | remove debris and floatables from structure in accordance with stormwater maintenance requirements | |

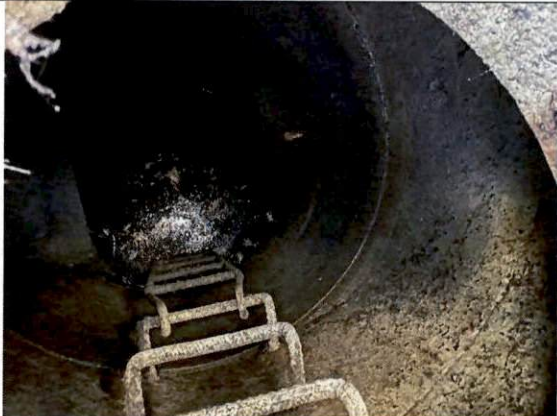
| ID | Type of Structure | Observed Condition | Sediment Accumulation | Additional Observations | Recommended Actions | Photographs |
|---|---|--|--|---|--|--|
| MH4 | maintenance hole | structurally sound; functioning normally | water in structure and too deep to measure | lid overgrown; floatables and organic debris on surface, slight organic sheen | remove debris and floatables from structure in accordance with stormwater maintenance requirements | |

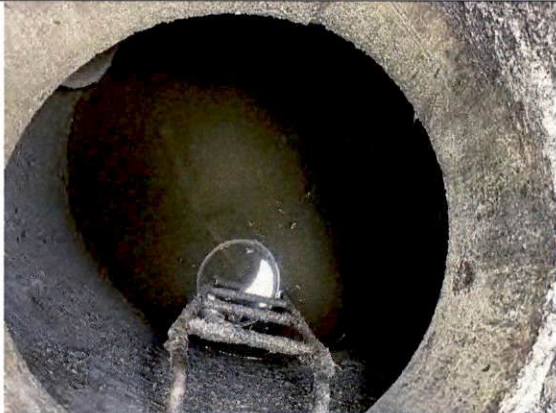
| ID | Type of Structure | Observed Condition | Sediment Accumulation | Additional Observations | Recommended Actions | Photographs |
|---|---|--|---|---|---|--|
| MH7 | maintenance hole | structurally sound; functioning normally | water in structure and too deep to measure | no visible debris, floatables, or sheen | none | |

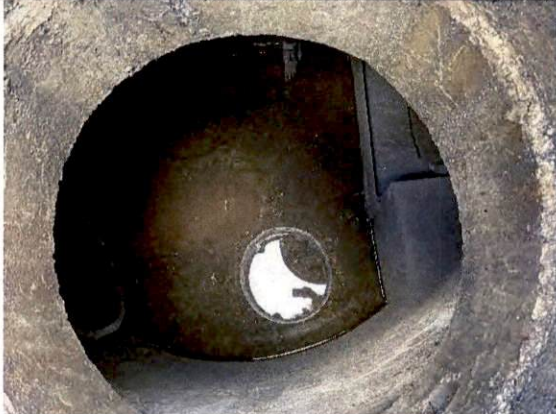
| ID | Type of Structure | Observed Condition | Sediment Accumulation | Additional Observations | Recommended Actions | Photographs |
|---|---|--|---|---|---|--|
| MH8 | maintenance hole | structurally sound; functioning normally | minimal visible accumulation in structure; water in structure and too deep to measure | no visible debris, floatables, or sheen | none | |

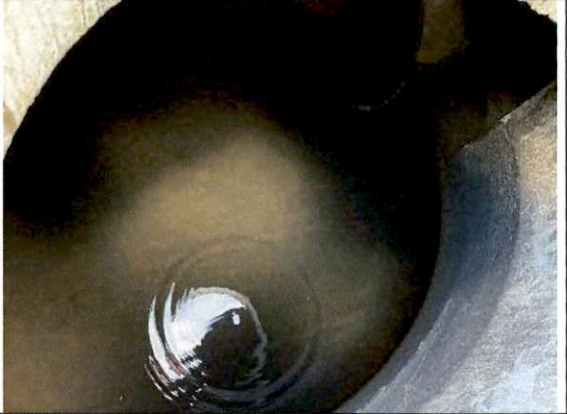
| ID | Type of Structure | Observed Condition | Sediment Accumulation | Additional Observations | Recommended Actions | Photographs |
|---|---|--|--|--|--|--|
| MH9 | maintenance hole | structurally sound; functioning normally | water in structure and too deep to measure | no debris, floatables, or sheen | none | |

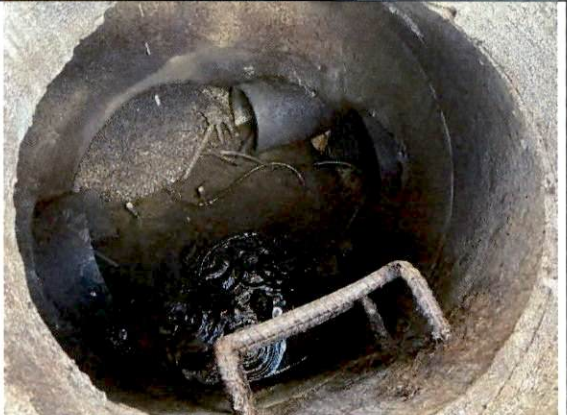
| ID | Type of Structure | Observed Condition | Sediment Accumulation | Additional Observations | Recommended Actions | Photographs |
|---|---|--|--|--|--|--|
| MH10 | maintenance hole | structurally sound; functioning normally | visible sediment accumulation up to pipe invert; too deep to measure | rebar, hose, and other debris in structure | remove sediment and debris from structure in accordance with stormwater maintenance requirements | |

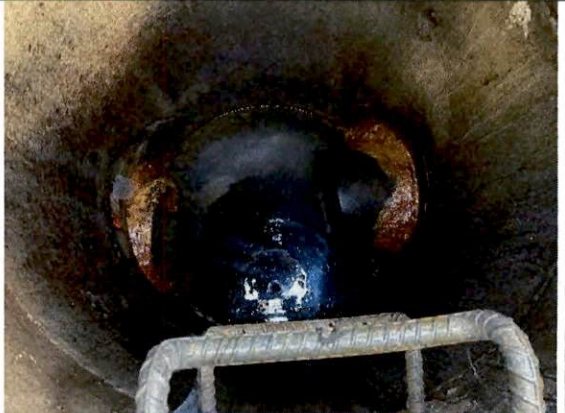
| ID | Type of Structure | Observed Condition | Sediment Accumulation | Additional Observations | Recommended Actions | Photographs |
|---|---|--|--|--|--|--|
| MH11 | maintenance hole | structurally sound; functioning normally | water in structure and too deep to measure | organic sheen with floatables on surface | remove floatables in accordance with stormwater maintenance requirements | |

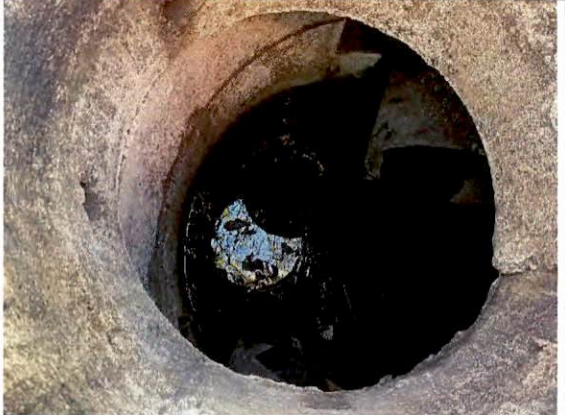
| ID | Type of Structure | Observed Condition | Sediment Accumulation | Additional Observations | Recommended Actions | Photographs |
|---|---|--|--|--|--|--|
| MH12 | maintenance hole | structurally sound; functioning normally | water in structure and too deep to measure | debris on surface | remove debris in accordance with stormwater maintenance requirements | |

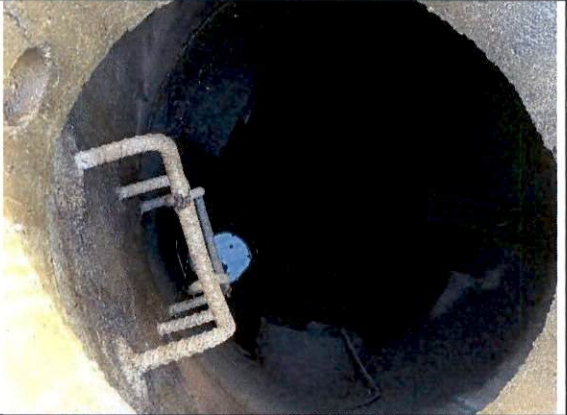
| ID | Type of Structure | Observed Condition | Sediment Accumulation | Additional Observations | Recommended Actions | Photographs |
|---|---|--|--|---|---|--|
| MH13 | maintenance hole | structurally sound; functioning normally | water in structure and too deep to measure | floatables and trace organic sheen on surface | remove floatables in accordance with stormwater maintenance requirements | |

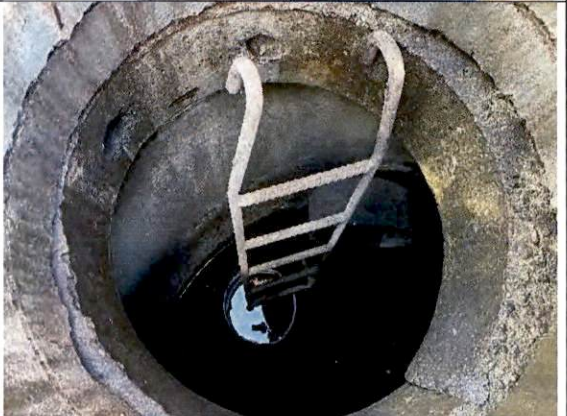
| ID | Type of Structure | Observed Condition | Sediment Accumulation | Additional Observations | Recommended Actions | Photographs |
|---|---|--|--|---|---|--|
| MH14 | maintenance hole | cracking in upper portion of structure; functioning normally | water in structure and too deep to measure | floatables on surface | remove floatables in accordance with stormwater maintenance requirements; monitor structure condition | |
