ENVIRONMENTAL CAP AND DRAINAGE SYSTEM INSPECTION REPORT

FORMER LOUISIANA PACIFIC/PONY LUMBER FACILITY

June 15, 2022

Enforcement Order No. DE 92TC-S312 (December 21, 1992)
Washington State Department of Ecology Facility Site ID # 1209
Inspection Dates: February 24, 2022

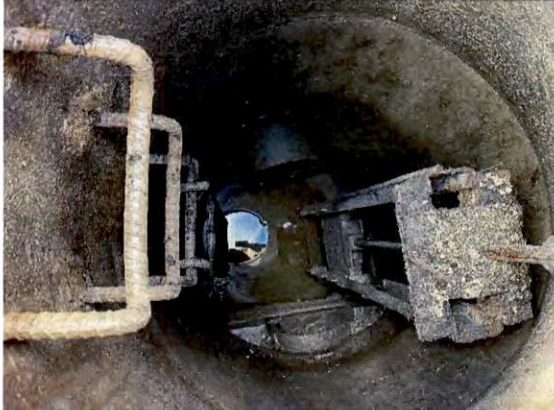
| ID | Type of Structure | Observed Condition | Sediment Accumulation | Additional Observations | Recommended Actions | Photographs |
|---|---|--|--|---|--|--|
| MH15 | maintenance hole | structurally sound; functioning normally | sediment accumulation on structure walls and in pipes; water in structure and too deep to measure | no floatables, debris, or sheen | remove sediment accumulation in accordance with stormwater maintenance requirements | |

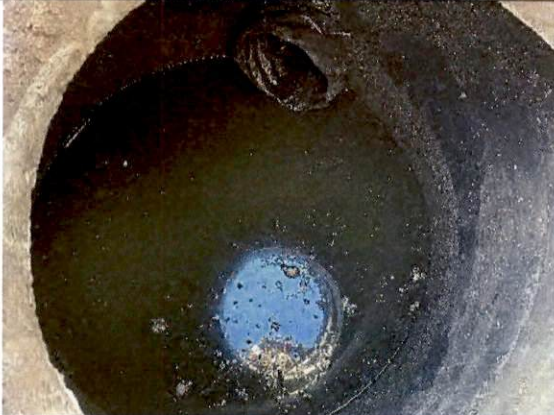
| ID | Type of Structure | Observed Condition | Sediment Accumulation | Additional Observations | Recommended Actions | Photographs |
|---|---|--|--|---|--|--|
| MH16 | maintenance hole | structurally sound; functioning normally | approximately 0.5 inches sediment accumulation in pipe; water in structure and too deep to measure | floatables and organic sheen on surface | remove sediment accumulation and floatables in accordance with stormwater maintenance requirements | |

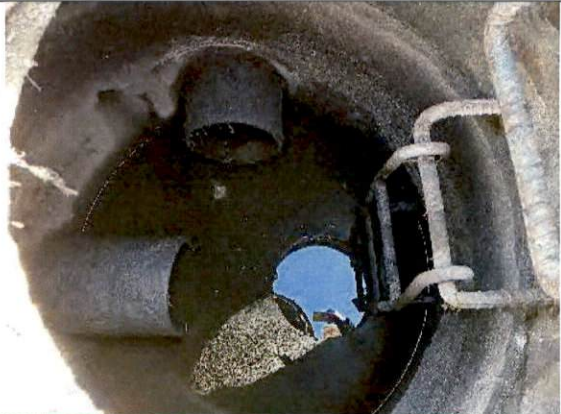
| ID | Type of Structure | Observed Condition | Sediment Accumulation | Additional Observations | Recommended Actions | Photographs |
|---|---|--|---|---|---|--|
| MH17 | maintenance hole | structurally sound; functioning normally | approximately 0.25 inches sediment accumulation in pipe; water in structure and too deep to measure | floatables on surface | remove sediment and floatables in accordance with stormwater maintenance requirements | |

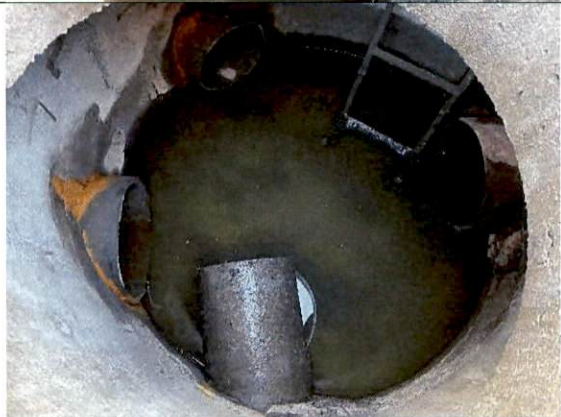
| ID | Type of Structure | Observed Condition | Sediment Accumulation | Additional Observations | Recommended Actions | Photographs |
|---|---|--|---|---|---|--|
| MH18 | maintenance hole | structurally sound; functioning normally | visible sediment accumulation in bottom of structure; water in structure and too deep to measure | no floatables, debris or sheen | remove sediment in accordance with stormwater maintenance requirements | |

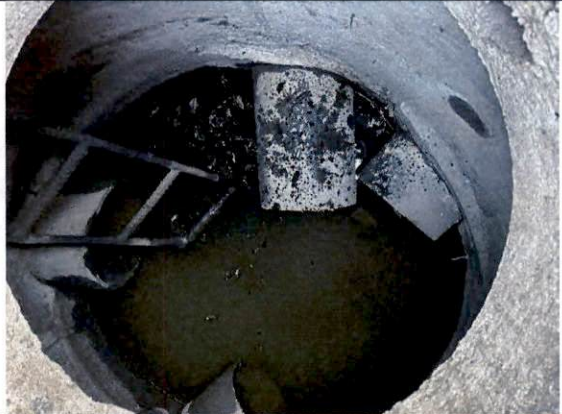
| ID | Type of Structure | Observed Condition | Sediment Accumulation | Additional Observations | Recommended Actions | Photographs |
|---|---|--|--|--|--|--|
| MH19 | maintenance hole | structurally sound; functioning normally | water in structure and too deep to measure | trace floatables on surface | remove floatables in accordance with stormwater maintenance requirements | |

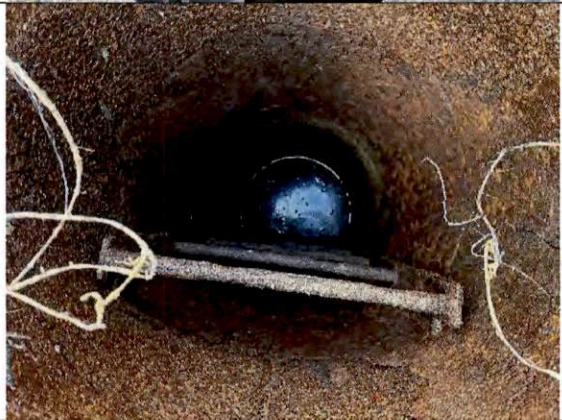
| ID | Type of Structure | Observed Condition | Sediment Accumulation | Additional Observations | Recommended Actions | Photographs |
|---|---|--|--|--|--|--|
| OWS1 | oil/water separator | functioning normally | water in structure and too deep to measure | metal structure with signs of corrosion; floatables and sheen visible on water surface | pump out the oil/water separator for inspection; have a corrosion engineer evaluate maintenance hole walls for integrity | |

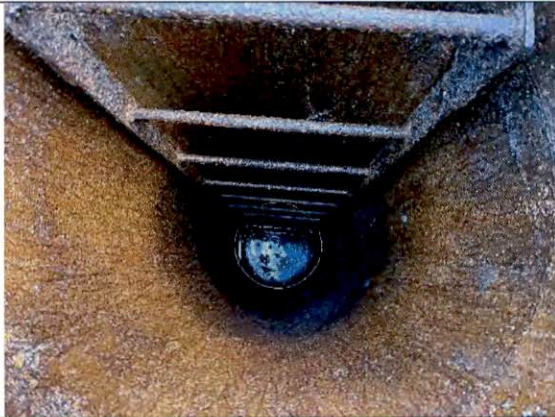
| ID | Type of Structure | Observed Condition | Sediment Accumulation | Additional Observations | Recommended Actions | Photographs |
|---|---|--|--|---|--|--|
| OWS2 | oil/water separator | functioning normally | water in structure and too deep to measure | metal structure with signs of corrosion; floatables and sheen visible on water surface | pump out the oil/water separator for inspection; have a corrosion engineer evaluate maintenance hole walls for integrity | |

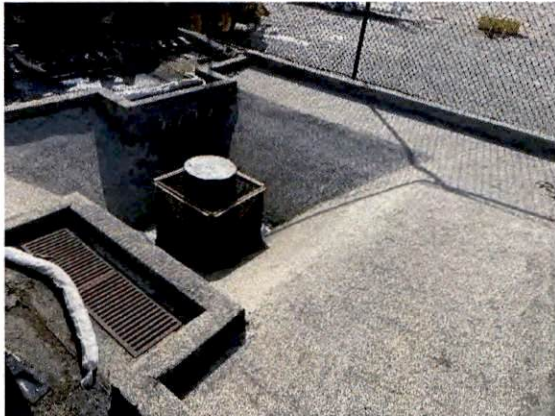
| ID | Type of Structure | Observed Condition | Sediment Accumulation | Additional Observations | Recommended Actions | Photographs |
|---|---|--|--|---|--|--|
| TB1 | treatment basin | structurally sound; functioning normally | 1 inch accumulation in basin and approximately 1/8 inch in pipes | booms instead of screens in front of grates; organic debris in basin; sediment accumulation around basin; some deterioration of pavement curb on east corner of basin (rebar exposed) | replace missing screens; remove accumulated sediment in accordance with stormwater maintenance requirements; repair pavement curb if conditions worsen | |

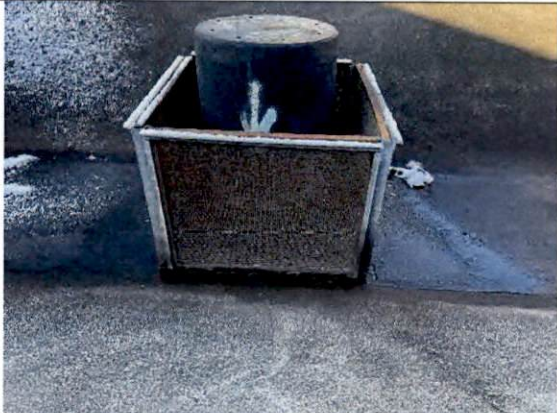
| ID | Type of Structure | Observed Condition | Sediment Accumulation | Additional Observations | Recommended Actions | Photographs |
|---|---|--|---|--|--|--|
| TB2 | treatment basin | structurally sound; functioning normally | 0 inches | screens and basin in good condition | none | |

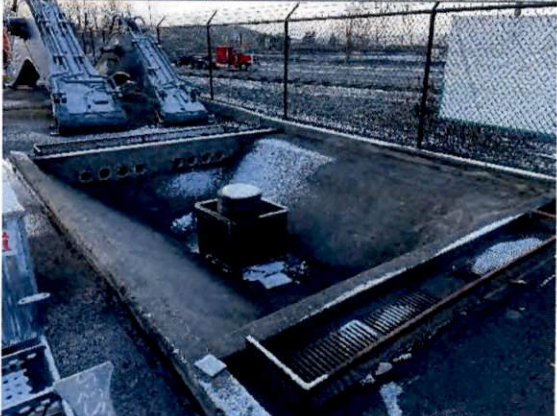
| ID | Type of Structure | Observed Condition | Sediment Accumulation | Additional Observations | Recommended Actions | Photographs |
|---|---|--|---|--|--|--|
| TB3 | treatment basin | structurally sound; functioning normally | 0 inches | gapping in west screen large enough to allow sediment bypass | repair screen in accordance with stormwater maintenance requirements | |

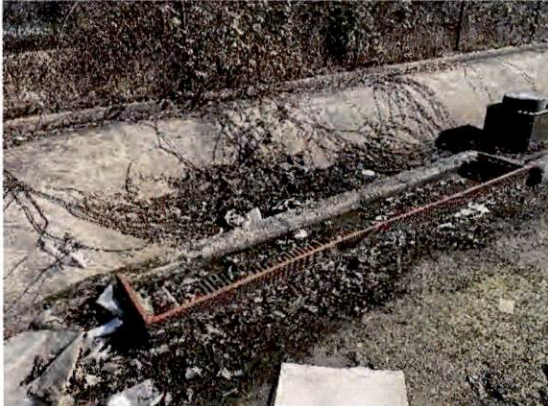
| ID | Type of Structure | Observed Condition | Sediment Accumulation | Additional Observations | Recommended Actions | Photographs |
|---|---|--|---|--|---|---|
| TB6 | treatment basin | structurally sound; functioning normally | 0.75 inches in basin | blackberries beginning to grow into basin; organic and inorganic debris in basin; damage to north grate; north facing screen is torn; sediment accumulation on all screens | remove accumulated sediment and debris from basin and screens in accordance with stormwater maintenance requirements; trim blackberries; replace damaged screen | |
