## **Periodic Review**

### **Kimberly Clark Riverside Wood Mill**

**3700 Railway Avenue, Everett, WA 98201**

January 2024

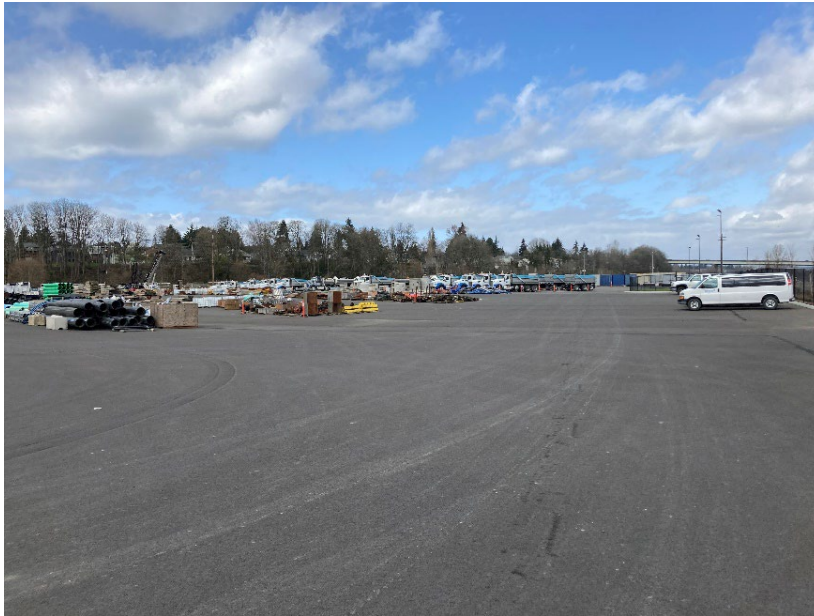
**Photo 1:** View to the northwest from the entrance to 2320 Railroad Avenue (contractor's storage yard). Pavement ends after the trucks in the background.

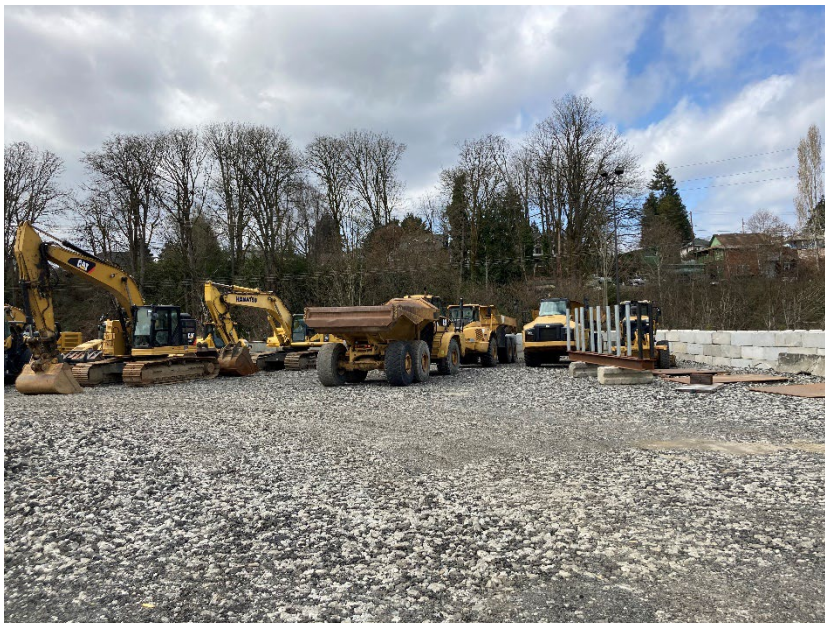
**Photo 2:** View to the west of the northwestern corner of the 2320 Railway Avenue Parcel. Crushed concrete and asphalt used for surfacing in the northern half of the parcel is visible in the foreground.

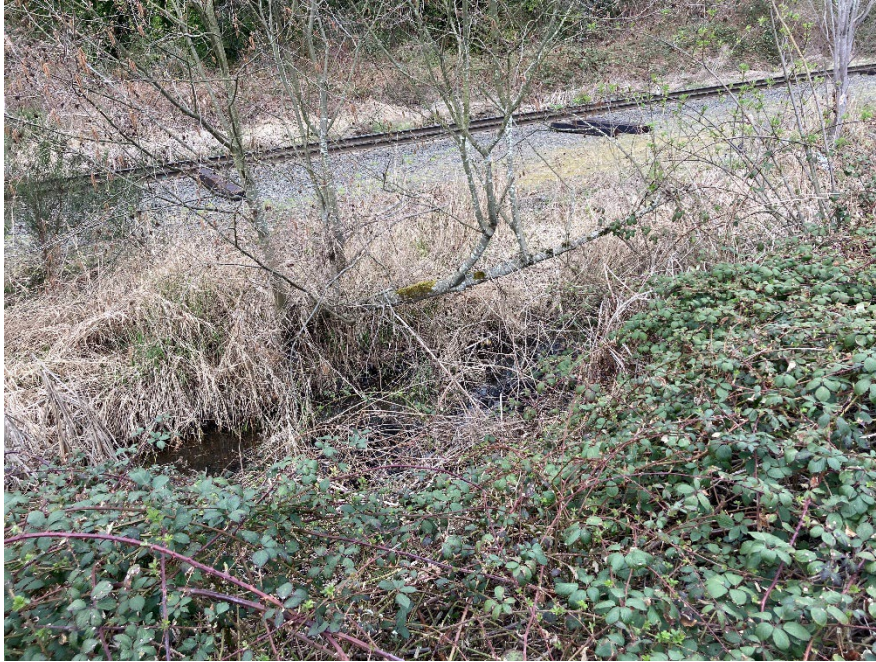
The western draining swale area (where contaminated soil was left in place) is located on the west side of the access road. Access to the western drainage swale area from the residences to the west appears to be unlikely. The residences are located uphill of the Property on top of a steep, vegetated bluff, on the west side of the active rail line located to the west of the Property.

**Photo 3:** Western drainage swale area on the western side of the Site. Active BNSF tracks are visible in the background.

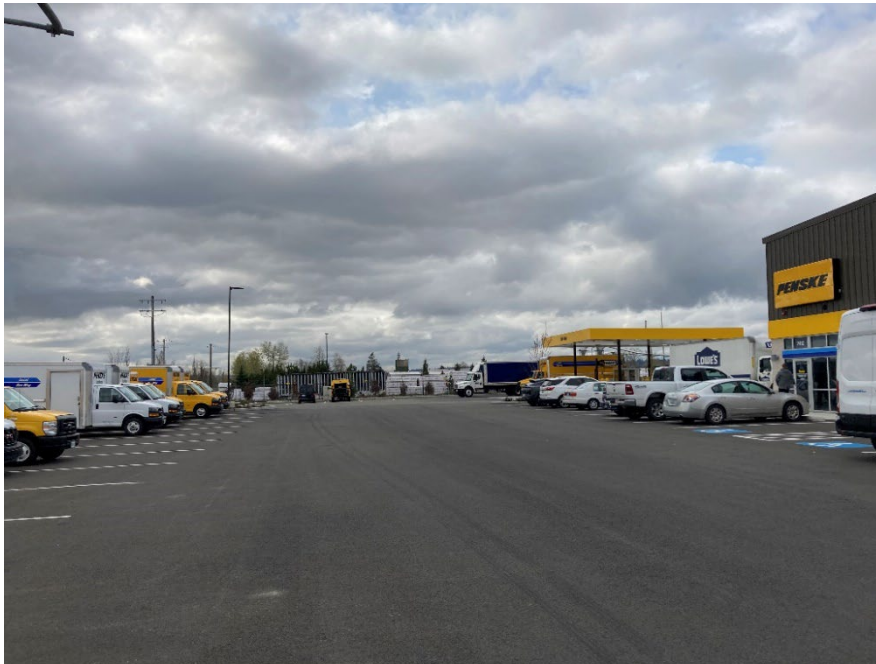
**Photo 4:** Current configuration of 2410 Railway Avenue (truck rental facility). Facing south near eastern boundary of parcel.

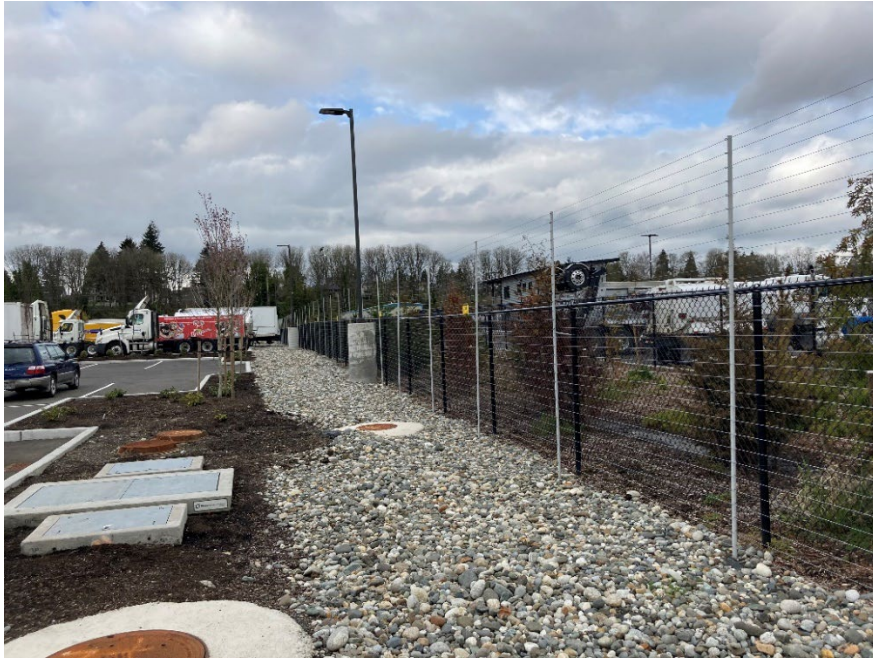
**Photo 5:** Looking west along the northern property boundary of the 2410 Railway Avenue Parcel. A shallow swale approximately 20 feet wide is present between 2410 and 2320 Railway Avenue.

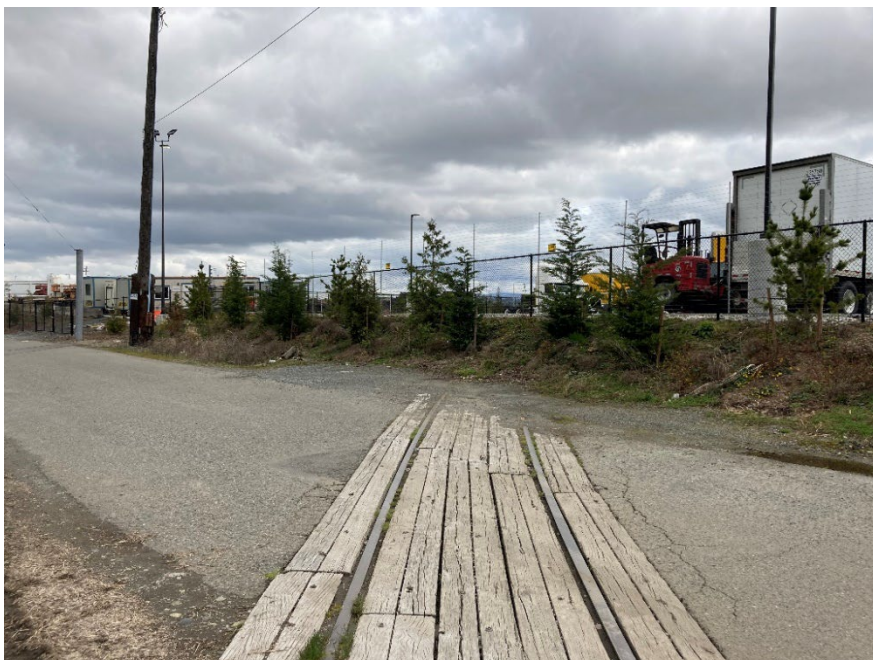
**Photo 6:** Looking northeast from the western side of the 2410 Railway Avenue Parcel showing additional 4 feet of grade above former surface. Former railroad spur crossing western access road in foreground.

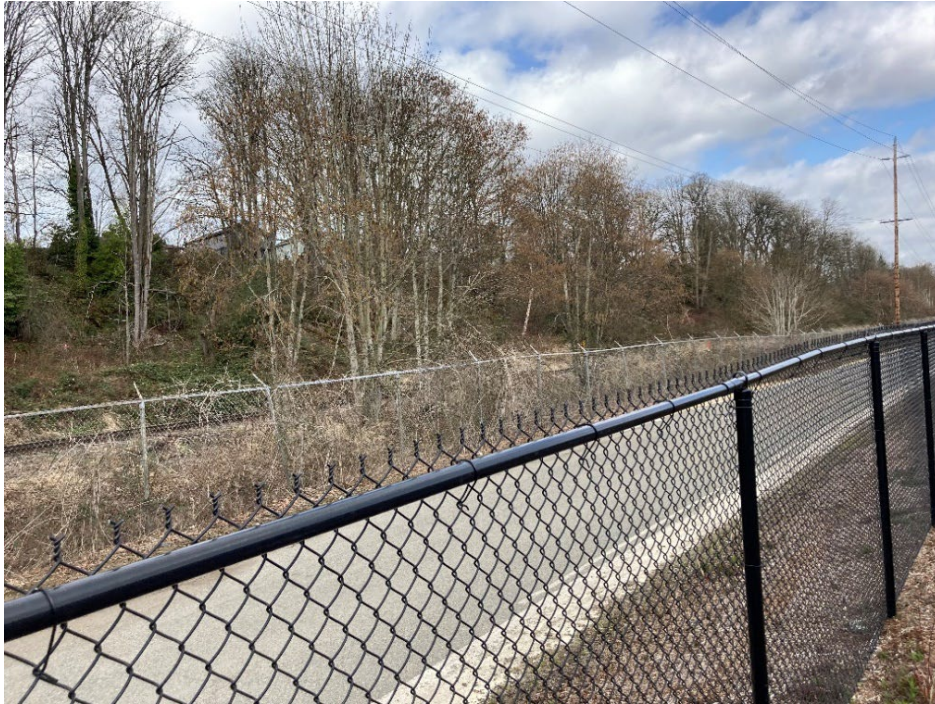
It is unlikely that Site contaminants migrated to the residences to the west based on their location on a steep, densely vegetated slope approximately 60 feet above the Site. Therefore, the remedy appears to be protective of the adjacent residences.

**Photo 7:** Western access road with the adjacent BNSF railroad tracks, steep vegetated slope, and residences beyond, looking northwest from the western boundary of the Site.

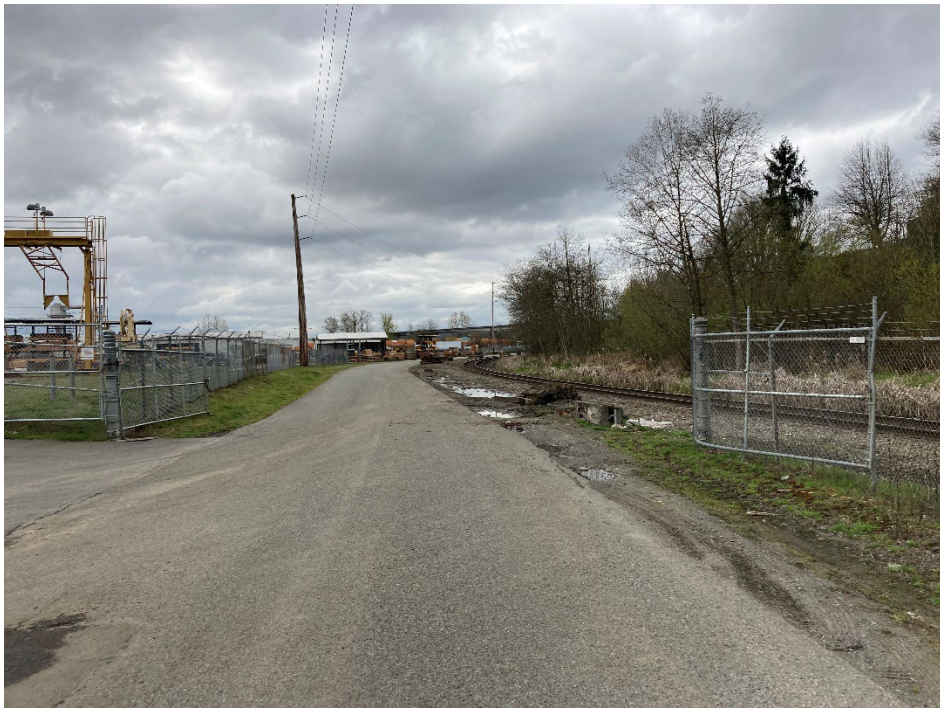
However, access to the western drainage swale area can be gained along the western margin of the Site via an access road that is publicly accessible. Evidence of dumping of furniture and household trash was observed on the western side of the Site. The access and use restrictions for the west side of the Site appear to be in need of maintenance. The gate which controls access to the access road on the western side of the northern and middle parcels should be repaired and kept closed to effectively limit public access.

**Photo 8:** The gate for the western access road needs to be repaired and kept closed to effectively limit public access to the western portion of Site.

No additional cleanup actions are required by the property owner at this time, aside from the access gate repairs noted above. The property owner is responsible for continuing to inspect the Site to ensure the integrity of the remedy is maintained.
