# Draft Final Second Periodic Review

**Former Scott Paper Mill  
17<sup>th</sup> – 20<sup>th</sup> Street & R Avenue  
Anacortes, WA 98221**

For the  
**Toxics Cleanup Program**

January 2024

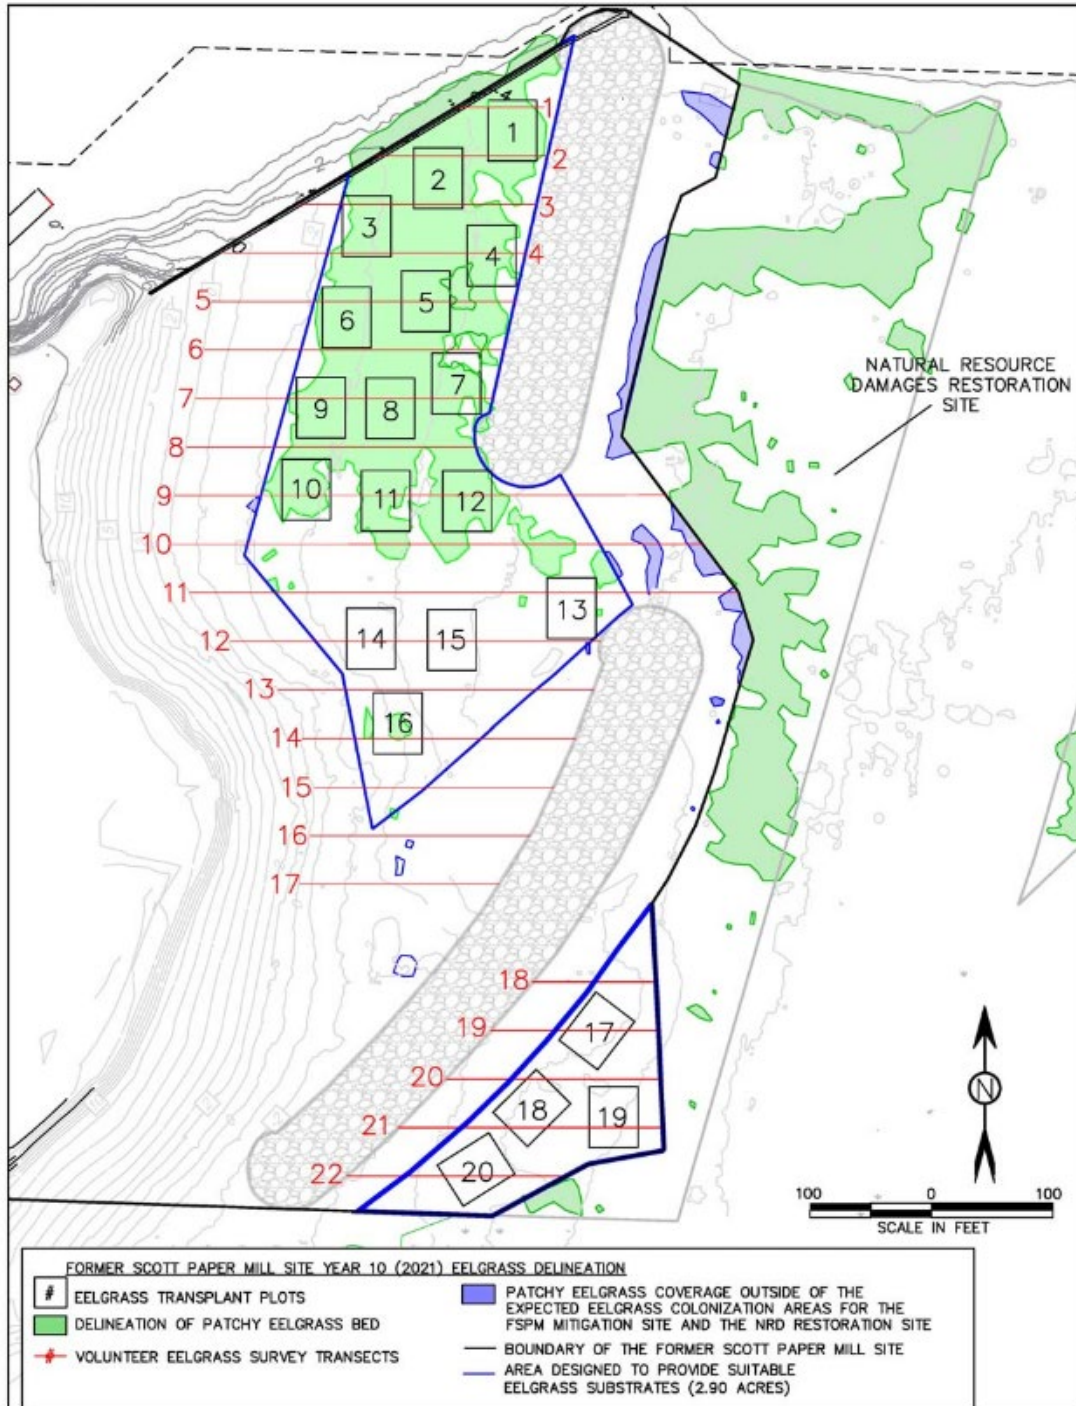
### 6.8 Year 10 (2021) Eelgrass Distribution

During the Year 10 (2021) monitoring of the Site (Grette 2021), the observed extent of the eelgrass bed had decreased to 1.33 acres of the highest turion densities in the north portion of the Marine Area west of the wave attenuators.

**Figure 7. Results of the Eelgrass Monitoring Within the Transplant Plots at the Former Scott Paper Mill Site.**

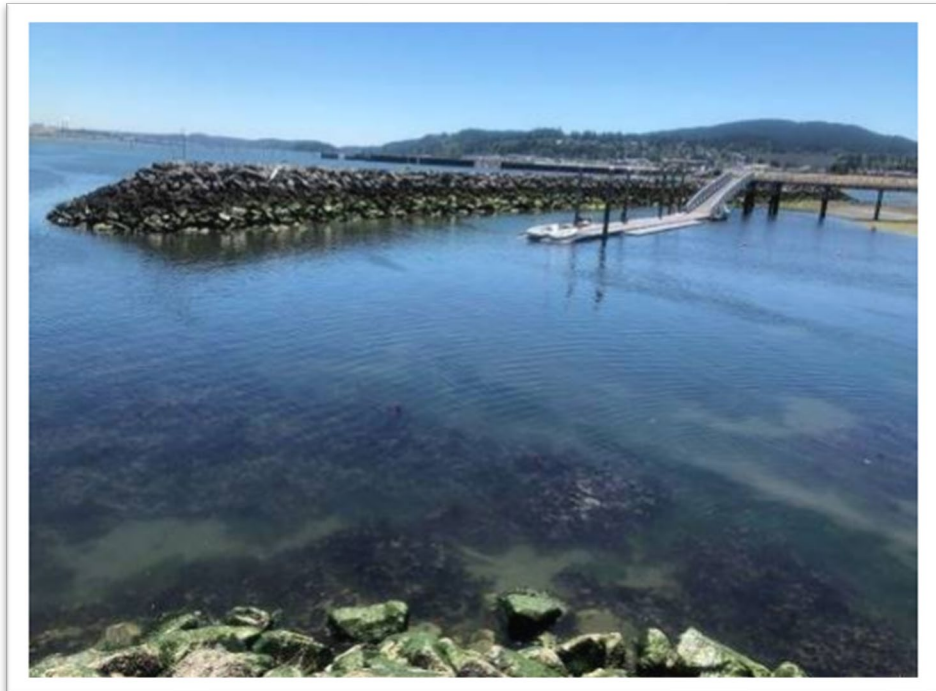
**Photo 2: Volunteer eelgrass colonization between the attenuators (June 24, 2021)**

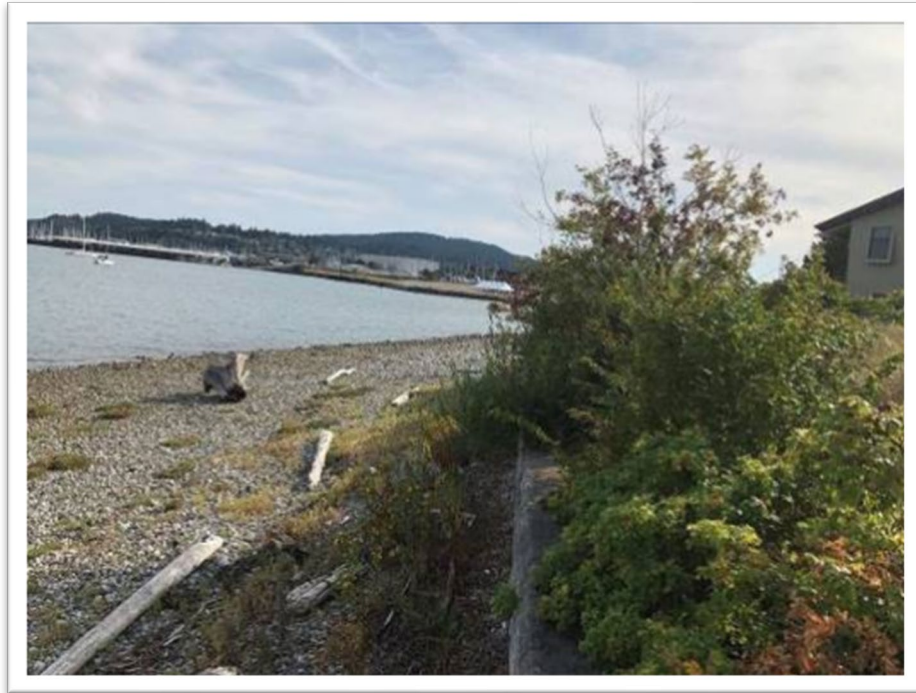
**Photo 3: Marine Area sediment cap and riparian vegetation coverage (June 24, 2021)**

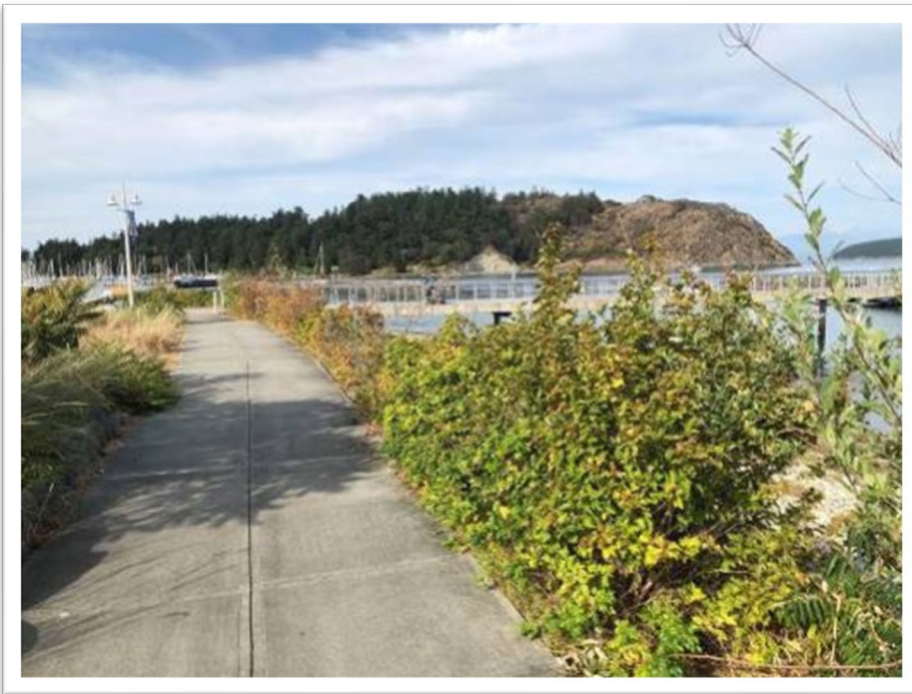
**Photo 4: Riparian vegetation coverage and Upland Area public access (June 24, 2021)**

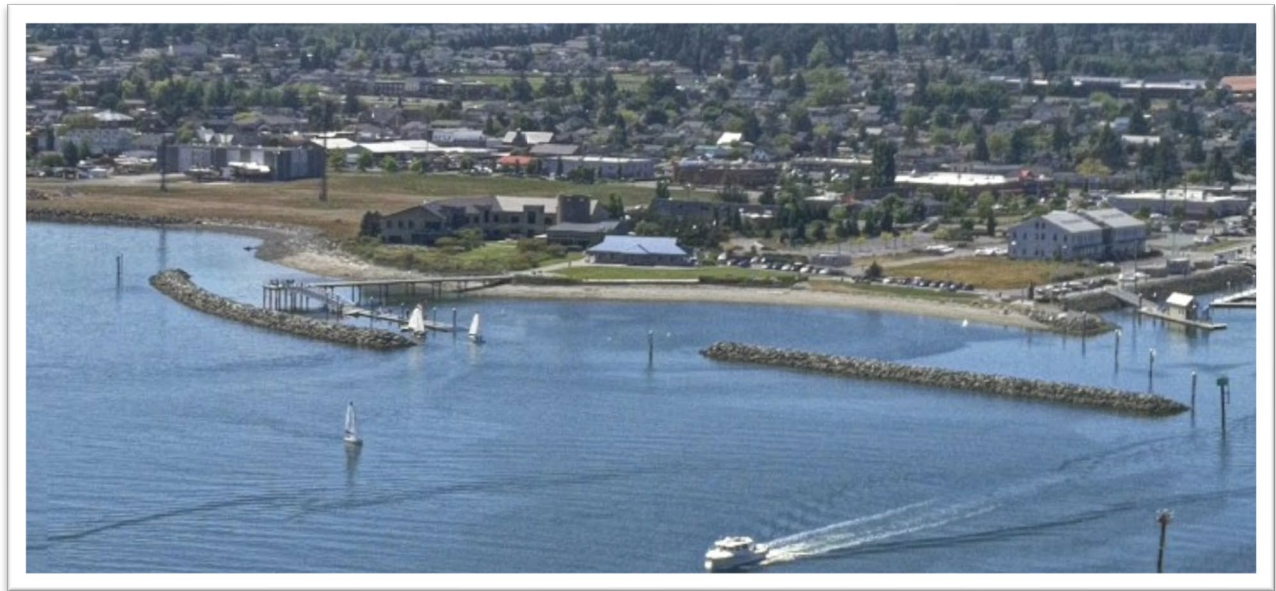
**Photo 5: Site Overview (May 2021)**
