March 28, 2022

**RE: RESPONSE TO ECOLOGY COMMENTS ON PERIODIC REVIEW
UNION STATION FACILITY SITE ID NO.: 2060
411 SOUTH JACKSON STREET
SEATTLE, WASHINGTON
FARALLON PN: 2644-001**

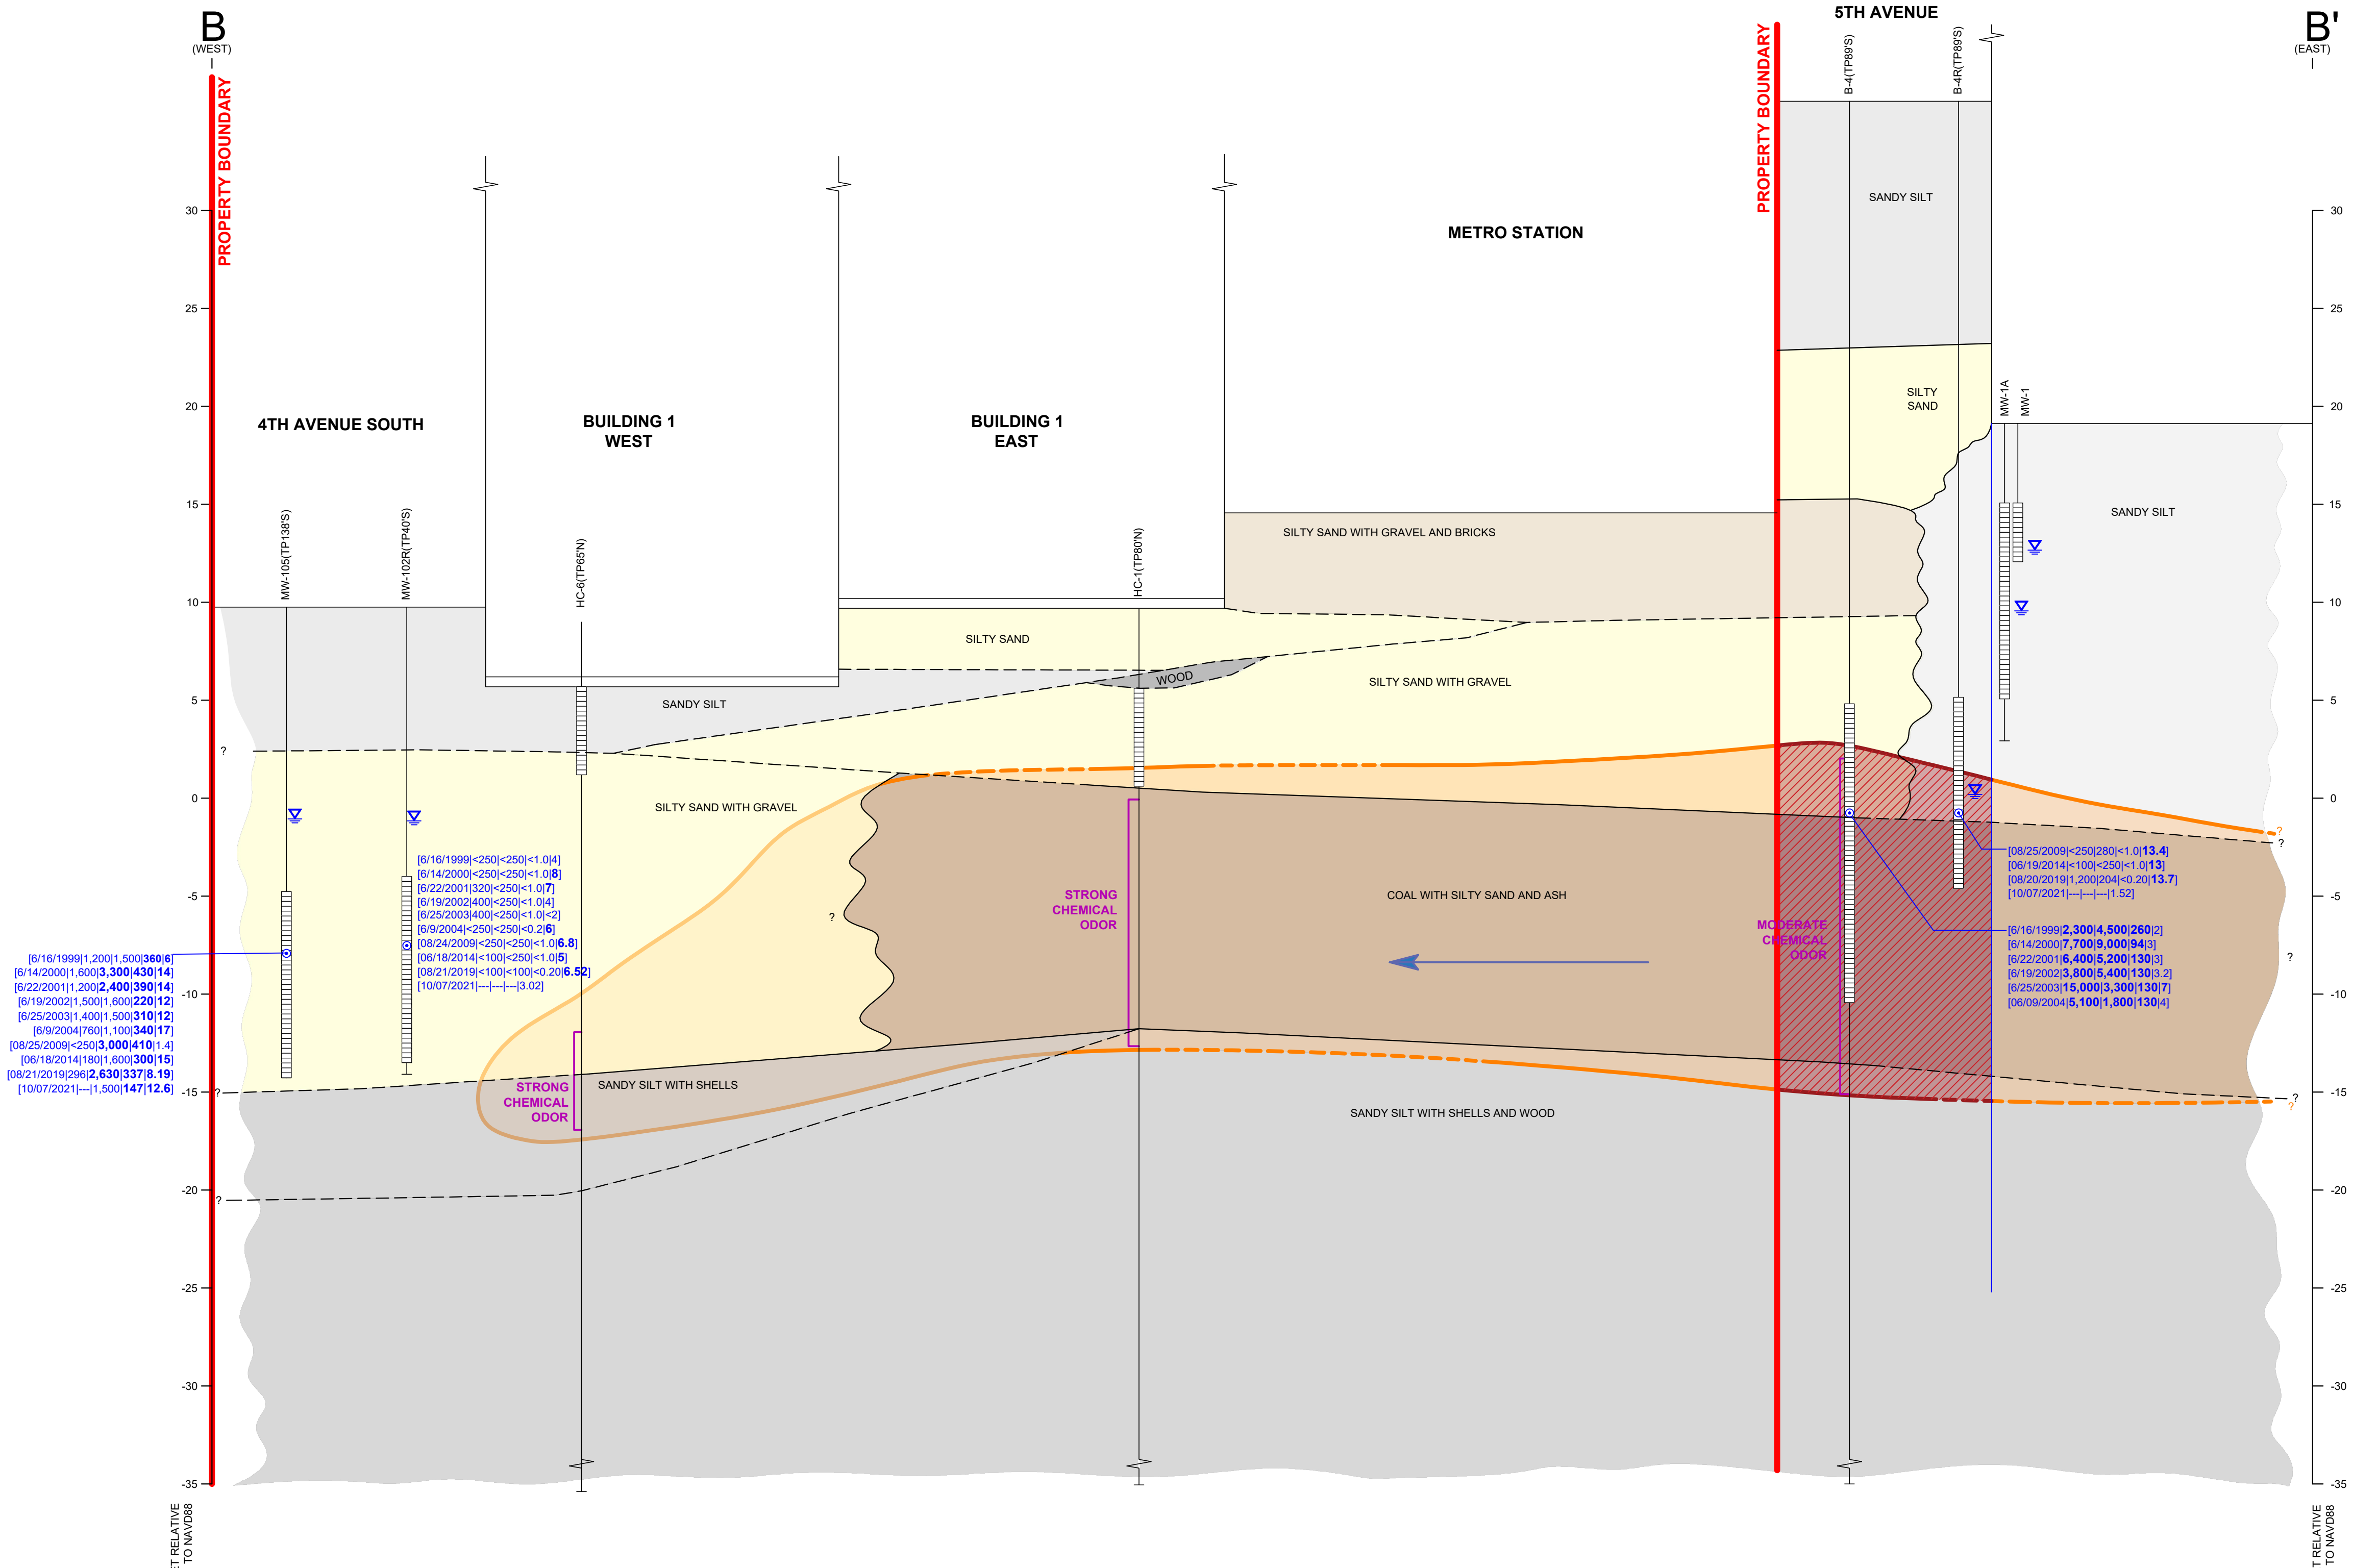
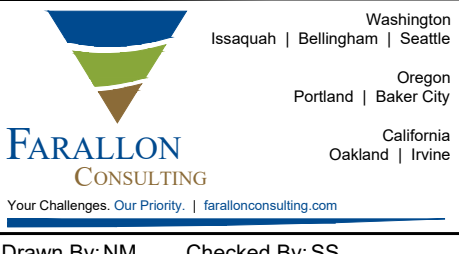
FIGURE 5
CROSS SECTION B-B'
UNION STATION PROPERTY
SEATTLE, WASHINGTON
FARALLON PN-2644-001
Date: 3/18/22

It should be noted that the highest concentrations of COCs in the Property vicinity were detected in up-gradient monitoring well B-4 installed in the 5th Avenue ROW (Figures 5 and 7).

During the 2019 groundwater monitoring event, petroleum hydrocarbons and/or polynuclear aromatic hydrocarbons (PAHs) and cPAHs were detected at concentrations exceeding site-specific groundwater cleanup levels and/or applicable screening levels in only two monitoring wells, MW-101R and MW-105, at the western Property boundary conditional point of compliance (Figure 7; Tables 3 and 4).
