COLLEGE AVENUE STEAM PLANT ADAPTIVE REUSE

Integrated Cleanup and Implementation Plan

Port of
Whitman
County

PORT OF WHITMAN COUNTY
March 30, 2020

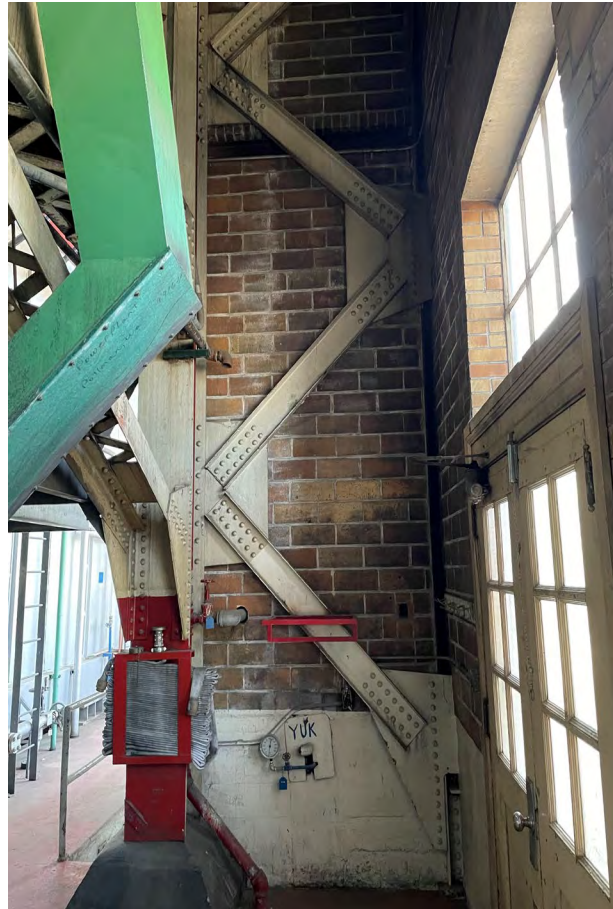
Figure 10: Interior Bracing Photograph

Lateral System. The main lateral system appears to be unreinforced brick masonry between the structural columns in the perimeter walls. The center high portion of the structure has structural steel angles bracing the tall, slender walls on the east and west ends.

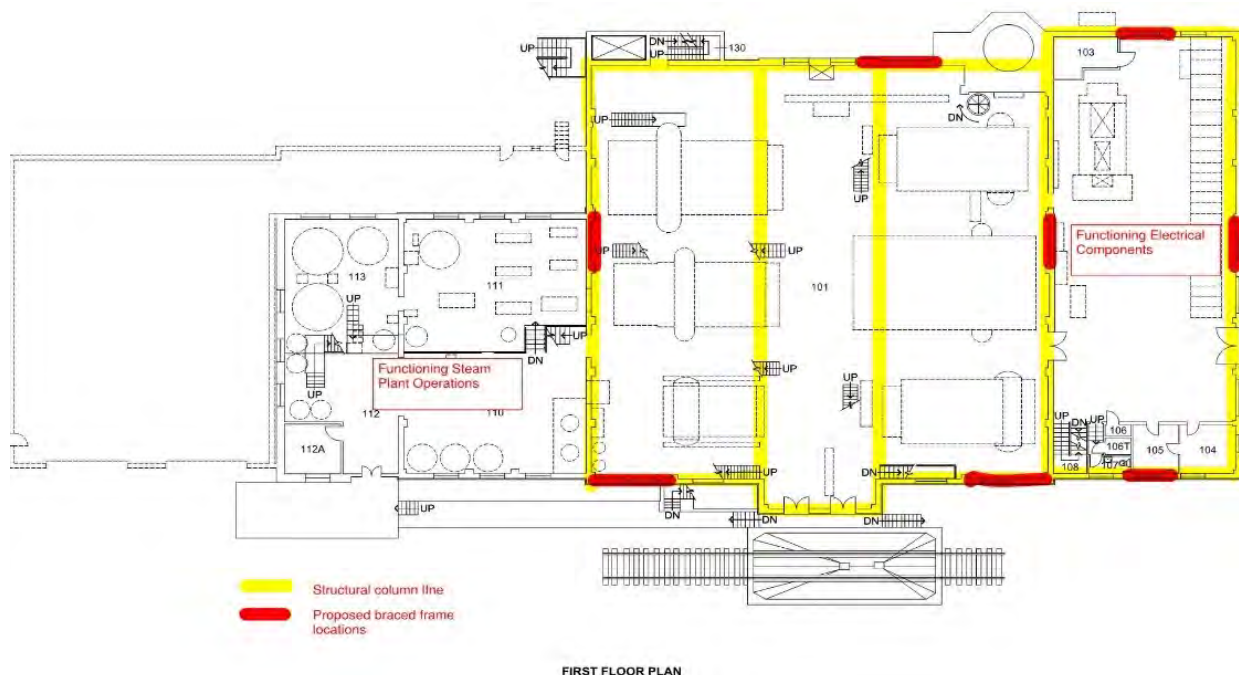
Figure 11: Potential Lateral Element Needs

A seismic evaluation or ASCE 41 Tier 1 analysis has not been performed on the existing structure. However, if the building undergoes significant alterations and upgrades, a new lateral force-resisting system will have to be implemented to satisfy the International Building Code. Figure 10 illustrates the locations of new lateral elements to support the existing structure. As new frames are installed[built?] to support the existing structure, new foundations will also be required. Drilled micropiles have been used successfully to counteract downward and uplift forces in retrofits such as this. They also are very cost-effective to install in confined spaces such as the basement and subbasement.

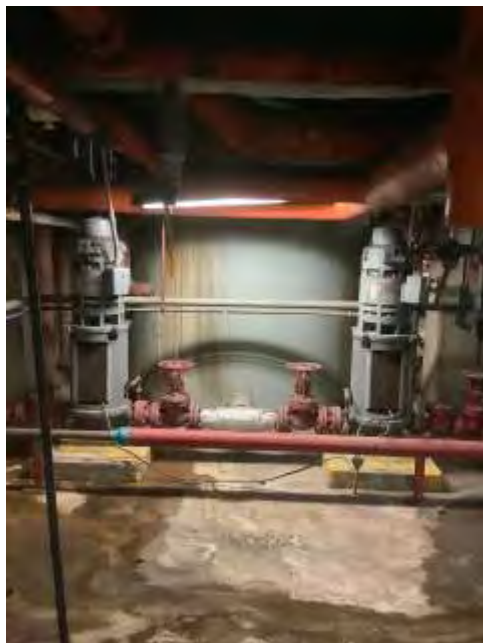
General Fixture Location:	Detailed Fixture Location:
Room 11	Throughout room.
Type of Fixture:	Quantity:
Low clearance.	Several
Condition:	Additional Fixture Notes:
Good	Low pipes and supports.
