January 2024

2023 Land Use Control Inspections Technical Memorandum

**Sites 302, 303, and 304 and Tank 50
Naval Base Kitsap Manchester, Kitsap County,
Washington**

**United States Department of the Navy
Naval Facilities Engineering Systems Command**
1101 Tautog Circle
Silverdale, WA 98315-1101

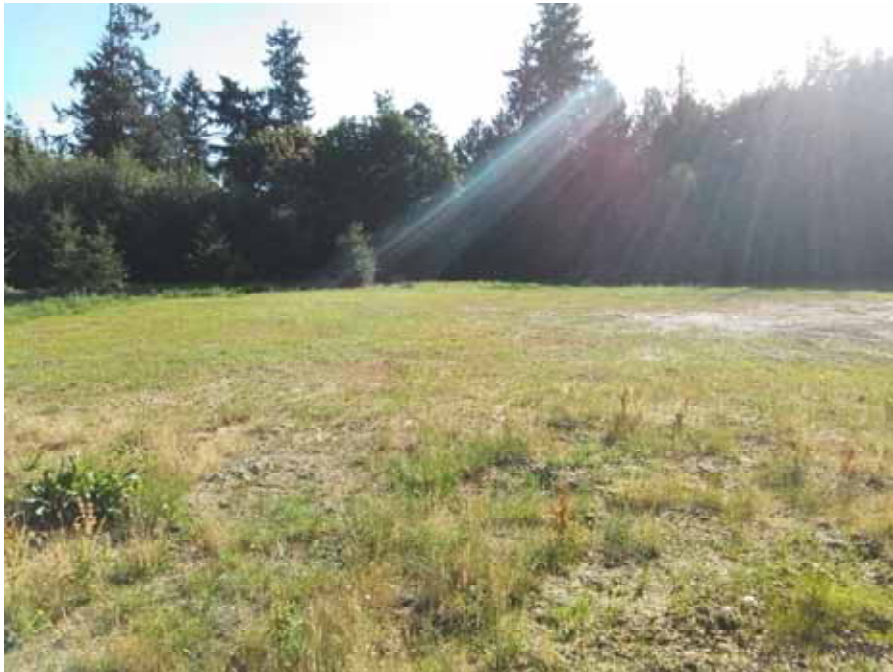
Photograph 6

Central area of the site, facing northwest. Stockpiles have been removed.

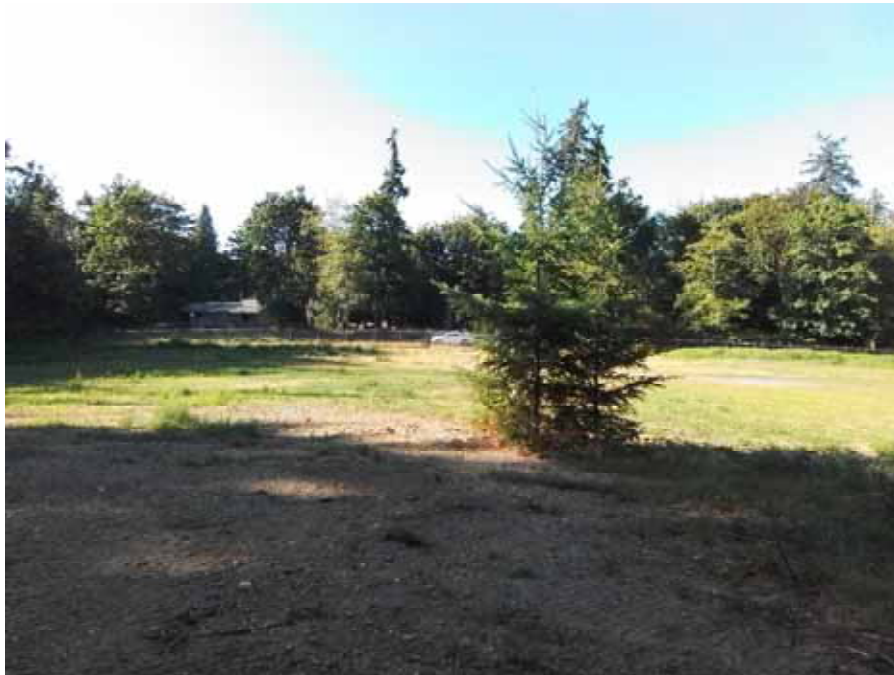
Photograph 9

Central area of site, facing south. Soil stockpiles have been removed.

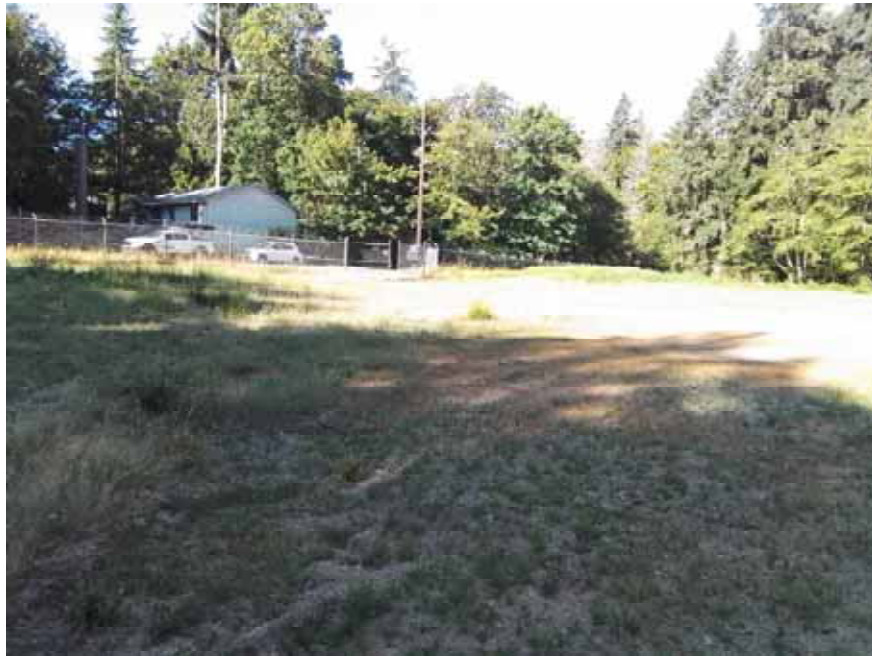
Photograph 11

Central area of site, facing southwest. Soil stockpiles have been removed.

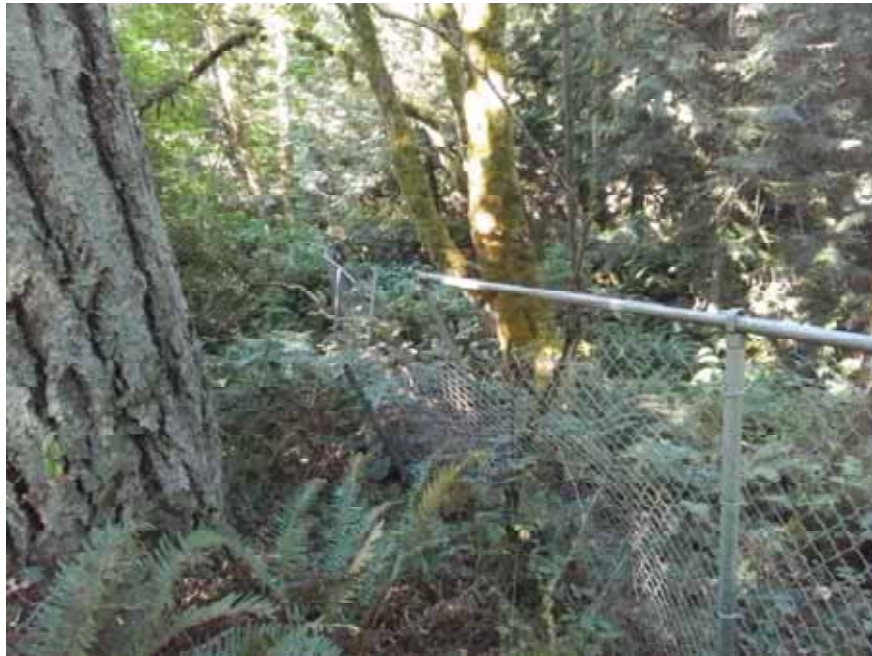
Photograph 15

- **Finding 1:** Approximately 60 linear feet of fencing was noted during the 2023 LUC inspection to be collapsed along the western boundary of the site due to fallen trees.
- **Finding 2:** Approximately 100 linear feet of fencing on the northwestern side of the site was observed to be heavily overgrown with vegetation and the area was inaccessible.

Broken section of fence (approximately 50 feet) along west perimeter, facing southwest.

1. Site 302: Approximately 60 linear feet of fencing was noted during the 2023 LUC inspection to be collapsed along the western boundary of the site where repairs are recommended to ensure the security requirements of the LUC are met.
2. Site 302: Approximately 100 linear feet of fencing on the northwestern side of the site was observed to be heavily overgrown with vegetation and the area was inaccessible. It is recommended that the vegetation be cleared, and necessary fence requirements be made.

The Navy plans to conduct the vegetation and tree clearing and fence repair for items 1 and 2 above and the sign replacement for item 3 above in FY 2024. The Environmental Restoration, Navy (ERN) group will coordinate with NBK – Manchester on implementation.

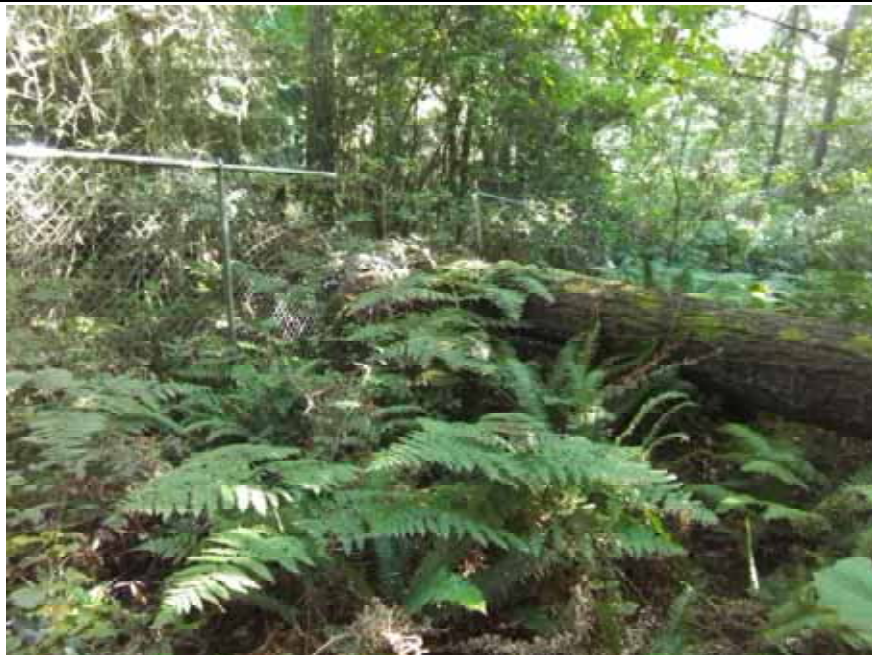
Photograph 16

Broken section of fence (approximately 10 feet) along west perimeter, facing west.

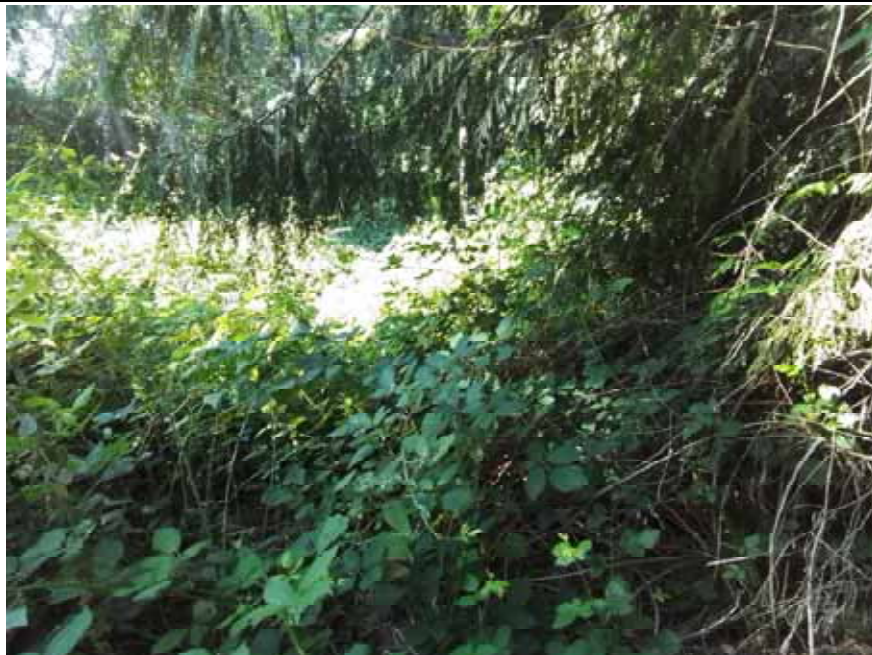
—	✓	✓	✓	✓	Approximately 100 linear feet of fencing on the northwestern side of the site was observed to be heavily overgrown with vegetation and the area was inaccessible.	Reconstruct fence.	The Navy plans to conduct the vegetation and tree clearing and fence repair in FY 2024, and the ERN group will coordinate with NBK – Manchester on implementation.
Site 303 – D-Tunnel Tanks							
—	—	—	—	—	There is no LUC signage warning of contaminated soil and groundwater at Tanks D-24, D-25, D-27, or D-28.	Add signage at the primary vehicle or pedestrian access point to each UST (Tanks D-22, D-24, D-25, D-26, D-27, D-28, D-29, and D-30) warning of contaminated soil and groundwater and prohibiting unauthorized dumping and/or soil excavation.	Completed; signs were installed at Site 303, according to the 2016 recommendations.
—	—	—	—	—	In 2016, numerous vapor monitoring wells could not be located, including Tank D-22, MW-3; Tank D-25, all wells except MW-2 and MW-13; Tank D- 26, MW-13; Tank D-27, all except for one unknown well; Tank D-28, all monitoring wells; Tank D-29, MW-1, MW-3, MW-4, MW-6, MW-8, MW-9, and MW-11; and Tank D-30, MW-1 and MW-4.	Locate all monitoring wells and assess for condition and integrity; mark with survey stakes, if feasible.	Completed; a well rehabilitation and decommissioning study, including a records review and site reconnaissance, was conducted from 2016 through 2017 (Navy, 2017).

Photograph 20
Northwest boundary fence covered with heavy vegetation, facing southwest.

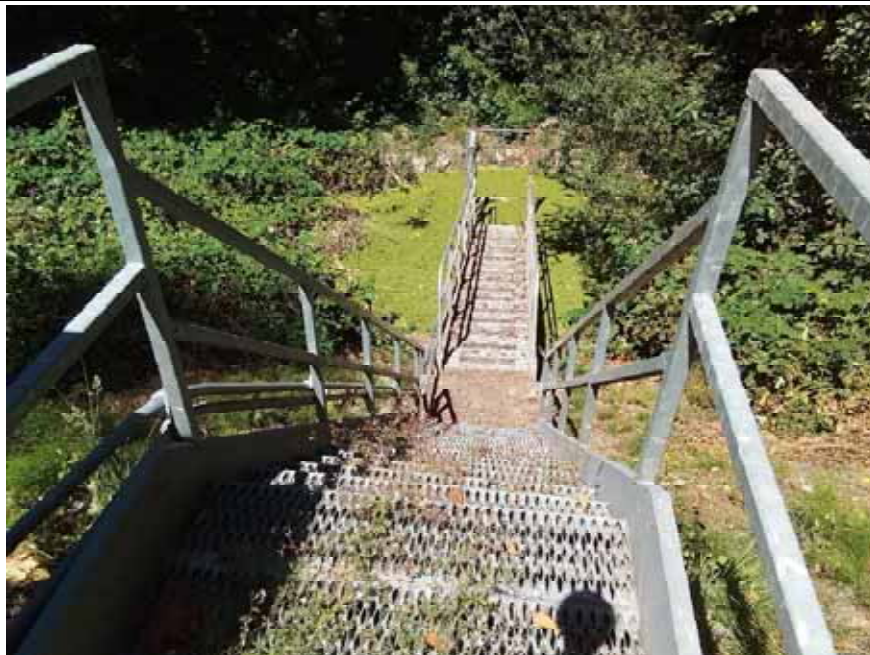
Photograph 6
Stairway and ponded water south of Tank 24, facing north.

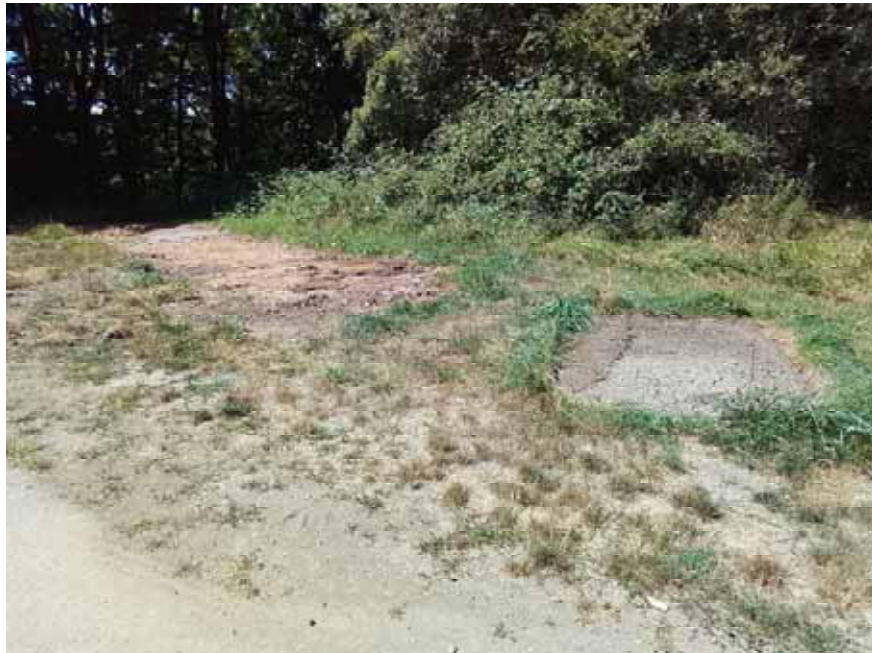
Photograph 14
Soil stockpile has been removed north of Tank 29, facing northwest.

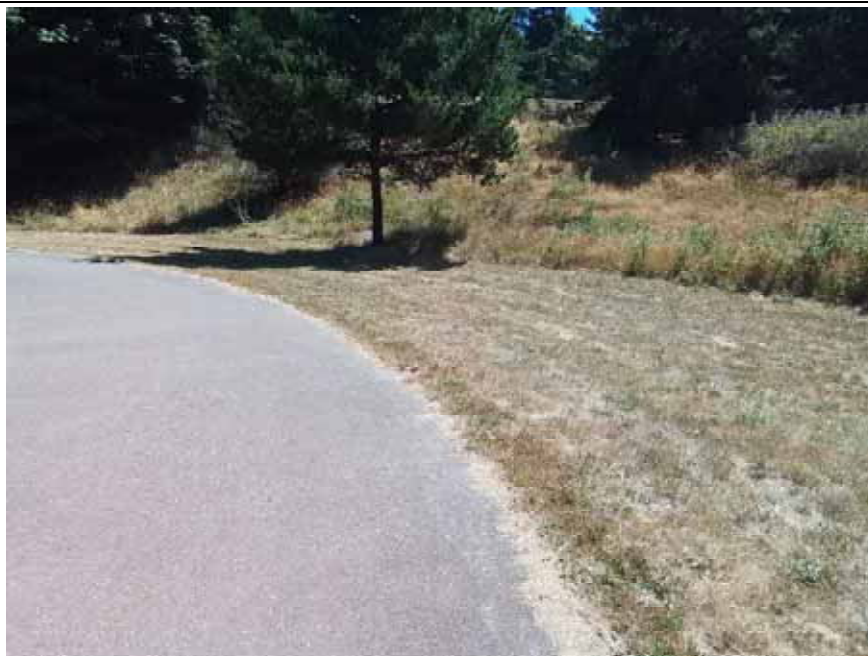
Photograph 19

Repaired former construction access road at Tank 30, facing east.

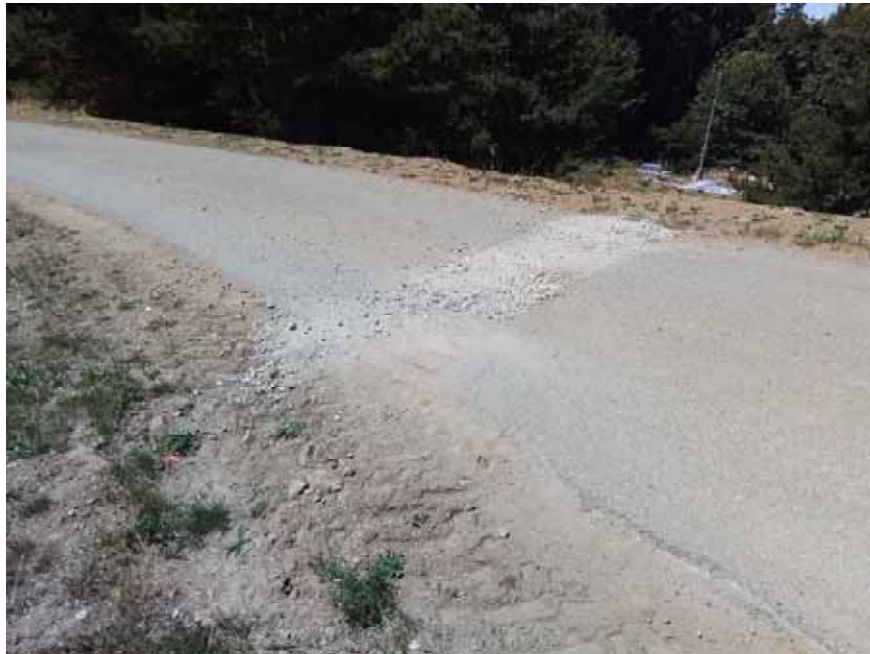
Photograph 21

Repaired cut in road related to former construction access road near Tank 30, facing west.

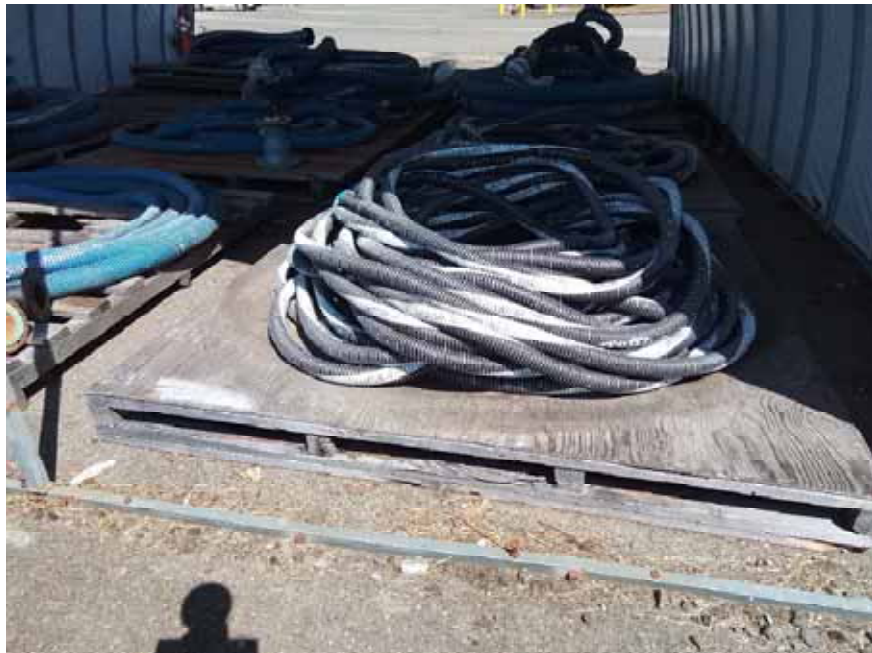
Photograph 4

Groundwater monitoring well MW-4 (covered by pallets), located along southcentral boundary of site facing north.

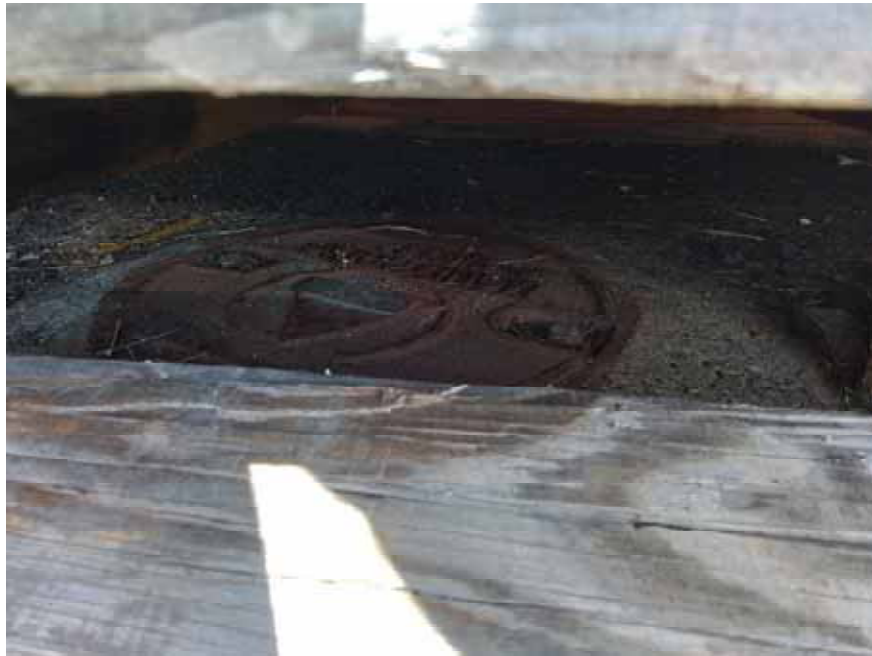
Photograph 5

Close up of groundwater monitoring well MW-4 (covered by pallets), located along southcentral boundary of site facing north.
