**FIFTH FIVE-YEAR REVIEW REPORT FOR
WYCKOFF CO./EAGLE HARBOR SUPERFUND SITE
KITSAP COUNTY, WASHINGTON**

**U.S. Environmental Protection Agency
Region 10
Seattle, Washington**

July 26, 2022

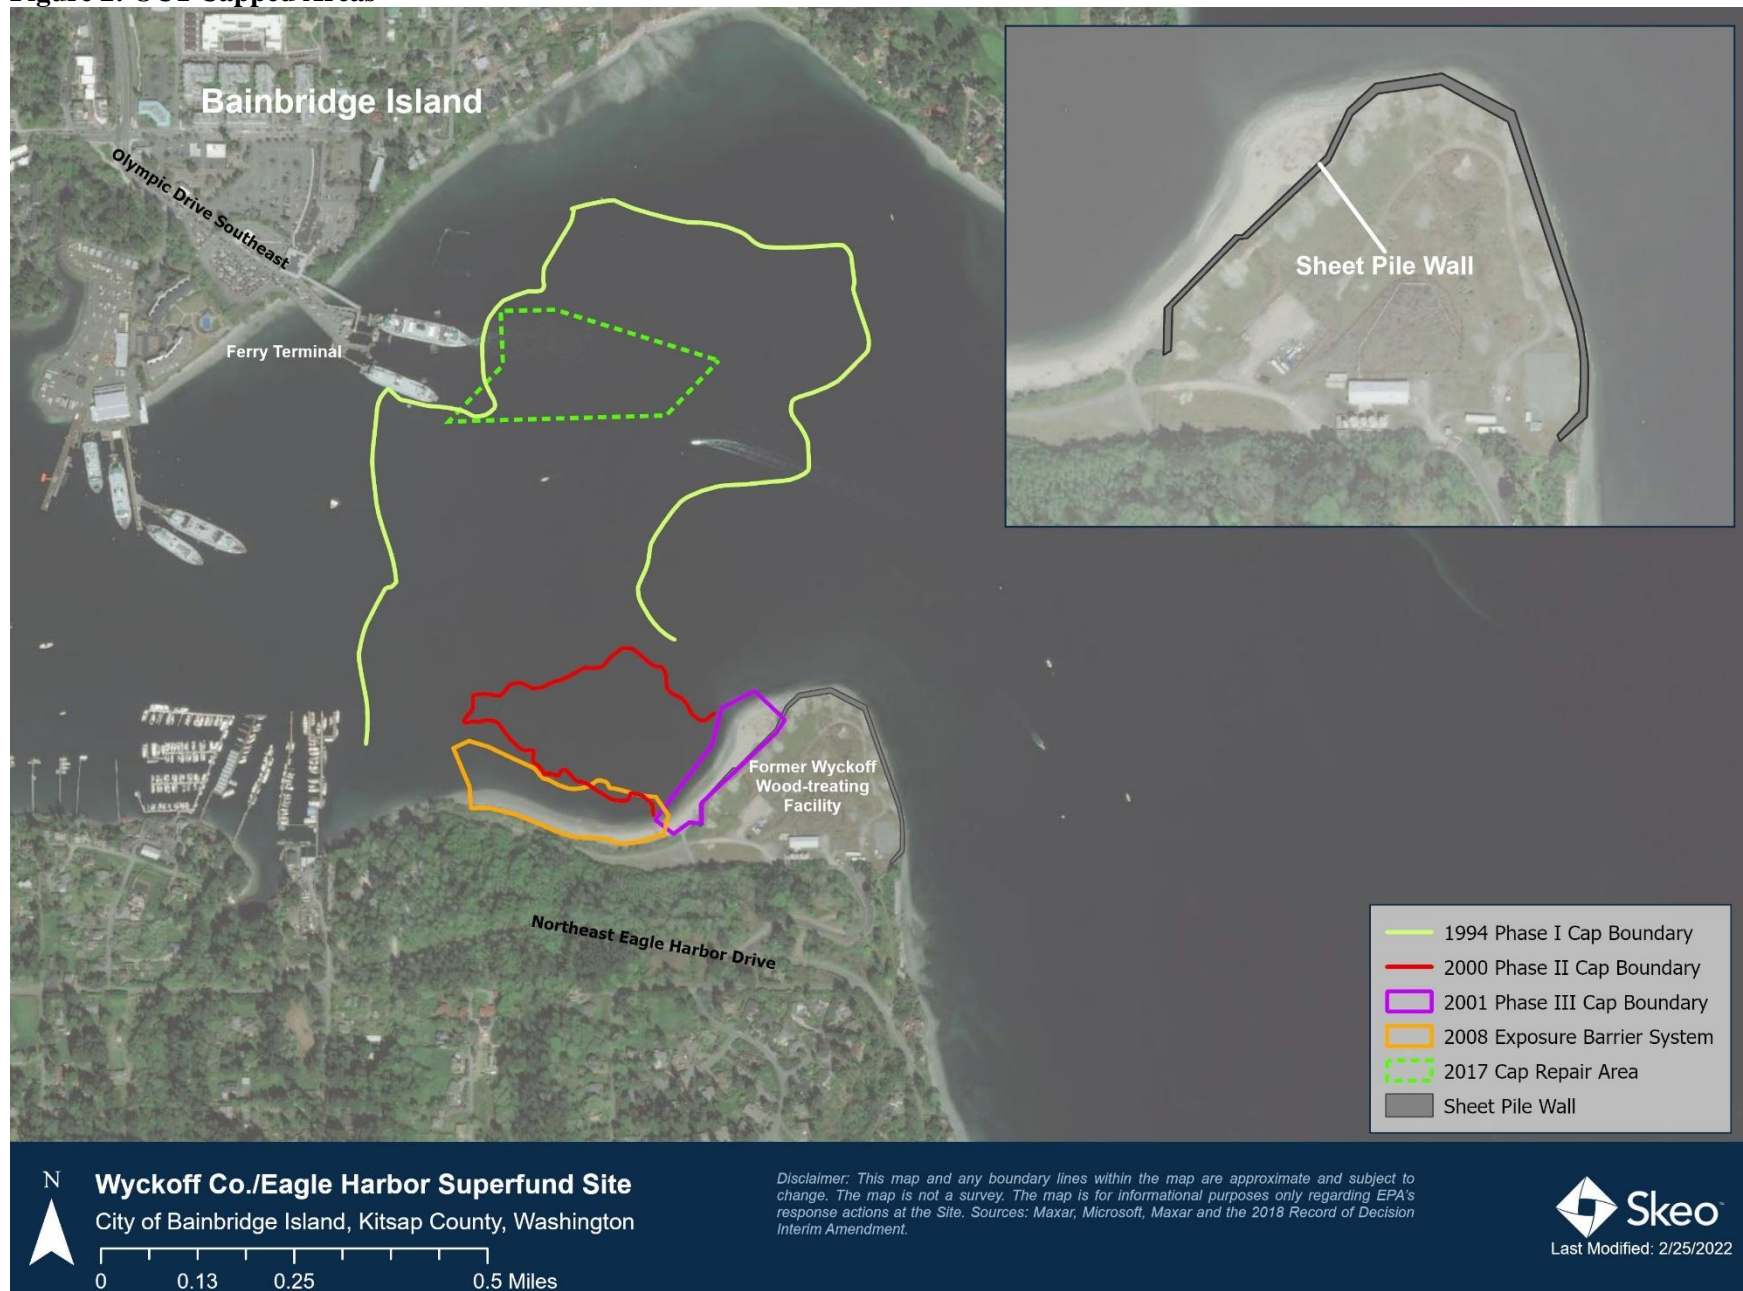
Figure 2: OU1 Capped Areas

In addition, material loss was seen on the northern portion of the subtidal Phase I cap, along the ferry lane, particularly at the approach to the Winslow terminal. In early 2017, repairs were made to the subtidal cap in this area (Figure 2). To restore necessary isolation, 1 foot of clean sand was added over the exposed area (9.3 acres). The high impact center of the ferry lane (3.5 acres) also received an additional 2-foot-thick rock/armor layer to prevent future erosion of the clean sand cap. In September 2017, a Remedial Action Report was issued detailing the subtidal sediment cap repair work completed. In April 2021, EPA and Ecology agreed that the remedy in the subtidal portion of OU1 is complete and functioning as intended. EPA transferred responsibility for O&M of subtidal sediments in OU1 to Ecology. EPA remains responsible for the intertidal areas of OU1 and areas that may be needed for construction of the remedy selected in the 2018 Interim ROD Amendment.

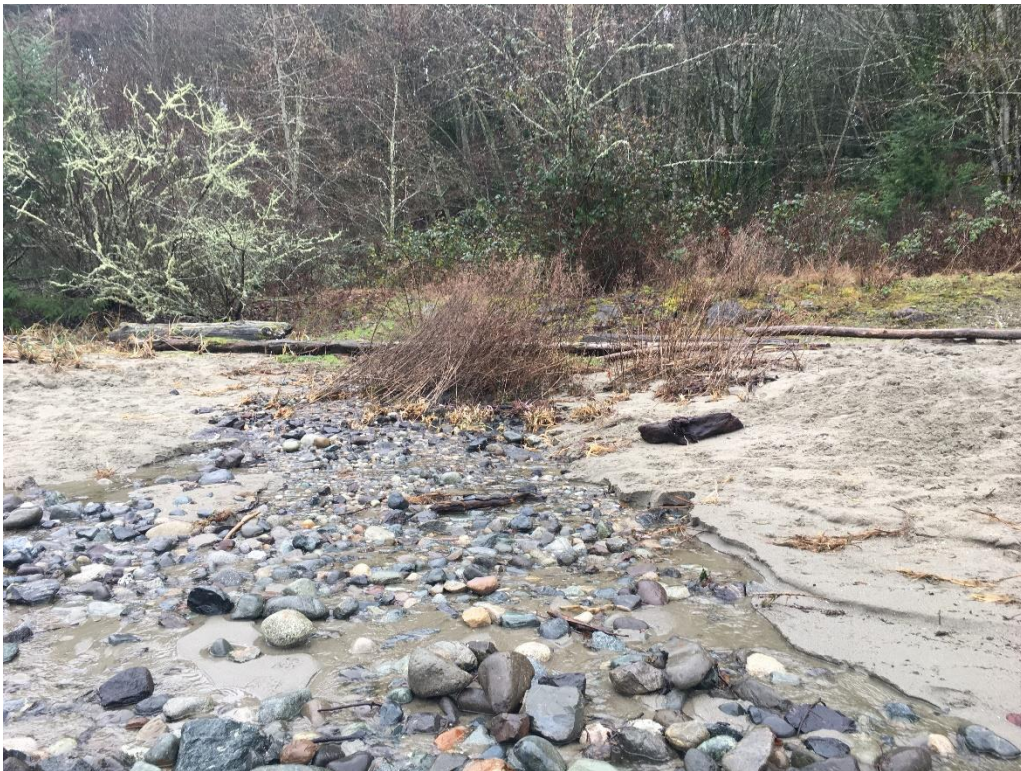
Cobbles downgradient from the outfall that drains onto the EBS

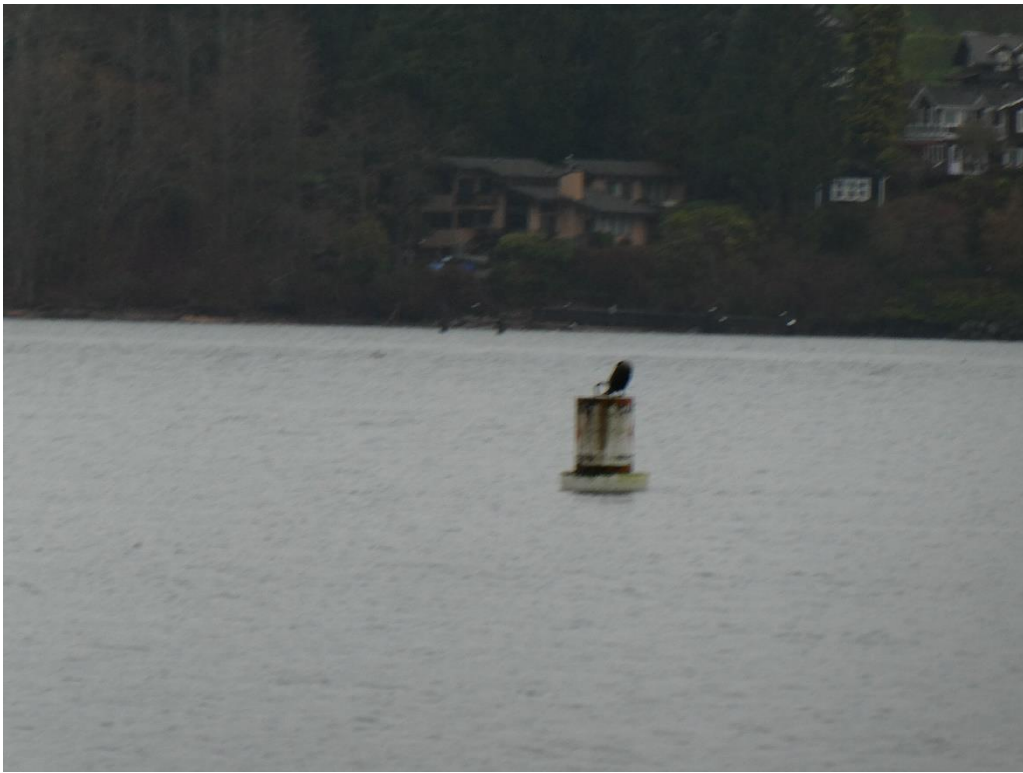
No anchor buoy

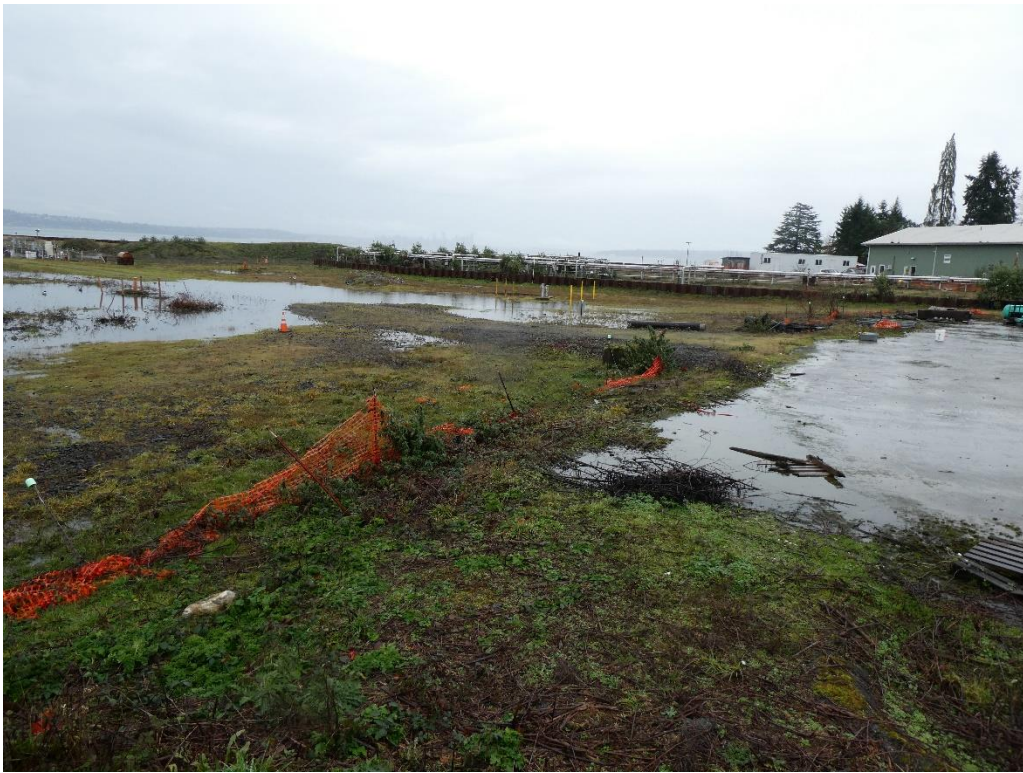
FPA, extraction and production wells visible with ponding

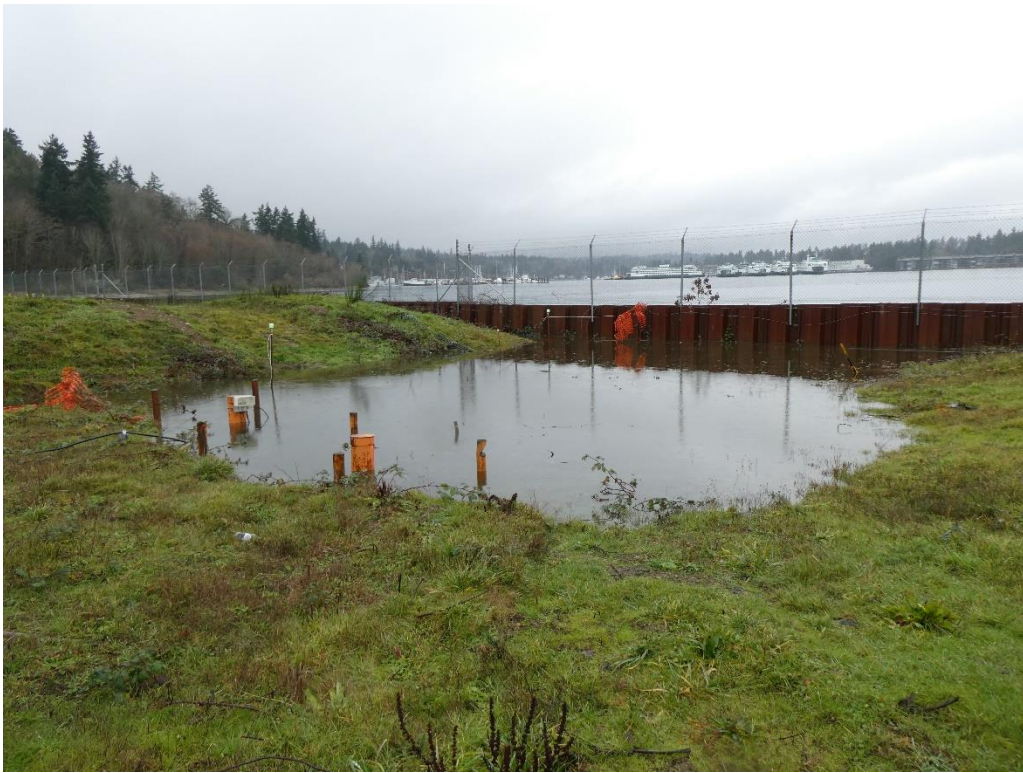
Western sheet pile wall and extraction wells with standing water

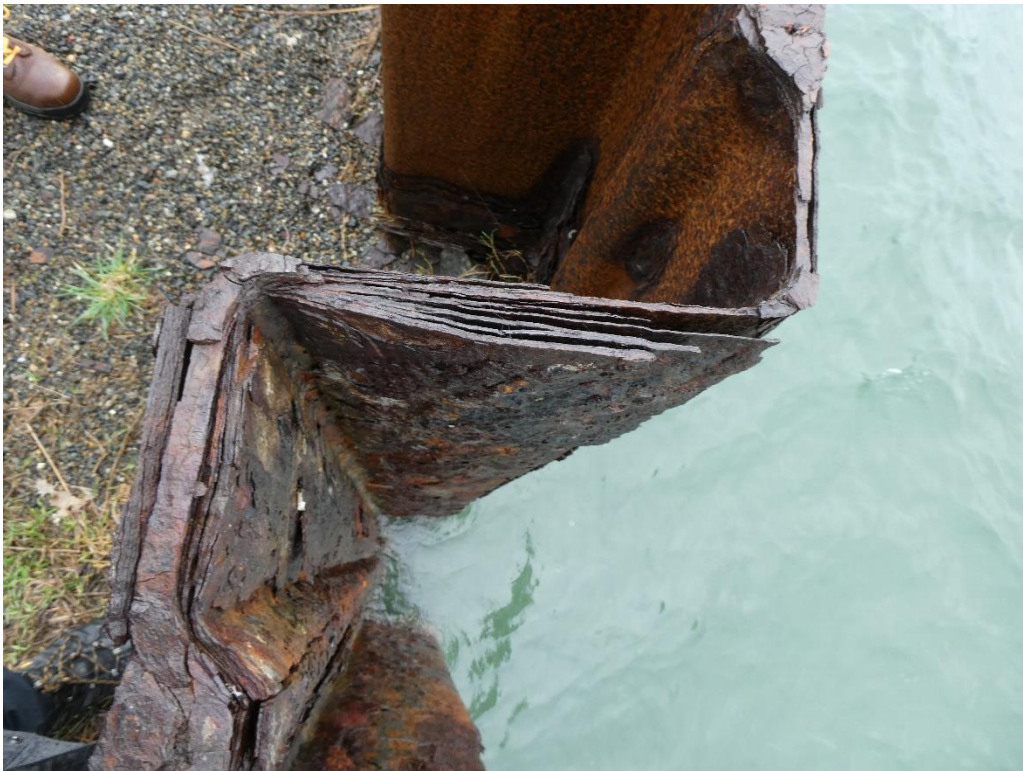
2/4	The sheet pile wall has experienced significant corrosion reducing its life span.	Perform repairs, or replace, the sheet pile wall to prevent leaks and other failures.	Ongoing	In 2018 an interim ROD amendment was signed selecting a replacement wall. In 2020, a pre-design investigation was completed, focusing on the nature and extent of subsurface debris in upland soils and soil/reagent mix design tests to compare different mix designs for the new perimeter wall, which will use a concrete soil mix as a primary technology. This investigation will help inform the design of the replacement perimeter wall. It will also help refine the cost estimate and debris handling and disposal plan. Design of the replacement perimeter wall is ongoing.	Not applicable
2/4	Recent groundwater data has shown increasing PAH concentrations in the lower aquifer, which is considered a potential drinking water source.	Evaluate opportunities to limit migration of contamination to the lower aquifer.	Completed	The May 2019 Interim ROD Amendment selected a new remedy for upland soil and groundwater that will solidify NAPL in upland soil, preventing further migration to the lower aquifer. The remedy will also reinforce portions of the aquitard that are thin, further limiting contaminant transport to the lower aquifer.	5/10/2019

Degraded eastern sheet pile wall

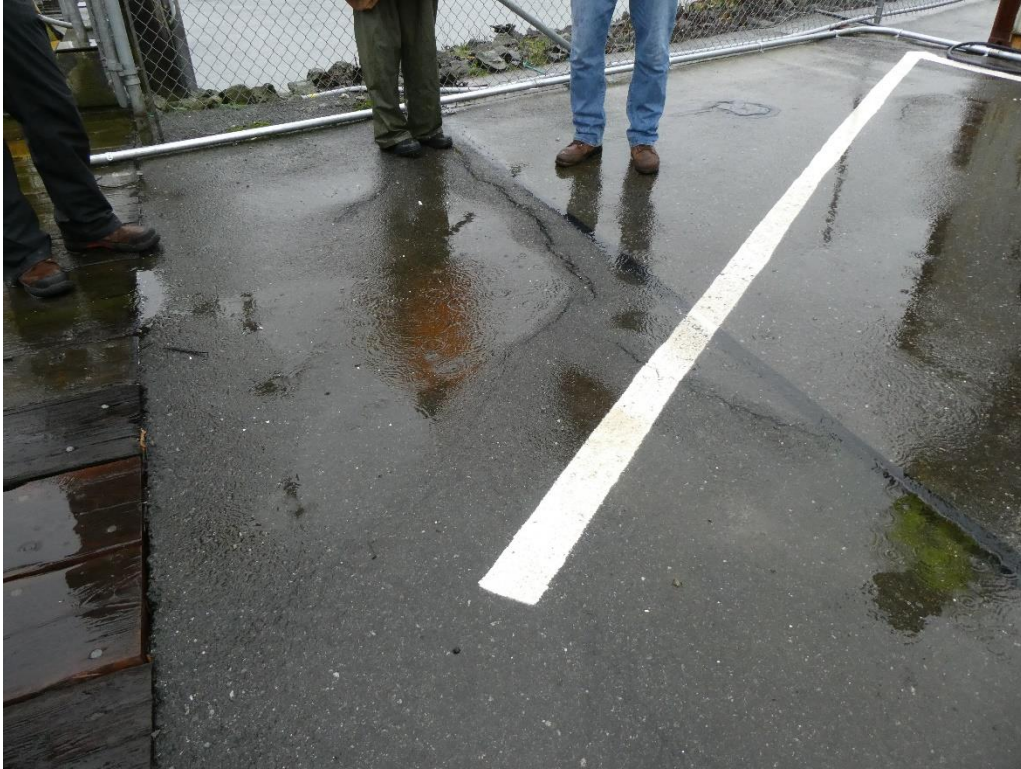
During the previous FYR period, asphalt cracking was a persistent problem at OU3. Several long cracks along the construction joints were originally discovered in 2009 and were sealed with asphalt the same year. Additional repairs were made in 2011 and 2012. In 2011, a pavement engineer evaluated the asphalt cap surface and found it in overall good structural condition, though showing signs of aging. In 2013, the cracks were resealed using a new method. Evaluations of the cap condition in 2016 and 2017 found it in sound structural condition despite the signs of aging. It was decided to continue monitoring semi-annually to determine when a full asphalt overlay is needed. During this FYR period, asphalt repairs were conducted in 2018 and 2019. In 2020, a 6-foot-long crack of medium severity (1/4 to 1/2 inch wide) was observed in the subsidence area adjacent to the southern edge of the asphalt concrete cap. In addition, a minor crack of low severity (less than 1/4 inch wide) was observed near the fence west of the CDF. The observed asphalt cracks were not repaired in 2020 due to work constraints associated with COVID-19, but WSDOT pavement repair crew completed the repairs in spring 2021.

Asphalt crack repair

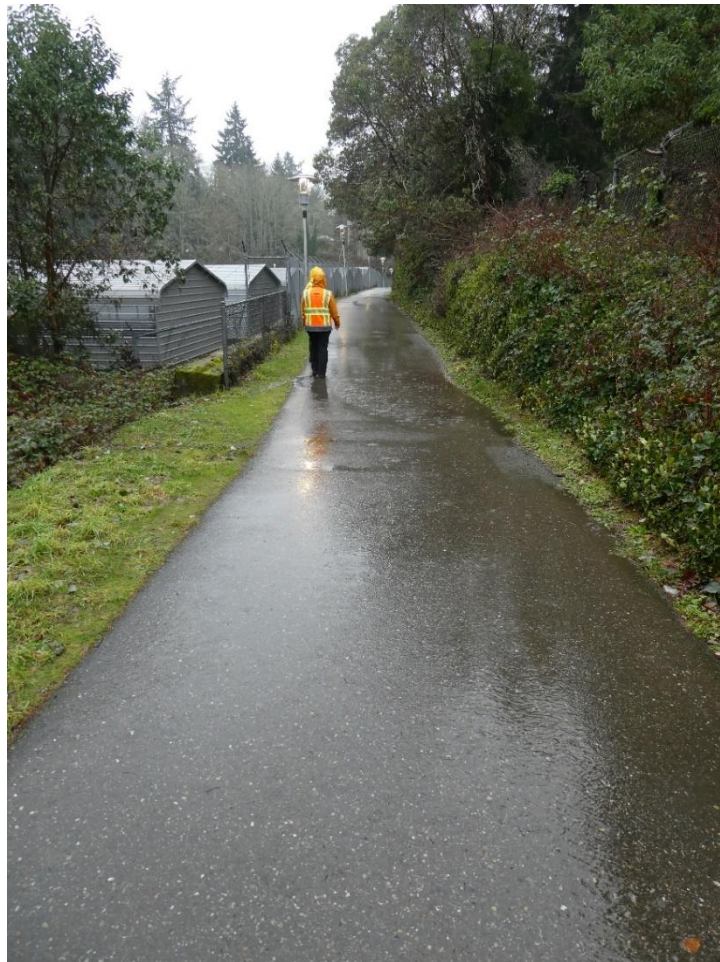
Ponded water near the northern drainage cutoff wall

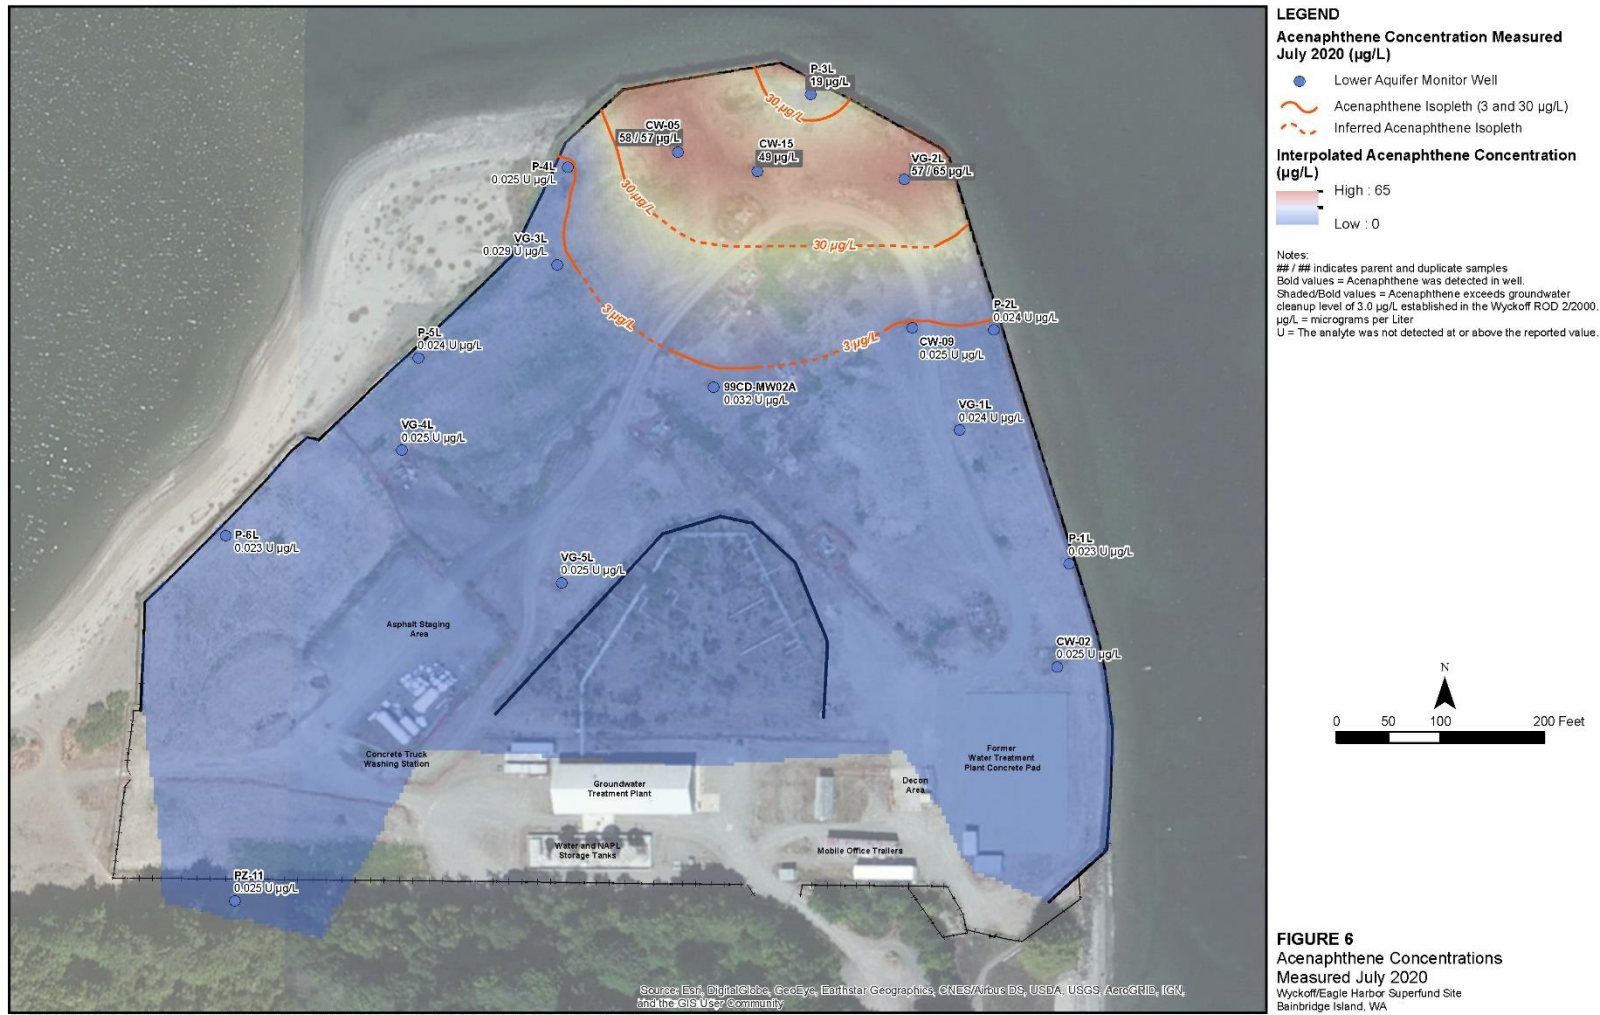
Figure H-6: 2020 Acenaphthene Concentrations¹²

In 2018, 2019 and 2020, DNAPL was detected at wells VG-2L, P-3L, CW05 and CW15, with visual evidence observed on the tape. The July 2020 measurements at VG-2L, P-3L and CW15 are consistent with the May 2019, May 2018, July 2016 measurements, October 2014 observations and June 2012 measurements. Wells VG-2L, P-3L and CW15 are in the northern portion of the FPA where PAHs have been consistently detected in lower aquifer groundwater samples at concentrations near or above the cleanup levels. Acenaphthene, a PAH contaminant indicator for the Site, was detected above the cleanup level of 3 µg/L with concentrations between 19 and 65 µg/L (Figure H-6 in Appendix H).
