## TECHNICAL MEMORANDUM

**RE:** 2023 Annual Operation and Maintenance Site Inspection  
Hamilton Street Bridge Site  
Spokane, Washington  
Project No. 0236042.140

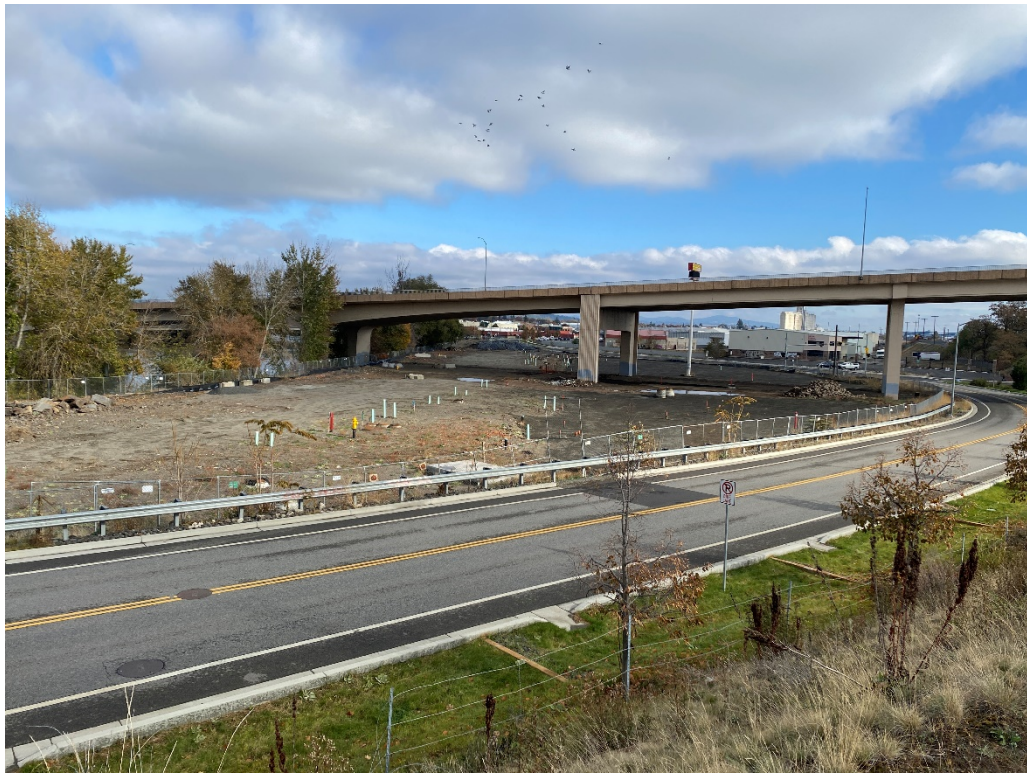
1. View of former SGP portion of the site (looking northeast).

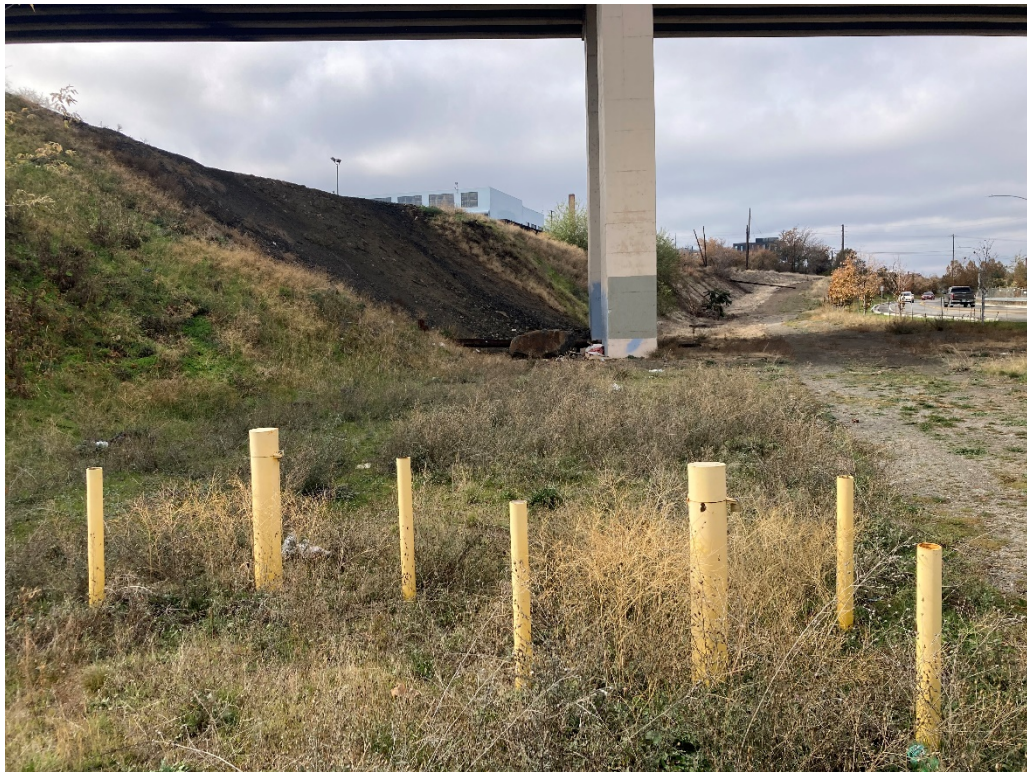
2. View of ATC portion of the site and ATC monitoring wells (looking west).

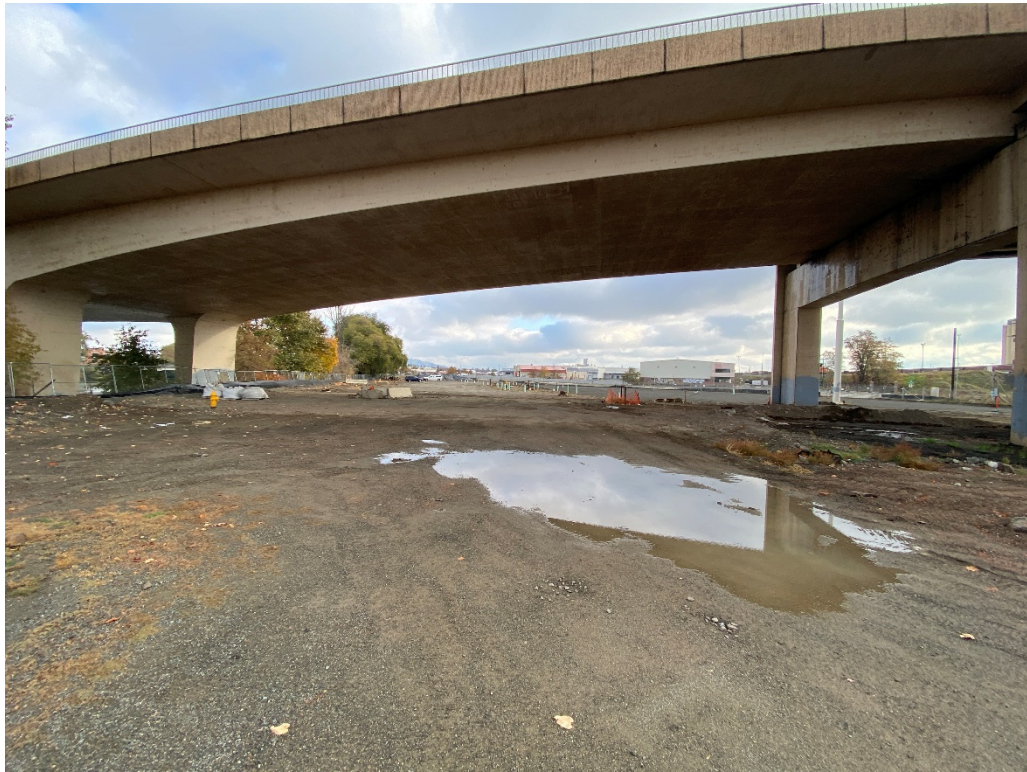
- Site Grading on the former SGP portion of the Site. As part of Sagamore’s redevelopment of the Site, the grade on the former SGP portion of the Site has been altered. Stormwater at the footprints of buildings 2A and 2B appears to be directed away from cPAH-impacted soil by the sloped crushed surface cover, and a sumped stormwater collection basin was observed near the northeast corner of the building 2A footprint, outside the area of cPAH-impacted soil. No ponding was observed at the footprints of buildings 2A and 2B. Stormwater throughout the remainder of the former SGP portion of the Site appears to infiltrate, including in areas containing cPAH-impacted soil. Ponding from rainfall was observed throughout the remainder of the SGP portion of the Site.

1. View of former SGP property with ponding from rainfall within cPAH impacted soil footprint. (looking east).

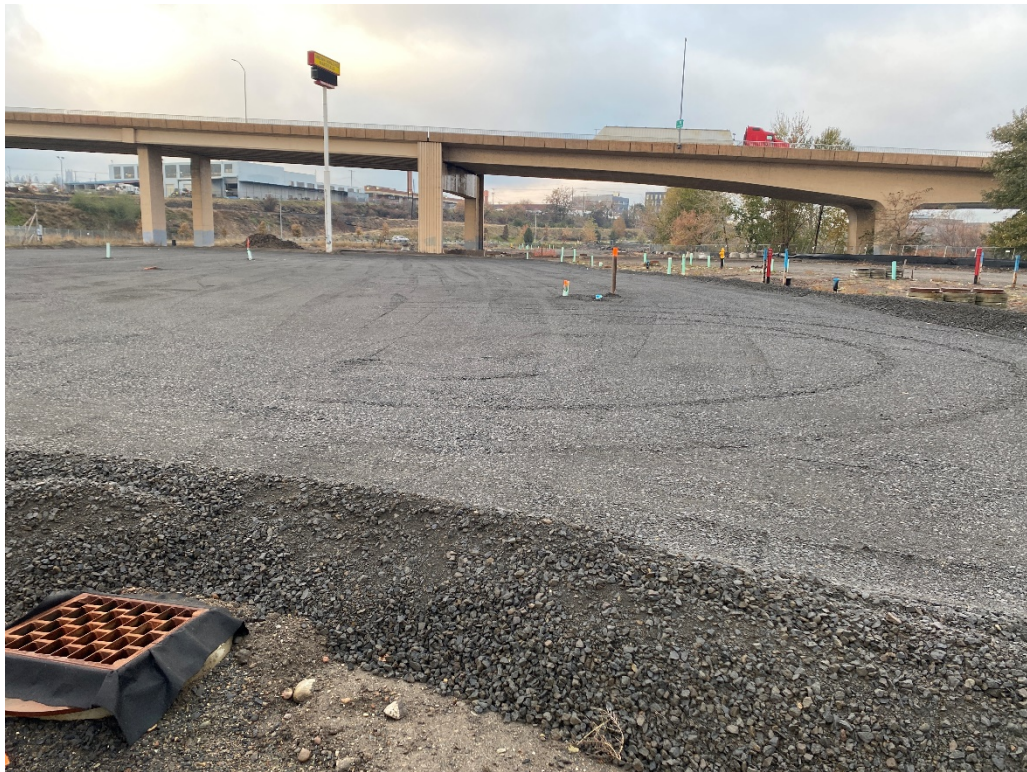
2. View of recently re-graded area in the footprint of Building 2A on former SGP property (looking west).

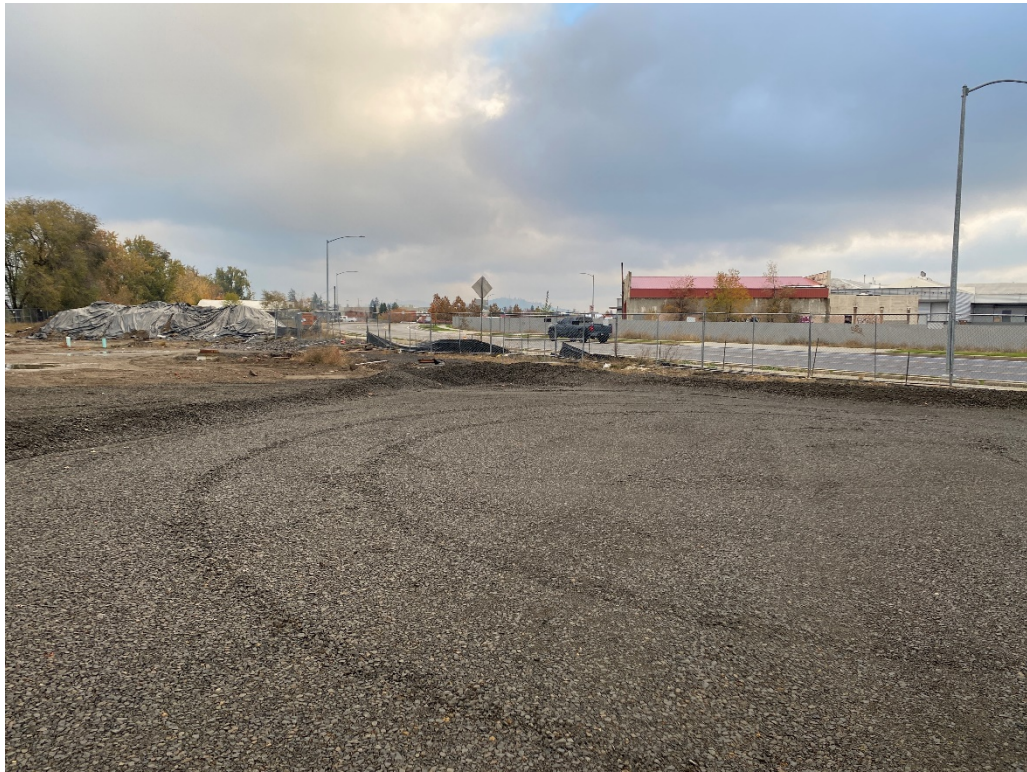
- **Grading.** Grading at the footprints of buildings 2A and 2B was observed to be generally sloped away from the cPAH-impacted soil boundary, and a sumped stormwater collection basin was observed near the northeast corner of the building 2A footprint. An elevated area of soil, approximately 2.5 ft above the surrounding grade, was observed in the western portion of the Site between the building 2B footprint, the riverbank, and the west infiltration gallery. An open

1. View of the east end of the recently re-graded area in the footprint of Building 2A sloped to sumped basin in center of photo on former SGP property (looking east).

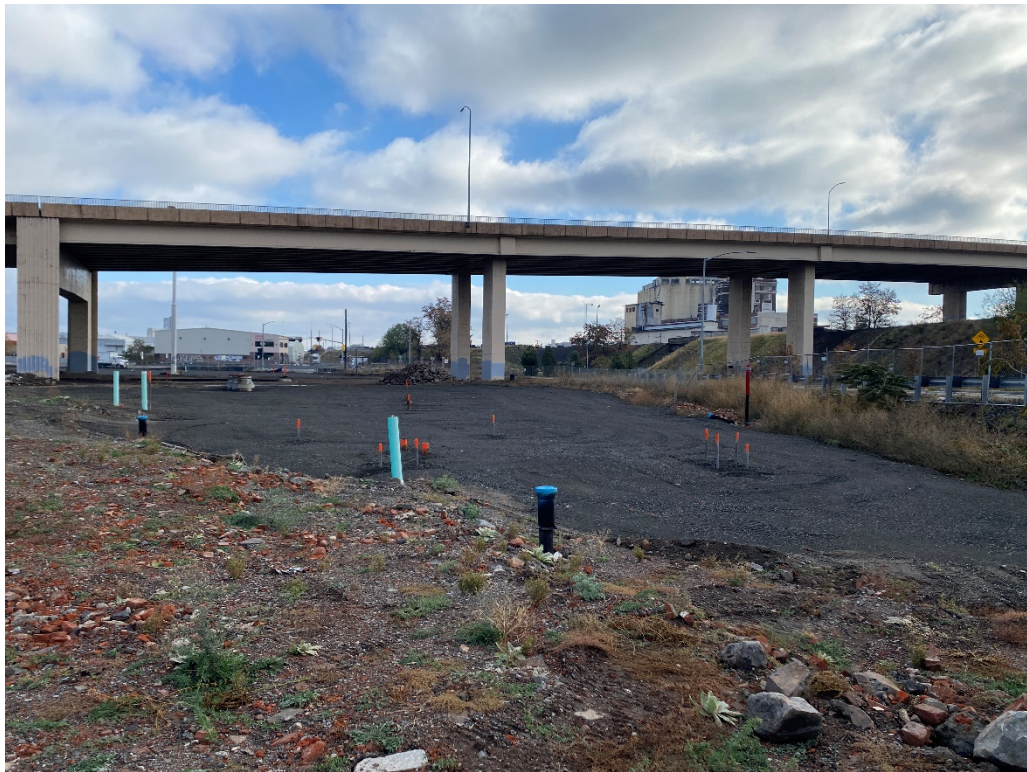
2. View of recently re-graded area in the footprint of Building 2B on former SGP property (looking east).

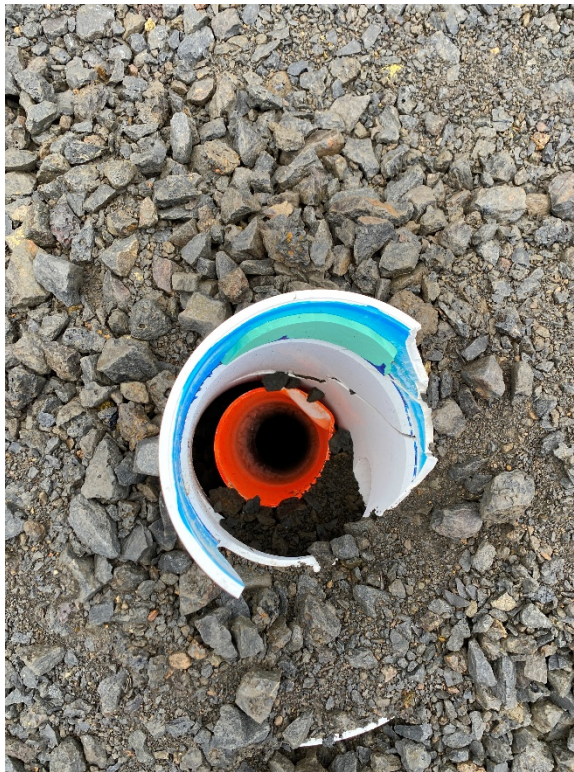
- **Test Piles.** Test piles were observed within the footprint of buildings 2A and 2B during Landau's Site visit. Test piles within the area of cPAH-impacted soil were observed to be open to as deep as 3.8 ft below ground surface (bgs), and test piles observed outside of the area of cPAH-impacted soil were open to depths greater than 25 ft bgs (Figure 2).

1. View of test pile within the cPAH impacted soil footprint on the former SGP property.

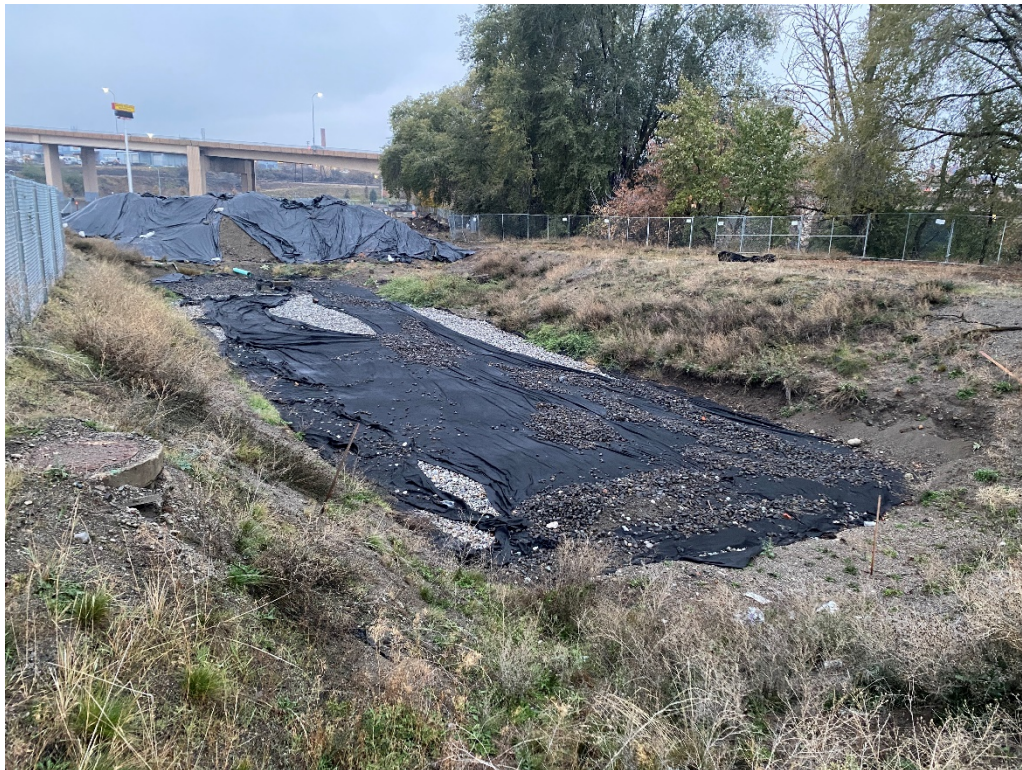
- **North Detention Basin.** It is Landau’s understanding that the modifications to this detention basin are being conducted under CAP Amendment 1. According to the EDR, stormwater collected from buildings on the eastern portion of the former SGP Site and from the Ben Burr Trail is intended to be routed to the north detention basin. Landau observed modifications to the north detention basin system, including geotextile fabric overlying drain rock in the entirety of the basin. Due to the grade on the SGP portion of the Site not being developed to direct surface water runoff toward the stormwater facilities, it did not appear that infrastructure was in place to transfer stormwater to the north detention basin at the time of Landau’s cap inspection Site visit. In addition, a large, mostly covered soil stockpile was present to the west of the north detention basin. No silt fence was present between the soil stockpile and the Spokane River.

2. View of north detention basin and stockpile to the southwest of the north detention basin on former SGP property (looking west).

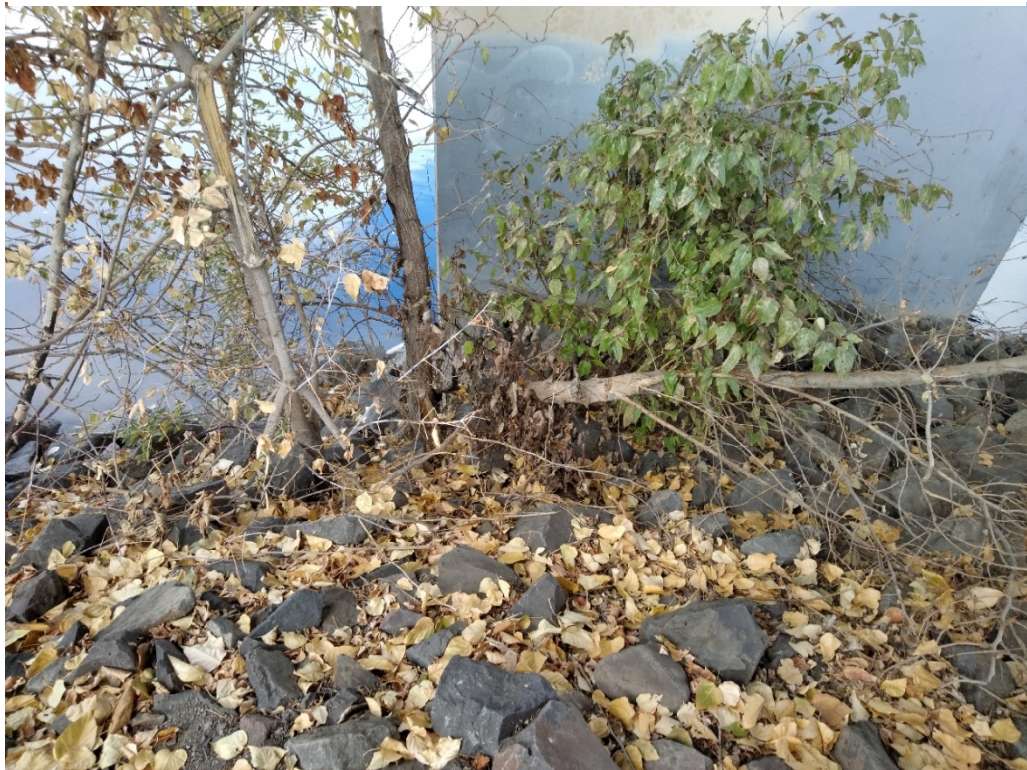
- a. Cleanup Action Shoreline Armoring and Bioengineering. The cleanup action shoreline armoring was generally observed to be in good condition and operating in accordance with the FCAP; however, several trees near the western extent of the cleanup action shoreline armoring and bioengineering had been cut down adjacent to transient camps observed along the shoreline.

2. View of cleanup action shoreline armoring transition zone with cut down tree on the former SGP property (looking north).

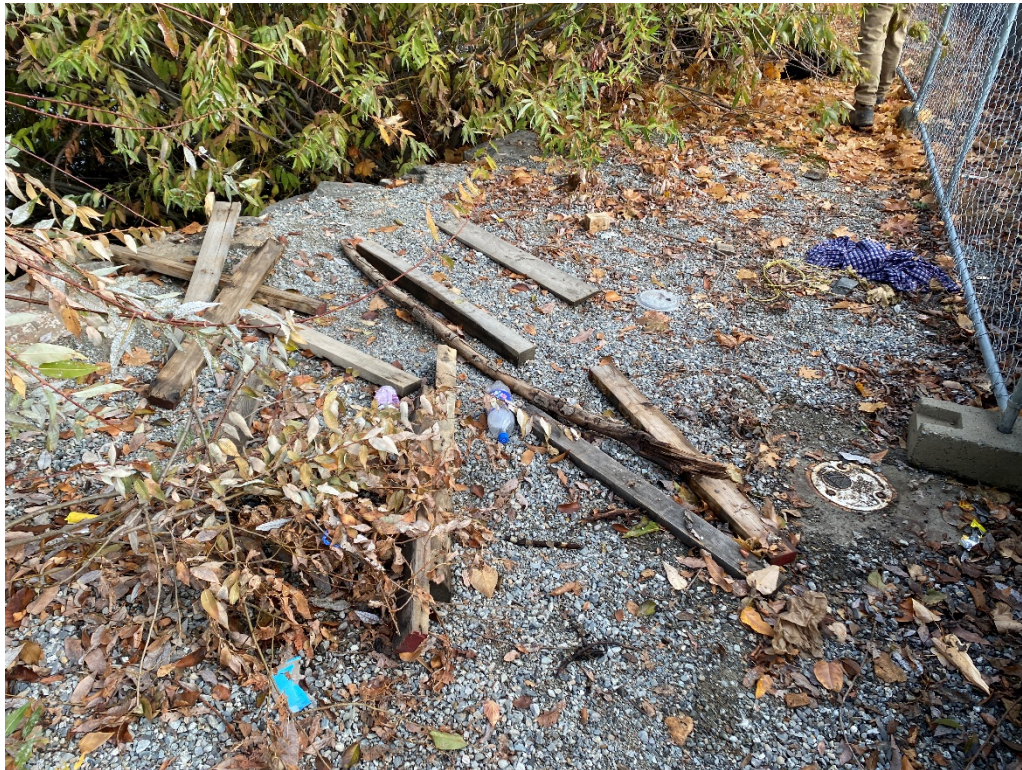
- b. Shoreline Armoring near MW2-40. The shoreline armoring near MW2-40 was observed to be in good condition. The unauthorized excavation between MW2-40 and the Spokane River was due to transient activity near the riverbank and required slope repairs, which Avista and BNSF implemented, to prevent further erosion and discourage continued unauthorized excavation into the slope. The temporary fencing installed on both sides of the shoreline repair appeared to be damaged, indicating transient foot traffic through the area is still occurring. A transient camp and several downed trees were observed to the east, and a transient camp was observed west of the erosion repair.

1. View of shoreline armoring transition zone and transient refuse near MW2-40 on the former SGP property (looking northeast).

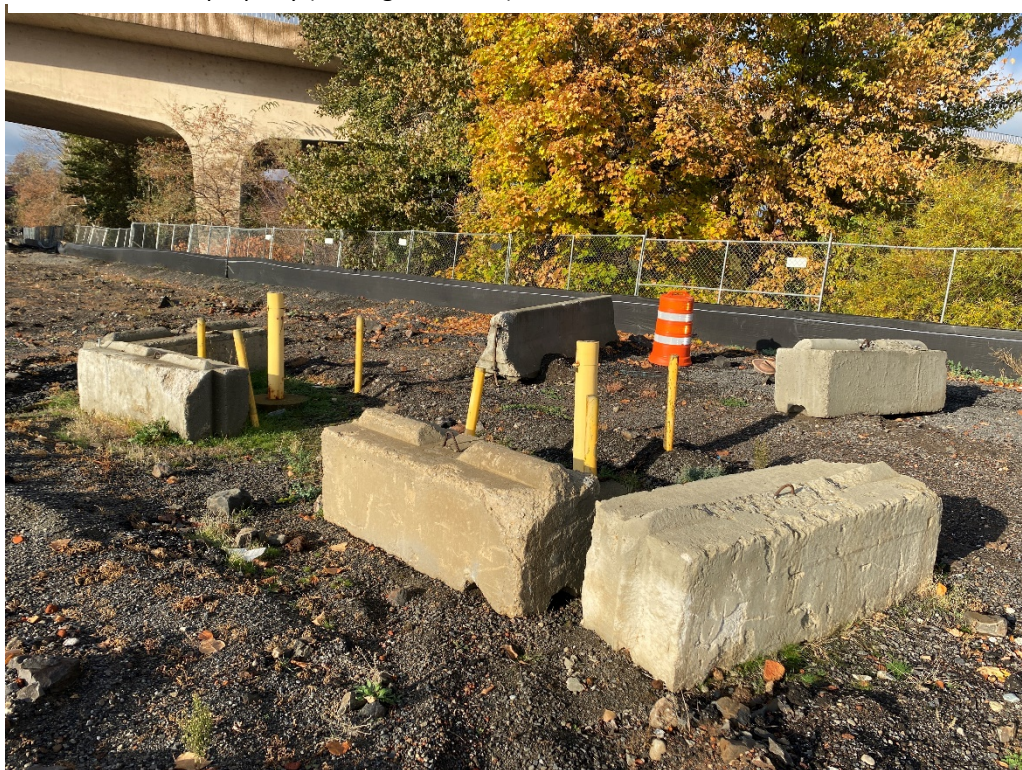
2. View of monitoring well cluster MW4. MW4-20 is located beneath the traffic barrel on the right (looking west).

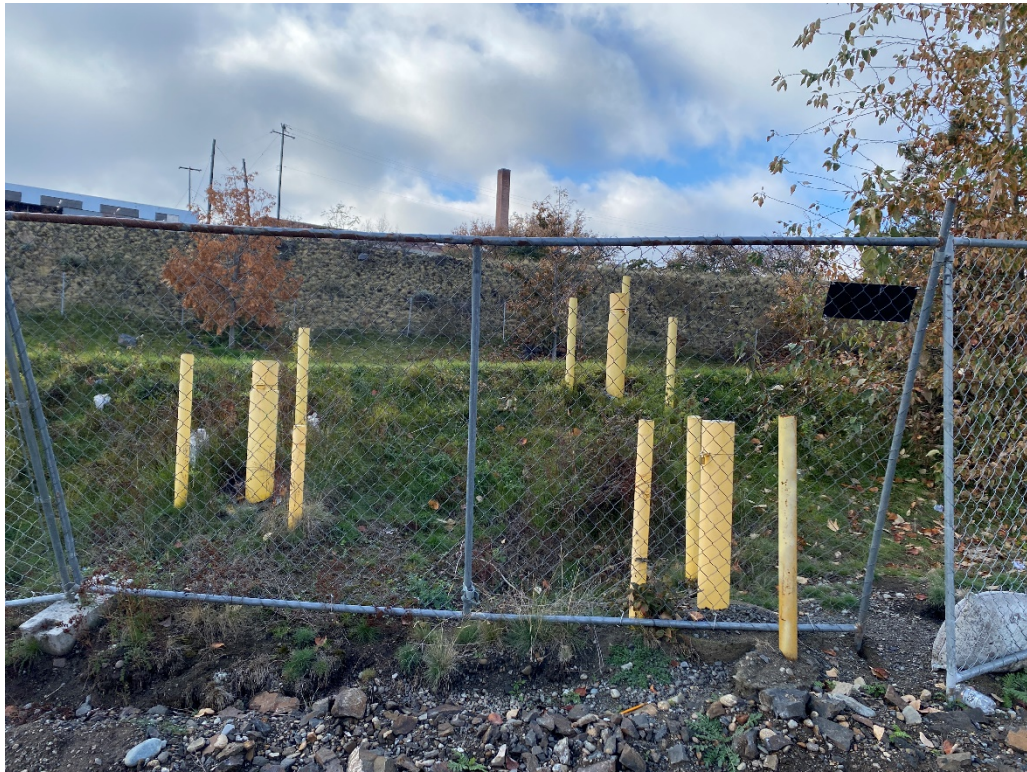
- Additional holes in the fencing around the former SGP portion of the Site were observed to the southwest of the north detention basin, approximately 100 ft to the northeast of MW4-20, and by the MW8 cluster of monitoring wells.

1. View of monitoring well cluster MW8 and compromised perimeter fence (right side) on the former SGP property (looking southwest).

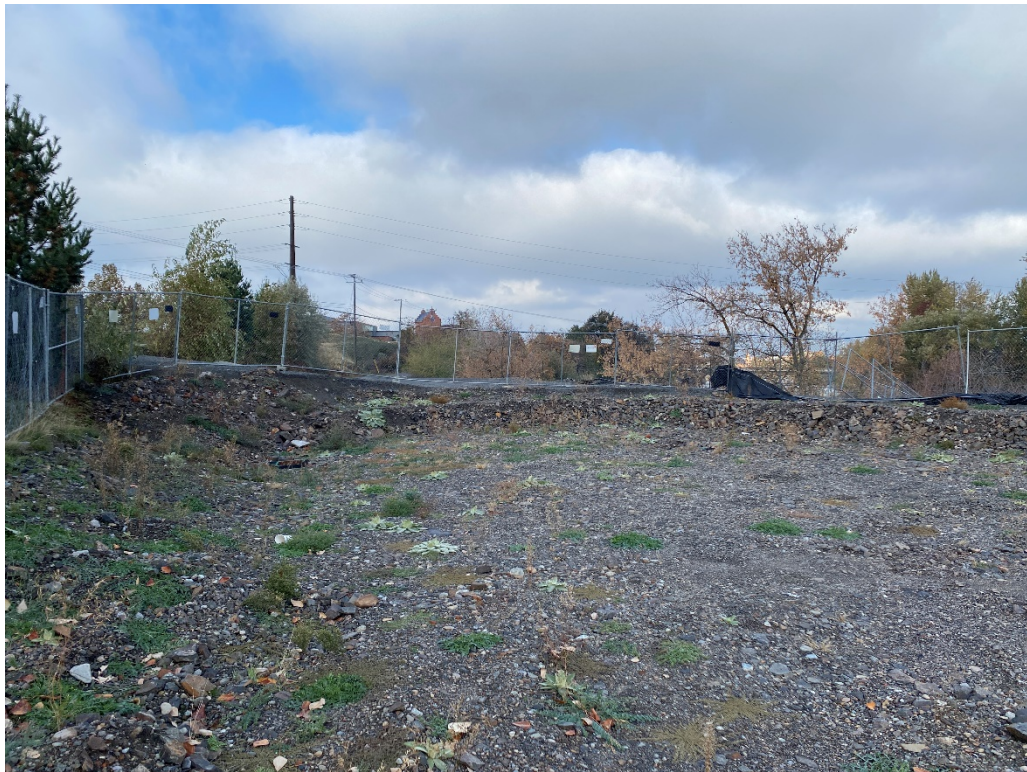
2. View of the new west infiltration gallery (looking west).

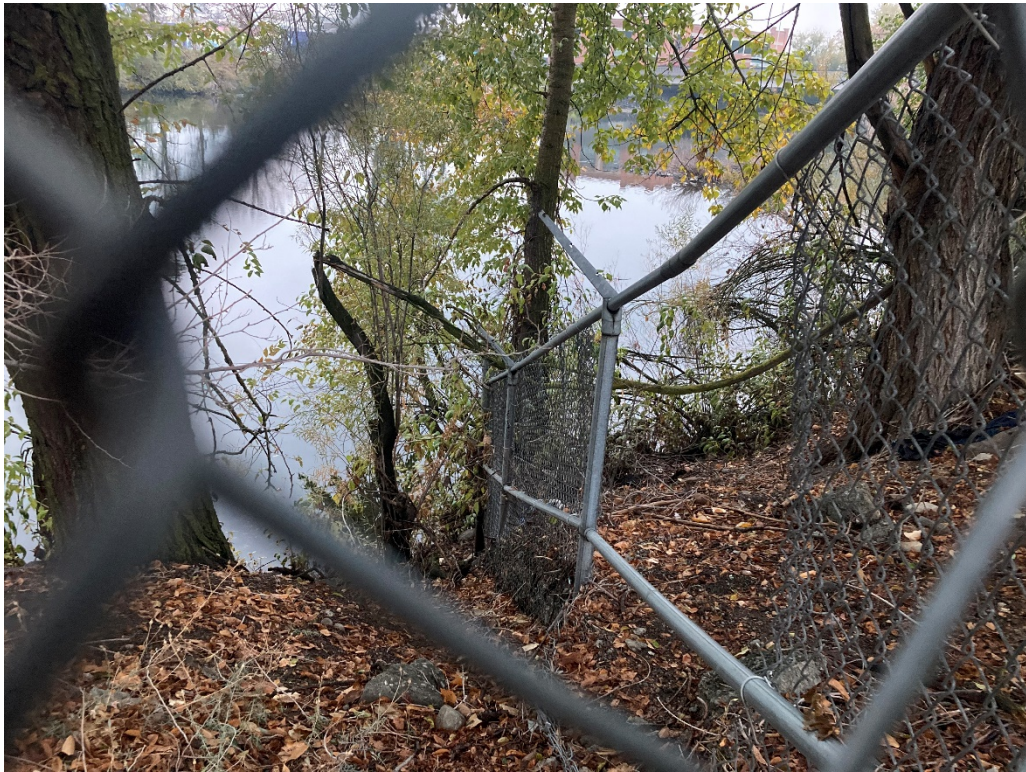
- During construction of the shoreline armoring near MW2-40 on October 11 and 12, 2022, a large hole cut into the portion of fence leading to the river near the north detention pond was observed, which allowed access to the shoreline between the river and the fencing at the top of

the slope. This hole was observed during Landau's 2022 cap inspection and again during Landau's 2023 cap inspection.

1. View of hole in fencing near north detention basin at the eastern end of the SGP portion of the site (looking north).

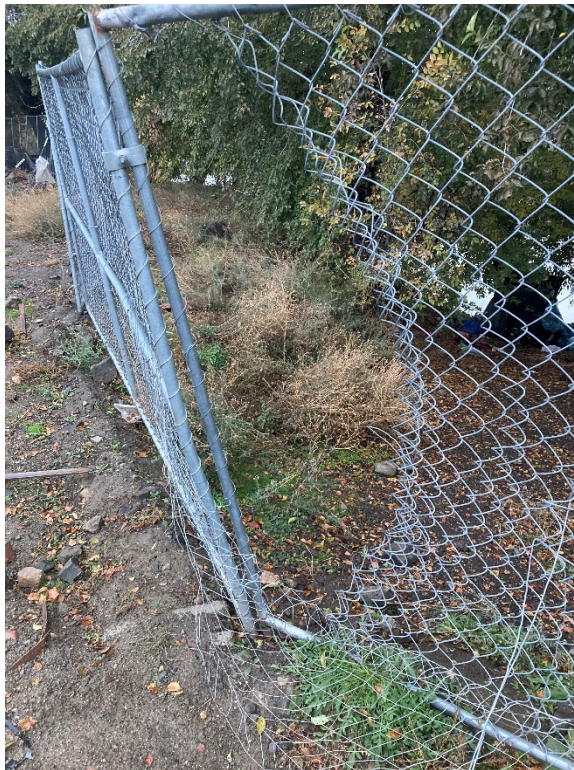
2. View of hole in fencing, leading to transient camp on shoreline, to the southwest of the north detention basin on former SGP property (looking west).

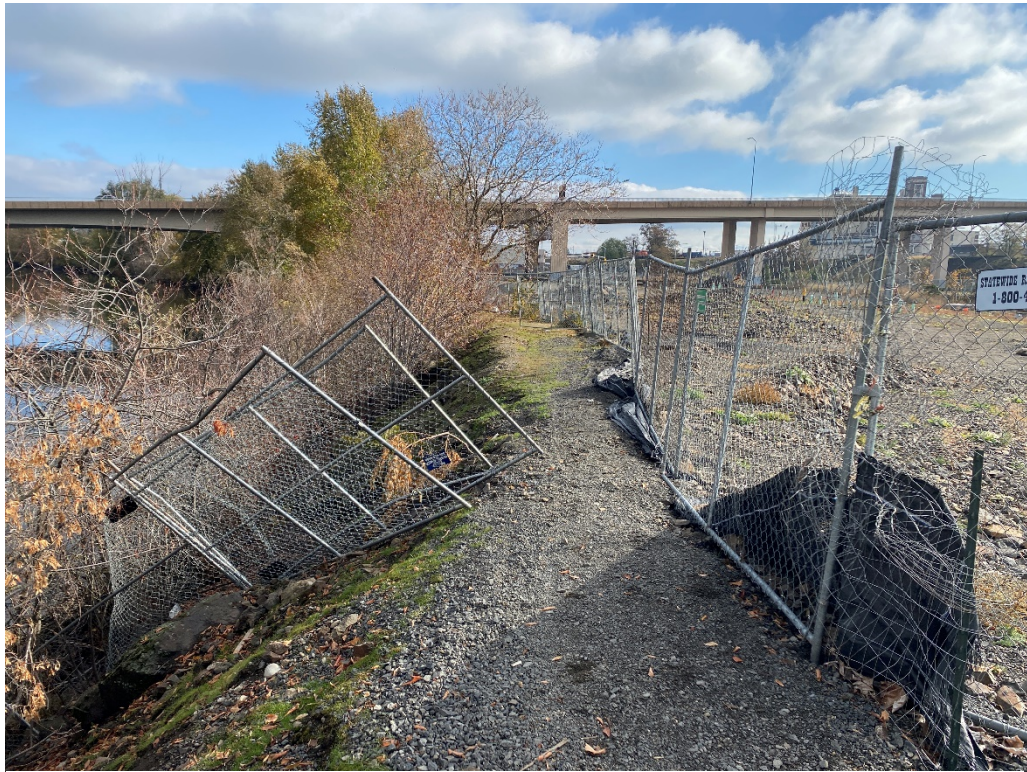
1. View of compromised perimeter fencing at the western boundary of the former SGP property (looking east).

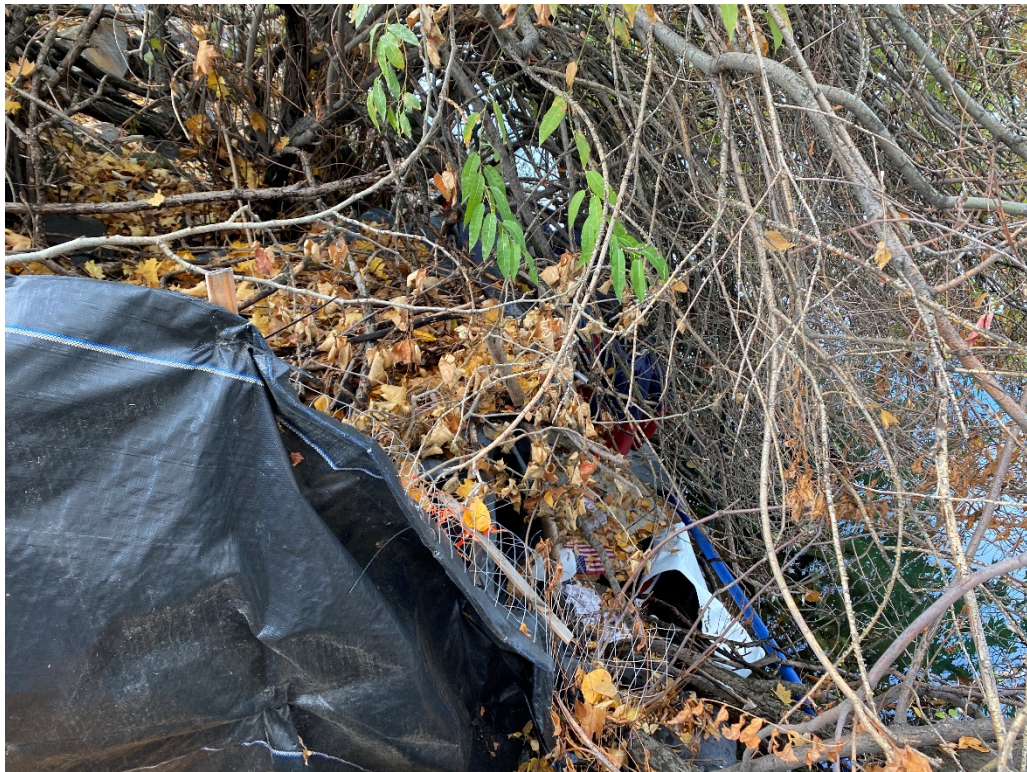
2. View of camouflaged transient camp to the east of the riprap slope installed near MW2-40 (looking west).

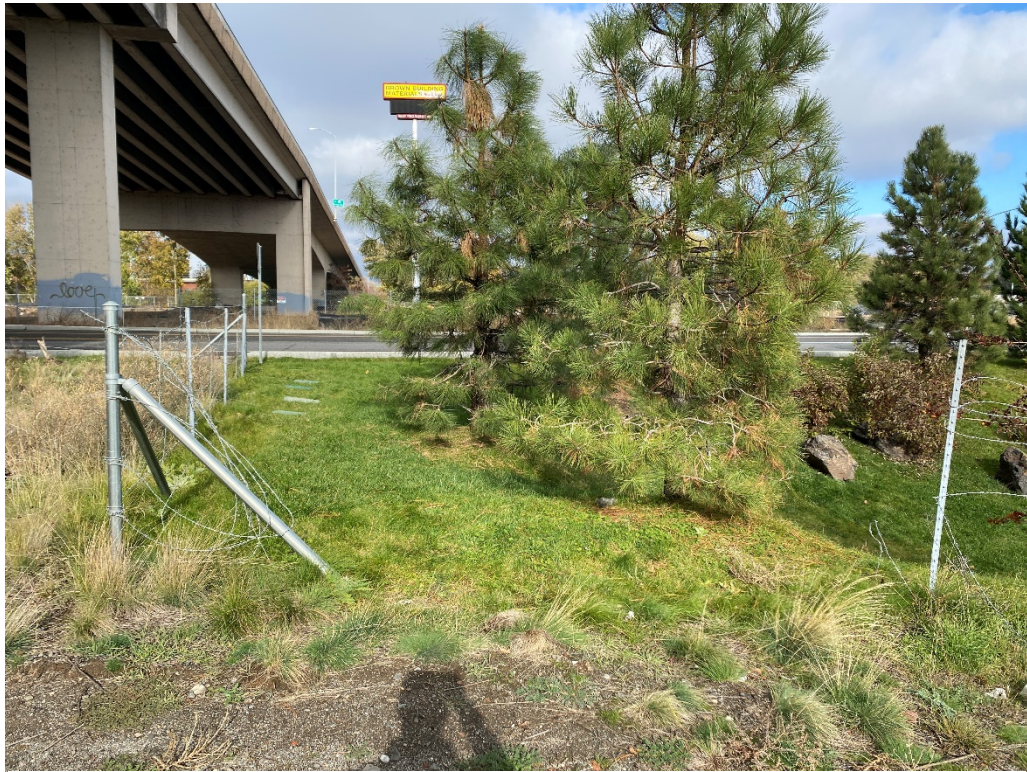
- a. ATC fencing. Sections of fencing on the ATC portion of the Site paralleling North Erie Street, at the southwest corner of the lined evaporation pond, and underneath the James E. Keefe Bridge were observed to be damaged.

1. View of damaged perimeter fencing at the southwest corner of the lined evaporation pond on the former ATC property (looking north).

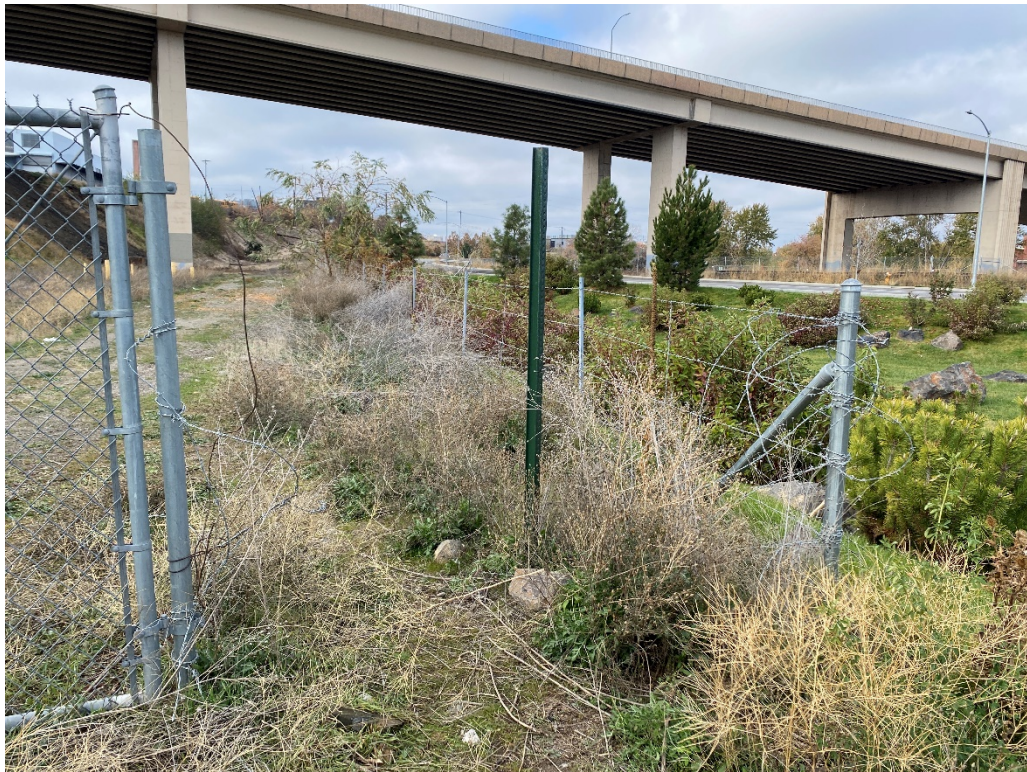
2. View of damaged perimeter fencing paralleling North Erie Street near ATC07-20 on the former ATC property (looking west).

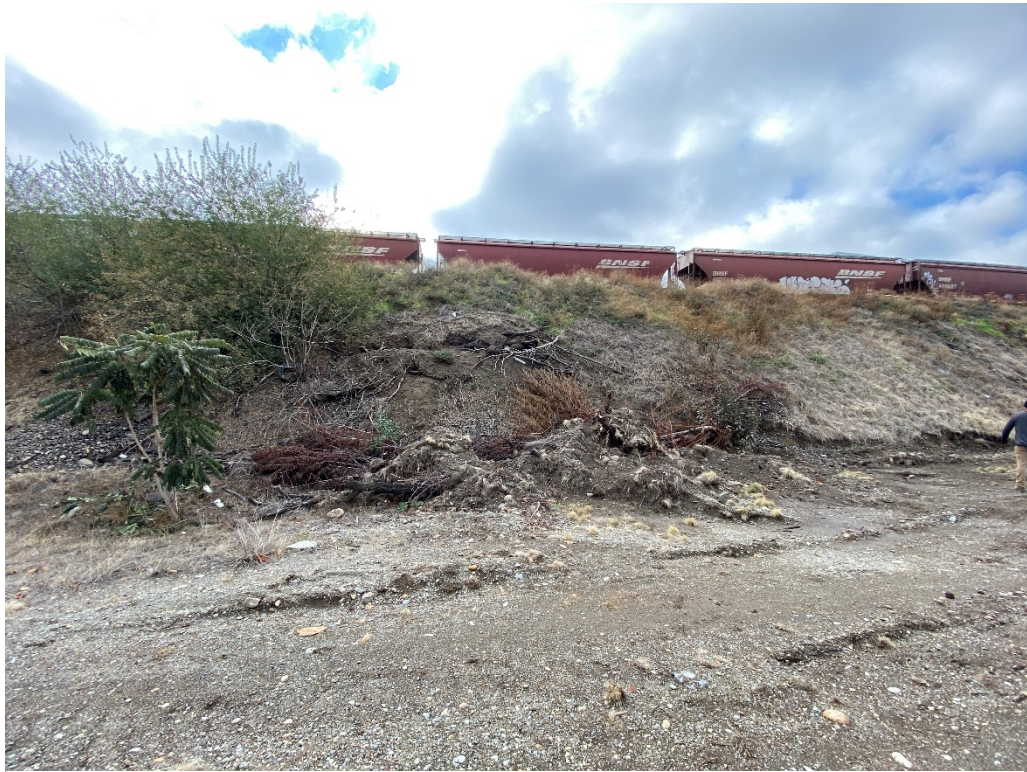
- b. ATC Soil Cap. The ATC soil cap was observed to be in good condition and operating in accordance with the FCAP. A debris pile consisting of trees and dirt was observed near the east end of the ATC soil cap.

1. View of debris pile at the east end of the soil cap on the former ATC property (looking south).

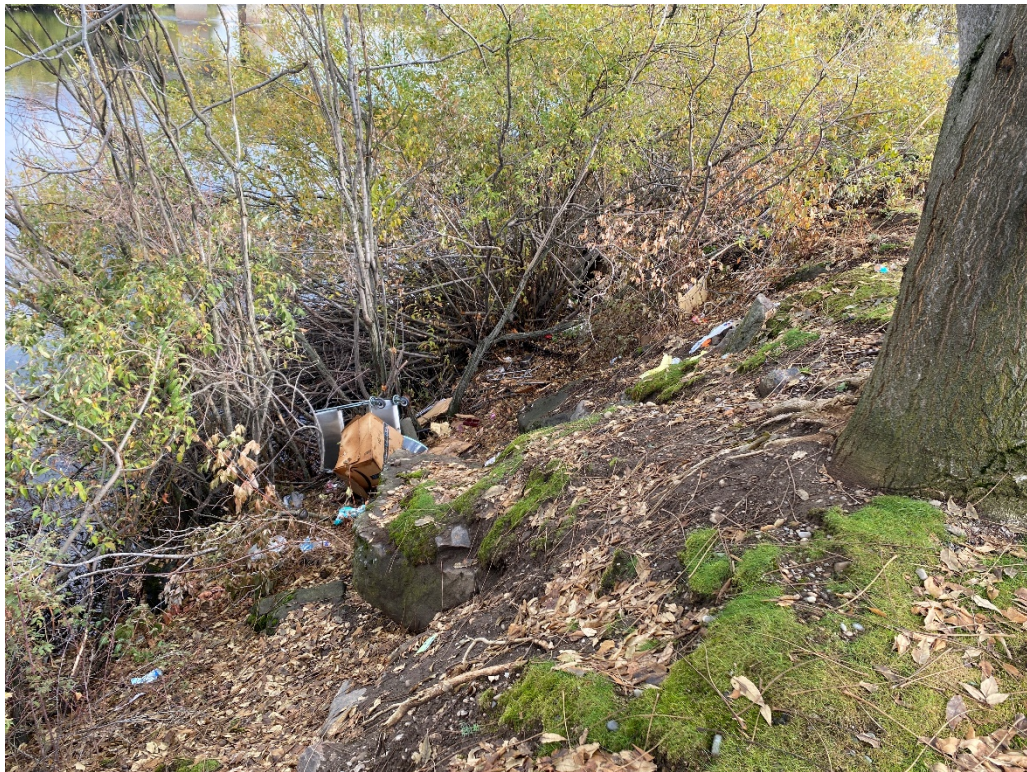
2. View of transient camp and related debris approximately 250 ft west of the James E. Keefe Bridge on the former SGP property (looking northeast).

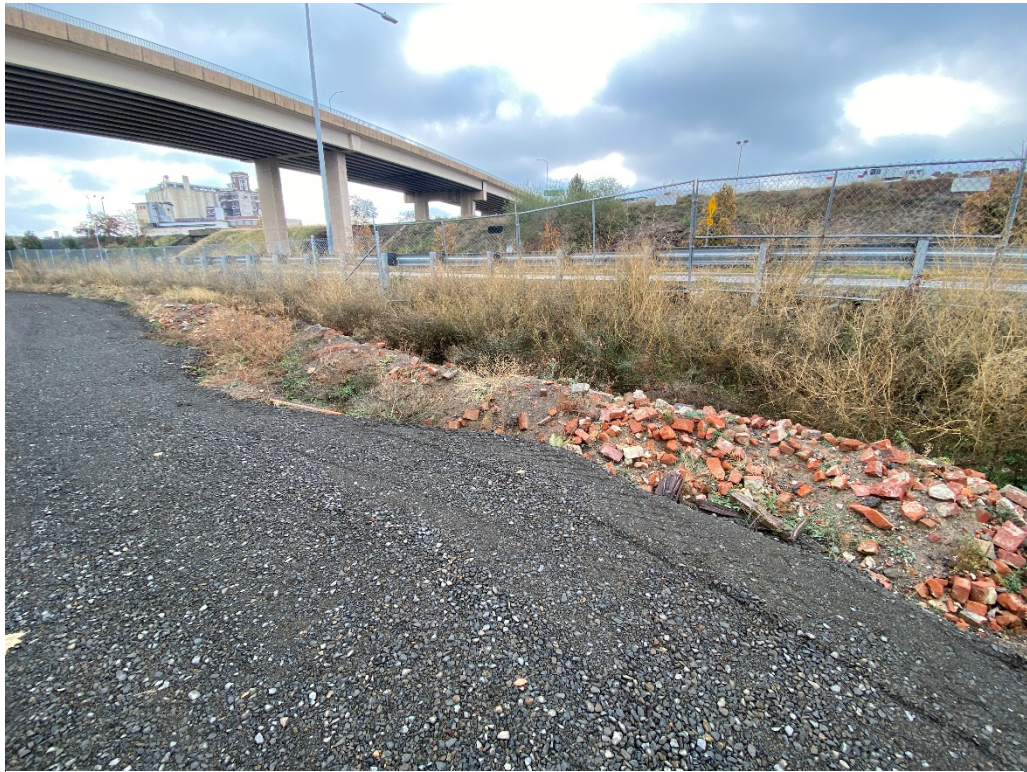
- d. A stockpile containing large boulders was present to the southeast of the new west infiltration gallery.
  - e. An elongated mound containing dirt and site debris (bricks) was present along the southern boundary of the building 2B footprint.

1. View of debris pile including bricks along the southern end of the Building 2B footprint on the former SGP property (looking southeast).

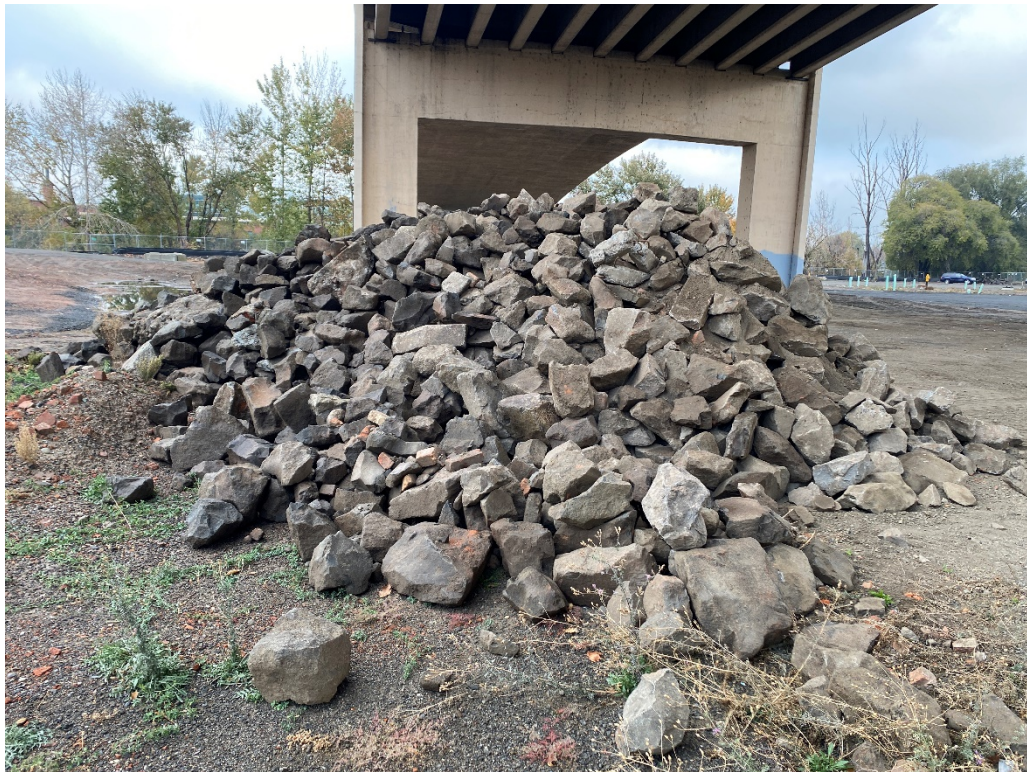
2. View of stockpile underneath the James E. Keefe Bridge toward the south end of the former SGP property (looking north).

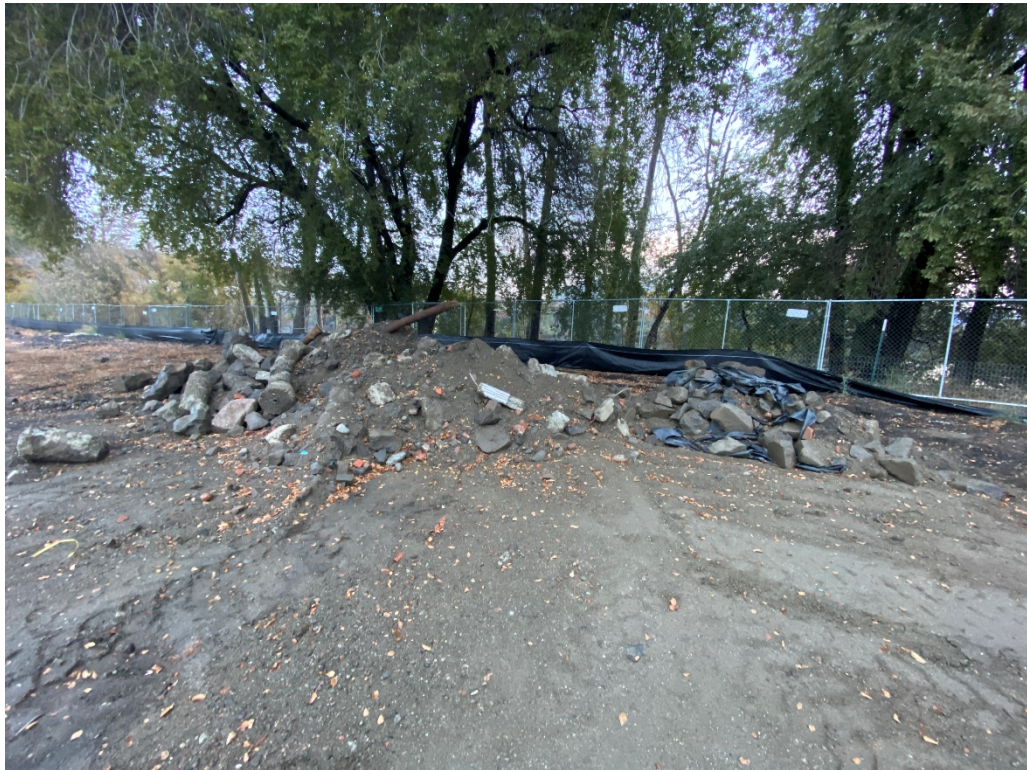
1. View of stockpile to the west of the north detention basin on the former SGP property (looking northwest).

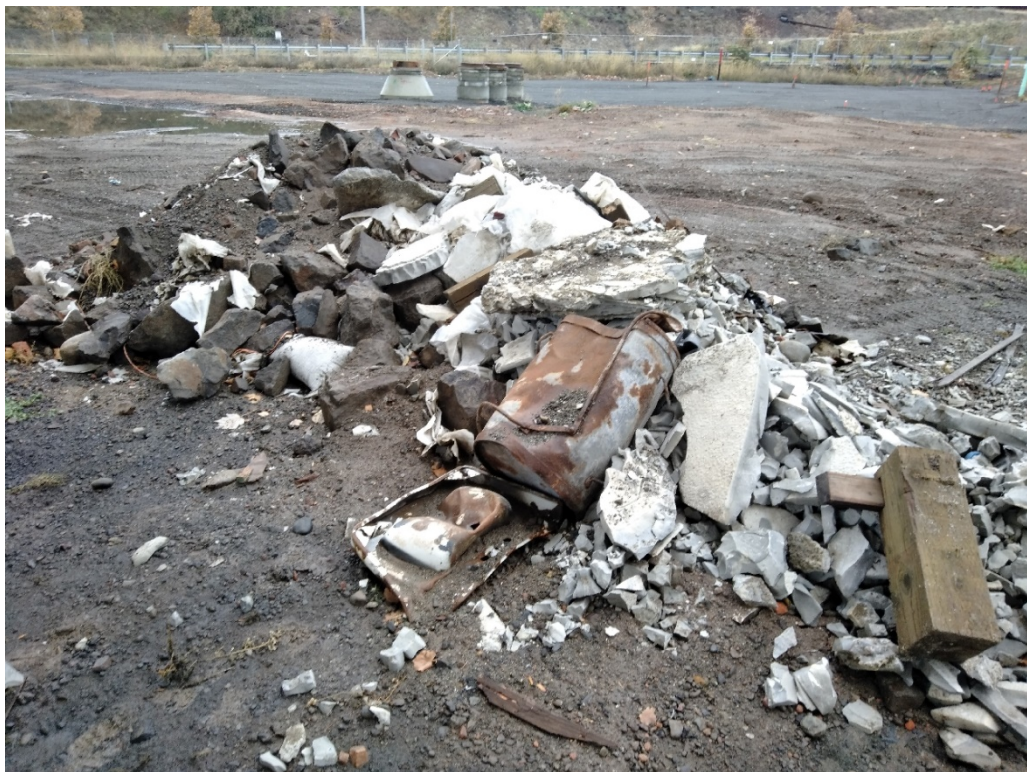
2. View of stockpile adjacent to the James E. Keefe Bridge to the northeast of the Building 2B footprint on the former SGP property (looking southwest).

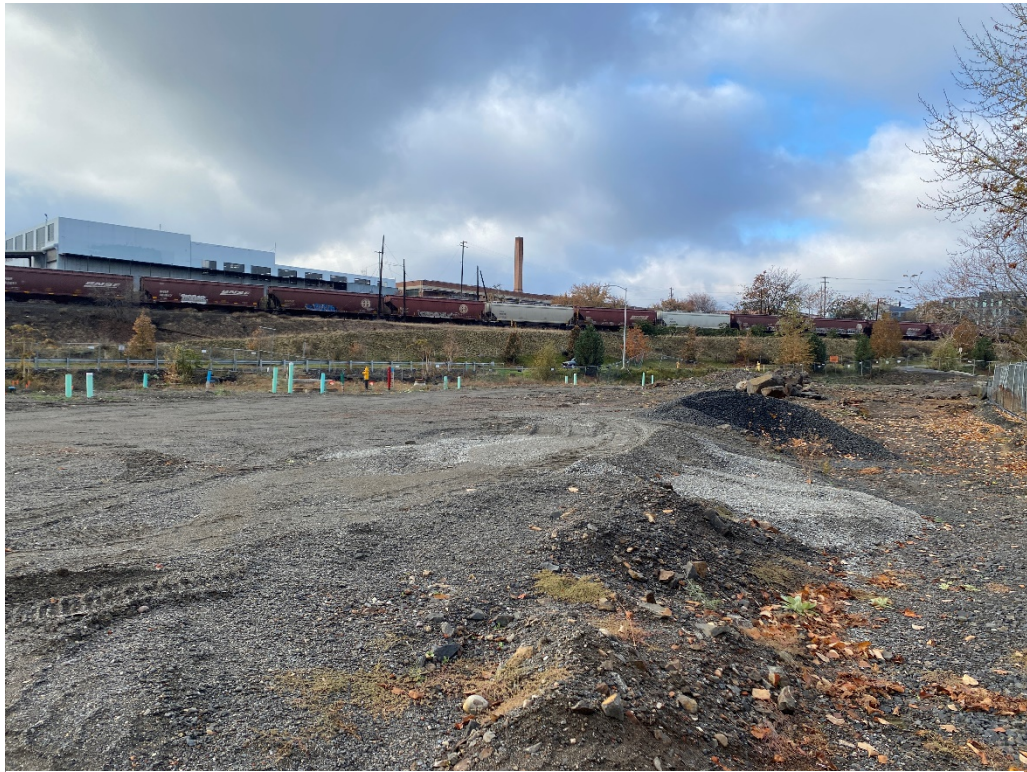
1. View of the elevated area of soil observed in the western portion of the former SGP property (looking southwest).
