## TECHNICAL MEMORANDUM

**RE:** 2023 Annual Operation and Maintenance Site Inspection  
Hamilton Street Bridge Site  
Spokane, Washington  
Project No. 0236042.140

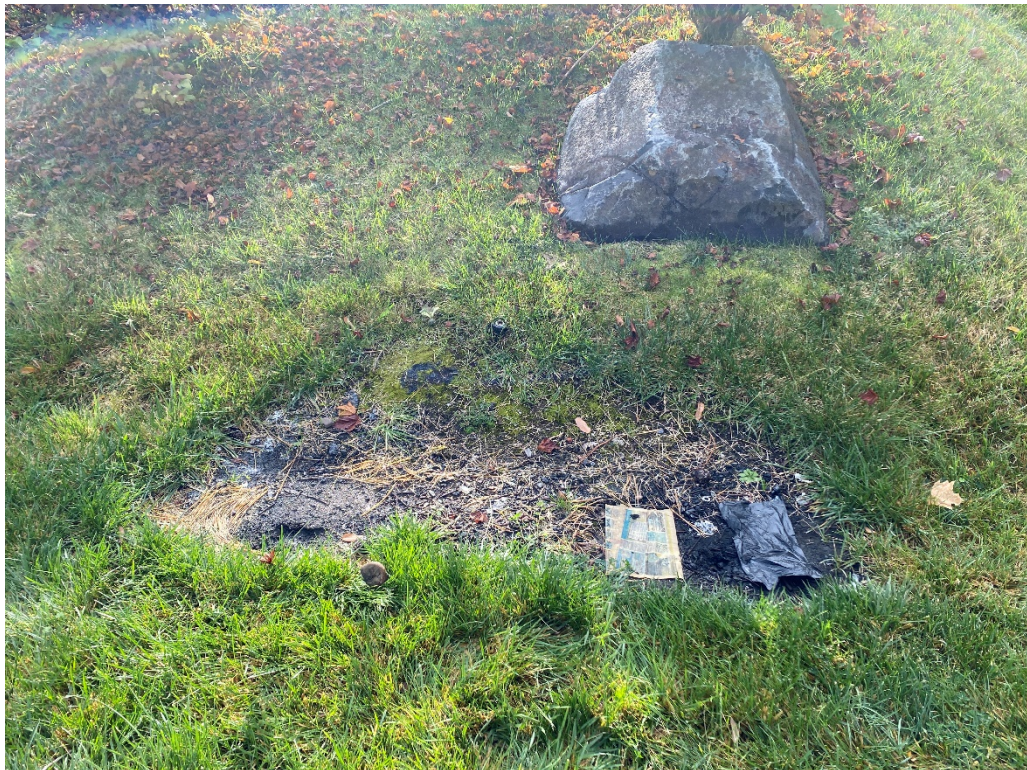
- **Evaporation Pond.** The City's lined evaporation pond contained healthy growing vegetation and appeared to be in good condition, with the exception of an apparent small fire pit near the southwest corner. Overall, the City right-of-way, which included the lined evaporation pond, was observed to be in good condition.
- **West Infiltration Gallery.** The west detention basin was removed as part of Sagamore's redevelopment activities. The west infiltration gallery, located approximately 130 ft west of the former west detention basin, was excavated by Sagamore in 2022 and contains two drywells. It is Landau's understanding that the removal of the west detention basin and excavation of the west infiltration gallery was conducted under CAP Amendment 1. According to Sagamore's Engineering Design Report (Aspect 2021), stormwater collected from buildings on the western

2. View of apparent small fire pit near the southwest corner of the lined evaporation pond on the former ATC property (looking south).
