2023 POST REMEDY INSPECTION REPORT

BNSF Northport Site

December 20, 2023

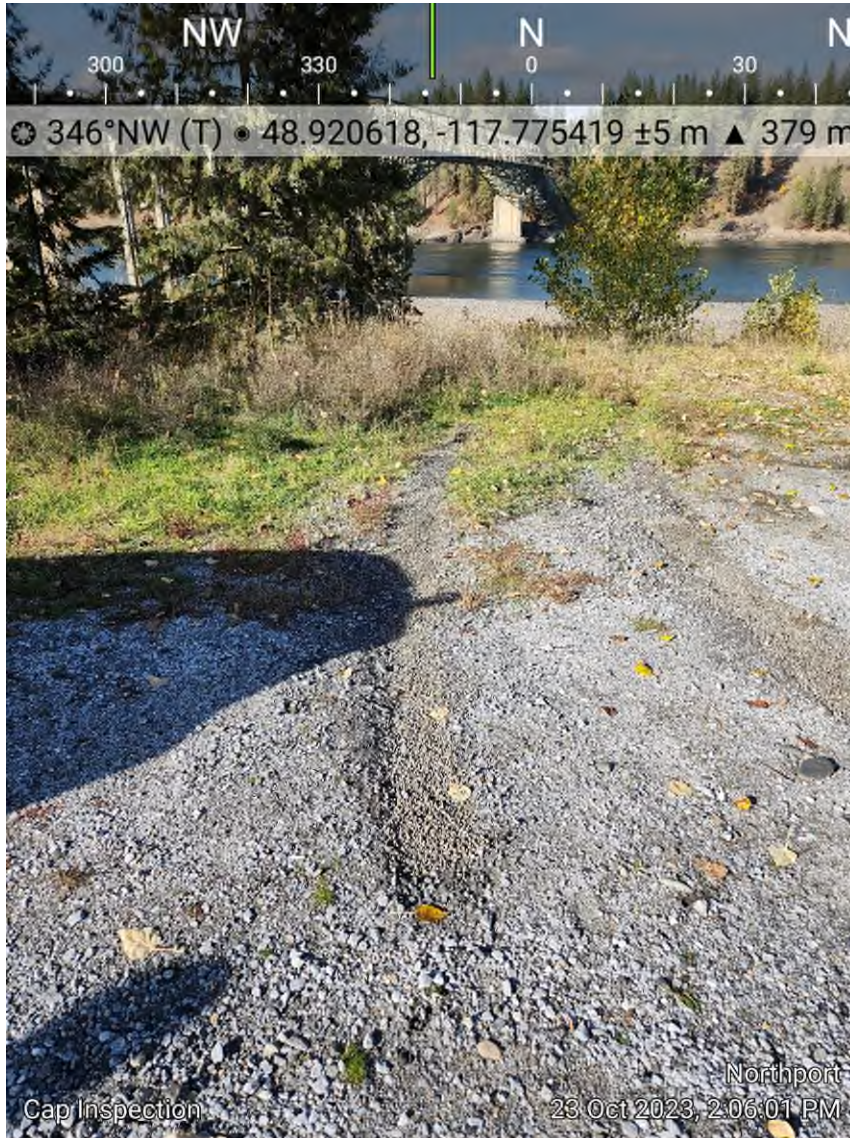
Inspection Point: 001

- Gravel disturbance from vehicle tires on the north portion of remedied area (Inspection Point: 001 in Appendix A).
- Possible animal burrows in remedied areas on north side of the tracks in the park (Inspection Point: 002 in Appendix A).
- Gravel disturbance from possible animal burrows on north edge of track between parking lot and tracks (Inspection Point: 003 in Appendix A).
- Erosion of topsoil on slope observed on north end of city park adjacent to south edge of tracks (Inspection Point: 004 in Appendix A).

Description:
Gravel disturbance from vehicle on west portion of remedied area.

The gravel disturbances identified during the site inspection were addressed through the application of additional gravel cover. Erosional features could develop from the multiple burrows observed on the south end of the city park adjacent to the track and fence. The next post remedy inspection will occur in the second half of 2024.

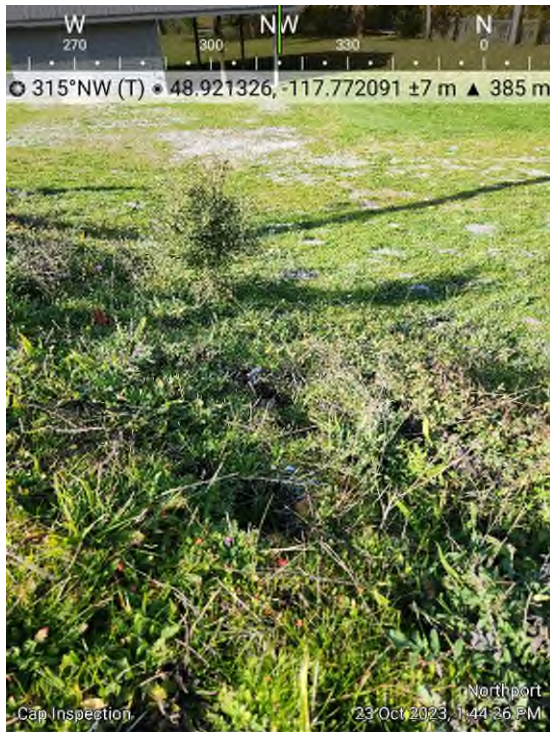
Inspection Point: 002

Possible animal burrows present on north side of track in park area.

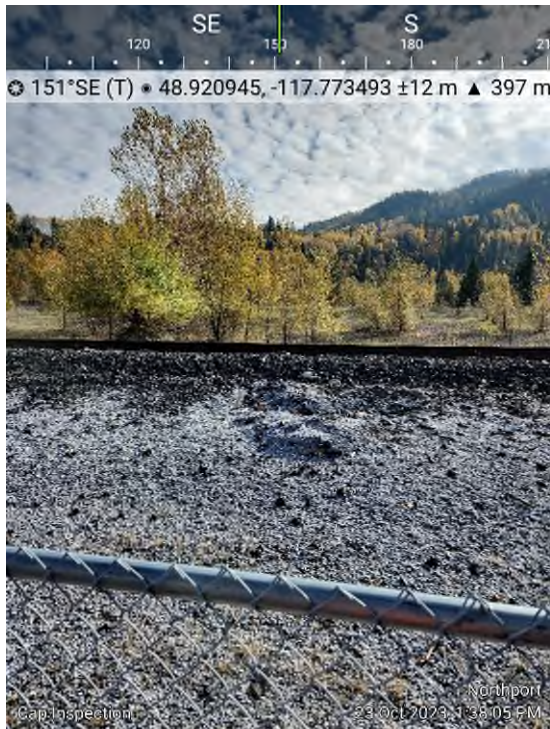
Inspection Point: 003

Gravel disturbance from possible animal burrows on north edge of track between parking lot and tracks.

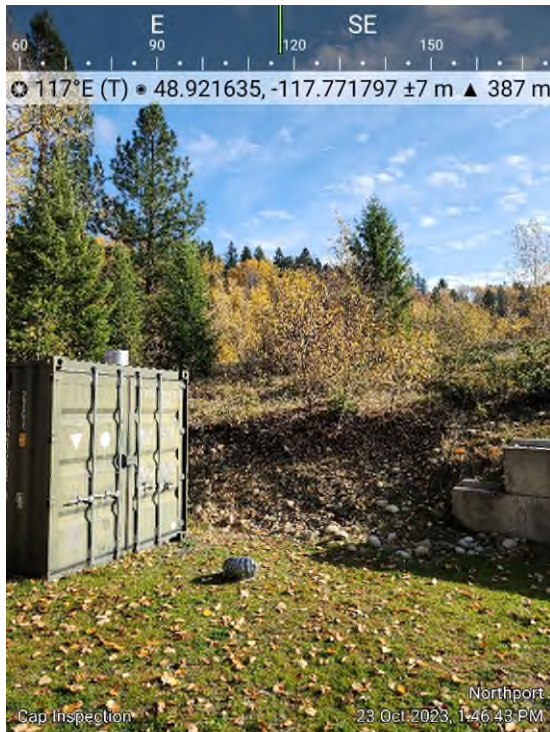
Inspection Point: 004

Description:
Erosion present along north side of tracks.

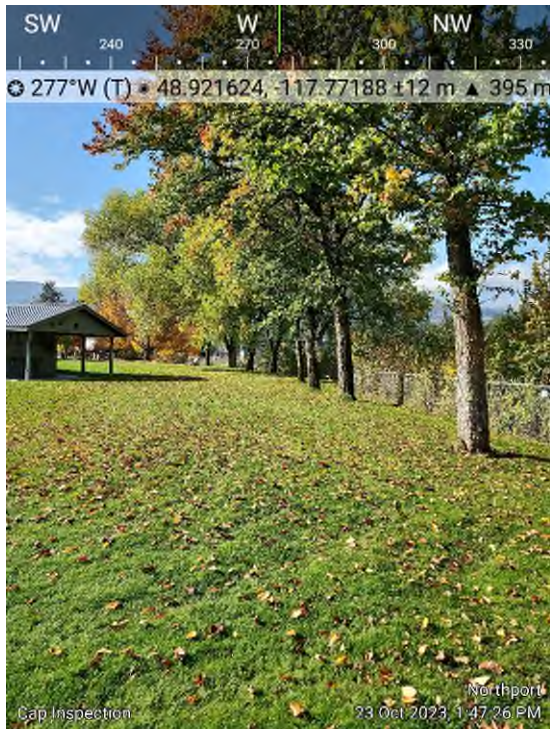
Inspection Point: 005

Trees located in areas that were not remediated appeared in good health and overlaying sod and soil in those areas were also observed to be in good condition (Inspection Point: 006 in Appendix A)

Description:
Large trees present in city park over within the area not remediated.

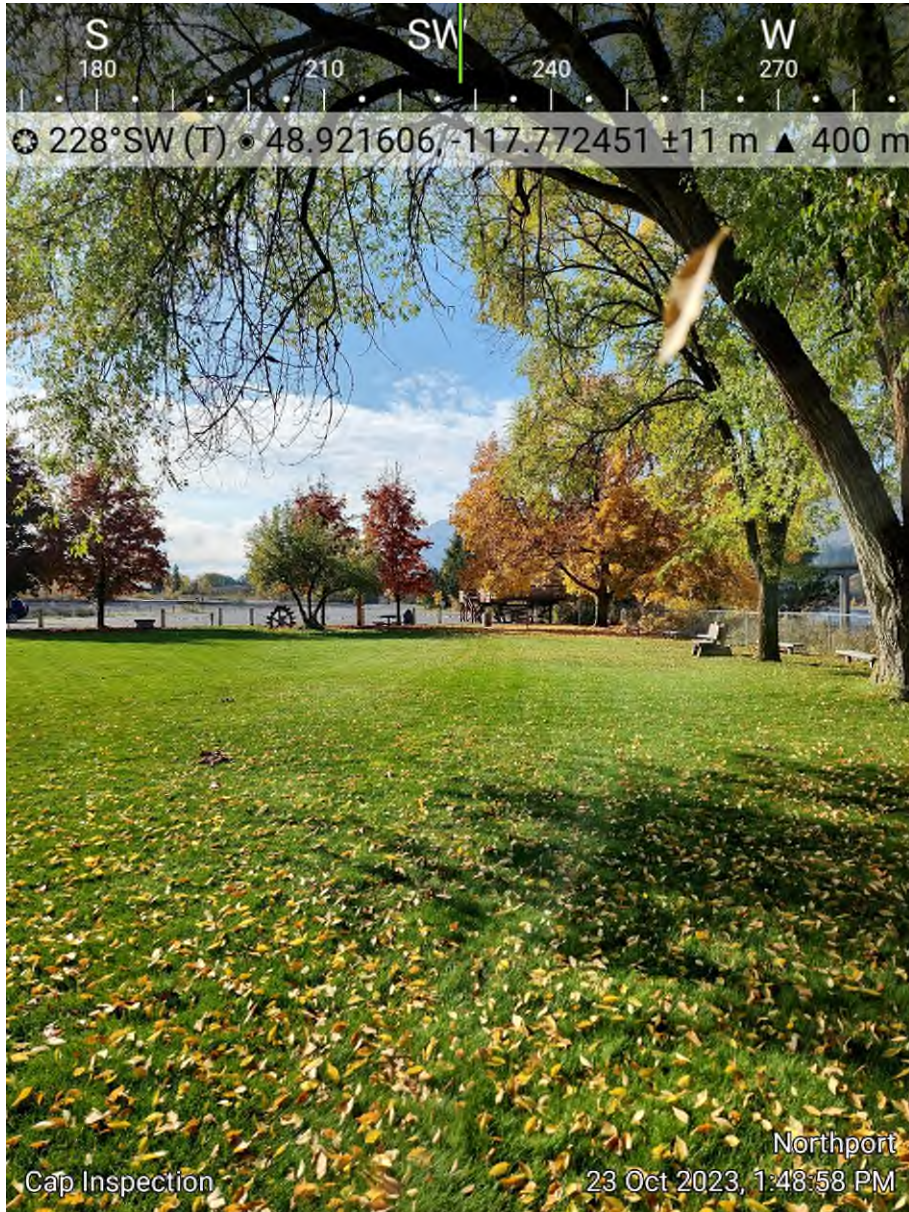
Inspection Point: 006

Description:
Sod condition in city park.

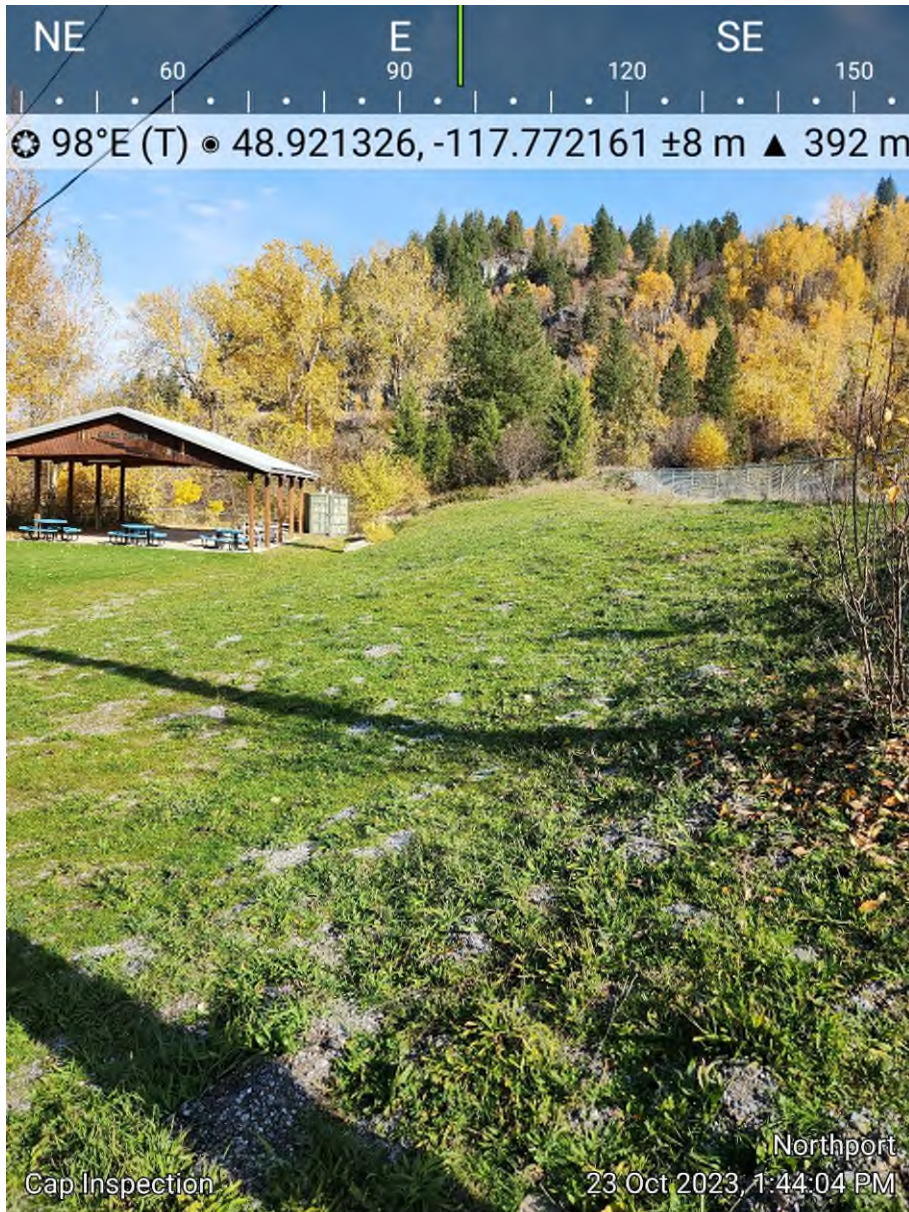
Inspection Point: 007

No damage was observed to the fence on the south side of the parking area, separating the city park parking lot from the BNSF tracks (Inspection point: 006, 007, and 008 in Appendix A)

Possible animal burrows present on north side of track in park area. Fence condition on south end of the city park.

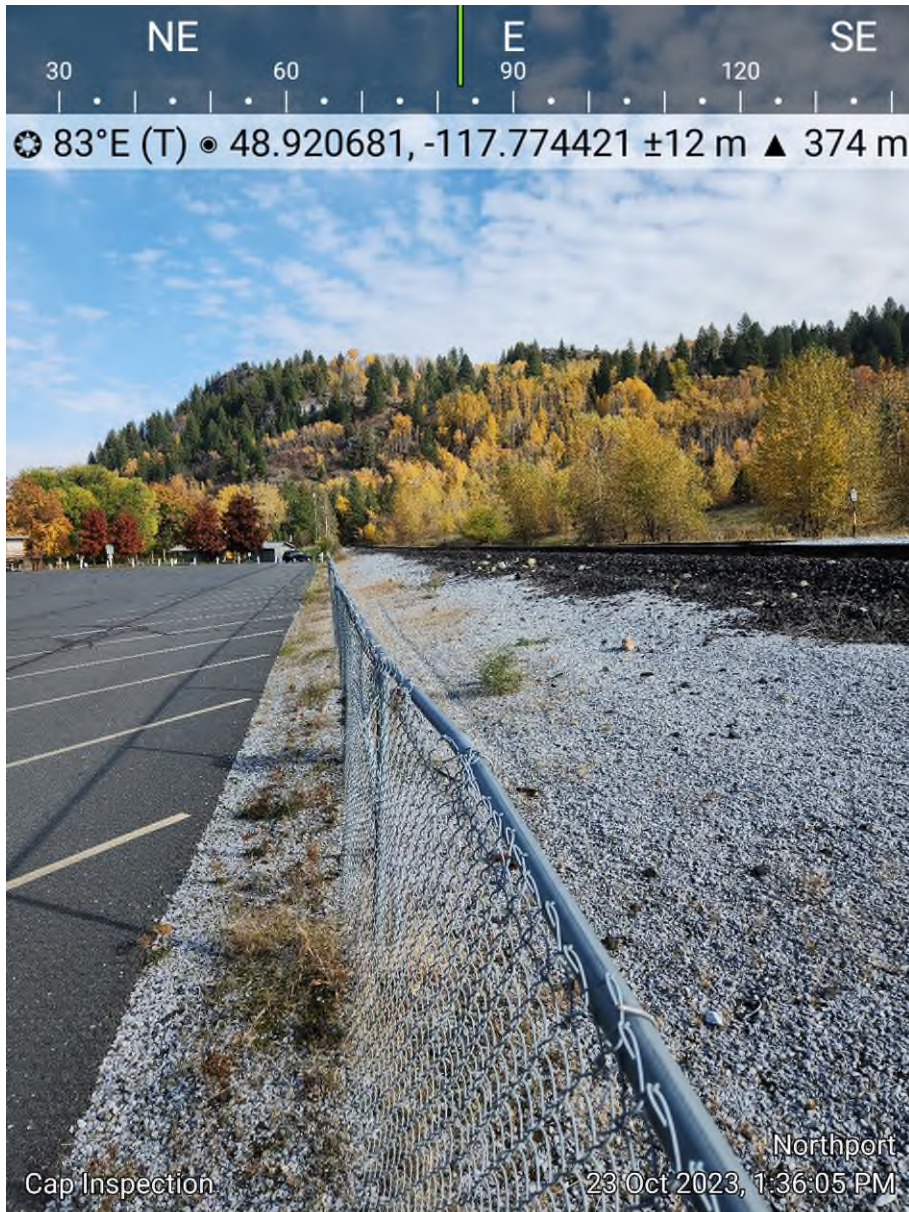
Inspection Point: 008

Fence condition on the south edge of city park parking lot
