Upland Structural Inspection Report

Harris Avenue Shipyard - Upland Area Condition Assessment Report

**Port of Bellingham
Harris Avenue Shipyard**

February 2023

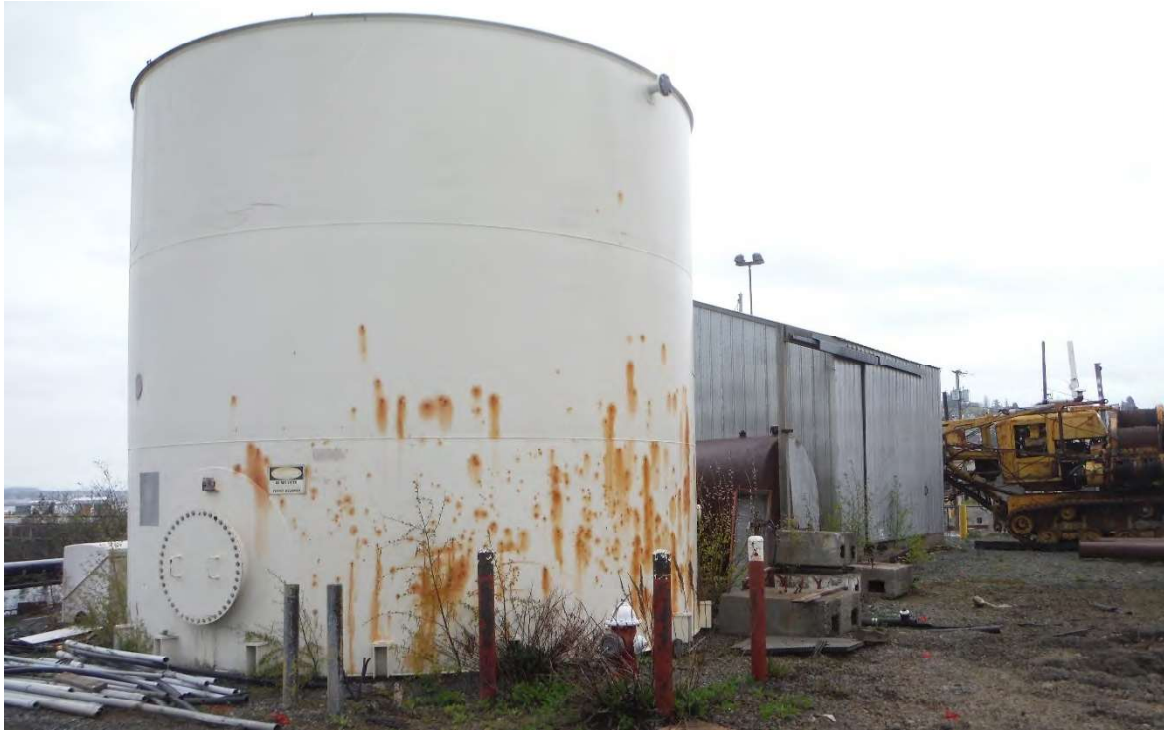
Photo 1 – Stormwater Tank 1

Tank 1 is in **fair** condition. Paint has worn in locations and minor corrosion stains were observed throughout the outer surface of the tank. See photo 1 in appendix A.

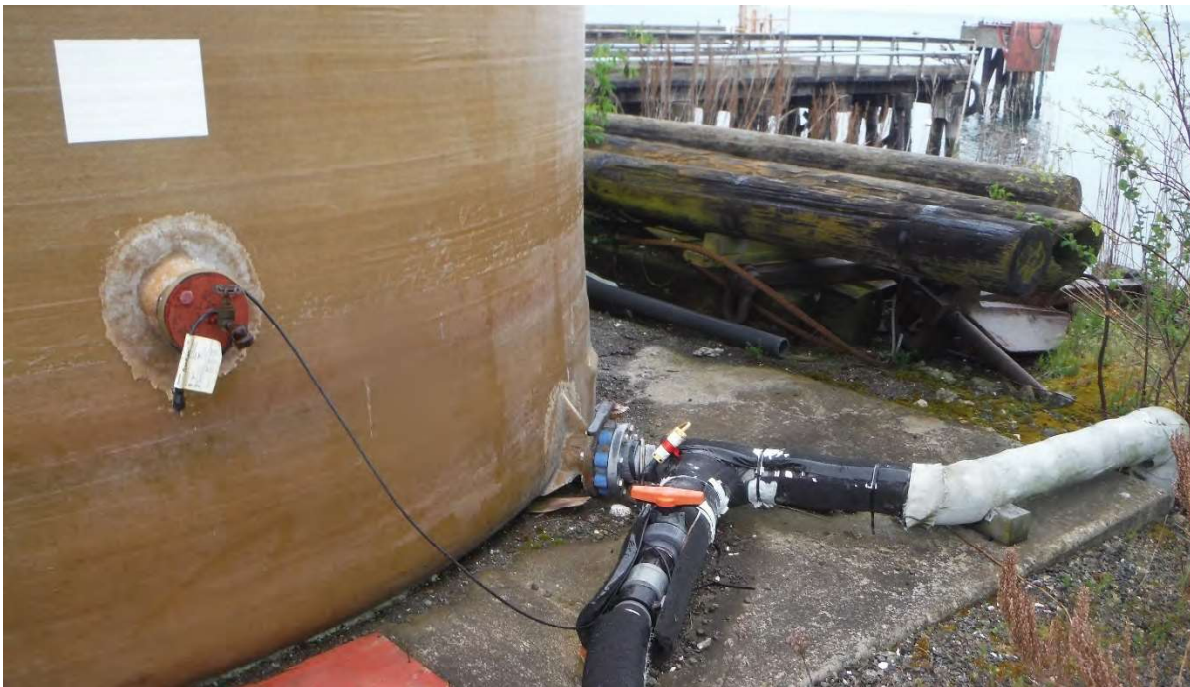
Photo 2 – Stormwater Tank 2 and Foundation

Tank 2 and 3 are in **fair** condition. Minor corrosion was observed bleeding through exterior fiberglass coating on the exterior of the tank. Minor cracks were observed throughout the concrete foundation slab around the tank. See photos 2 and 3 in appendix A

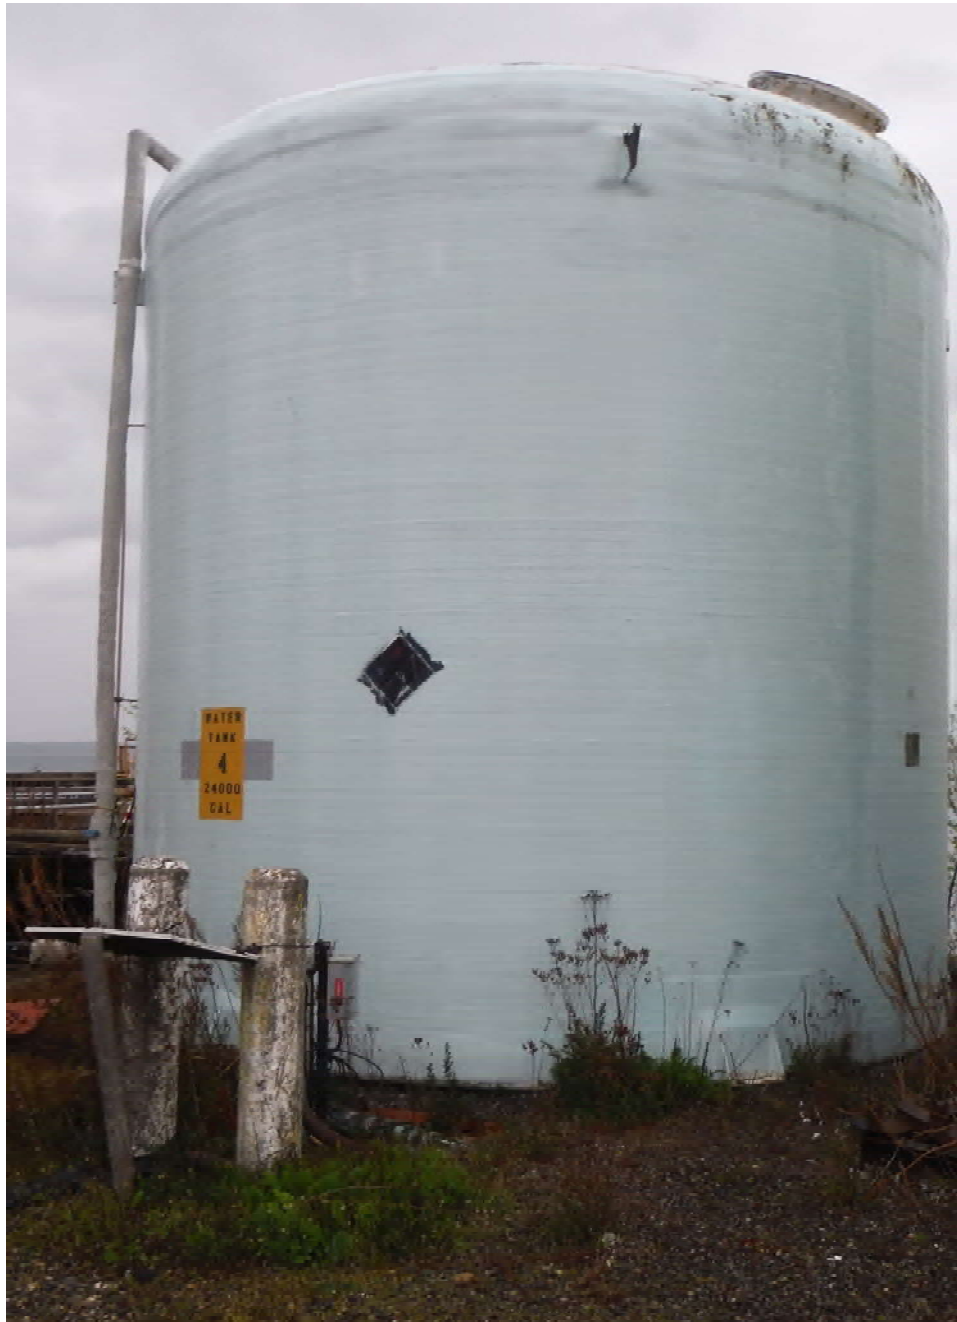
Photo 4 – Stormwater Tank 4

Tank 4 is in **fair** condition. A tear in the fiberglass protective layer was noted on the exterior of the tank. The tank was not supported by or fastened to a concrete foundation. See photo 4 in appendix A

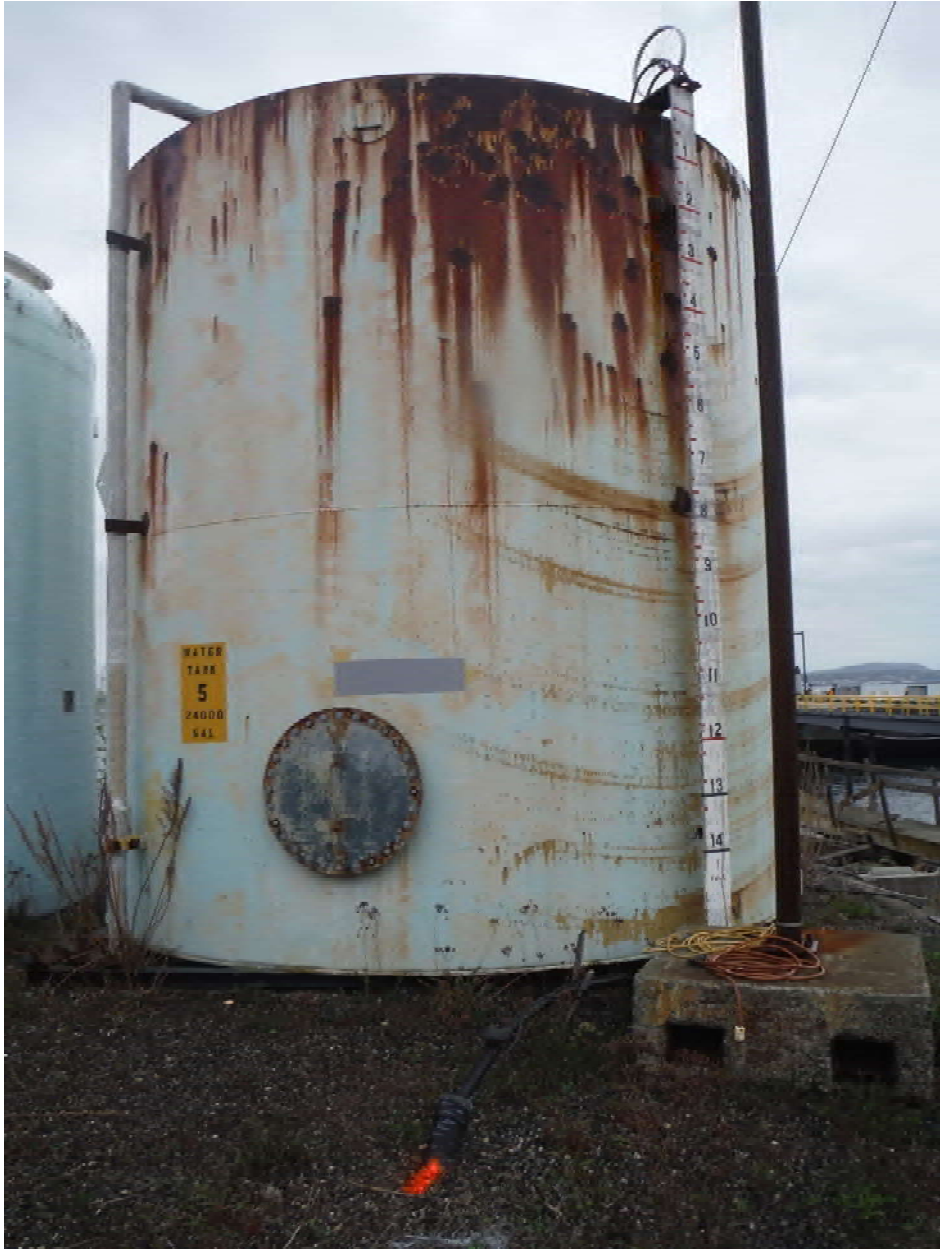
Photo 5 – Stormwater Tank 5

Tank 5 is in **fair** condition. A significant amount of corrosion stains was observed on the tank's outer surface but no substantial pitting or section loss was observed. The tank is supported by steel beams elevating the tank 6-inches above ground level. See photo 5 in Appendix A

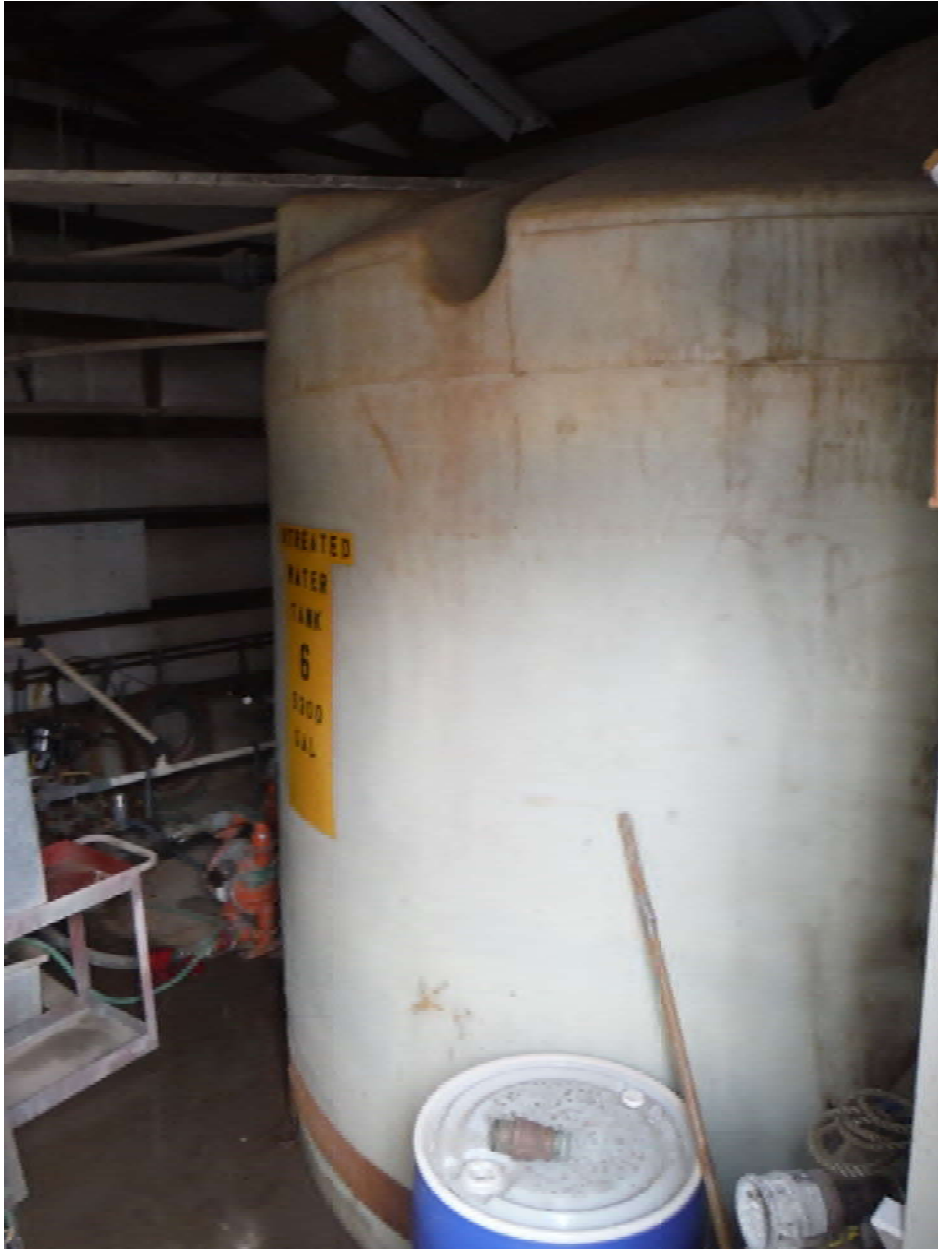
Photo 6 – Stormwater Tank 6

Tank 6 is in **fair** condition. No defects were noted on the plastic tank. See photo 6 in Appendix A.

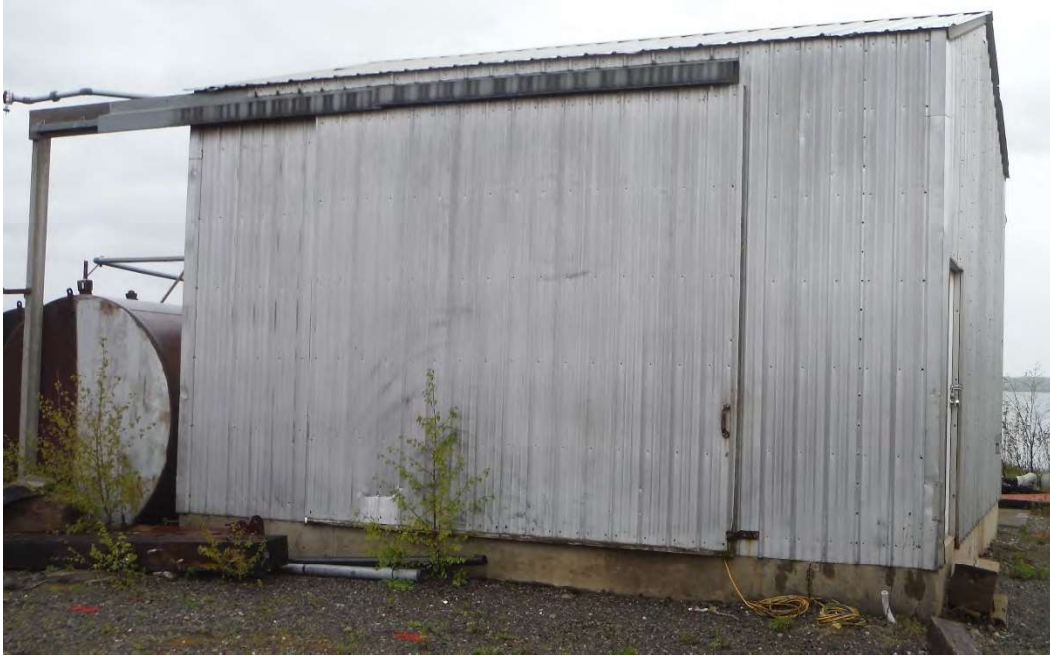
Photo 7 – Water Treatment Building Exterior

The Water Treatment Building is in fair condition. Some corrosion stains were observed on the building's exterior walls as well as mechanical damage such as dents scuffs and dings to siding. Some water had collected on the floor, inside the building. Minor tears to the plastic sheathing on the interior side of walls and roof exposed insulation in few locations. No visual defects in the of the building's interior framing were observed. See photos 7 and 8 in Appendix A

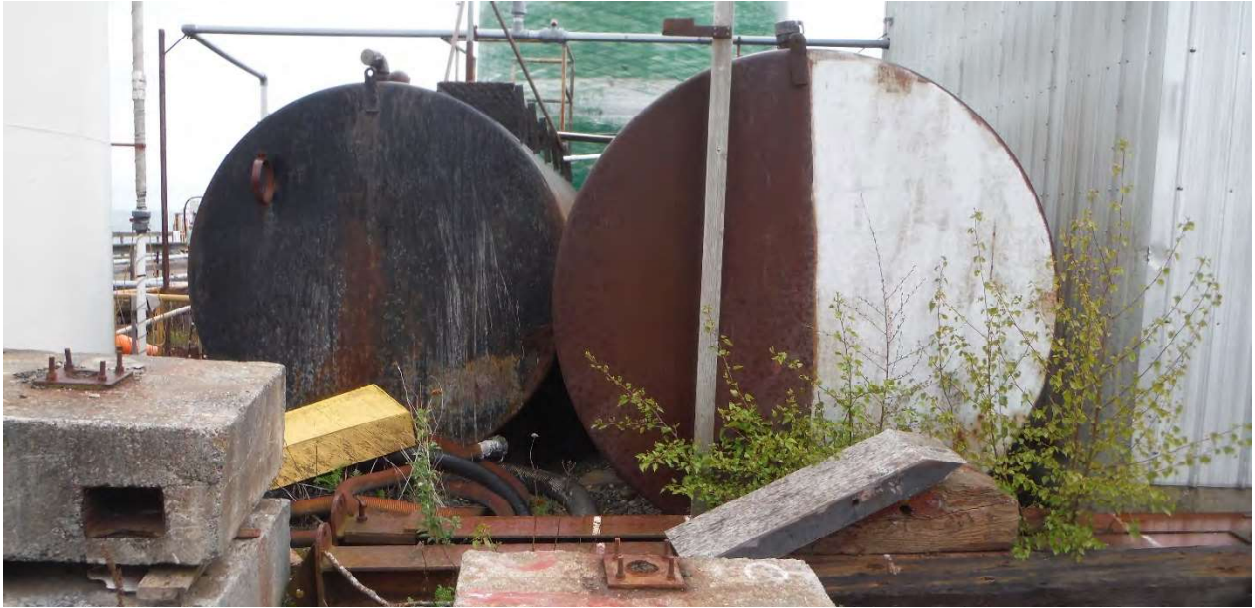
Photo 9 – Stormwater Tanks 7 and 8

Tank 7 and 8 is in **fair** condition. Minor corrosion stains were observed on the tank. See photo 9 in Appendix A

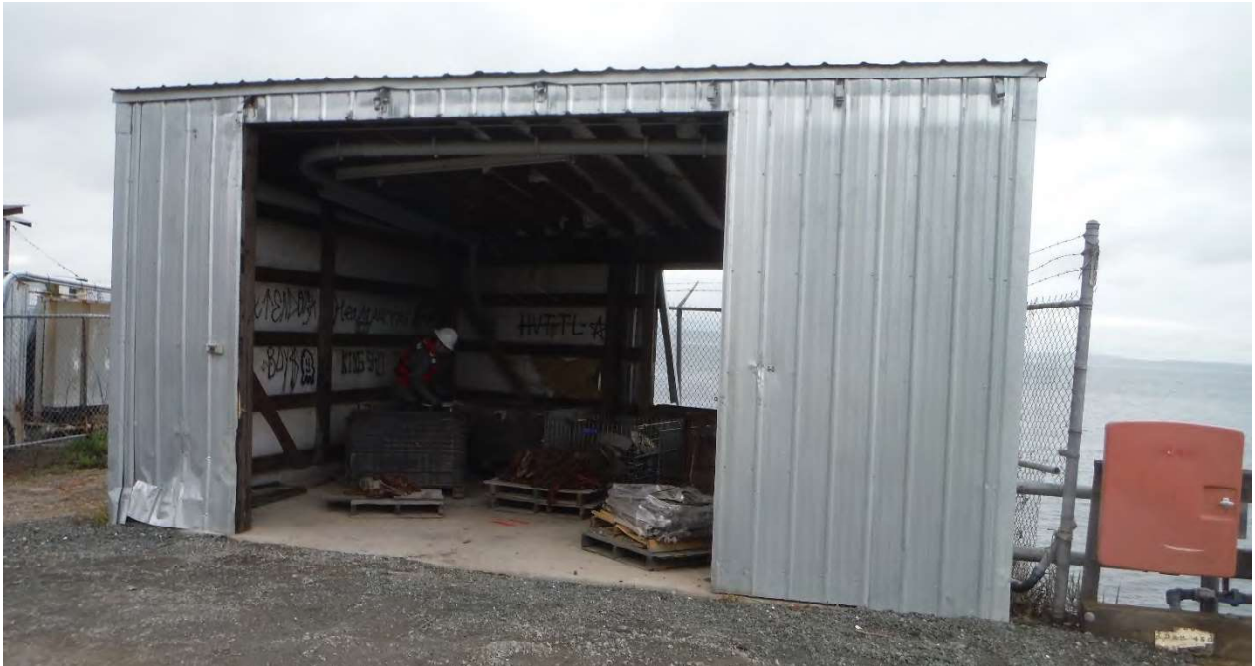
Photo 10 – Paint Building

The Paint Building is in **fair** condition. The steel roofing siding and timber walls are in good condition except for the southeast corner of the structure where damage was observed to the siding and column adjacent to the doorway/entrance. Hardware above the doorway entrance suggests a sliding door, similar to the Water treatment building, was once present. Tears in the plastic sheathing on the interior side of walls and roof exposed insulation in multiple locations. Minor cracking was present in the concrete slab foundation. See photo 10 in Appendix A

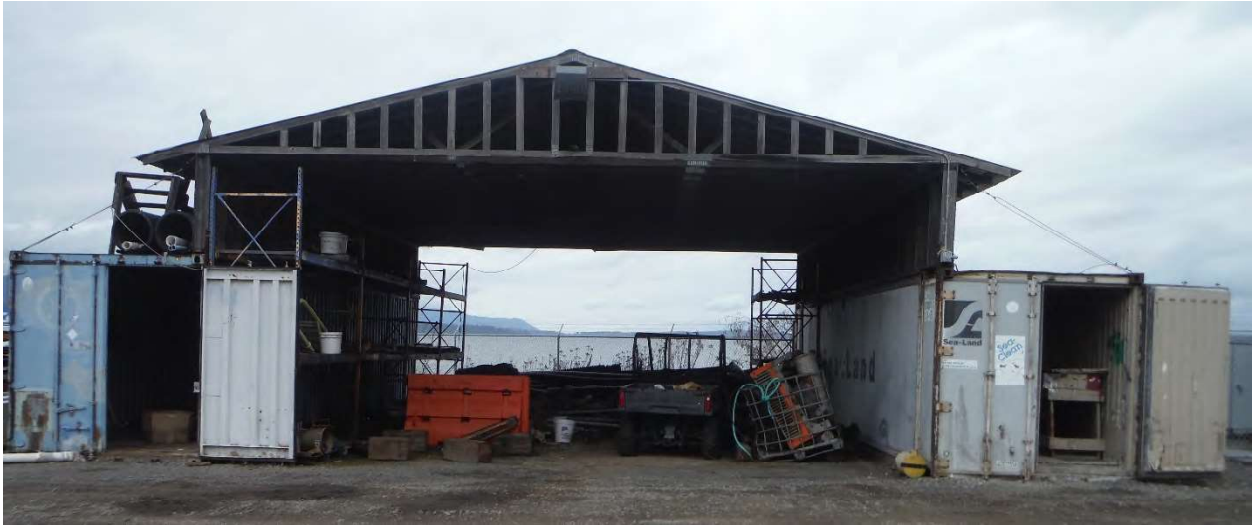
Photo 11 – Conex Building

The Conex Shed structure is in **fair** condition. Only minor defects were noted on timber truss framing elements. See photo 11 in Appendix A

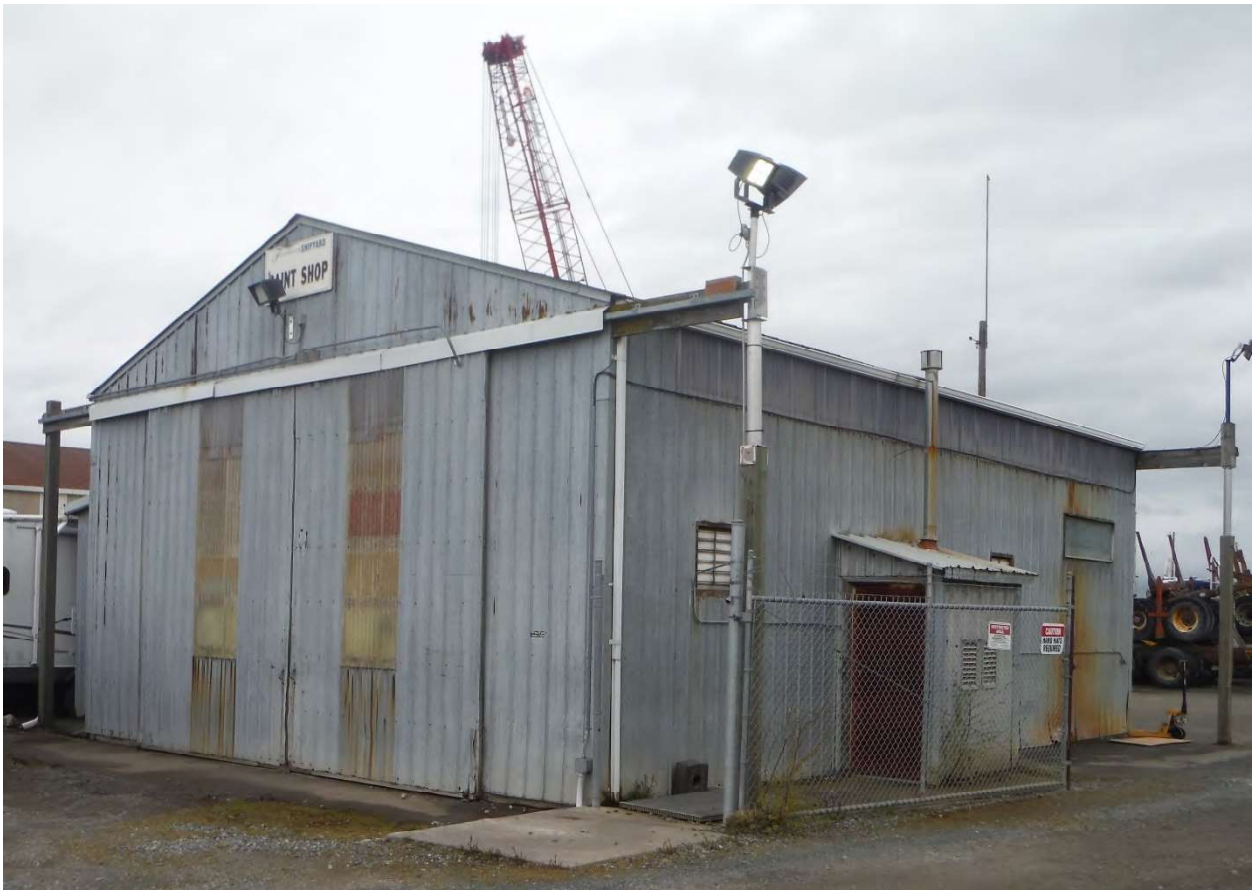
Photo 12 – Paint Shop

From the exterior, the Paint Shop is in **fair** condition. The steel walls have minor/moderate corrosion and minor dents. Minor defects were observed in the concrete slab adjacent to the building. The interior of this building was inspected as part of this scope. See photo 12 in Appendix A

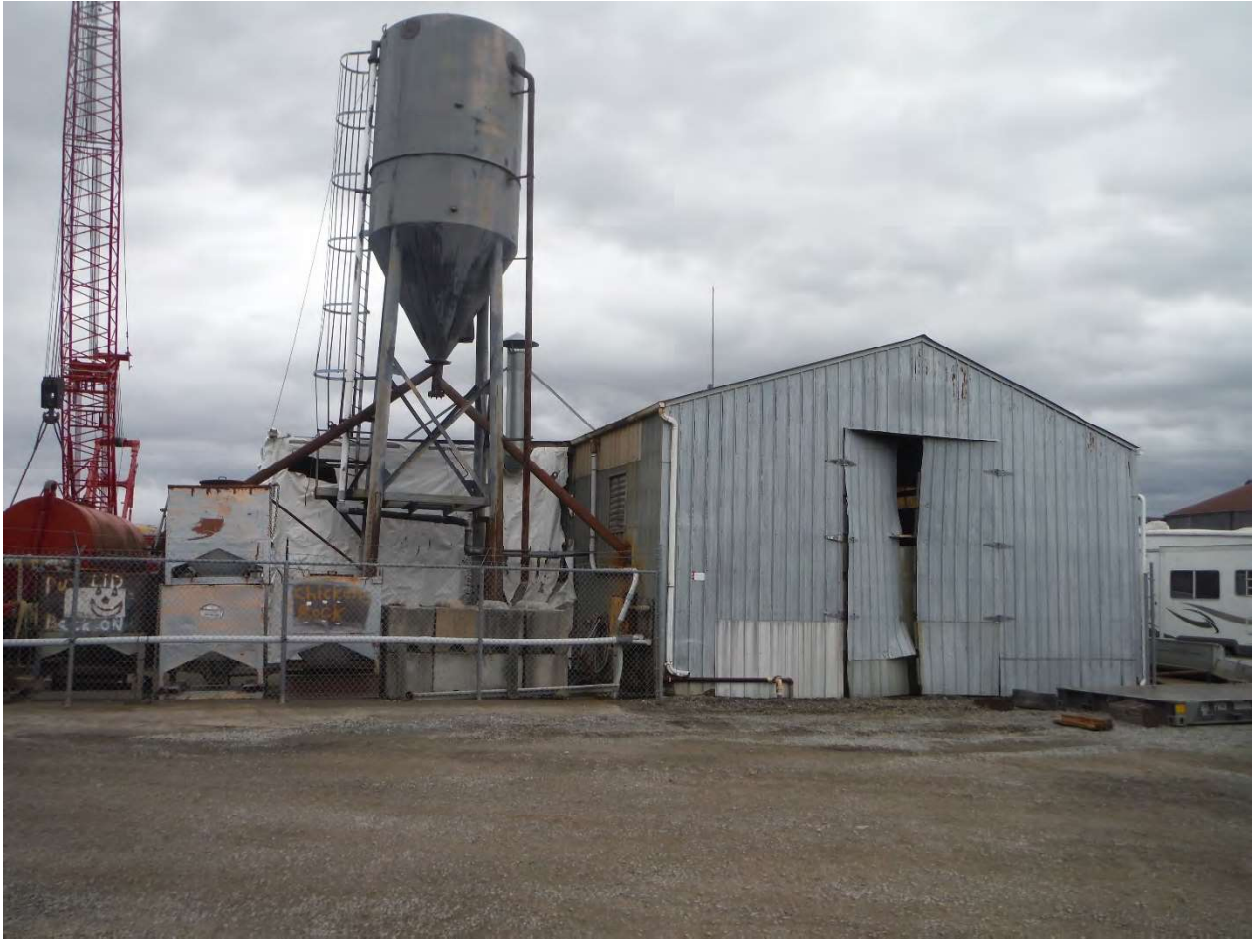
Photo 13 – Sandblast Shed

From the exterior, the Sandblast Shed is in **fair** condition. The steel walls have minor/moderate corrosion and minor dents. Minor defects were observed in the concrete slabs adjacent to the building. The door to the structure on the south side had a large dent. The interior of this building was inspected as part of this scope. See photo 13 in Appendix A
