**REPORT ON  
CUSTOM PLYWOOD MILL SITE  
PHASE III SUBTIDAL SEDIMENT CLEANUP  
CONSTRUCTION COMPLETION REPORT  
CLEANUP SITE IDENTIFICATION NO. 4533  
FIDALGO BAY  
ANACORTES, WASHINGTON**

by  
Haley & Aldrich, Inc.  
Seattle, Washington

for  
Washington State Department of Ecology  
Olympia, Washington

File No. 0202972-000 (19600-00)  
12 January 2024

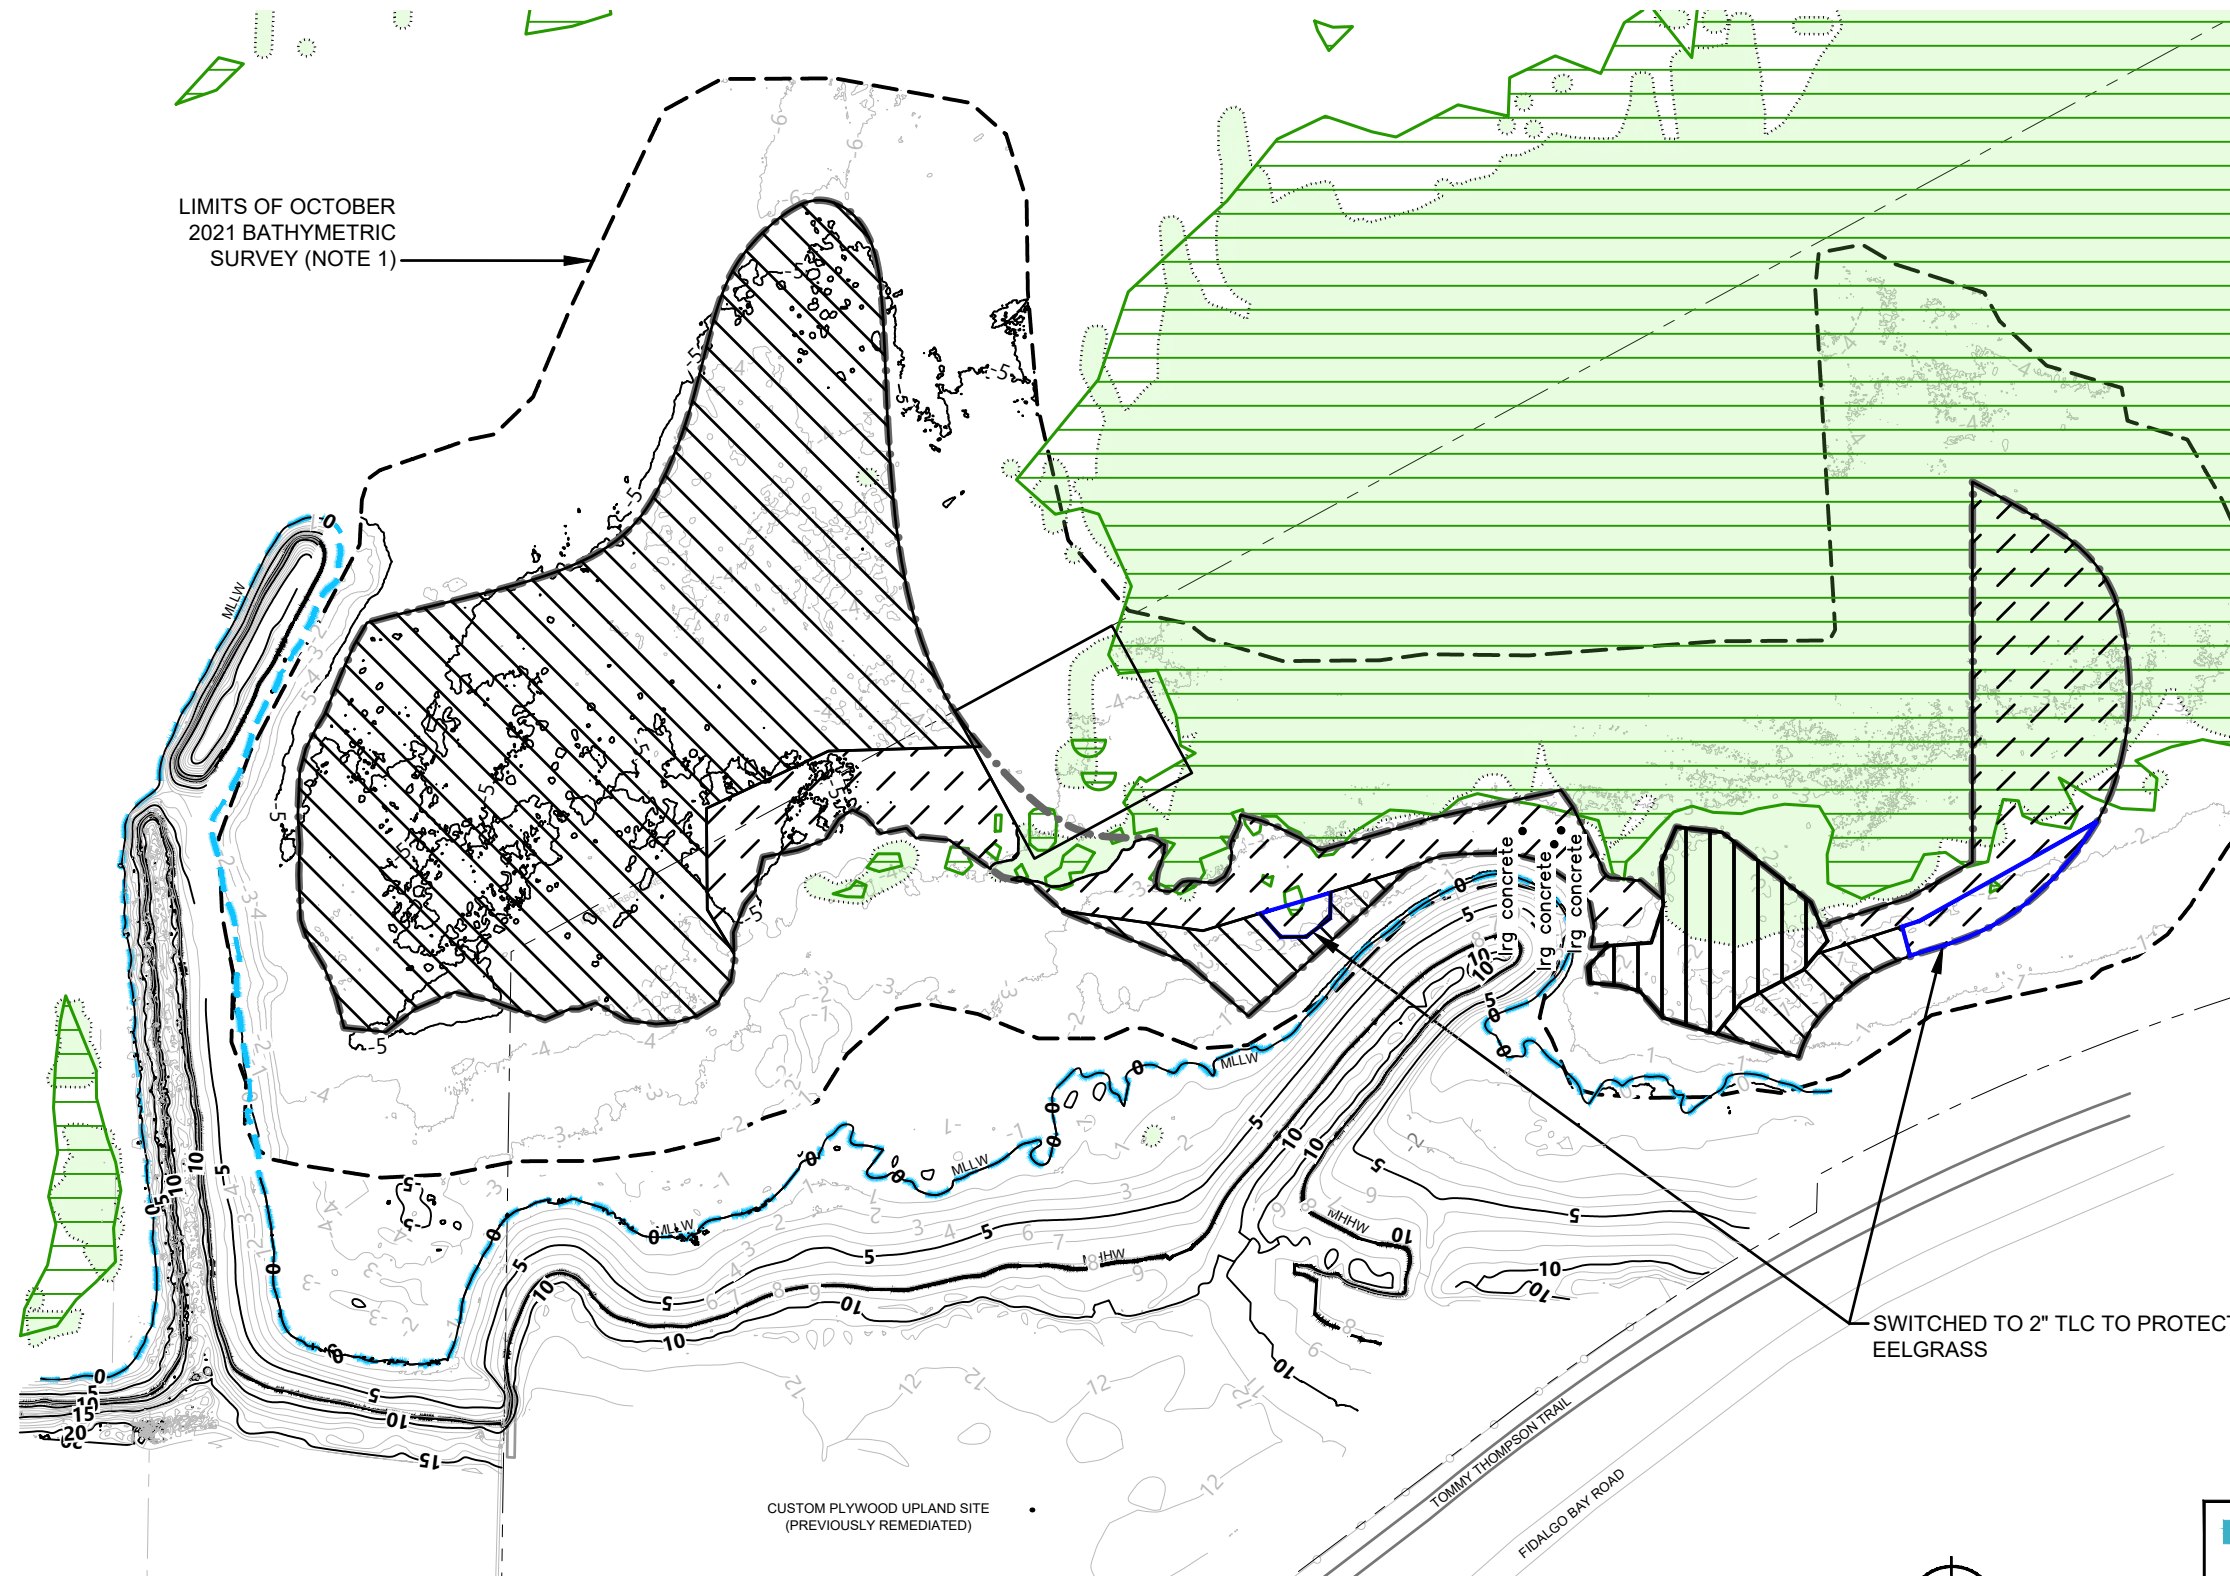
**FIGURE 5**

Approximately 4.4 acres of subtidal sediment (located outside the eelgrass areas) was planned to be capped with 8 inches of clean sand. This included areas of sediment which exceed the 10 ppt TEQ dioxin action level. Based on changing conditions, the 8-inch capped area ended up covering roughly 4.3 acres (6,124 CY), as shown on Figure 5.

Approximately 1.1 acres of transition zone subtidal sediment (located adjacent to eelgrass beds) was to be placed to avoid the occurrence of slumping/redistribution of capping layers into the nearby eelgrass area. This transition zone was planned to be capped with 2 inches of clean sand. Based on changing conditions, the 2-inch capped area ended up covering roughly 1.7 acres (424 CY including transition and eelgrass areas), as shown on Figure 5.

SWITCHED TO 2" TLC TO PROTECT EELGRASS

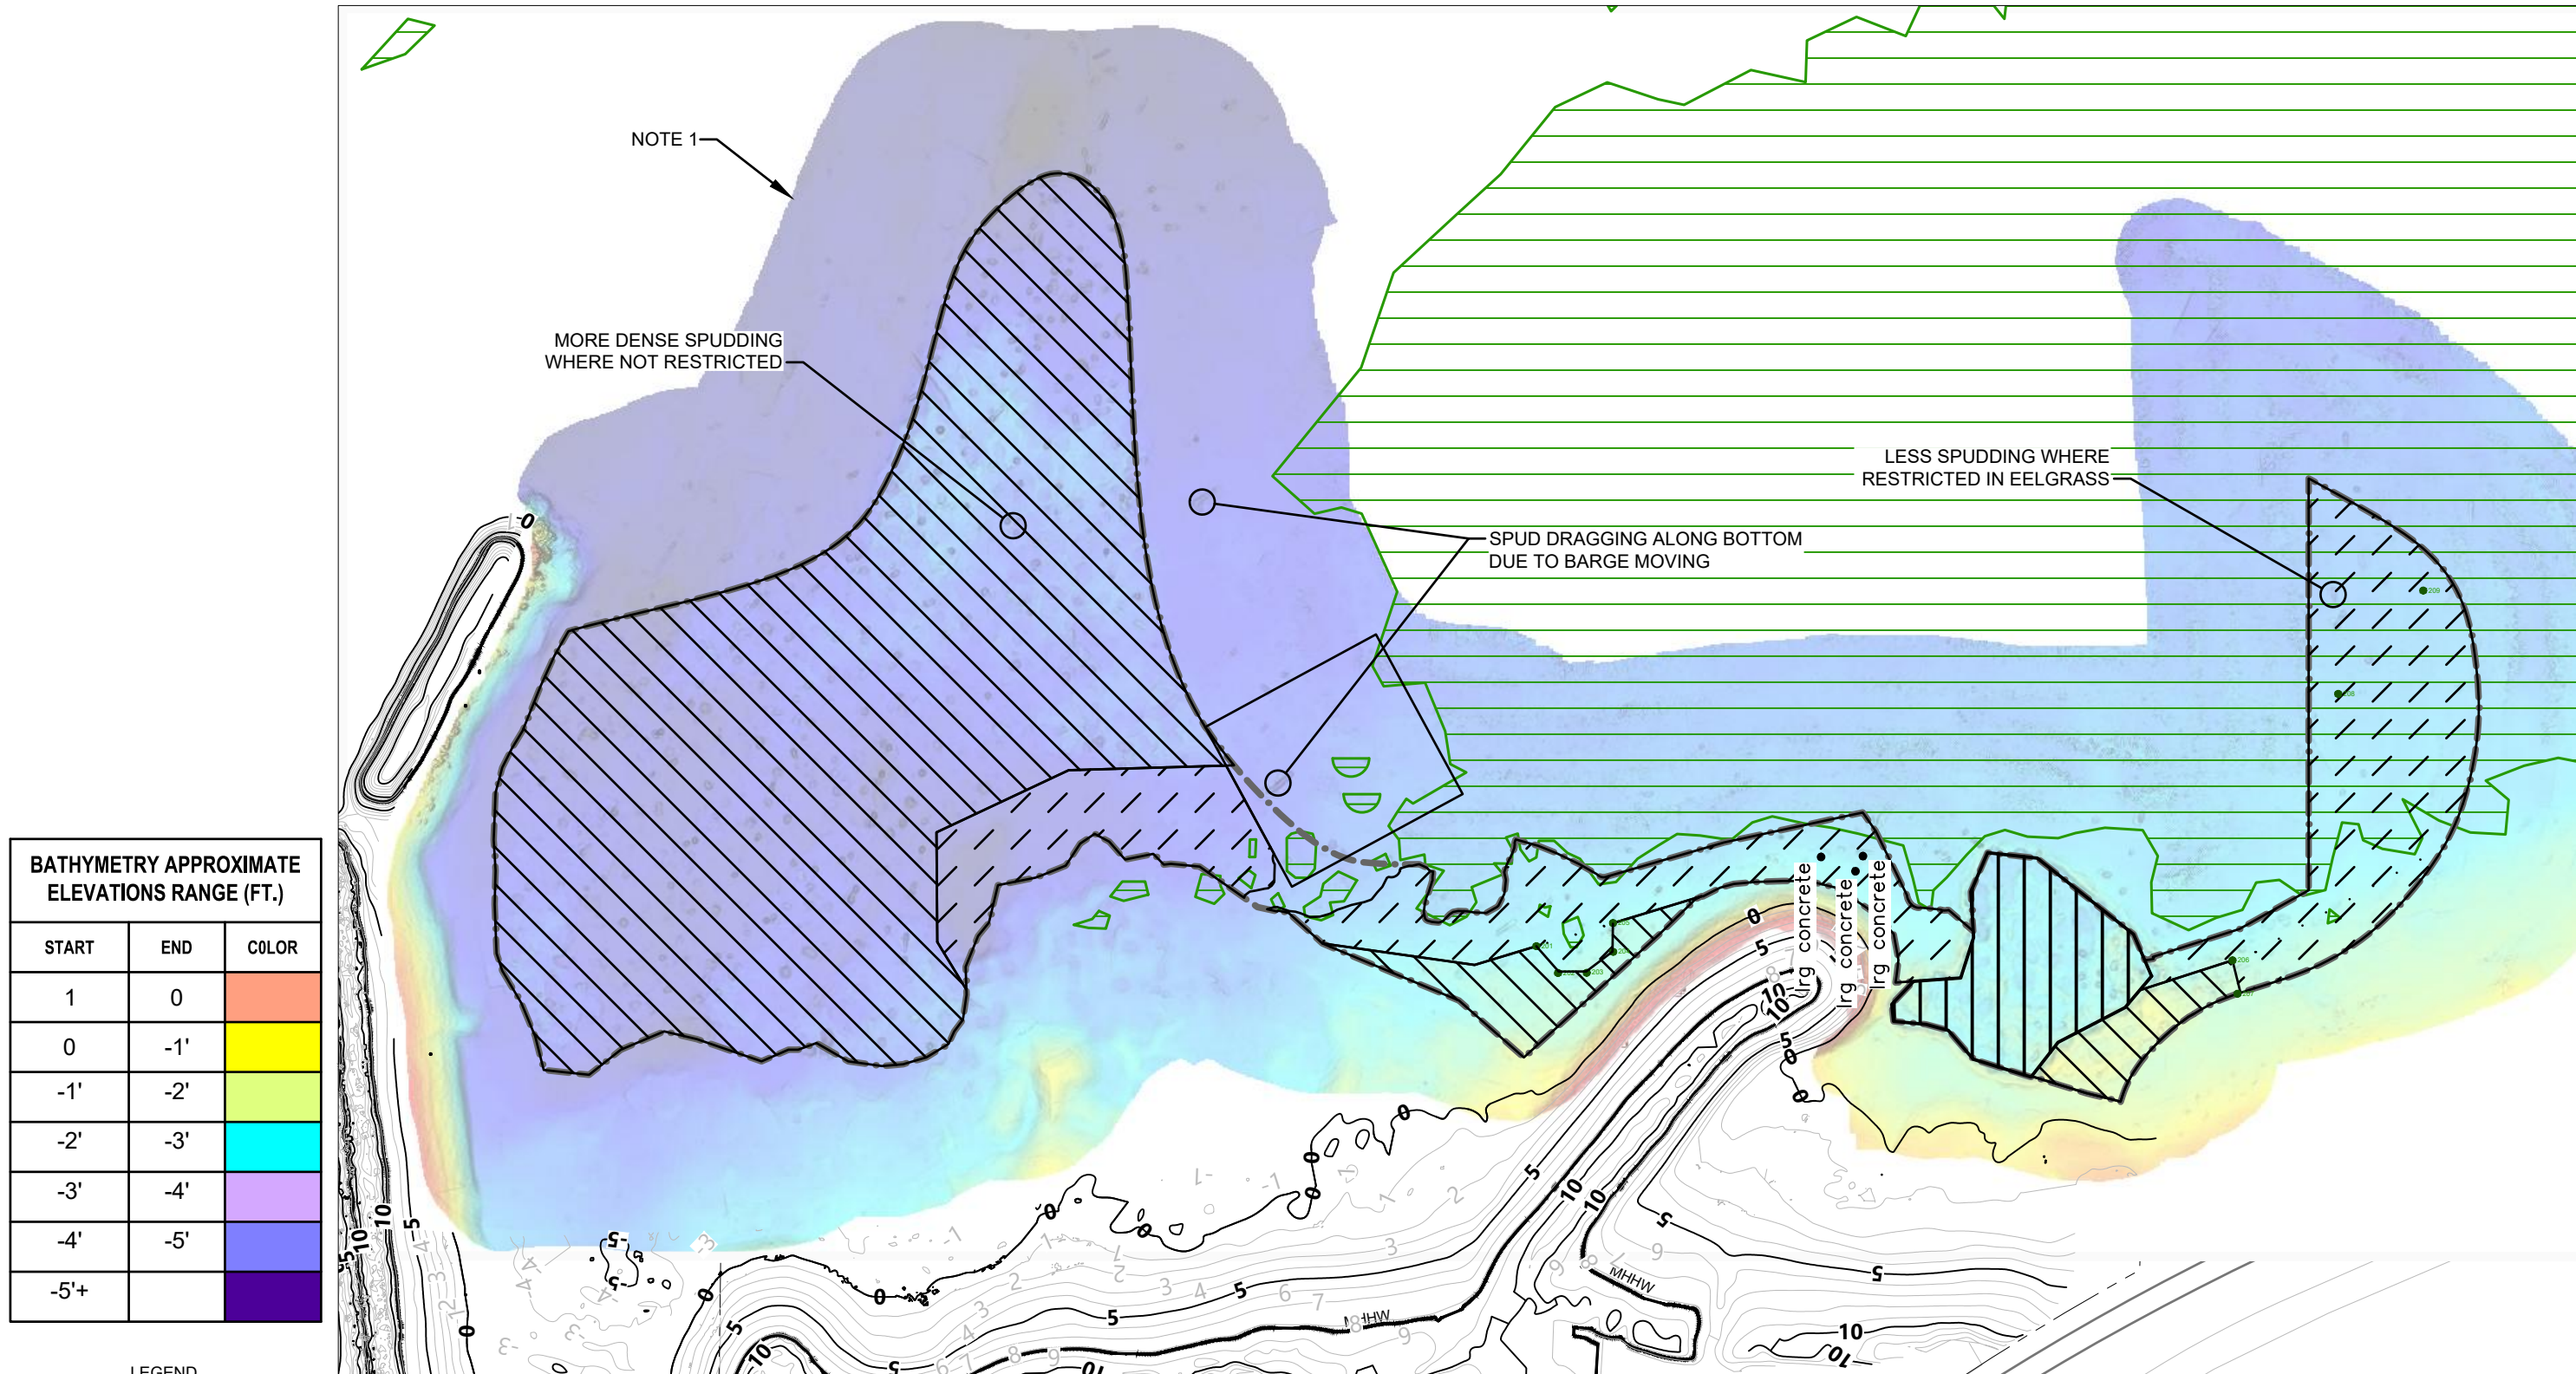
**FIGURE 7**

Several locations where spuds were placed were investigated by Grette divers following construction to gather additional information regarding the impact of spudding on benthic habitats. These areas were investigated visually though visibility proved to be challenging. Of the six locations observed, only two showed evidence of scarring or mounding likely caused by spudding. One spud location was directly adjacent to known eelgrass and was prioritized because of its proximity to the transplant area and potential for greater disturbance. Weather conditions led to movement of the barge while placing the spud, resulting in a small trench from the spud dragging before it was deep enough to stop barge movement. Divers did note a trench at this location approximately 2 feet wide by 8 to 10 feet long, about 1 to 1.5 feet deep. No eelgrass was present in or around the trench; therefore, we assume no eelgrass was damaged by this spud being dragged. This same trench is visible on the high-resolution bathymetry imagery included in Figure 7 (see call out).

While investigating the spudding areas, which is in the 8-inch TLC, divers noted that 6 to 8 inches of TLC sand was successfully placed.
