## **Second Periodic Review**

**Former Scott Paper Mill  
17<sup>th</sup> – 20<sup>th</sup> Street & R Avenue  
Anacortes, WA 98221**

For the  
**Toxics Cleanup Program**

January 2024

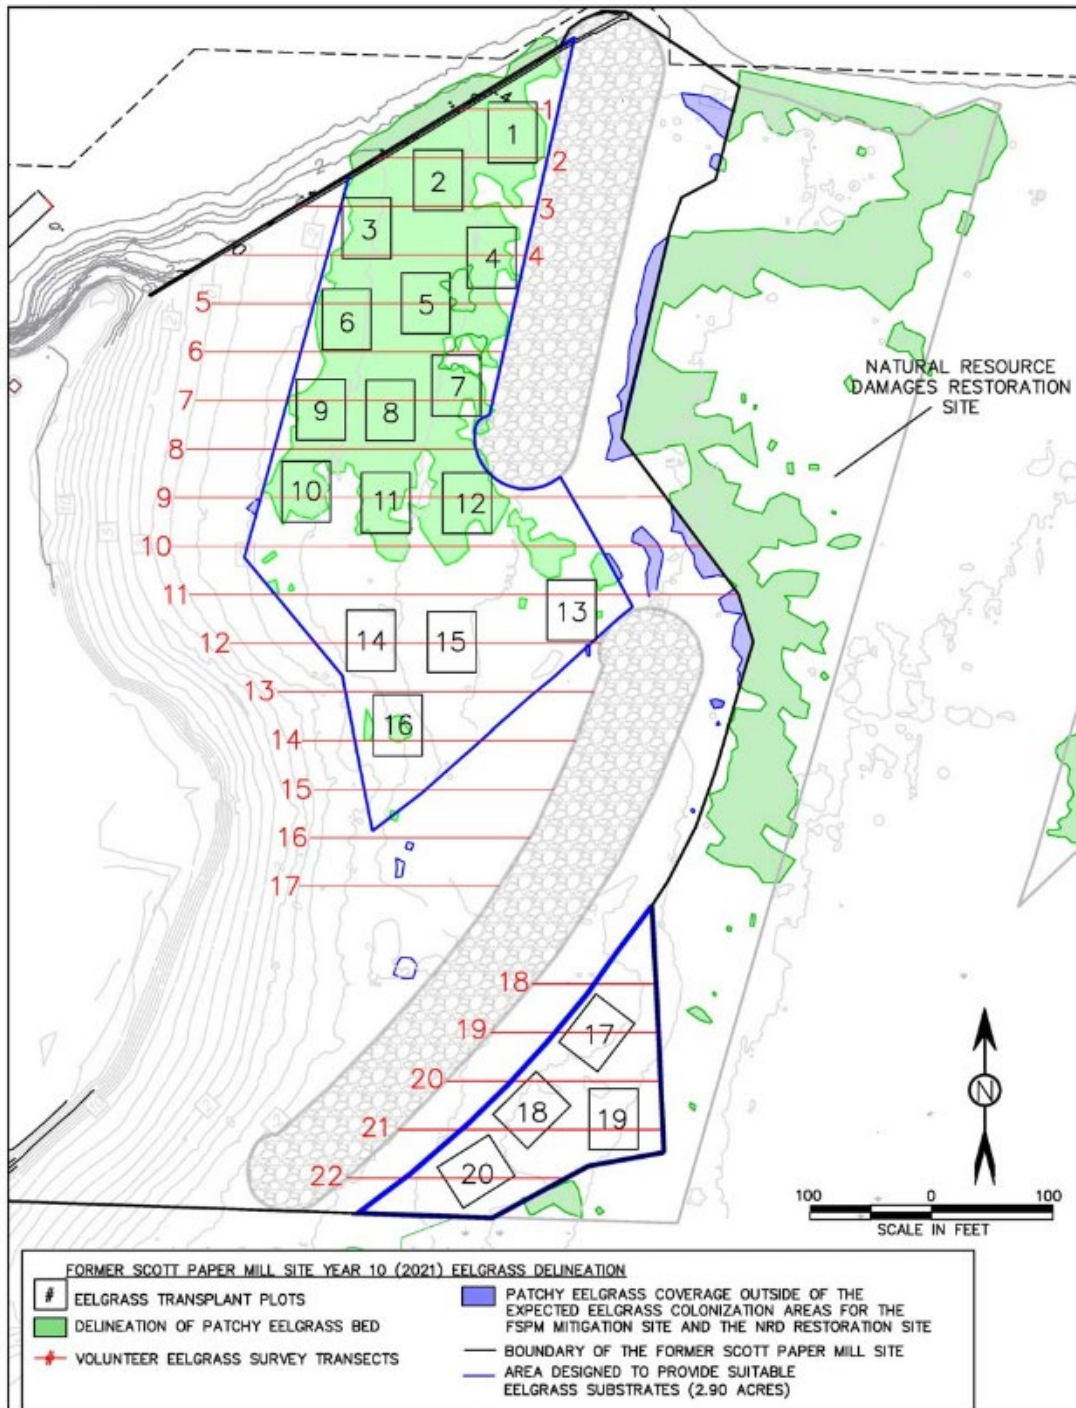
### 6.8 Year 10 (2021) Eelgrass Distribution

During the Year 10 (2021) monitoring of the Site (Grette 2021), the observed extent of the eelgrass bed had decreased to 1.33 acres of the highest turion densities in the north portion of the Marine Area west of the wave attenuators.

**Figure 7. Results of the Eelgrass Monitoring Within the Transplant Plots at the Former Scott Paper Mill Site.**

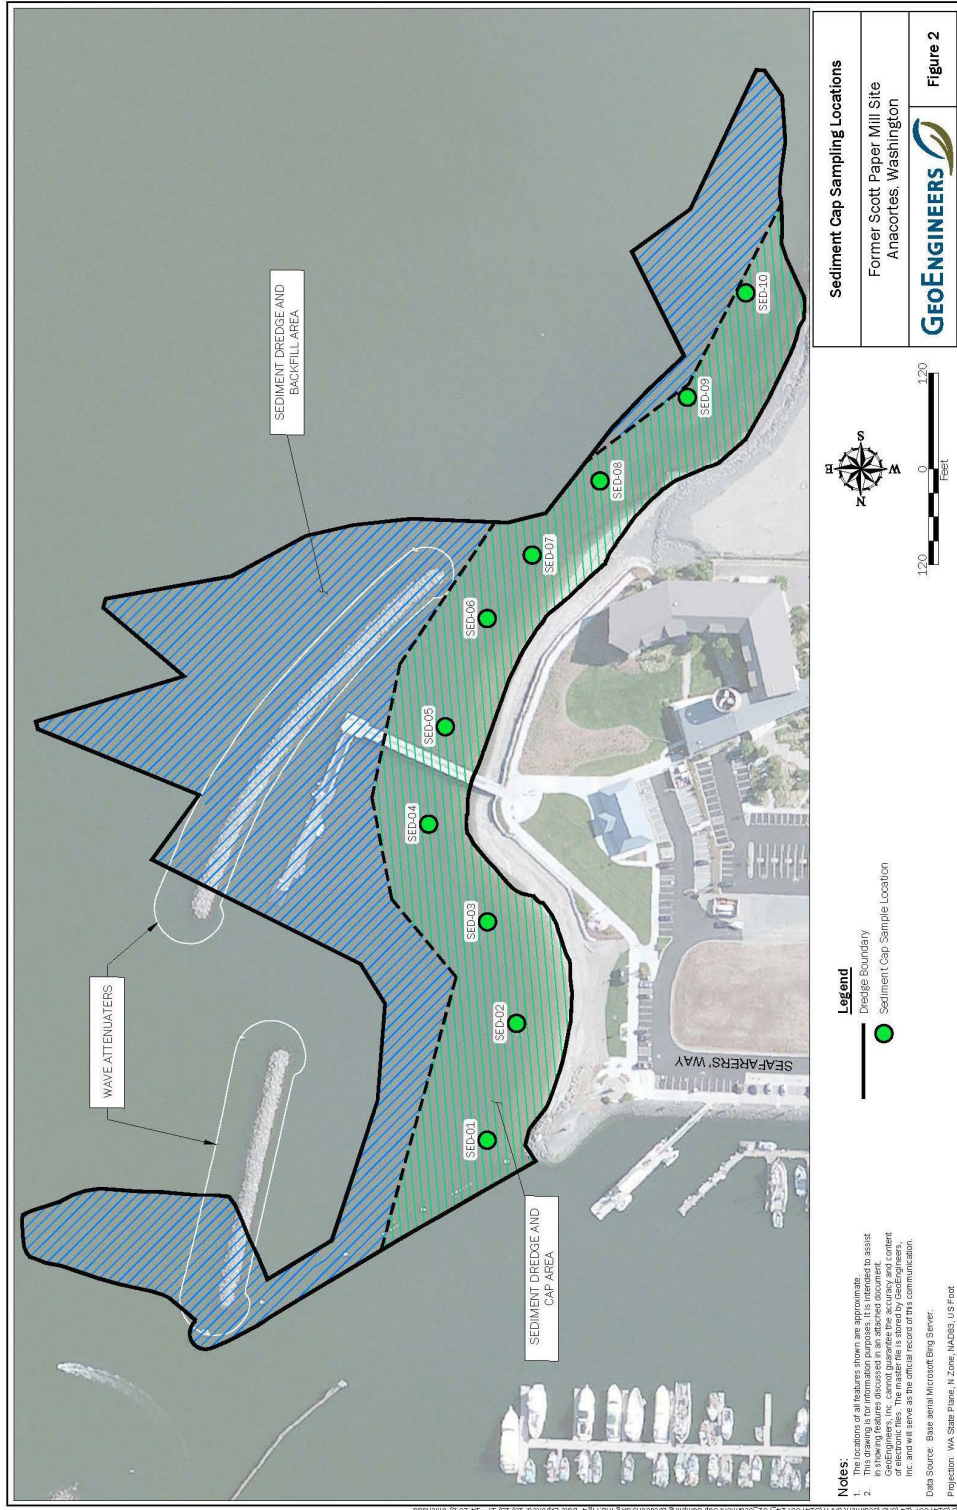
## 6.9 Marine Area Sediment Cap Monitoring

Based on the results of the September 2017 sediment cap monitoring event, compliance with the Site cleanup criteria was demonstrated at each sample location and Phase 2 monitoring was not required based on the Ecology-approved criteria. During the July 2023 sediment cap monitoring event, compliance with the Site cleanup criteria was further demonstrated at each sampling location. A localized low-level total PCB exceedance observed in a single sample collected in 2023 is attributable to an off-Site source. Localized accumulation of natural marine organic material in this sample likely resulted in preferential sorption of PCBs with low bioavailability in the interstices of the larger rock cap materials at the sample location. Based on the weight-of-evidence provided by the monitoring data, the overall integrity of the sediment cap remains intact. Accordingly, further Year-10 Phase 2 monitoring is not necessary unless requested by Ecology with site-specific reasoning.

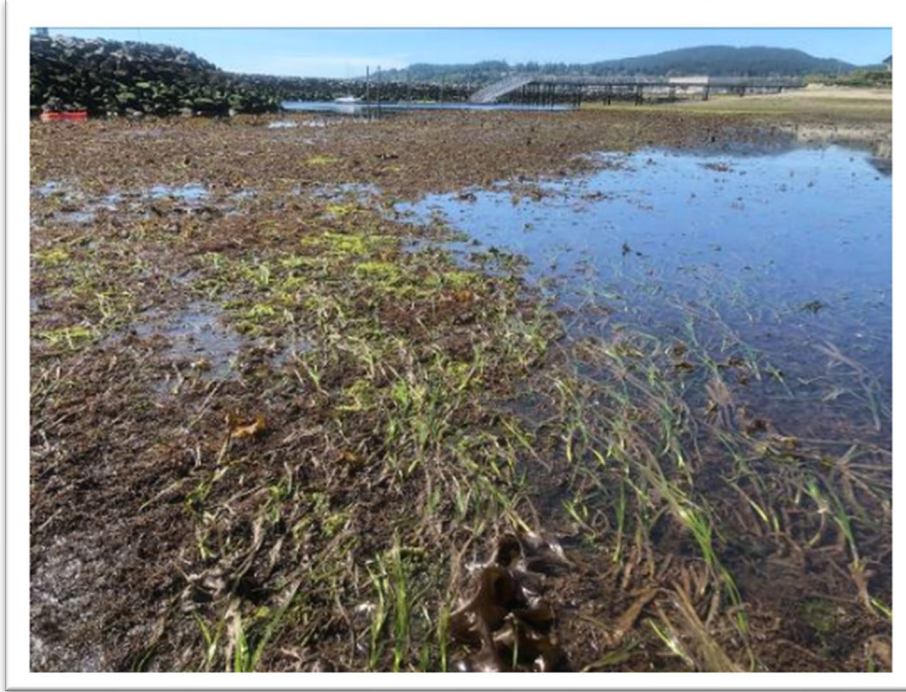
**Photo 1: Typical eelgrass coverage within the Transplant Plots within the northern portion of the Site (June 24, 2021)**

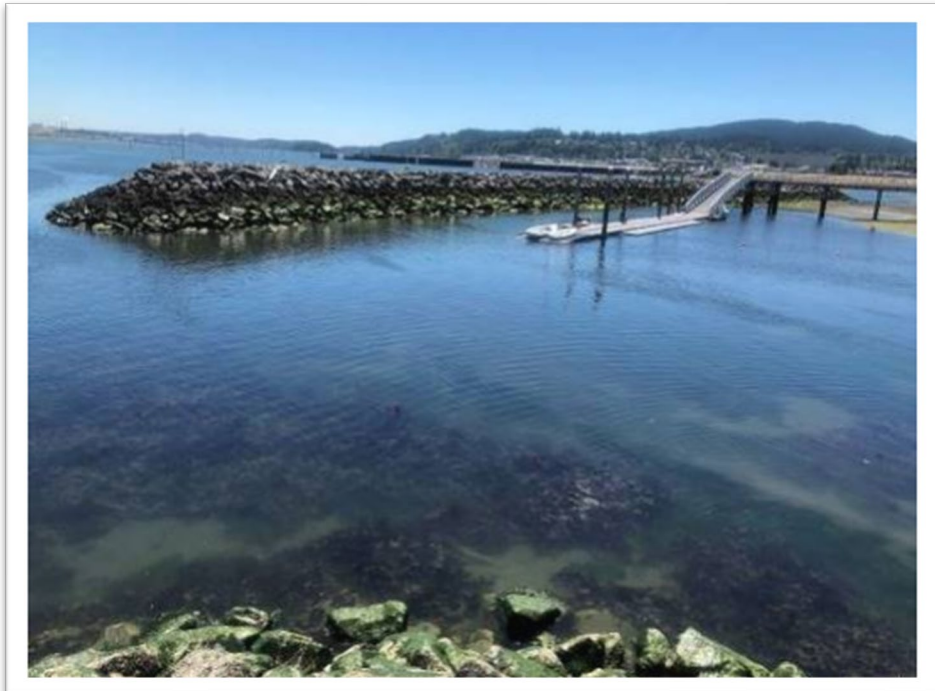
**Photo 2: Volunteer eelgrass colonization between the attenuators (June 24, 2021)**

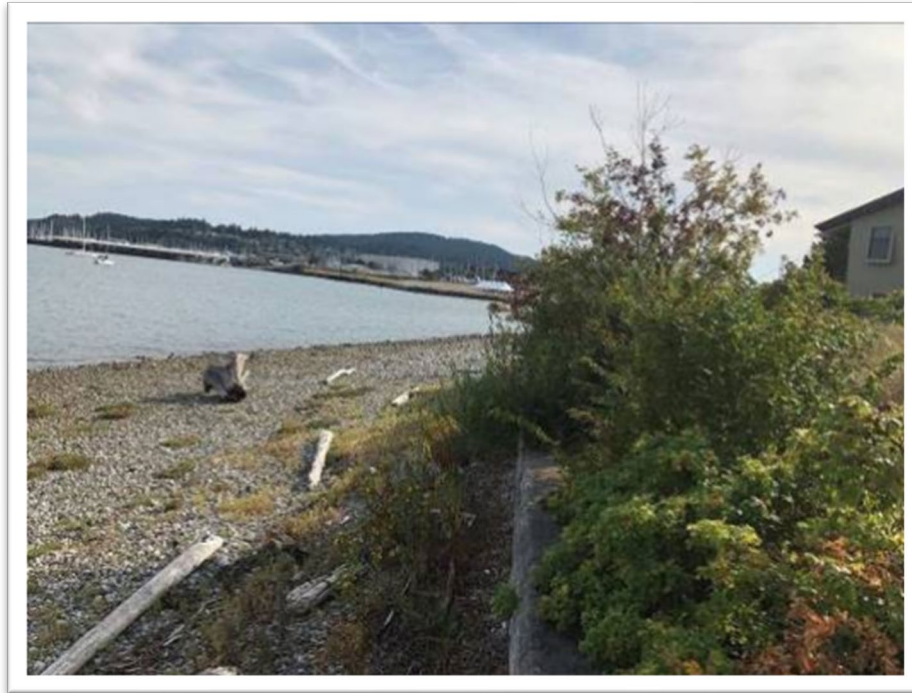
**Photo 3: Marine Area sediment cap and riparian vegetation coverage (June 24, 2021)**

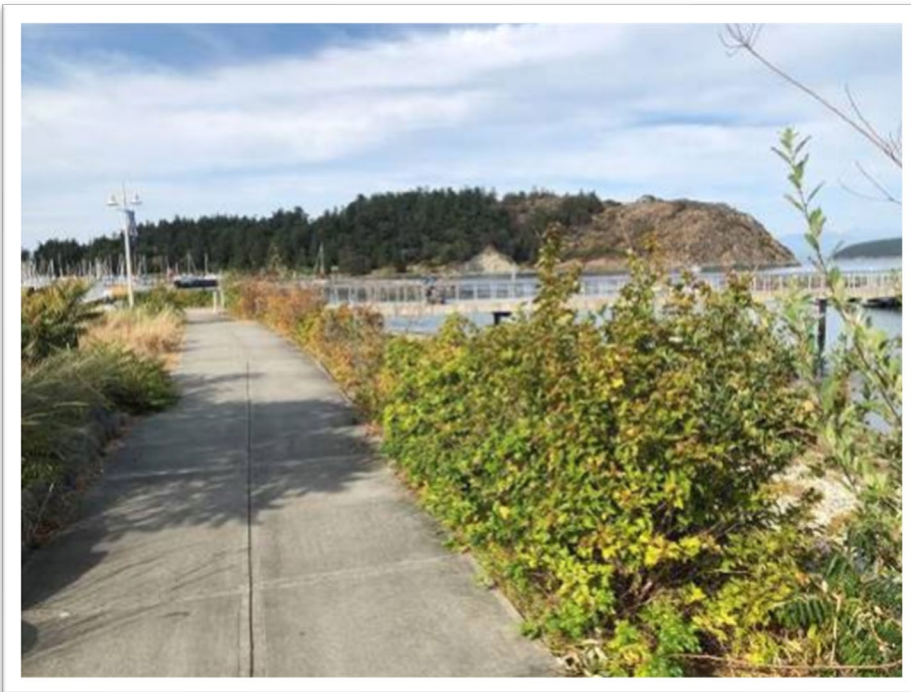
**Photo 4: Riparian vegetation coverage and Upland Area public access (June 24, 2021)**
