TECHNICAL MEMORANDUM

DATE: February 27, 2024

RE: **Former Mill E / Koppers Facility
2023 Annual Performance and Compliance Monitoring Report**

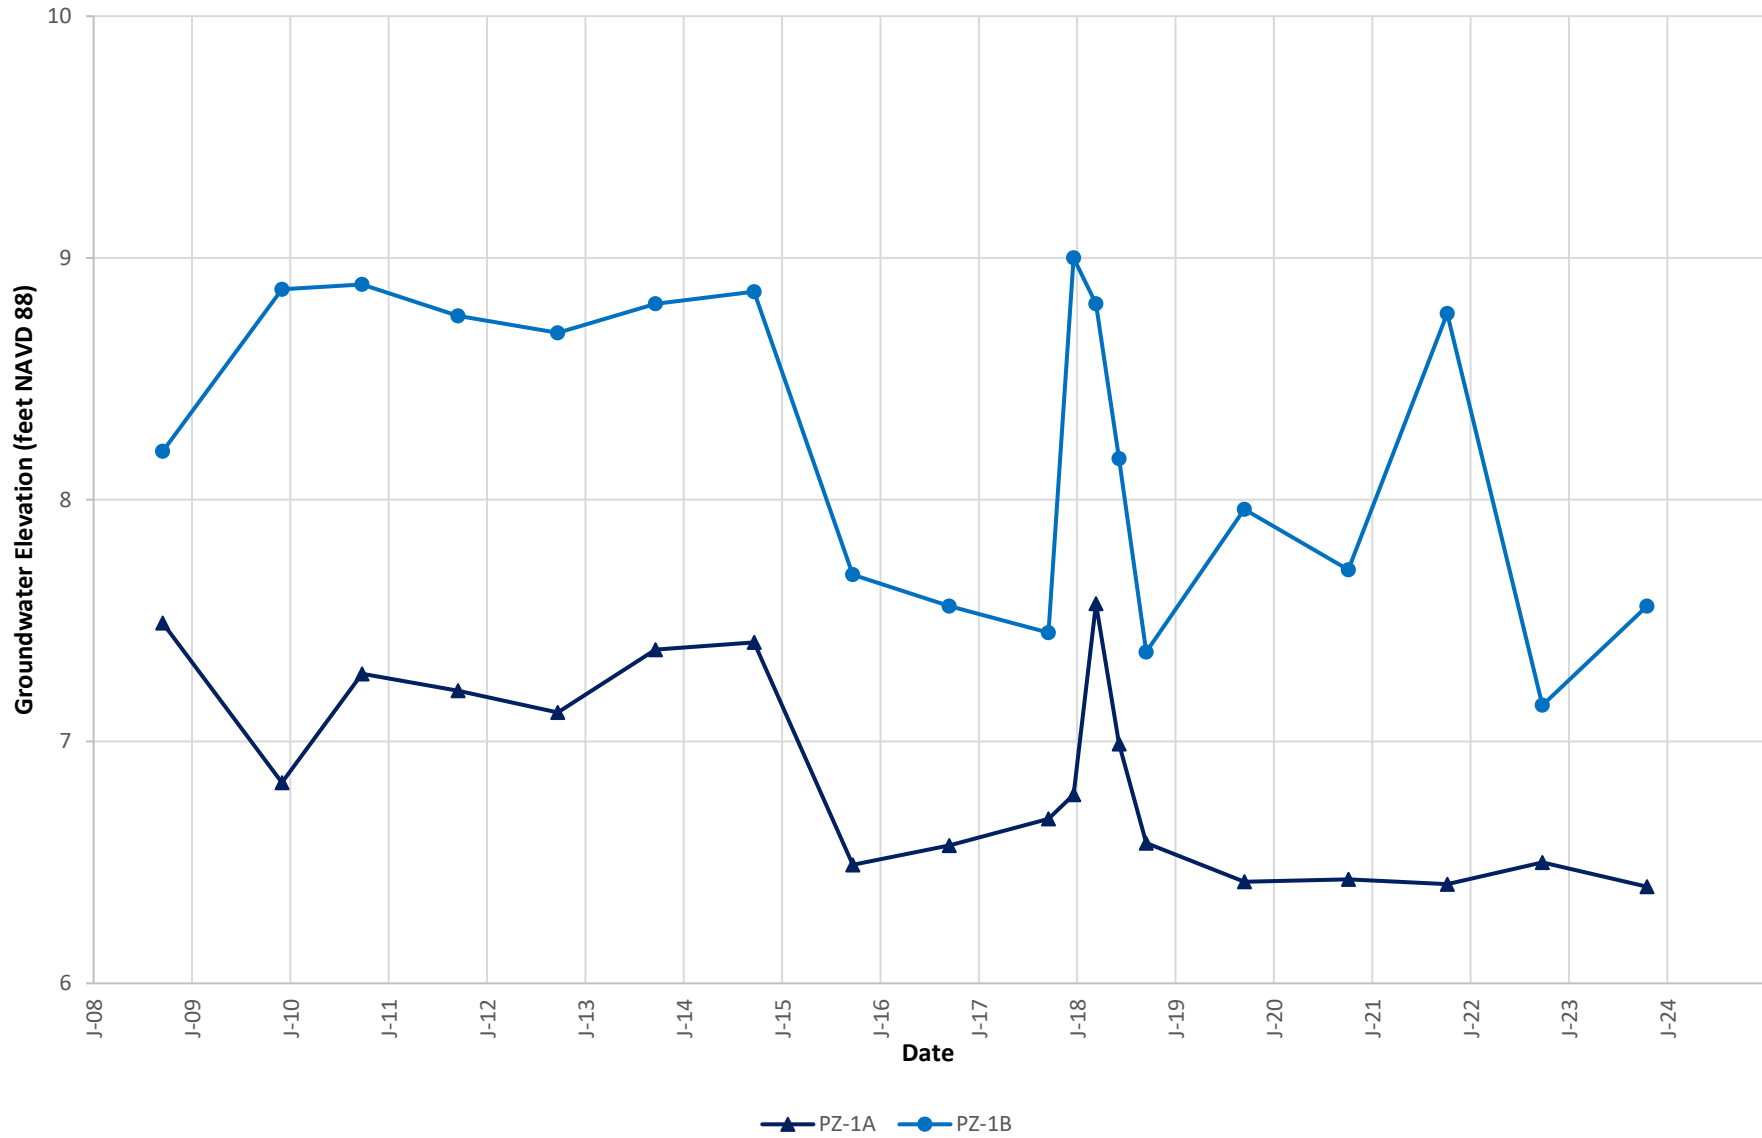
Figure 3
Groundwater Elevation Trends
PZ-1A and PZ-1B
Former Mill E / Koppers Facility
Everett, Washington

Groundwater elevation trends for each piezometer pair are presented on Figures 3 through 5 and show a comparison of historical groundwater elevation data over time obtained for the Site. Review of the data indicates that consistently the groundwater elevations outside of the barrier wall are higher than inside the barrier wall with the exception for piezometer PZ-1A in 2007 and PZ-3B in October and November 2022. The higher water level in piezometer PZ-1A in 2007 was assessed and it was determined to be a result of surface water collecting in the well monument. After this observation, the top of the well monument was raised to prevent surface water from seeping into the monument (AESI; Technical Memorandum dated December 17, 2009). The slightly lower than expected groundwater elevations in piezometer PZ-3B in October and November 2022 may be the result from the atypical dry summer months in 2022 (AESI, 2022).

The groundwater elevation data for the piezometers suggests the barrier wall is performing as intended and isolating groundwater inside the barrier from that outside the barrier.

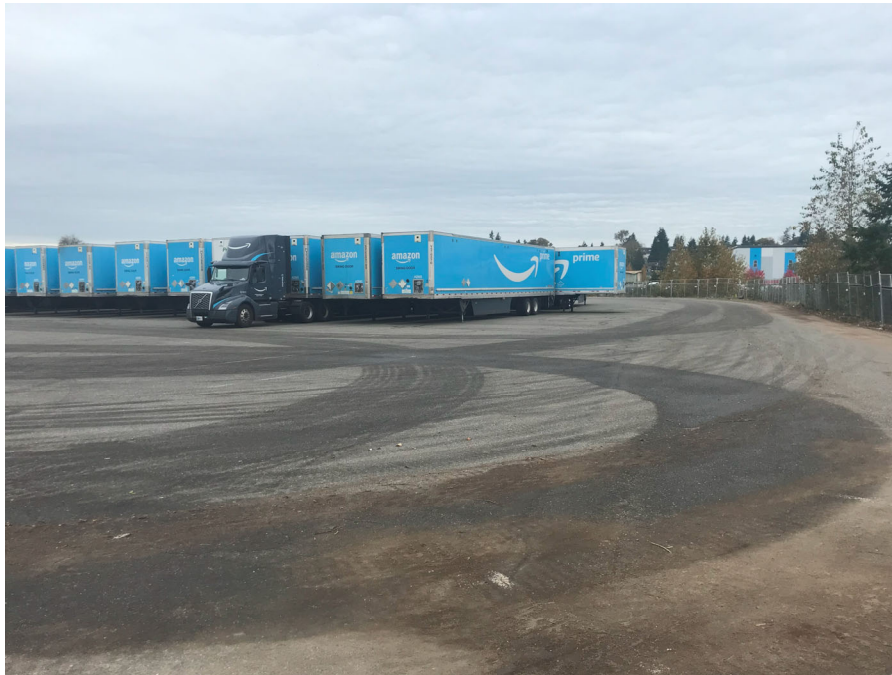
Most of the asphalt cap, about 85 to 95 percent, was visible at the time of the site visit. The asphalt cap was observed to be in serviceable condition. The northeast portion of the cap was observed to have repair work done on the cracks (Photograph 1) from the previous year. Minor cracks were observed on the southern portion of the cap (Photograph 2).

Photograph 1 – Looking west at the northern portion of the asphalt cap. Multiple cracks are observed to be repaired with a crack joint sealant.

Kane Environmental recommends removing any remaining visible vegetation from the minor cracks and sediment in the drainage ditches, and subsequently sealing the cracks in the ditches and the minor cracks observed in the southern and western portions of the asphalt cap. These minor asphalt cap repairs will help to maintain the asphalt cap in a serviceable condition and meet the performance objectives to prevent potential direct contact with contaminated soil and infiltration at the site.

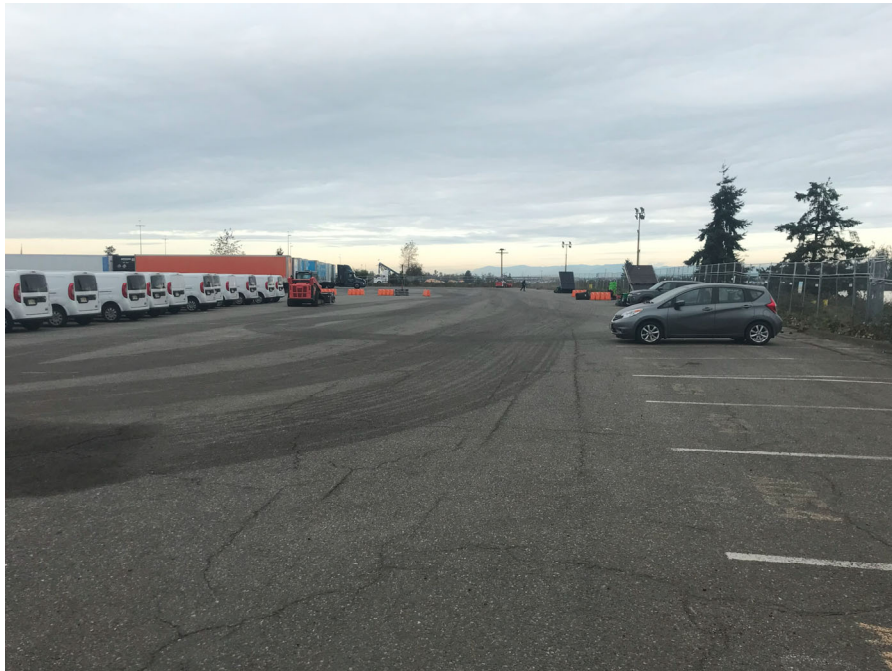
Photograph 2 – Looking north-northeast at the southeastern portion of the asphalt cap with thin cracks on surface.

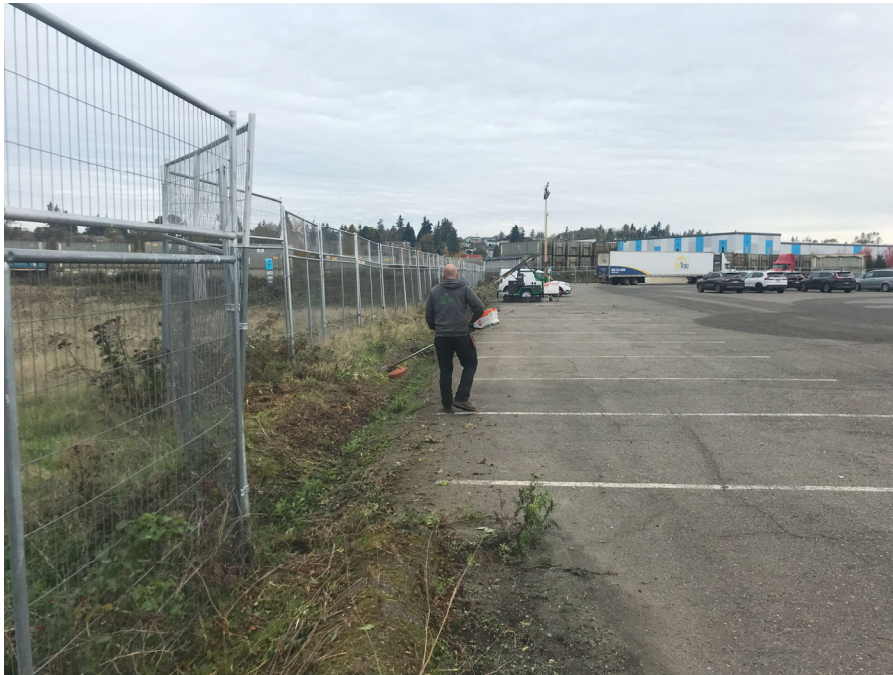
Drainage ditches had more accumulated sediment than previous year; however, accumulated appeared to be less than 1-inch. Minor cracks with vegetation growing through were observed along the southern drainage ditch (Photograph 3). In addition, vegetation was growing from the adjoining soil cap area. A landscape crew was removing overgrown vegetation along the fence line surrounding the asphalt cap area at the time of the site visit.

Photograph 3 – Looking west at southeastern portion of the asphalt cap. Photograph shows landscaping crew removing vegetation from the south drainage ditch. Vegetation was observed to be growing through minor cracks and adjoining soil cap area.

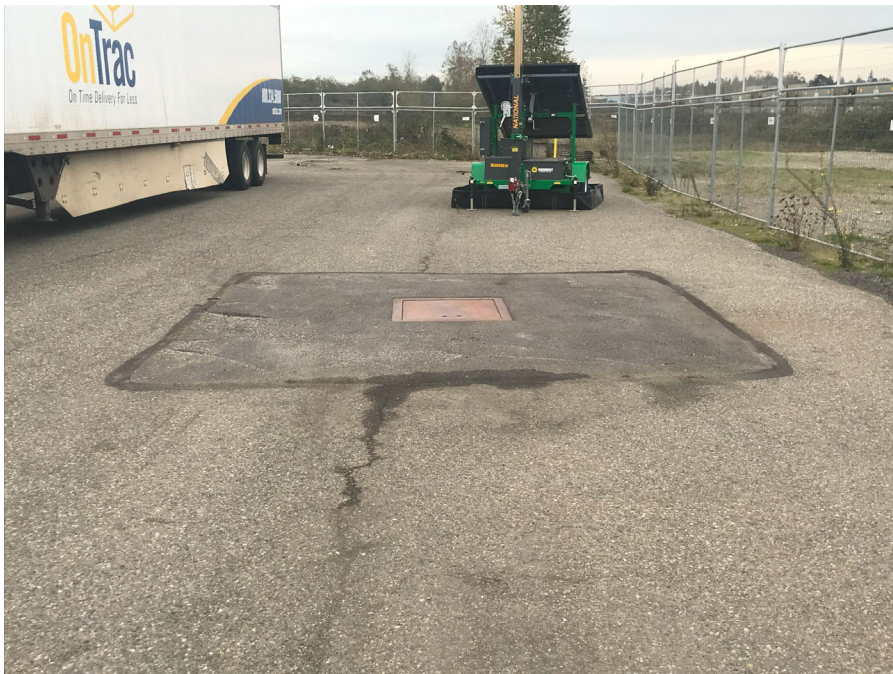
A raised asphalt patch was observed surrounding well PZ-1A, on the west portion of the asphalt cap (Photograph 4). Minor cracks in the asphalt cap were observed near well PZ-1A. Additional observations of asphalt cap with minor ponding on asphalt surface are shown in Photographs 5 and 6.

Photograph 4 – Looking south at central western portion of the asphalt cap with observed minor cracking on the surface.

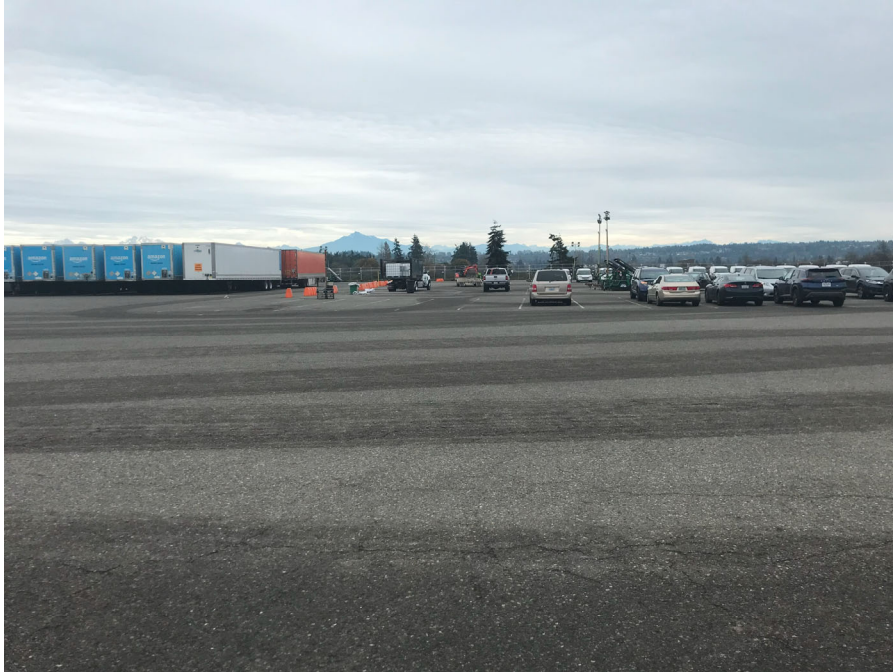
Photograph 5 – Looking east at central western portion of the asphalt cap. Minor ponding observed on the asphalt surface after a rainfall event.

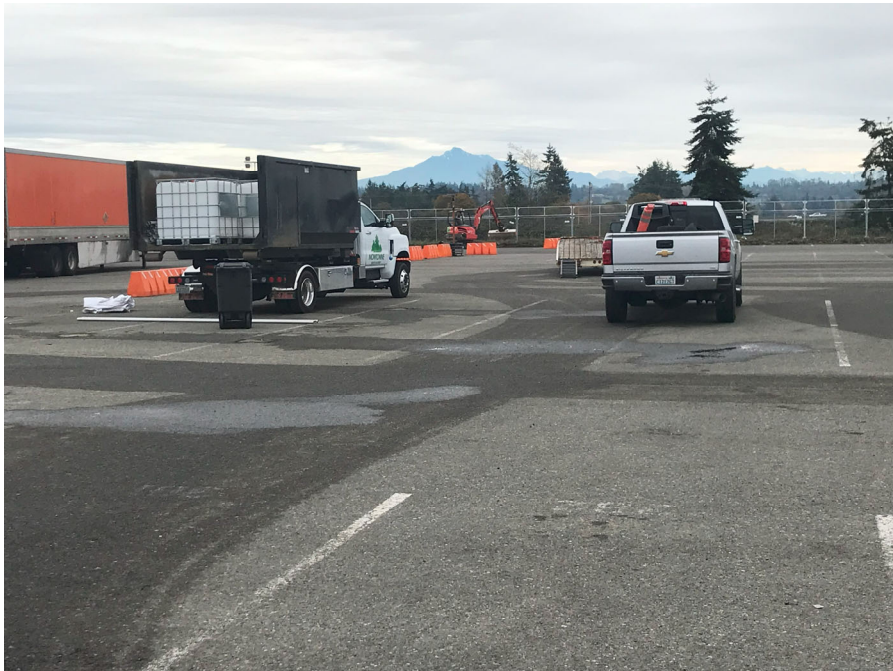
Photograph 6 – Looking east at center portion of the asphalt cap. Minor ponding observed on the asphalt surface after a rainfall event.
