ASPHALT INSPECTION FORM

Darling Ingredients - Tacoma, Washington Facility

Facility No.: 25455514, Cleanup Site No.: 8475, VCP Project No.: SW1317

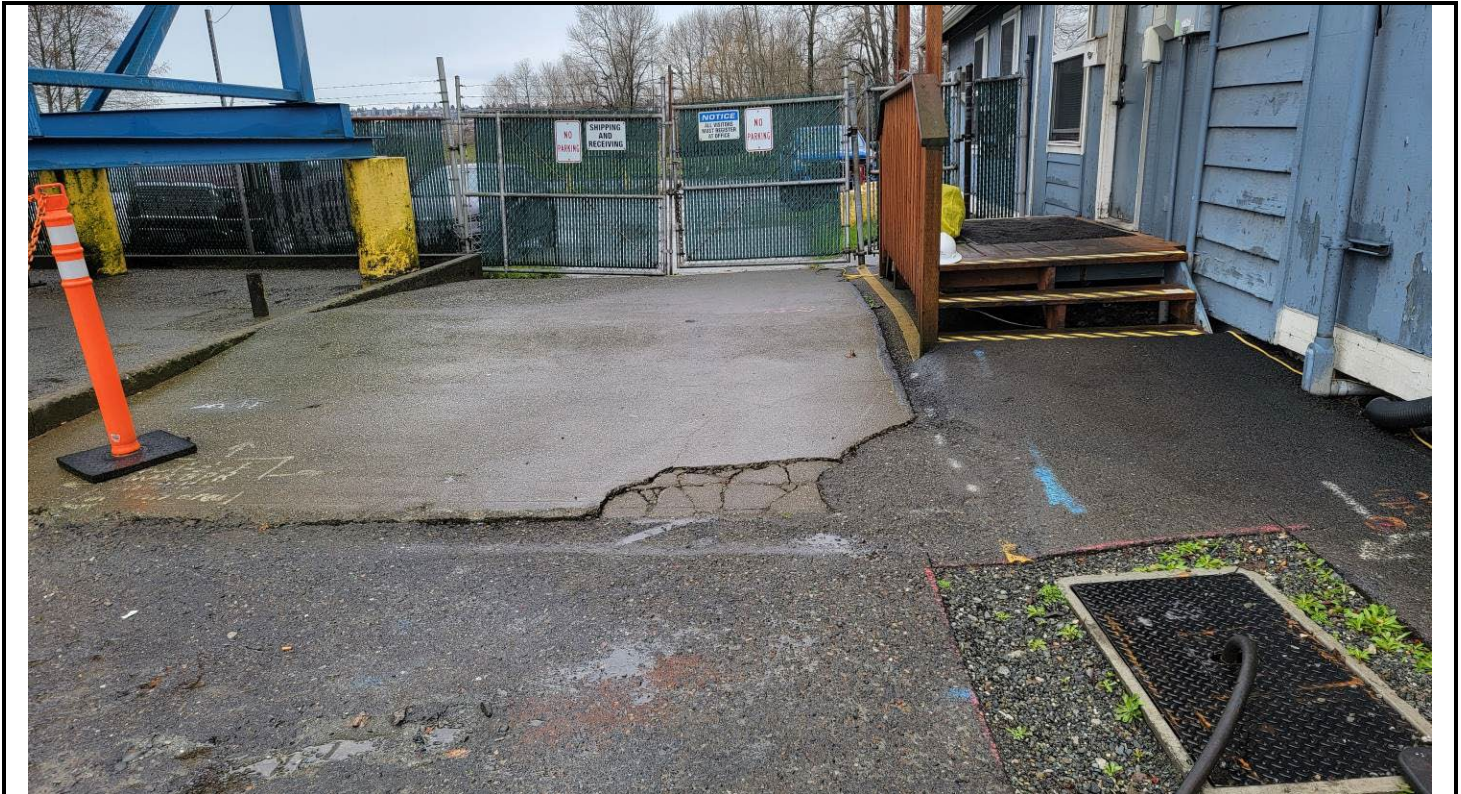
South exit gate concrete pad.

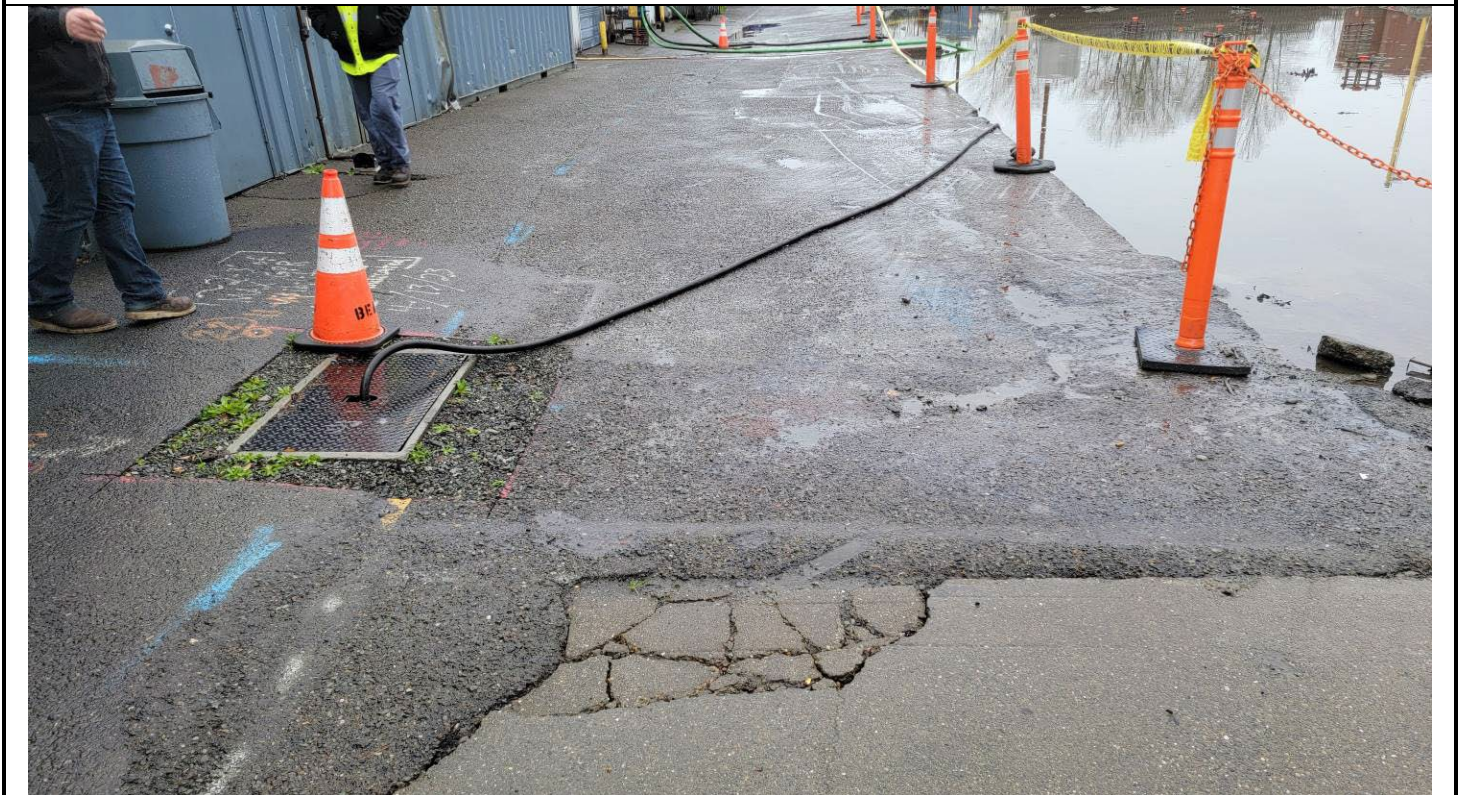
South portion of truck route, looking east. Area being pumped from sump in two locations to remove water from asphalt in truck route area to expose surface for asphalt inspection. Area flooded by rainwater prior to inspection due to recent precipitation events and water from excavation area that flowed into the area.

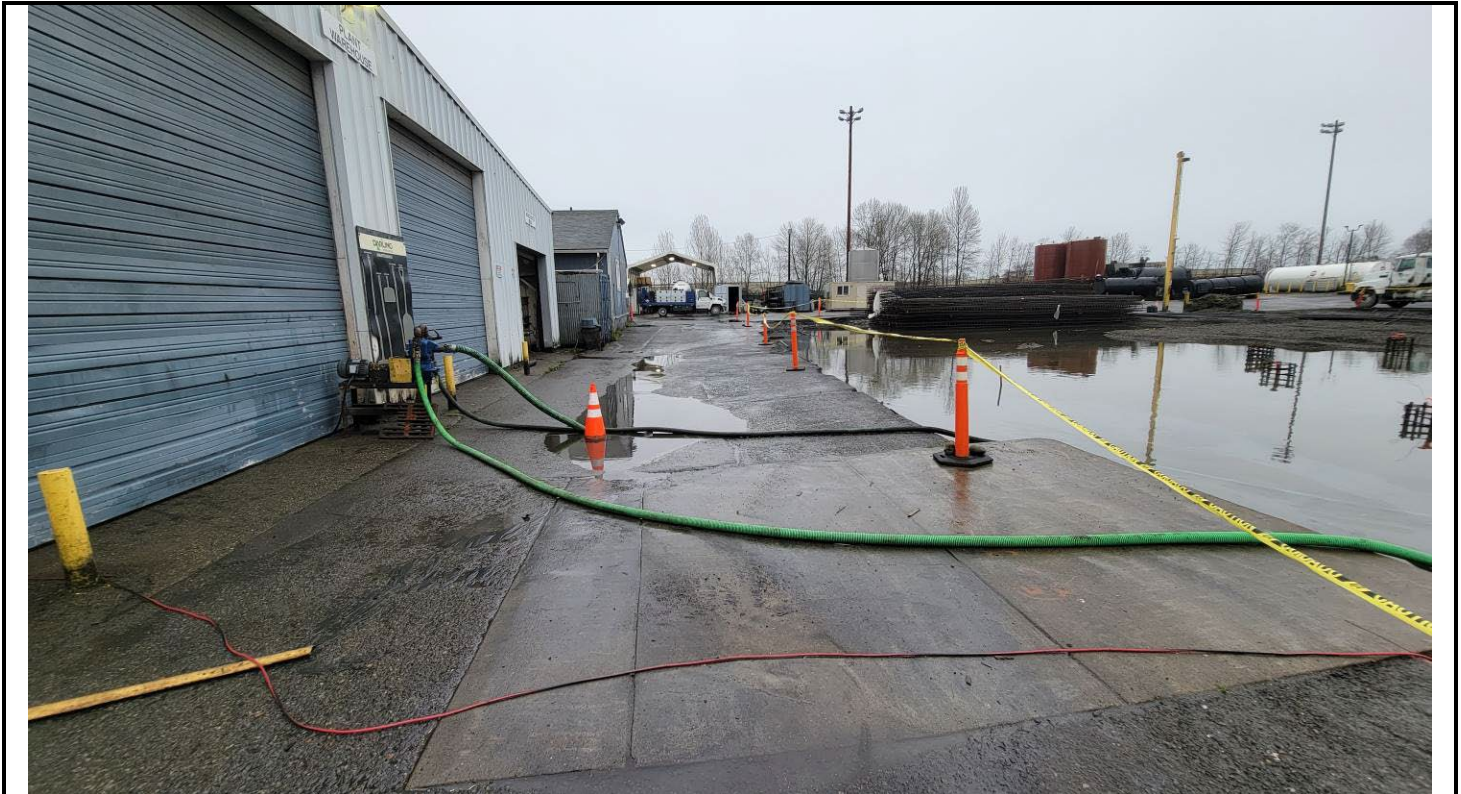
South portion of truck route, looking east. Area being pumped to remove water from asphalt in truck route area to expose surface. Area flooded due to recent rain events. Rainwater being pumped to former rendering plant footprint. South asphalt appears older (rougher) than asphalt near lunchroom; less traveled by truck traffic.

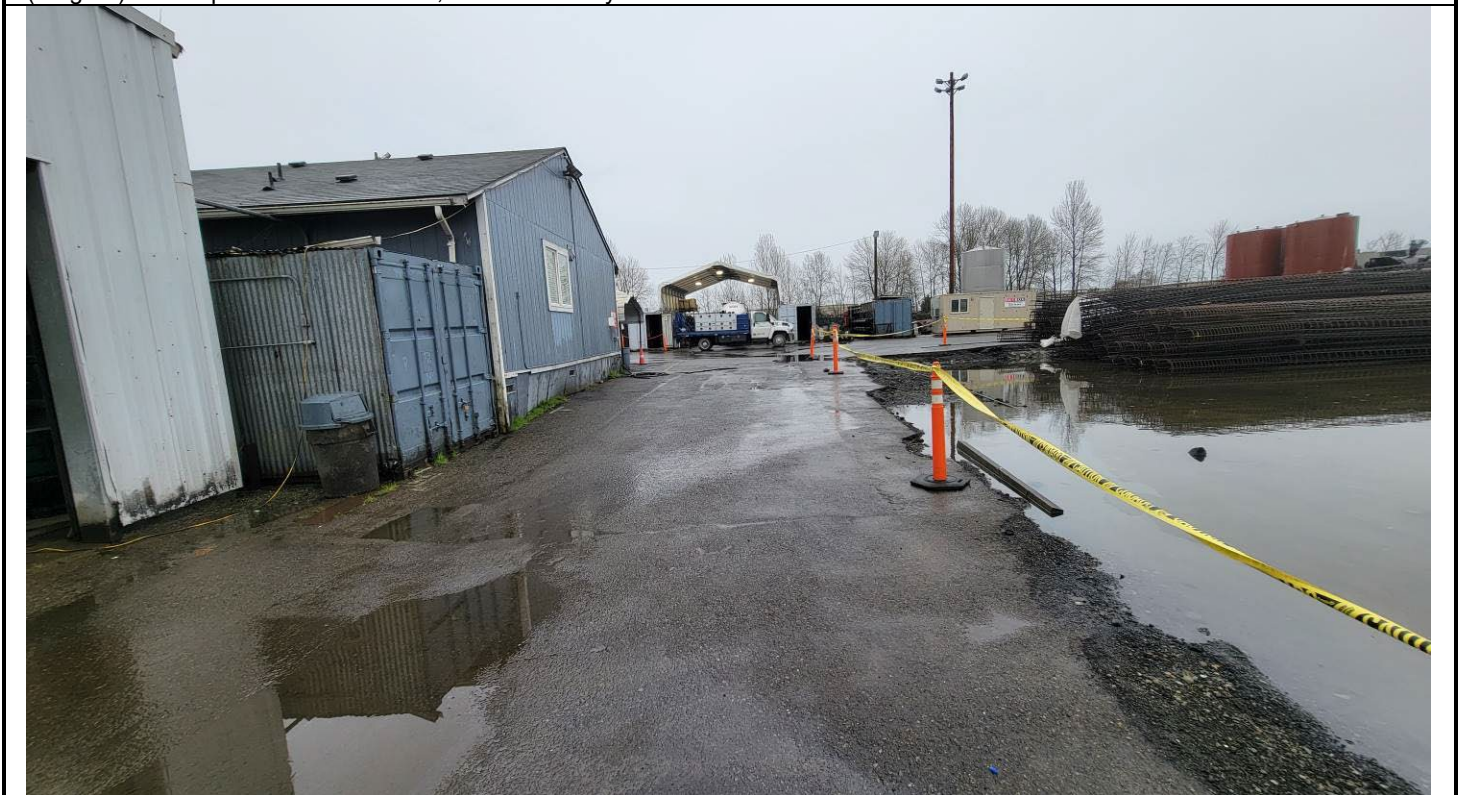
South portion of truck route. Looking east. Asphalt patch apparent in truck travel path.

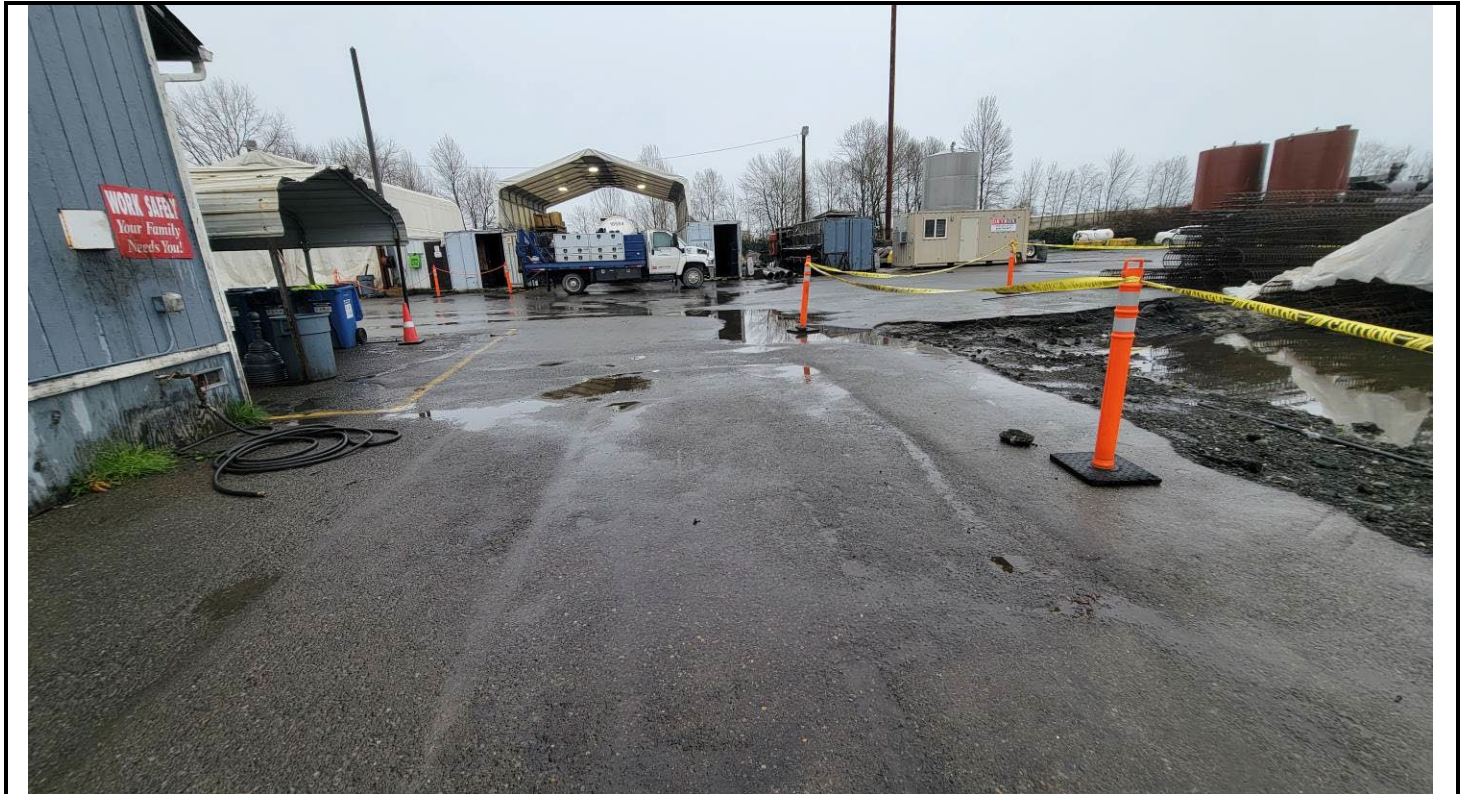
South portion of truck route, looking east, near adjacent to former UST removal area (under lunchroom building).

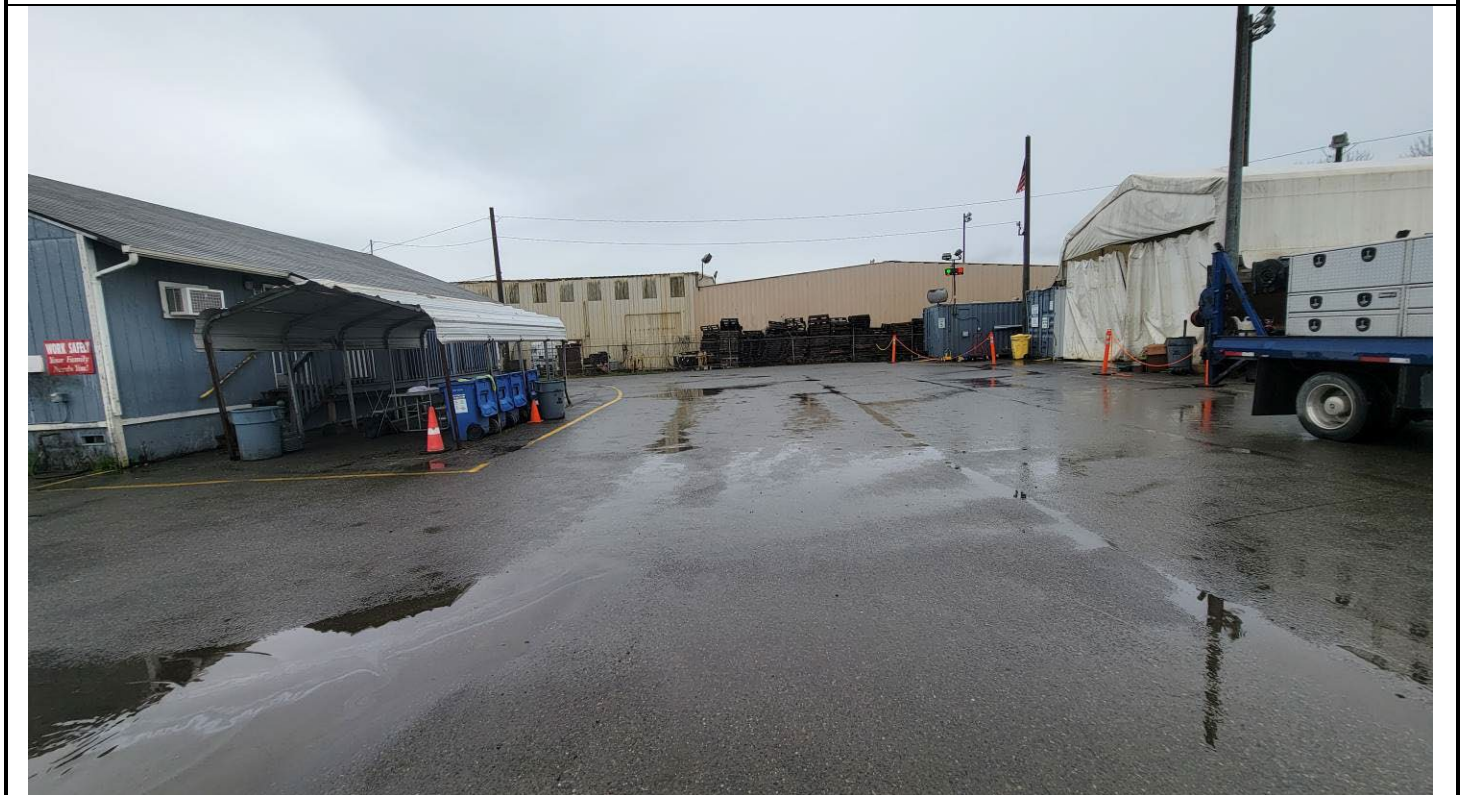
East portion of truck route. Looking north. Older asphalt under awning; some alligator cracking and rougher texture than newer asphalt surrounding east and south of awning.

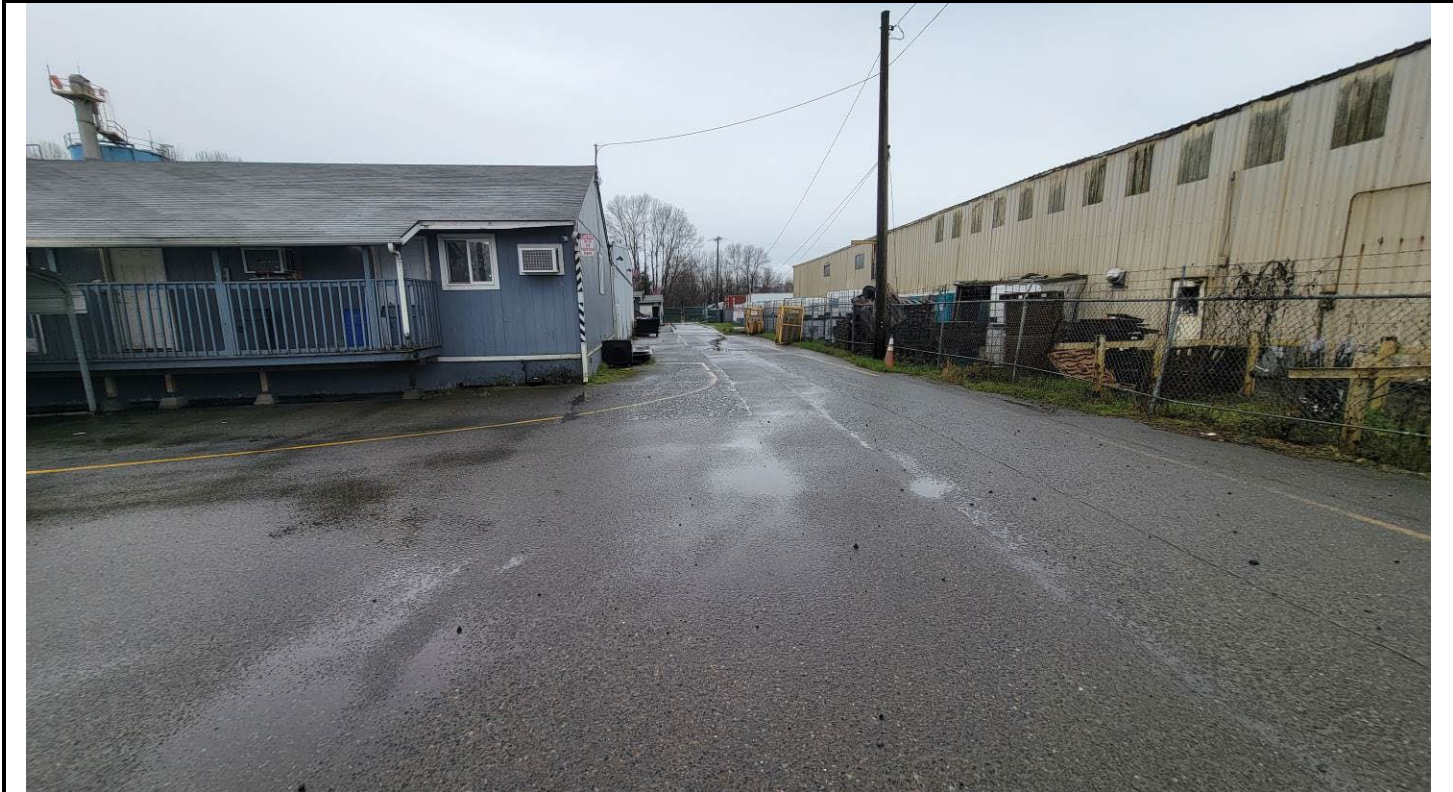
Northern portion of truck route, looking west. Former UST basin is under lunchroom. Asphalt patch running down south and middle portion of truck route, alligator cracking on right side of patch near telephone pole and stretching from lunchroom to workshop. Alligator cracks in area east of northeast corner lunchroom that extends along north side of lunchroom.

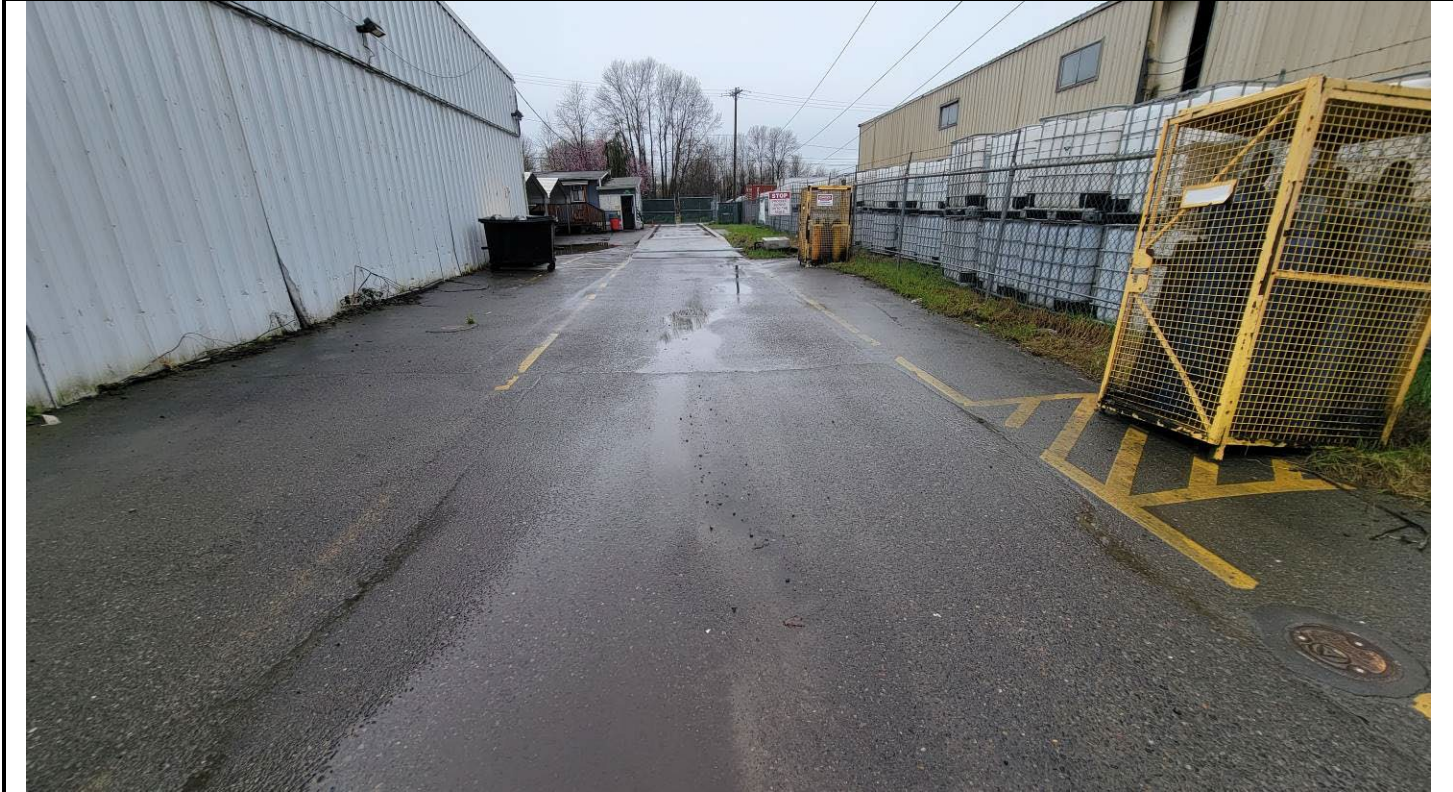
Northern truck route. Looking west. Shows some linear cracks near well MFG-2 (right) and alligator cracks near MFG-1 (middle left).

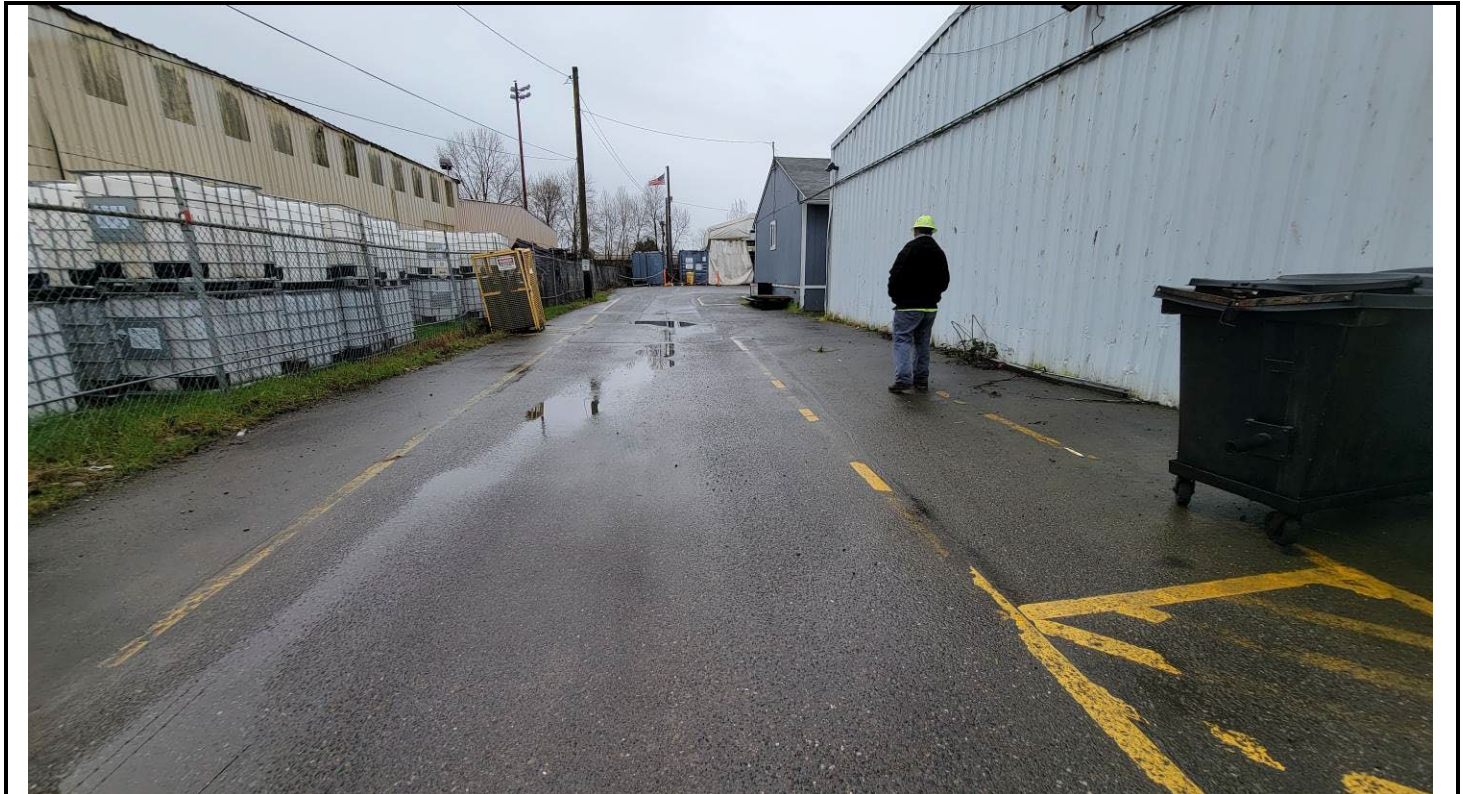
Northern truck route. Looking east. Linear cracks that may have received patch material in the past along north side of workshop and near well MFG-1. Alligator cracks near well MFG-1 in truck wheel lanes.

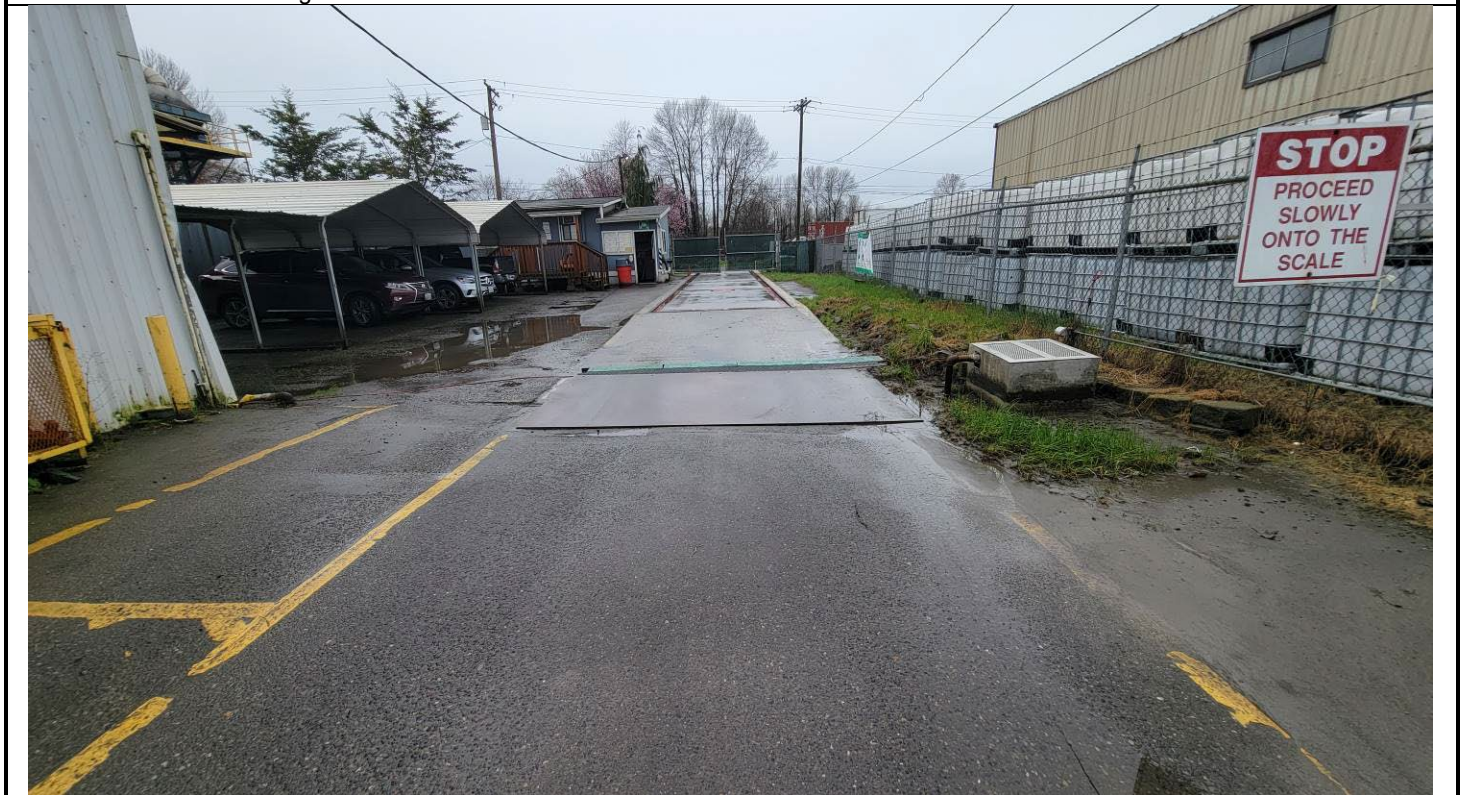
Weigh scale area. Looking west. Miscellaneous small linear cracks near truck scale and car port. Drain cut from building to weigh scale ramp on south side of ramp.
