**FINAL Third Periodic Review
Louisiana Pacific Corp
(aka Pony Lumber Company LLC)**

**3701 Taylor Way, Tacoma, Pierce County, 98421
Facility Site ID: 1209, Cleanup Site ID: 2317**

February 2025

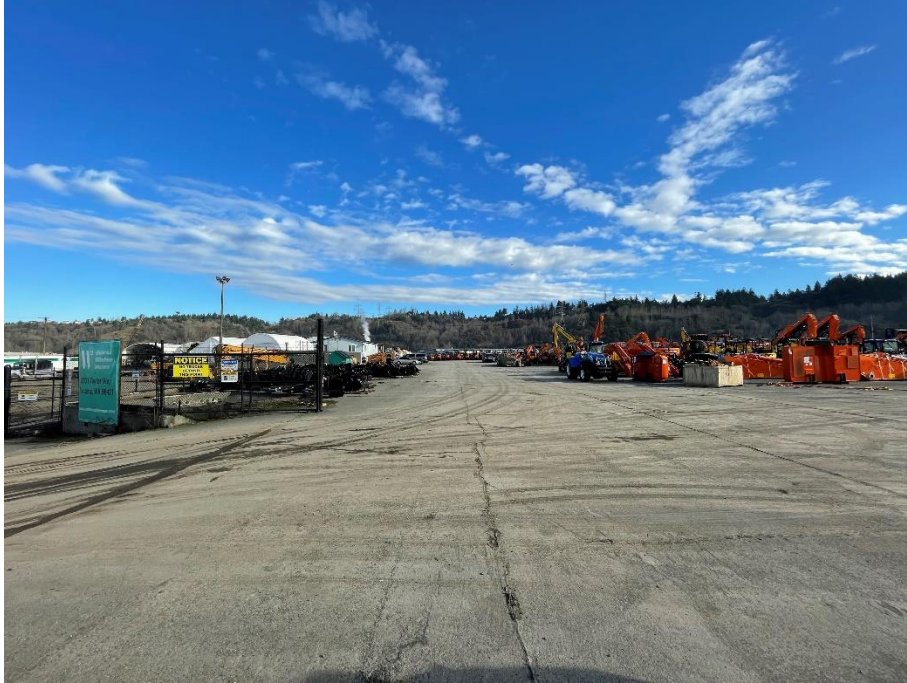
Photo 1 (facing northeast): View of capped area from the southwest entrance to the Site.

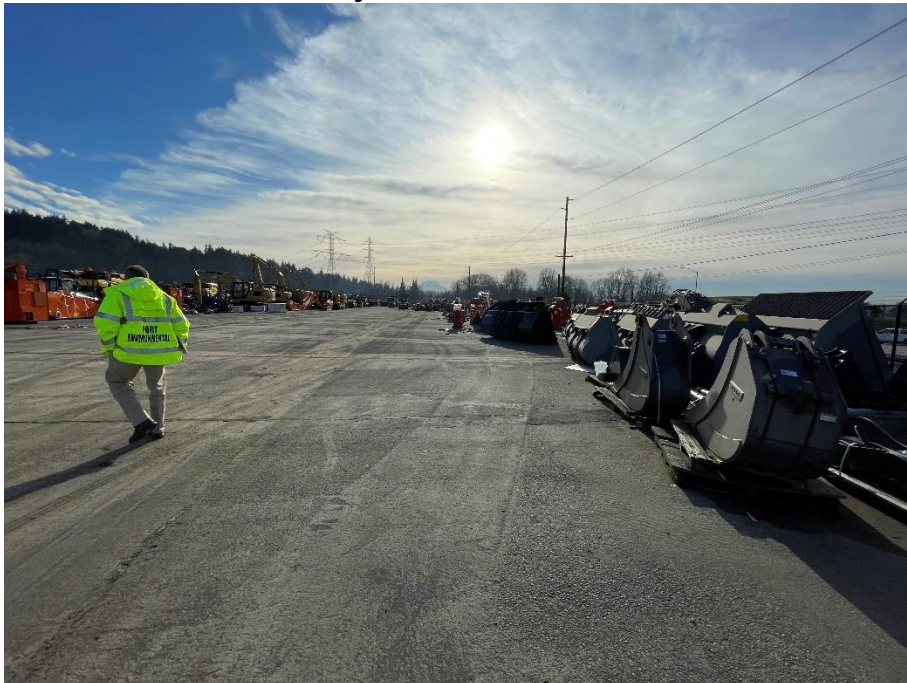
Photo 2 (facing southeast): View of capped area along the southwest boundary of the Site.

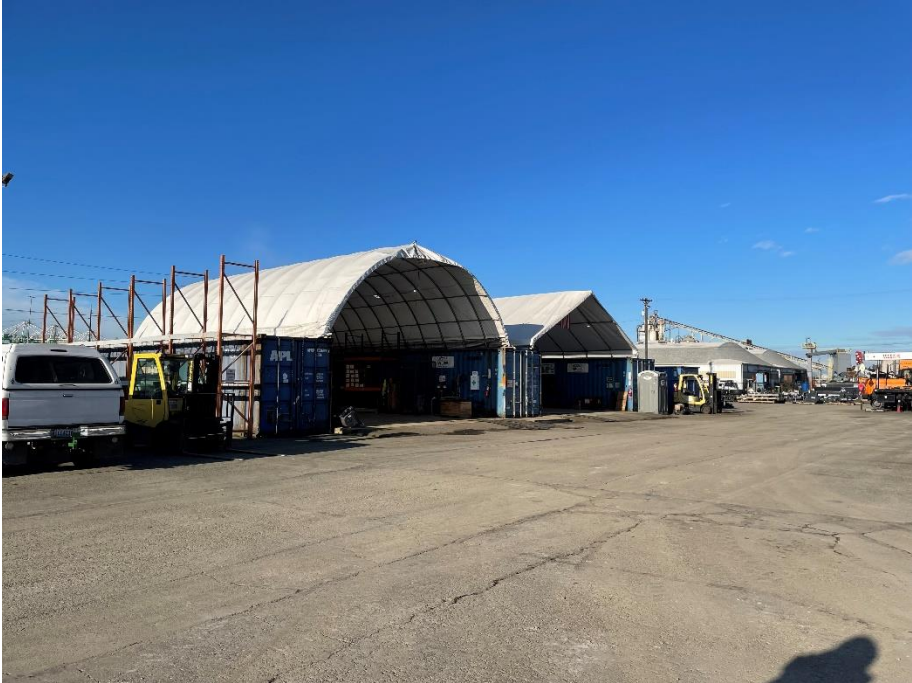
Photo 3 (facing west): View of the northwest portion of the capped area.

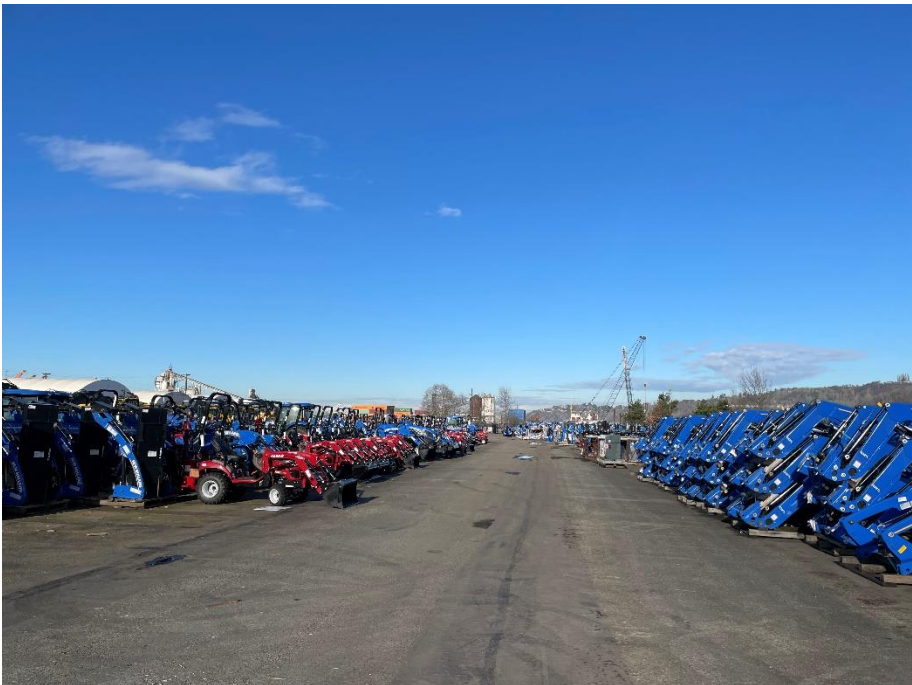
Photo 4 (facing northwest): View of the north-central portion of the capped area. Previous cap repairs are visible.

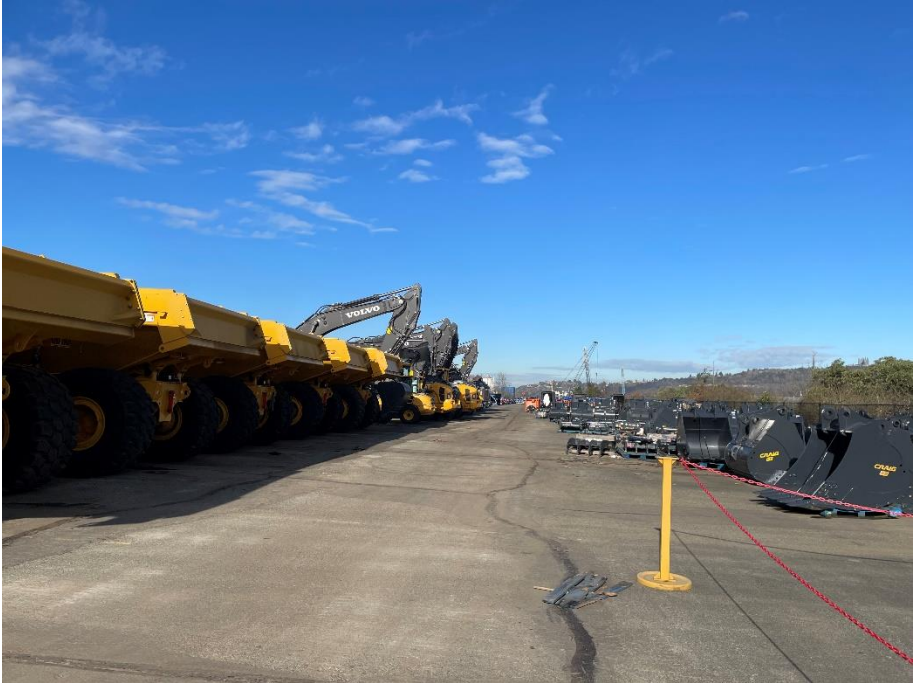
Photo 5 (facing northwest): View of the northeast portion of the capped area. Previous cap repairs are visible.

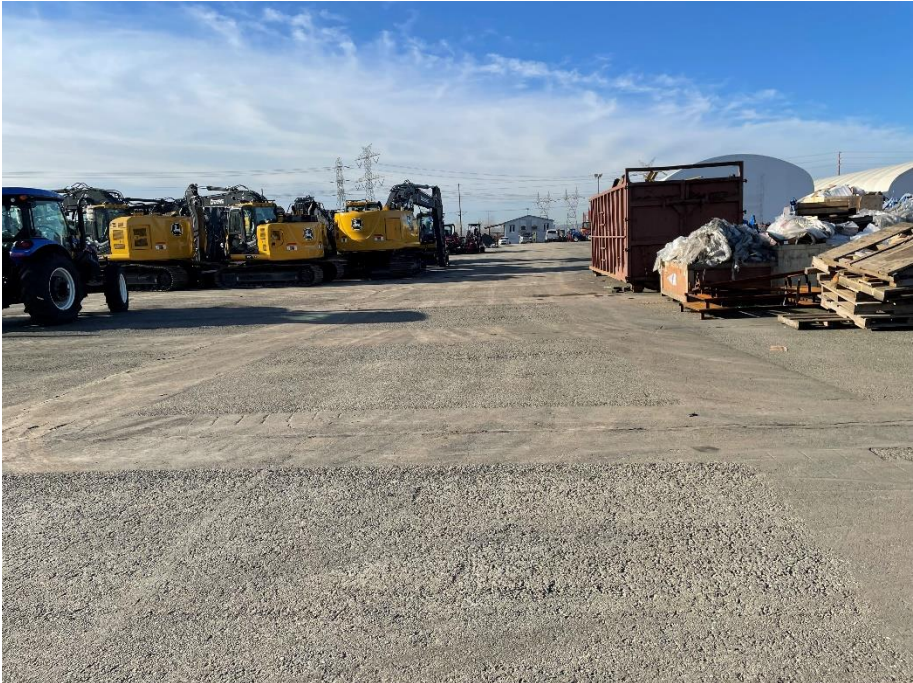
Photo 6 (facing northwest): View of the central portion of the capped area.

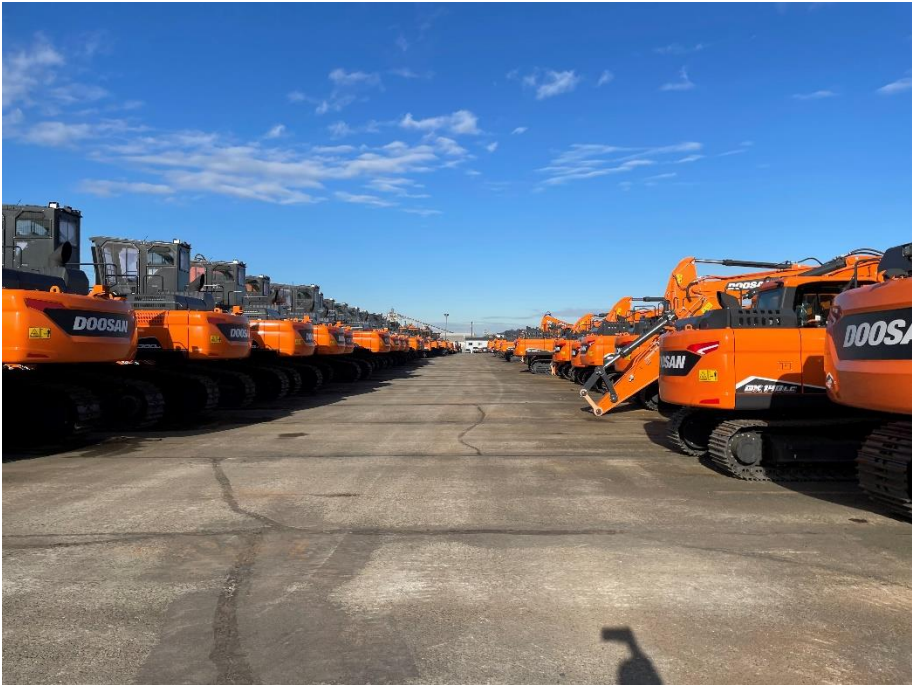
Photo 7 (facing northwest): View of the northeast portion of the capped area. Previous cap repairs are visible.

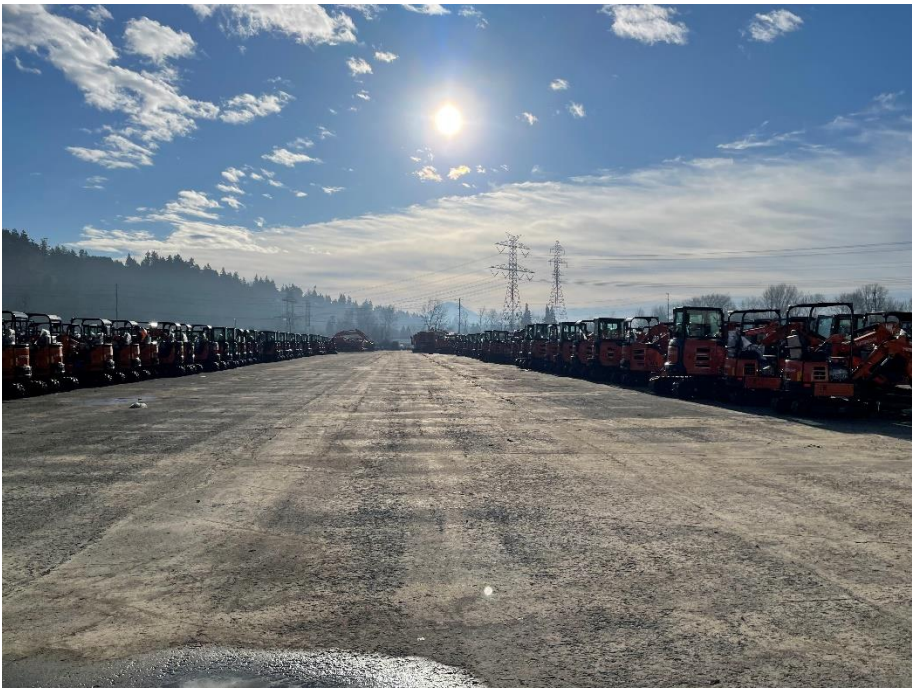
Photo 8 (facing southeast): View of the south-central portion of the capped area.

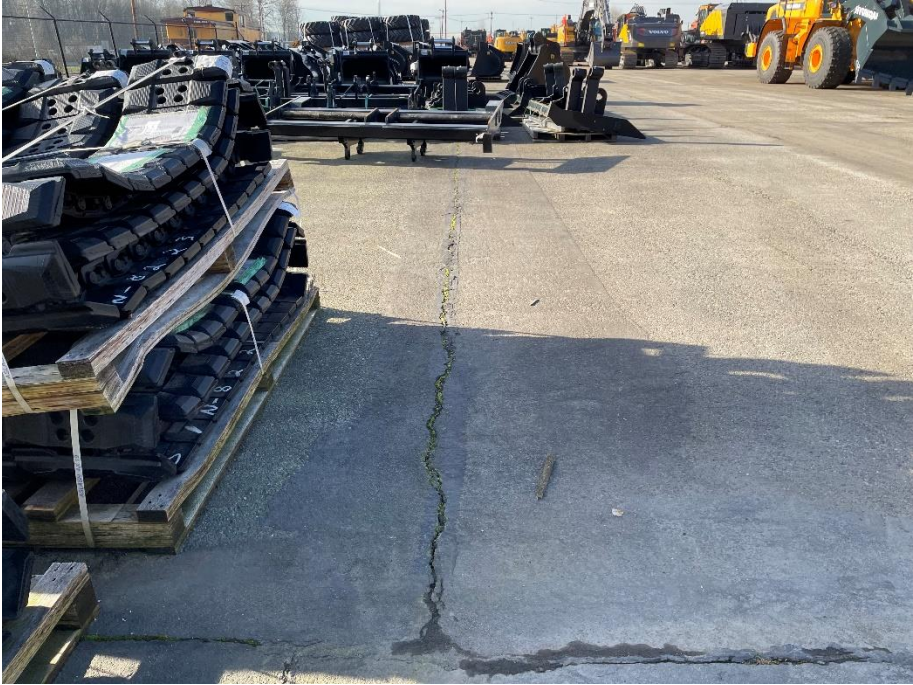
- The cap appears to be in satisfactory condition, and no repair, maintenance, or contingency actions are required at this time. Minor cracking was observed during the Site visit which should be evaluated during the next cap inspection event.

Photo 9 (facing southwest): View of minor cracking on the southern portion of the capped area.

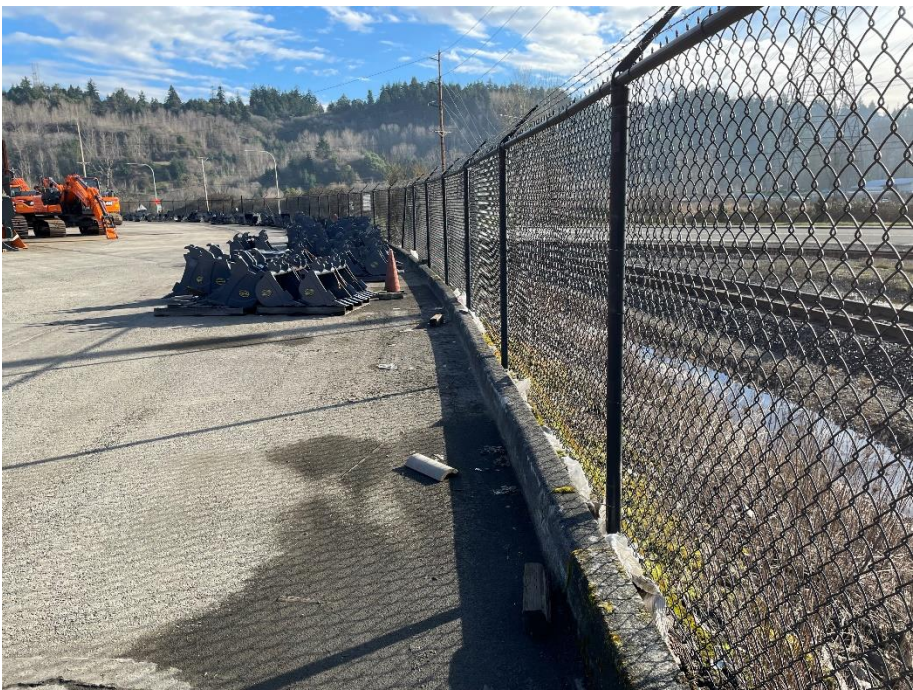
Photo 10 (facing northeast): View of curbing along the southern portion of the capped area.

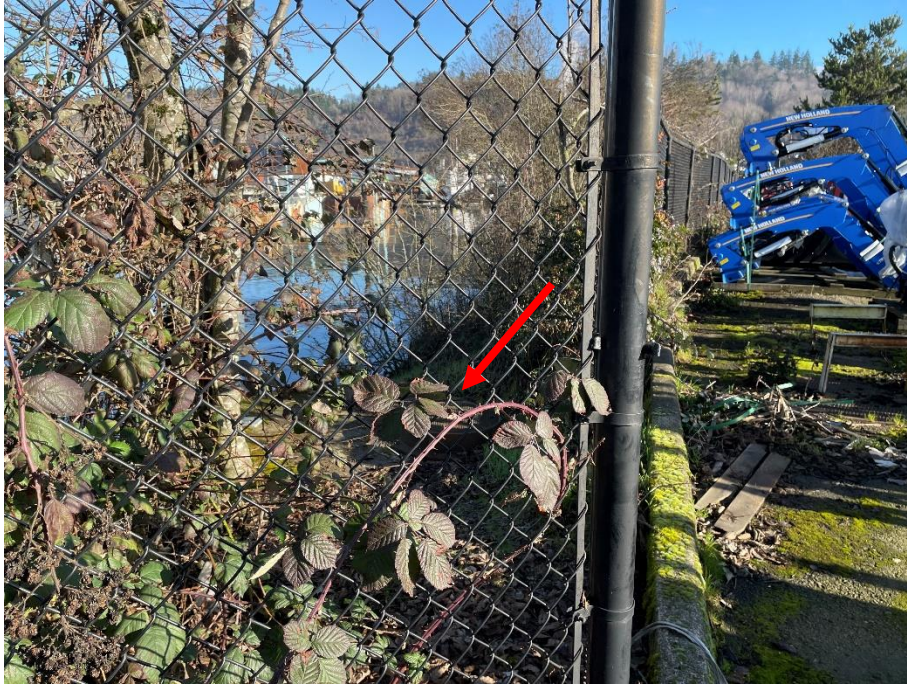
Photo 11 (facing northeast): View of a maintenance hole on the northern portion of the Site, adjacent to Hylebos Waterway.

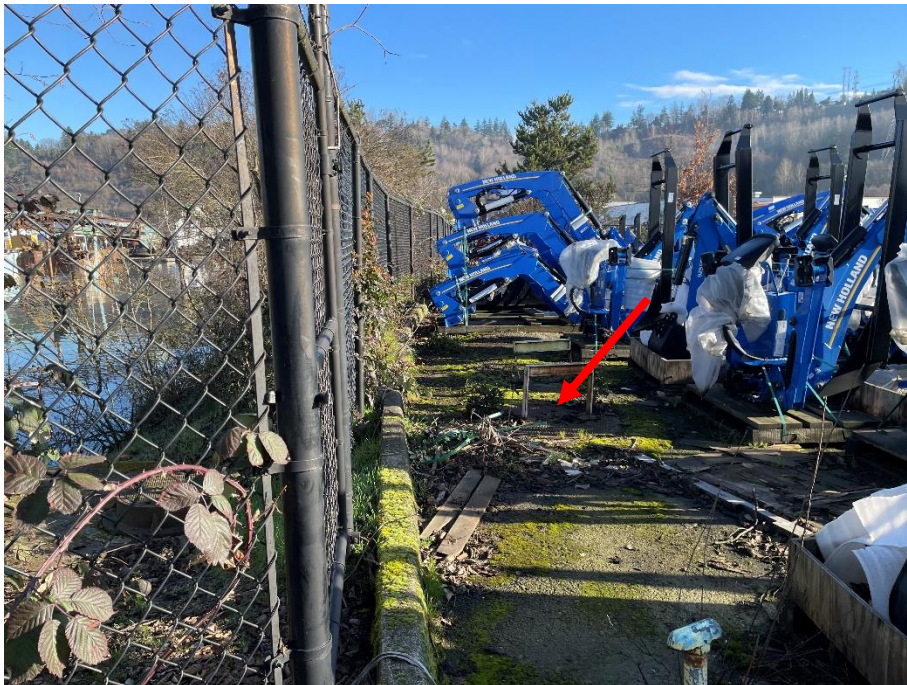
Photo 12 (facing northeast): View of the oil/water separator access on the northern portion of the Site.

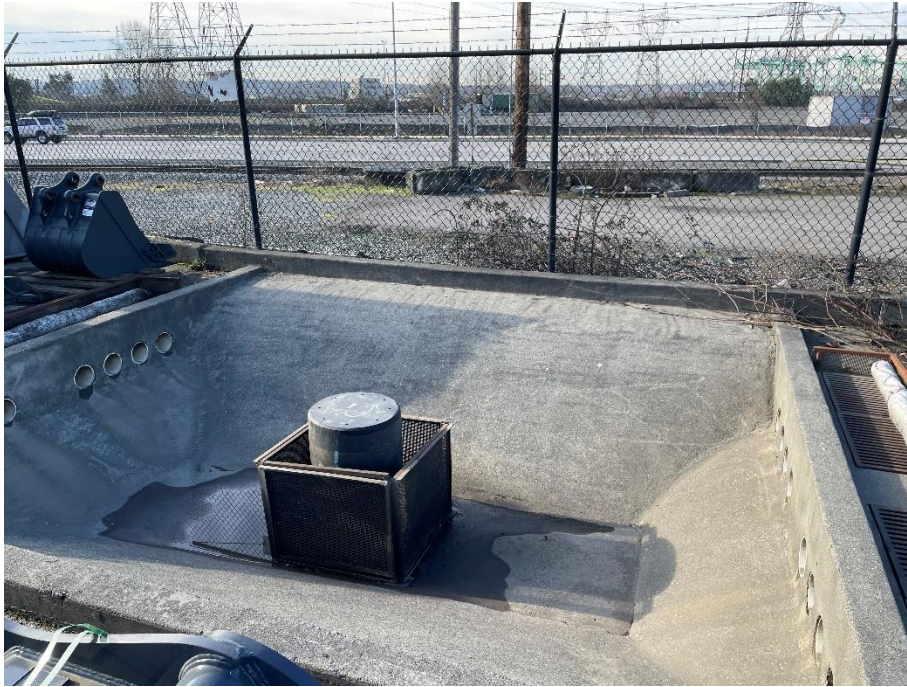
Photo 13 (facing southwest): View of a treatment basin on the southwest portion of the site near the main entrance.

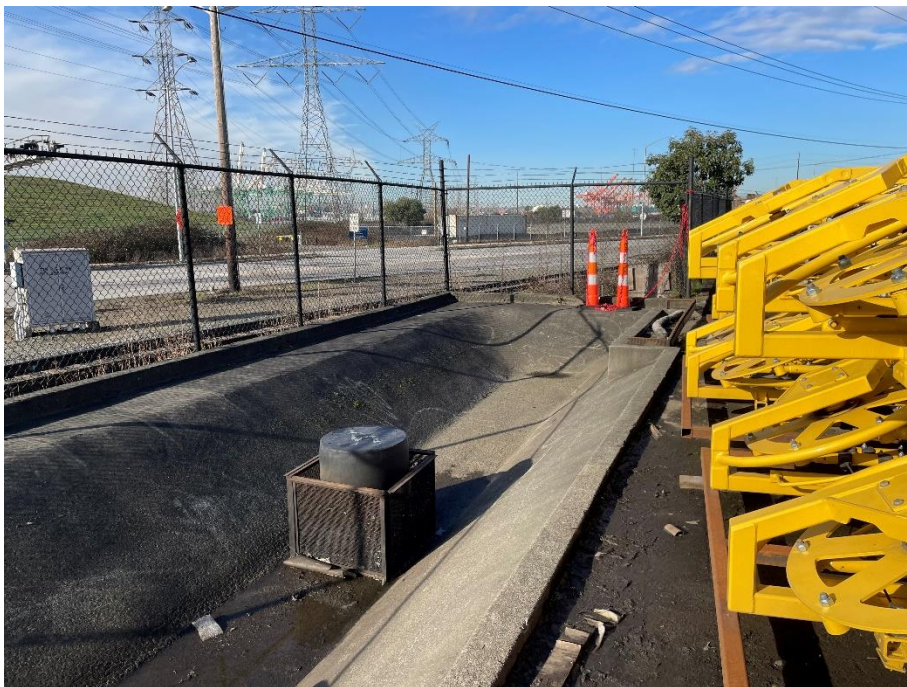
Photo 14 (facing southwest): View of another treatment basin on the southern portion of the Site.

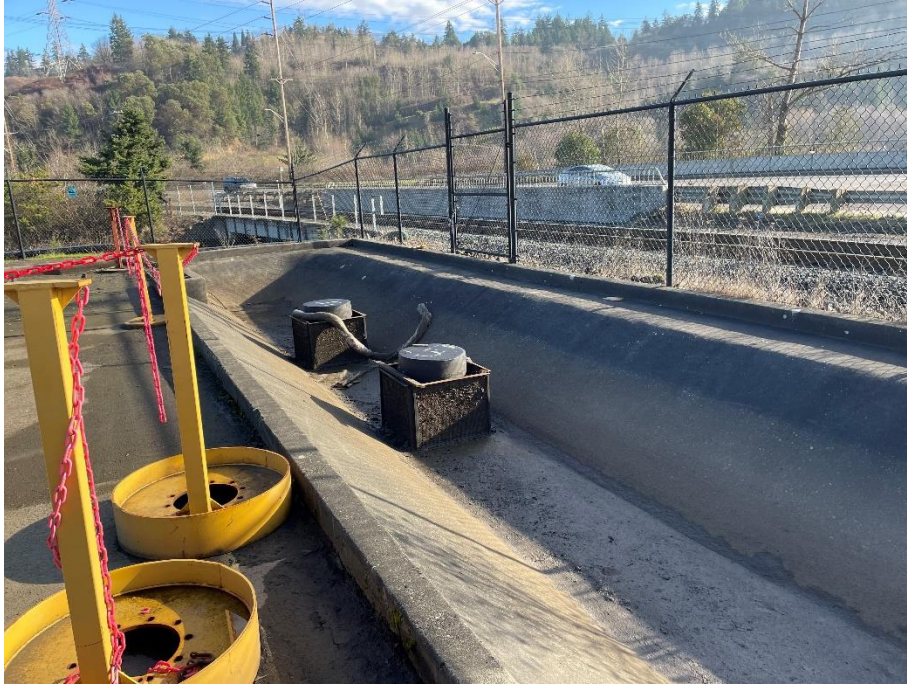
Photo 15 (facing northeast): View of a treatment basin on the eastern portion of the Site.

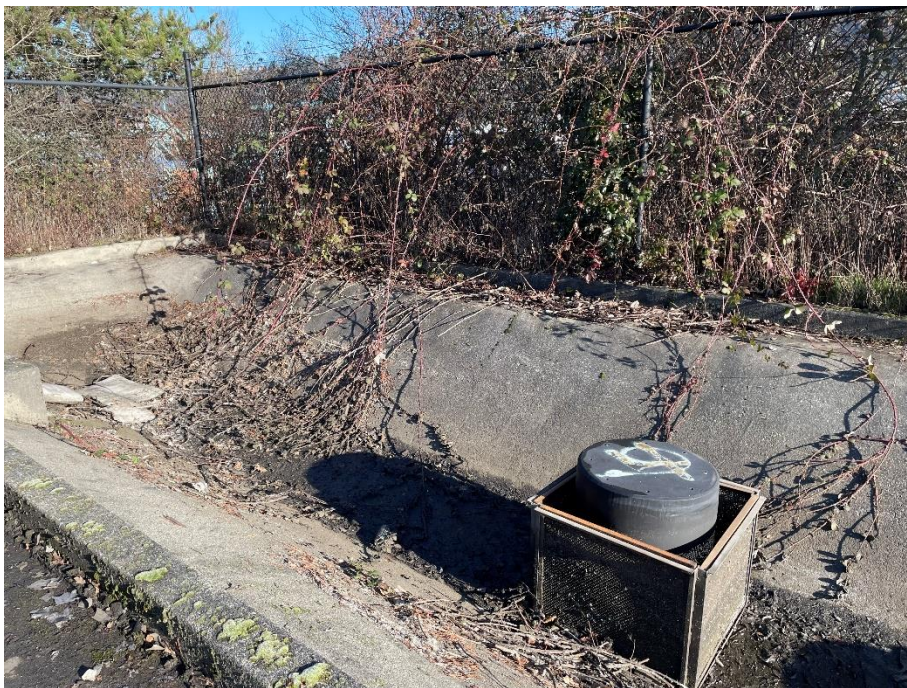
Photo 16 (facing north): View of a treatment basin on the northern portion of the Site. Some sediment and vegetation are visible.

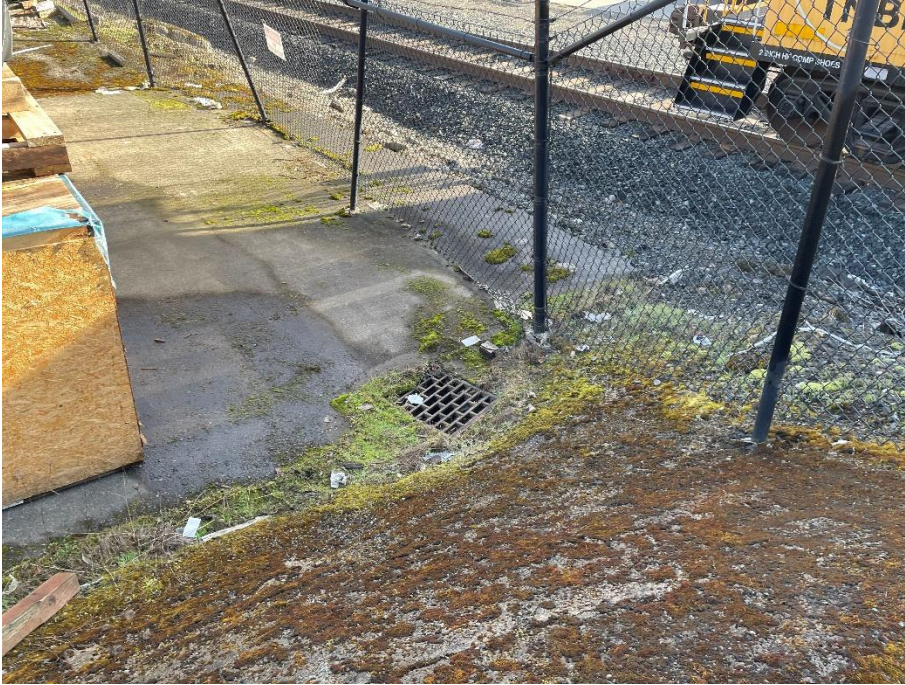
Photo 17 (facing not applicable [NA]): View of a catch basin on the southeast portion of the Site.

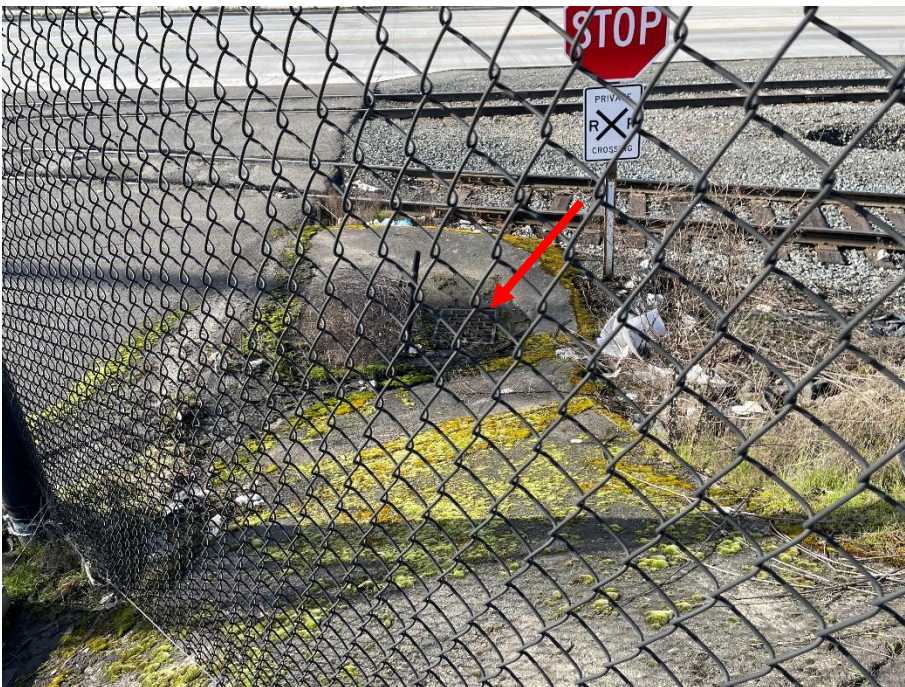
Photo 18 (facing NA): View of another catch basin on the southwest portion of the Site.

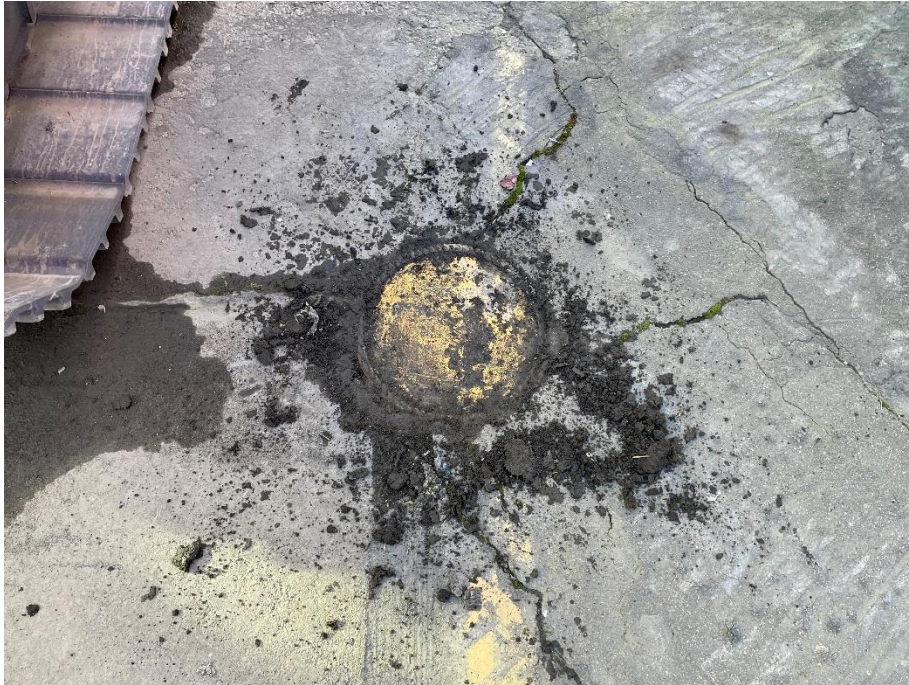
Photo 19 (facing NA): View of monitoring well LP-1.
