2023 ANNUAL PROGRESS REPORT

SWMU-1 OILY WATER SEWER

HF SINCLAIR PUGET SOUND REFINING LLC

MARCH 21, 2024

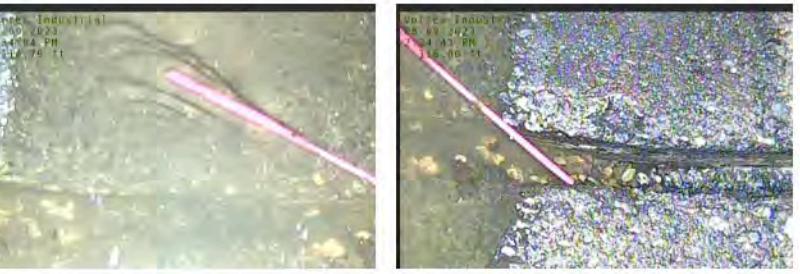
Crack Longitudinal	Point	122.7	Structural	0	5	2	0	0	1	Crack Longitudinal

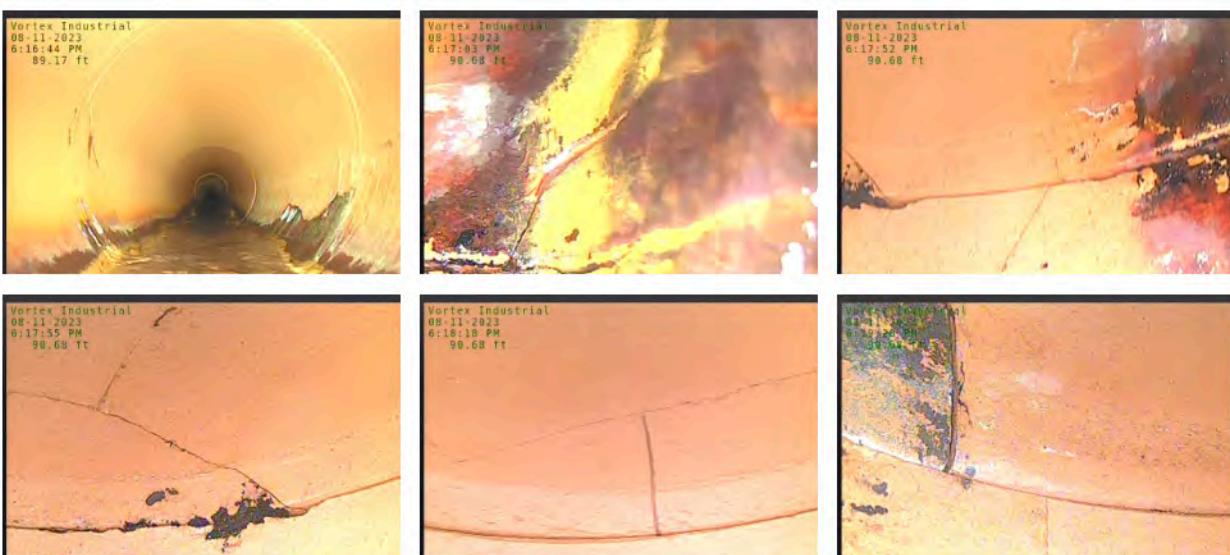
Crack Multiple	Point	90.7	Structural	0	12-12	3	0	0	2	Crack Multiple

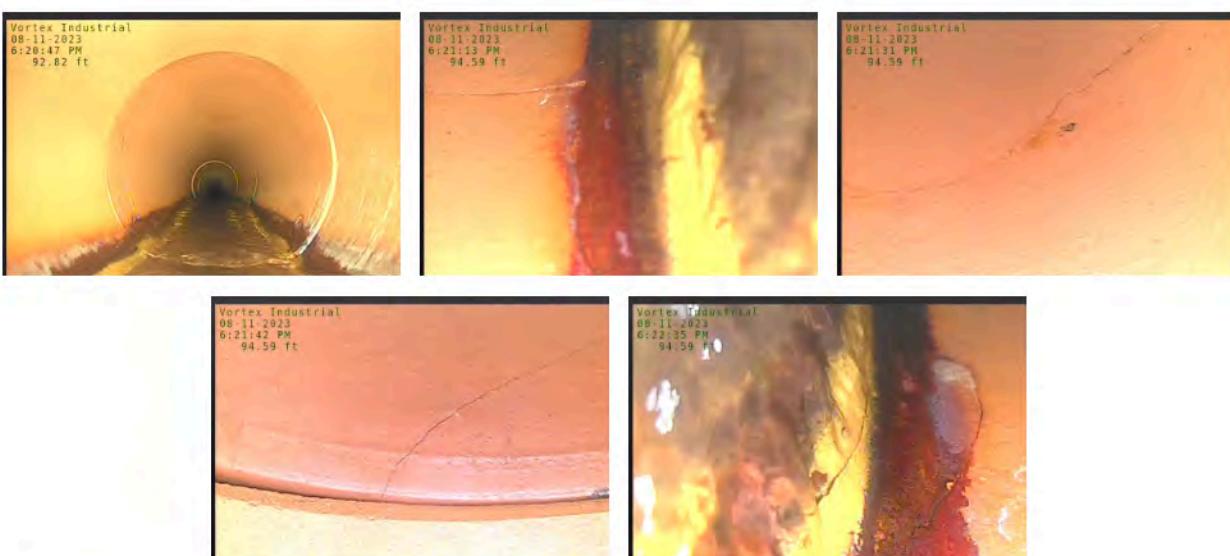
Crack Spiral	Point	94.6	Structural	0	12-12	2	0	0	2	Crack Spiral

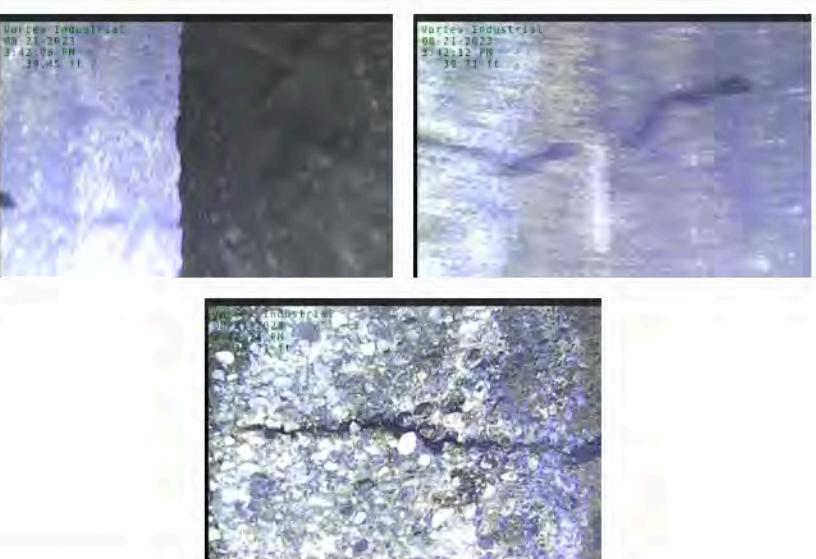
Crack Circumferential	Point	39.5	Structural	0	6-8	1	0	0	2	Crack Circumferential

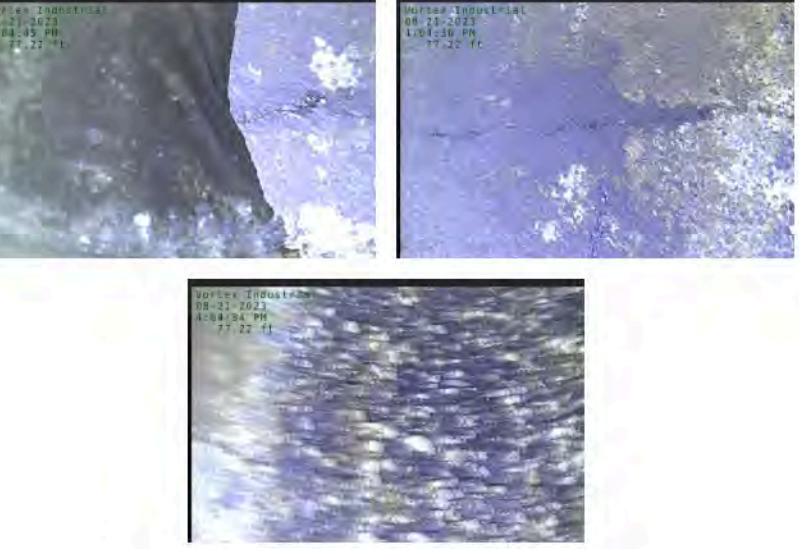
Crack Circumferential	Point	77.3	Structural	0	5-6	1	0	0	2	Crack Circumferential

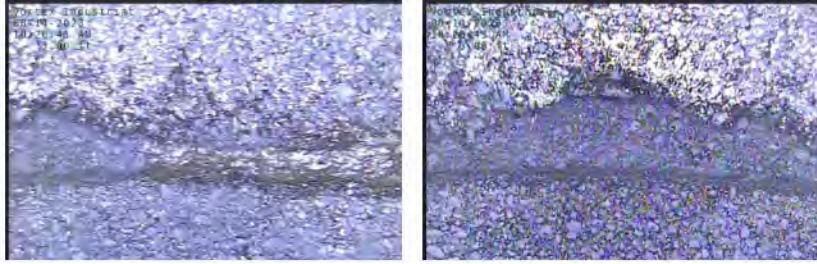
Fracture Circumferential	Point	3	Structural	0	10-11	2	0	0	0	2	Fracture Circumferential

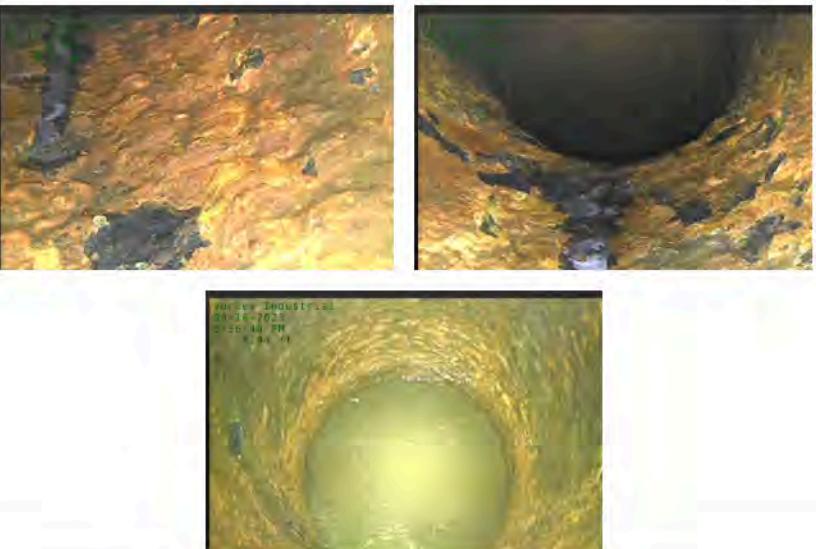
Surface Damage Corrosion	Continuous	0 - 14.9	Structural	0	12-12	3	0	0	2	2	Surface Damage Corrosion

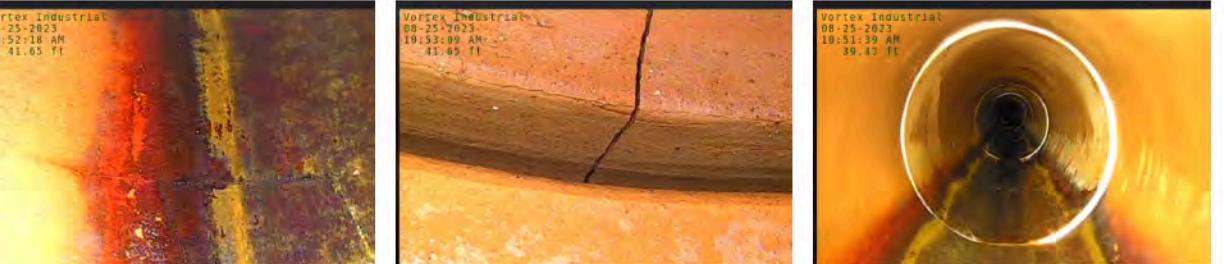
Crack Multiple	Point	41.7	Structural	0	5-11	3	0	0	2	Crack Multiple

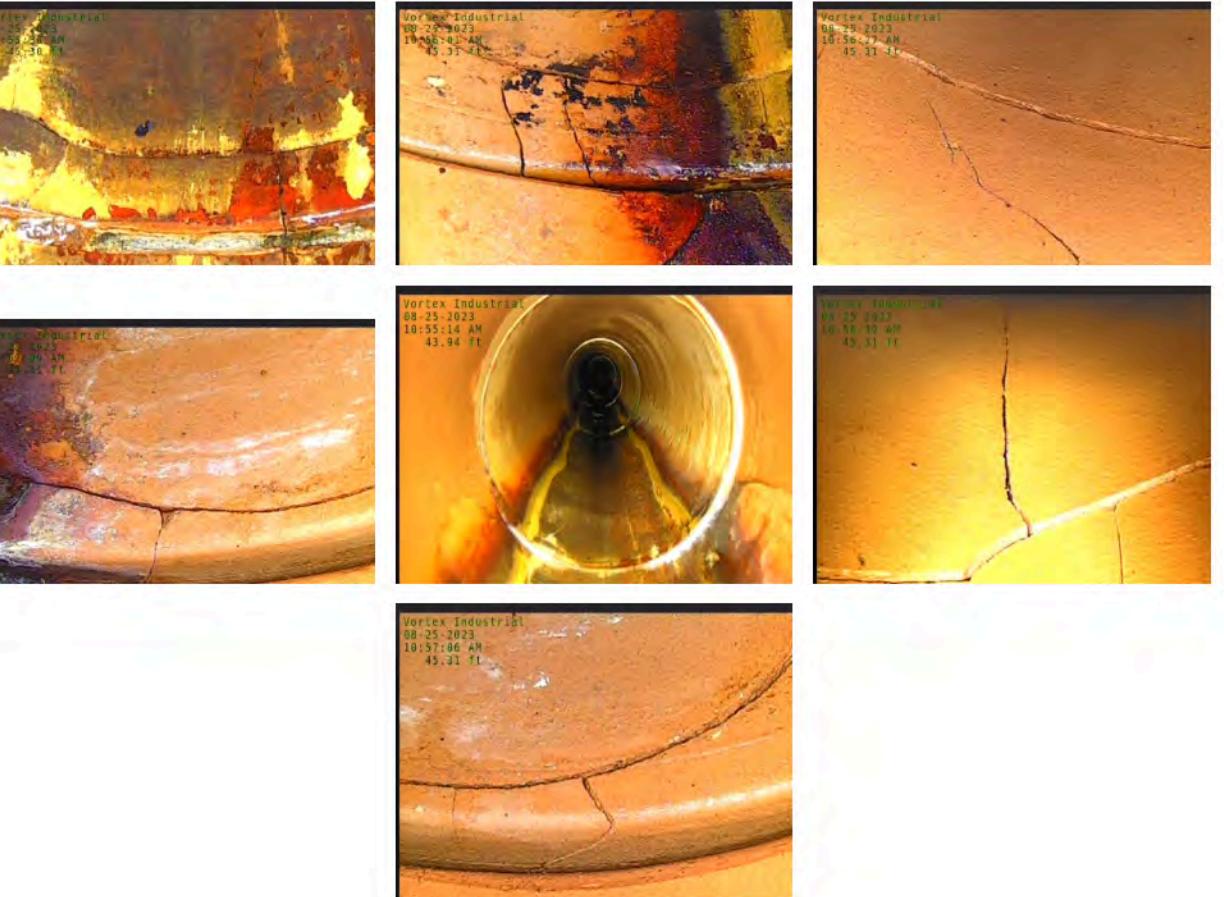
Fracture Multiple	Point	45.3	Structural	0	12-12	3	0	0	2	Fracture Multiple

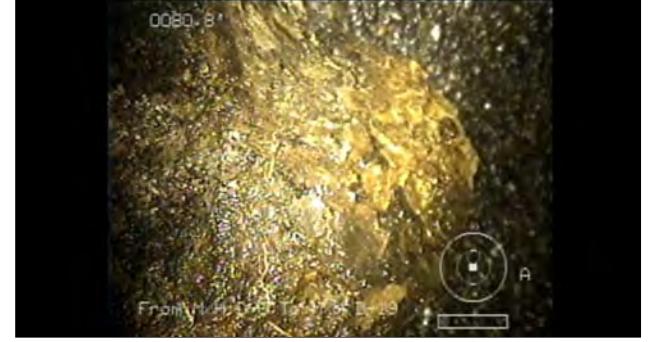
Obs: HSV - Hole Soil Visible		
Comments:		
EER: 3

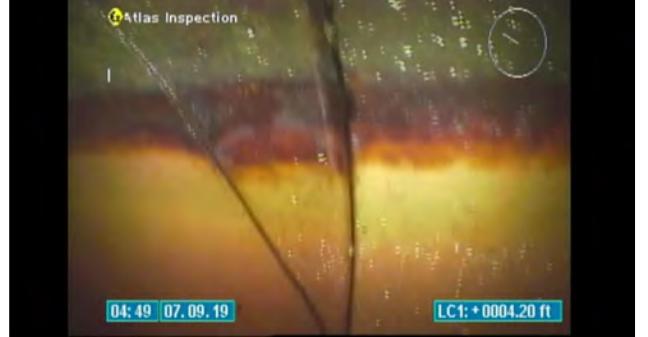
Distance: 0.9 ft		
Obs: FC - Fracture Circumferential		
Comments:		
EER: 2	04:48 07.09.19 LC1: +0000.60 ft	04:49 07.09.19 LC1: +0004.20 ft

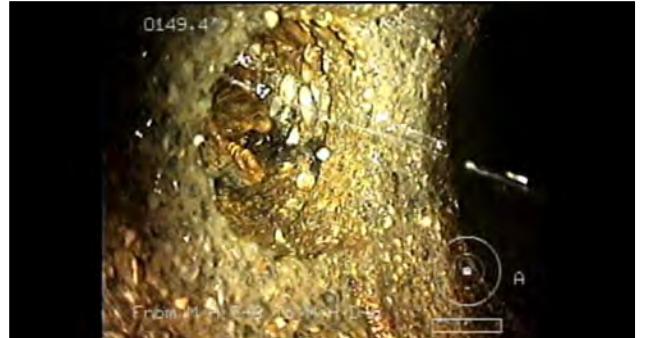
The maintenance and repair history of the AOC-1 D St. sewer segment was researched and it was determined that the EER 4 identified in the 2022 report was a cutout in the pipe to allow manhole D-20 to access the main trunk line. The line was original pipe installed circa 1957. Manhole D-20 was installed in 2002 per plan drawing 35ES0034. It is not uncommon for new manholes to be built around existing

pipes and the pipe be broken out when construction of the manhole is complete. A photo of the EER 4 identified in manhole D-20 is included in Attachment 3 of the 2023 TRC report (Setup ID 2023-ST-5, Structure ID *D-20*).

Based on the maintenance and repair history of manhole D-20, the EER 4 identified in the 2022 *Evaluation and NASSCO Rating of Existing Sewer Videos* report is actually not an EER 4 and could not cause a release to soil or groundwater. The EER 3s identified at AOC-1 in the 2022 report were corroborated by the 2023 inspection findings (TRC, 2024; Figure A-4).

149.4_BVV_From-09_To-.jpg	172.6_TBI_From-12_To-.jpg	
Date: 11/07/2022	Date: 11/07/2022	
Distance: 172.6 ft	Distance: 172.6 ft	
Obs: BVV - Broken Void Visible	Obs: TBI - Tap Break-in Intruding	
Comments:	Comments:	
EER: 3.	EER: 1
