**Re: East Side Conceptual Site Model and Data Gaps Report**

- **Site Name:** Boise Cascade Mill (aka Yakima Mill Site)
- **Site Address:** 805 N 7<sup>th</sup> Street, Yakima
- **Facility/Site ID No.:** 450
- **Cleanup Site ID No.:** 12095
- **Agreed Order No.:** DE 13959

# **East Side Conceptual Site Model and Data Gaps Report**

## ***Boise Cascade Mill Site (aka Yakima Mill Site)***

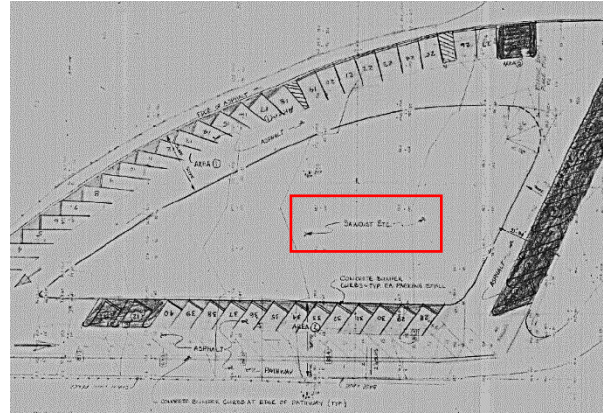
By 1968, the southeast corner of the parcel is mostly free of vegetation until the development of the Yakima Greenway's Rotary Lake Park and Ride parking lot. The parking lot is first visible in a 1991 aerial photograph and was likely constructed with the establishment of the Yakima Greenway in about 1988. An undated as-built map provided by Yakima County for the Rotary Lake Park and Ride parking lot identifies the area in the center of the parking lot loop as "sawdust, etc.". Based on the identification of sawdust in the Rotary Lake parking lot, it is concluded that log yard material placement extended into the southeast portion of Parcel B.

*Rotary Lake Park & Ride As-Built depicting "Sawdust Etc." on Parcel A (see Attachment C for the as-built drawing)*

Historical research shows that possible Mill-related impact to Parcel B is limited to the presence of log yard materials in the southeast corner of the parcel.

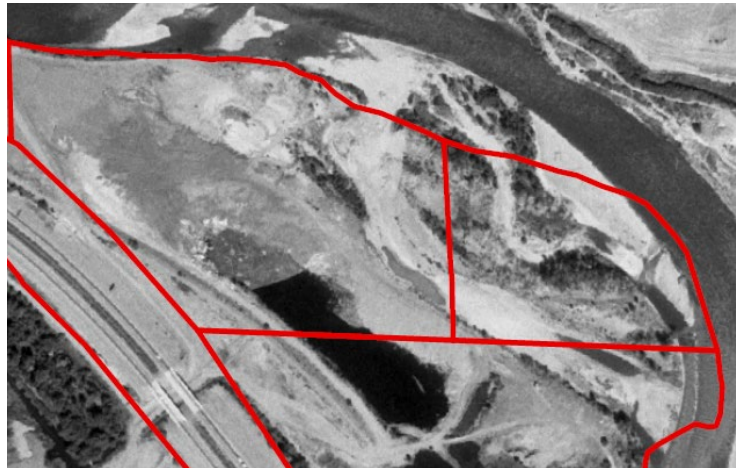
Log yard material placement appears to have occurred in portions of Parcel C1. The backfilled interstate borrow pit on Parcel C1 appears to have been filled with log yard material or some other fill. Pathways appear to lead from the Mill Site on the west side of I-82 to the filled interstate borrow pit. Other smaller ponds appear to have been excavated on the parcel for gravel production and then later backfilled, except for the remaining northeast Parcel C1 pond. This pond is located east of the levee and the Yakima Greenway Rotary Lake Park and Ride parking lot.

*1974 EDR Aerial - Backfill of the interstate borrow pit  
(see Attachment C for the aerial photograph)*

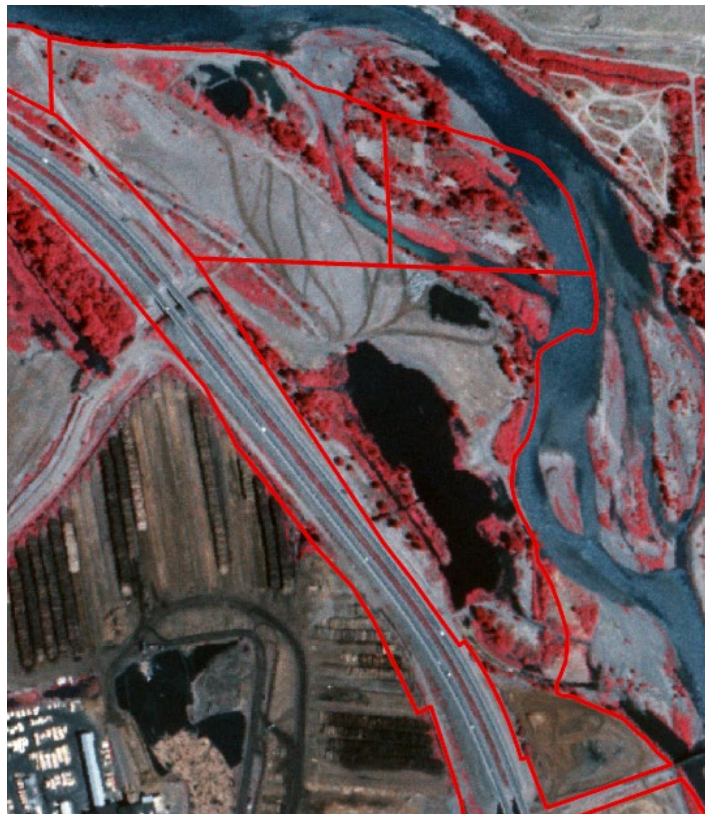
*1981 EDR Aerial depicting backfill, ponds, and gravel production on  
Parcels C and D (see Attachment C for the aerial photograph)*

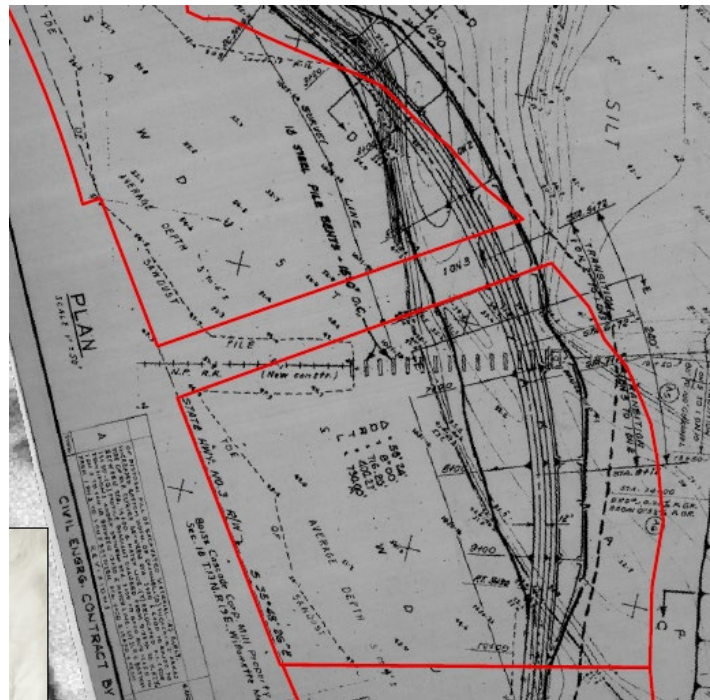
A 1966 levee repair map identifies sawdust on Parcel D, north and south of the railroad and on Parcel E. The 1966 levee repair map notes that the sawdust has an average depth of 3 to 4-feet.

*1966 Levee Repair Map with sawdust pile indicated on Parcels D & E  
(see Attachment C for the map)*

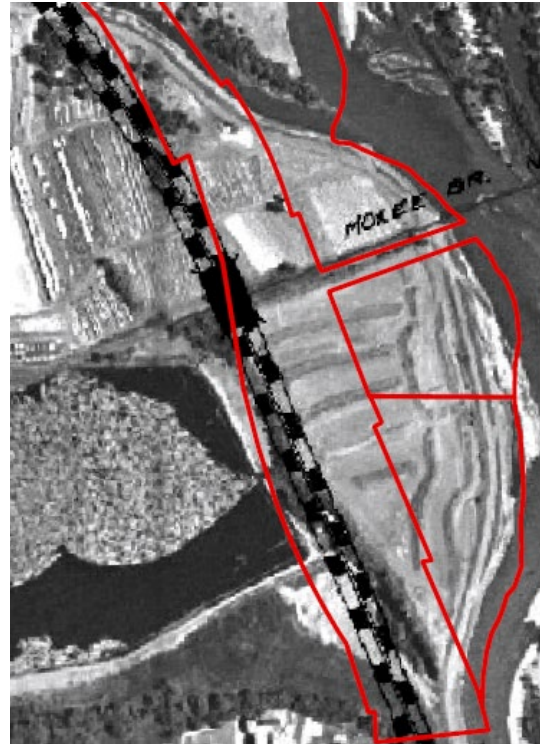
Most of Parcel E appears to have been potentially impacted by Mill-related activities, principally through the placement or storage of log yard materials.

*1947 Yakima County Aerial depicting material on Parcel E (see Attachment C for aerial photographs)*
